# Grand Canyon Park Headquarters

Historic Structure Report

**GRAND CANYON**  
National Park • Arizona

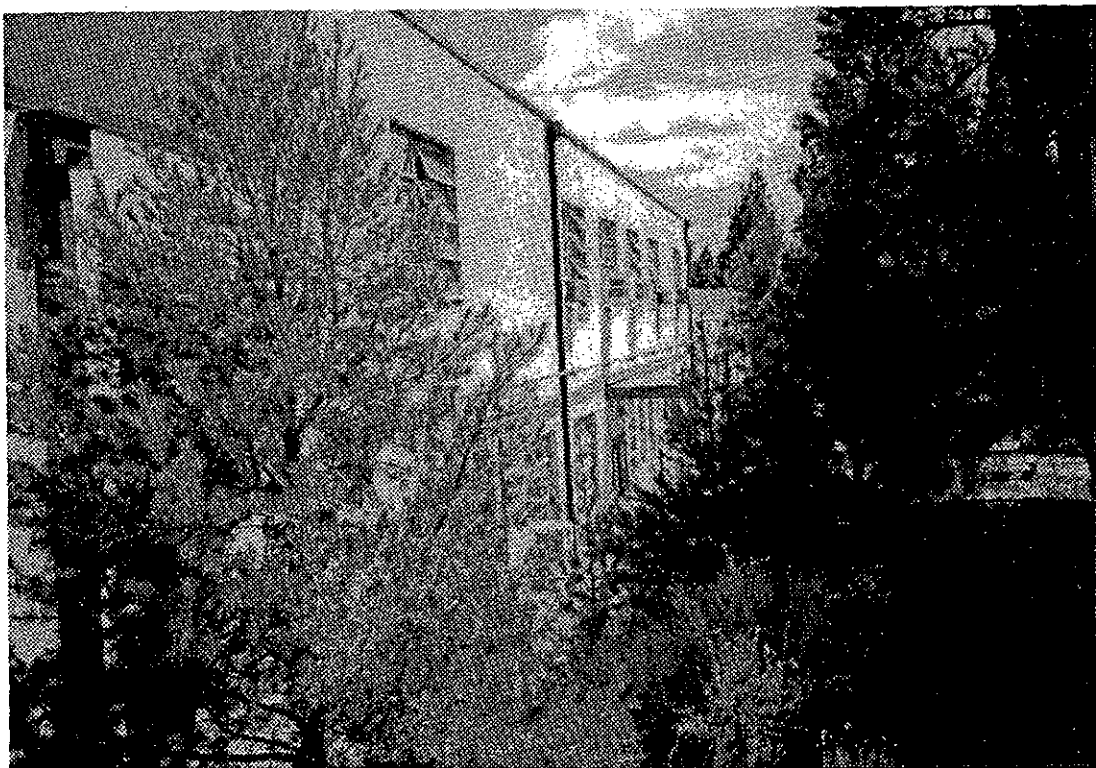
*Figure 5. Rear elevation is not landscaped. Plantings encroach on the structure. ARG Photo, dated May, 2000.*

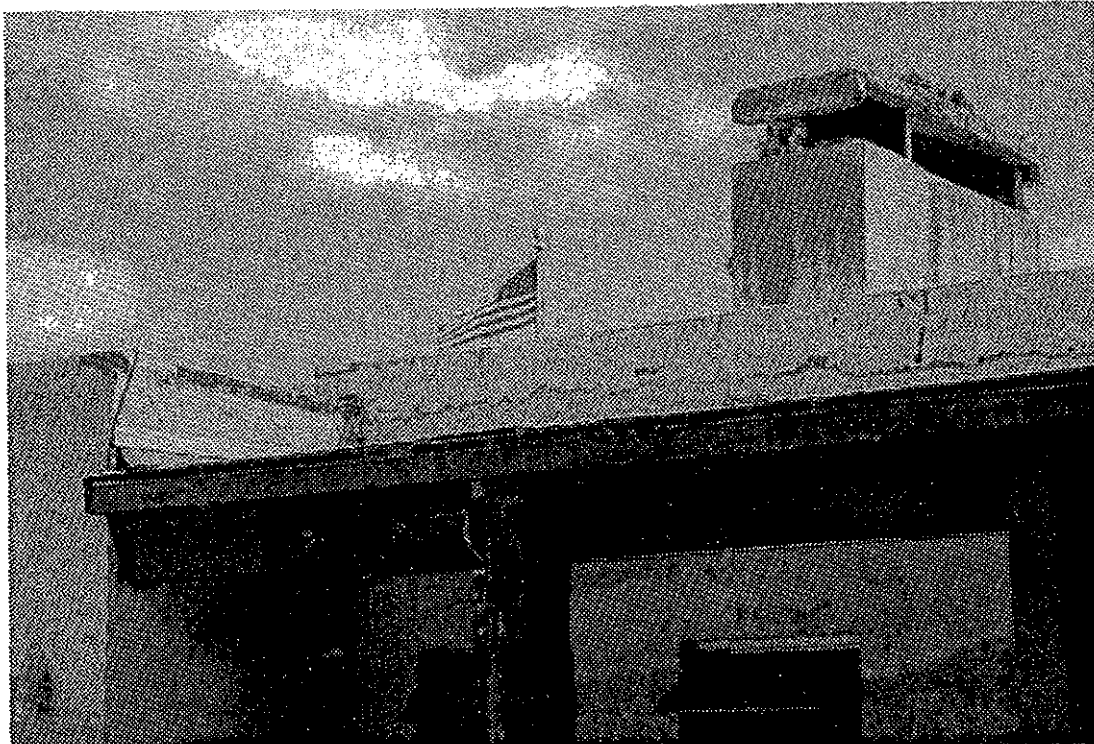
- cement stucco deterioration of the parapet, chimney and flue related to water infiltration and leading to concrete failure (See Appendix E, Figure 17) ;
- failure of the concrete ramp addition and limited concrete failure at retaining walls;
- deterioration of exterior flagstone paving stones;
- loss of mortar (See Appendix E, Figure 18);

*Figure 17. Parapet deterioration. ARG Photo, dated May, 2000.*

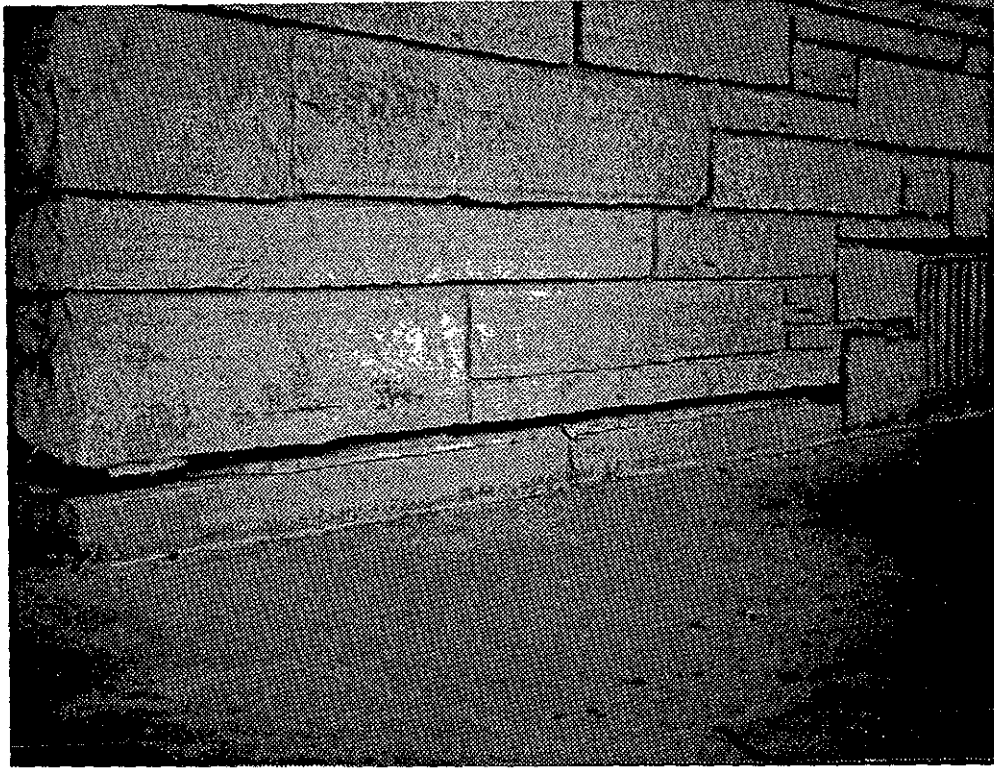
*Figure 18. Mortar loss at lower level of pier on principal elevation. ARG Photo, dated May, 2000.*

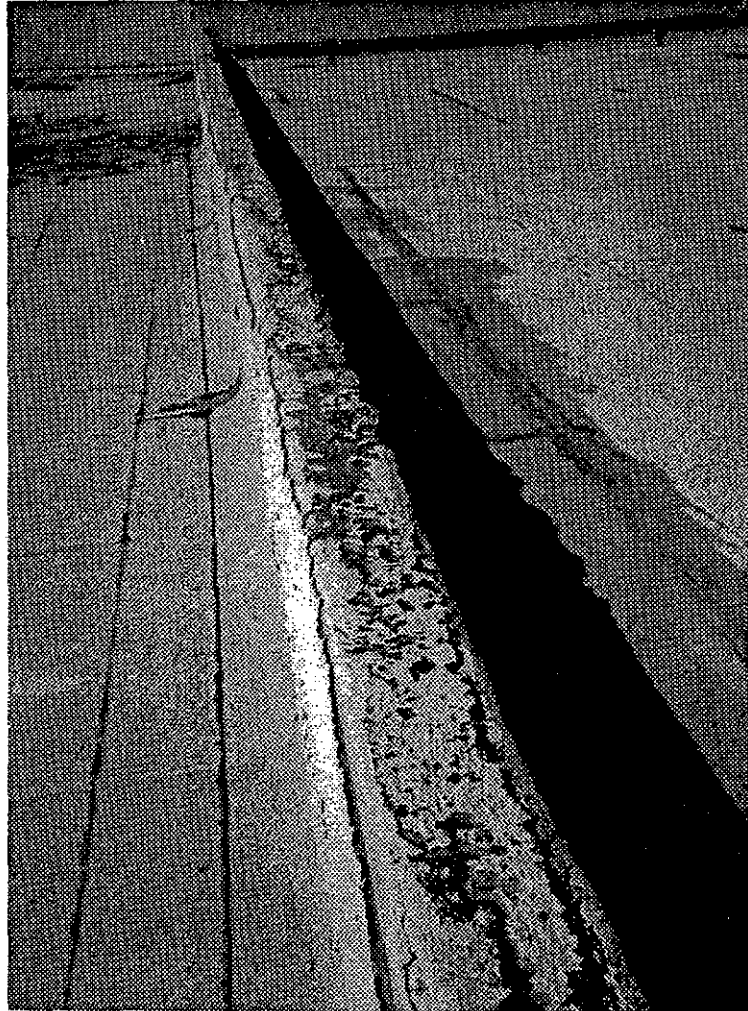
- roof membrane deterioration due to water and weathering (See Appendix E, Figure 20);
- poor drainage off roof and canopies;
- scuppers do not drain properly;
- deteriorated flat roof membrane due to weathering, flashing, persistent leakage, pooling water;
- failure of urethane sealant, yellowed, crumbling; and,
- problematic joints with flat overhangs, water problems at connections, evidence of efflorescence at entrance pier and canopy junction. (See Appendix E, Figure 21)

*Figure 20. Parapet deterioration at roof and extent of urethane repair failure. ARG Photo, dated May, 2000.*

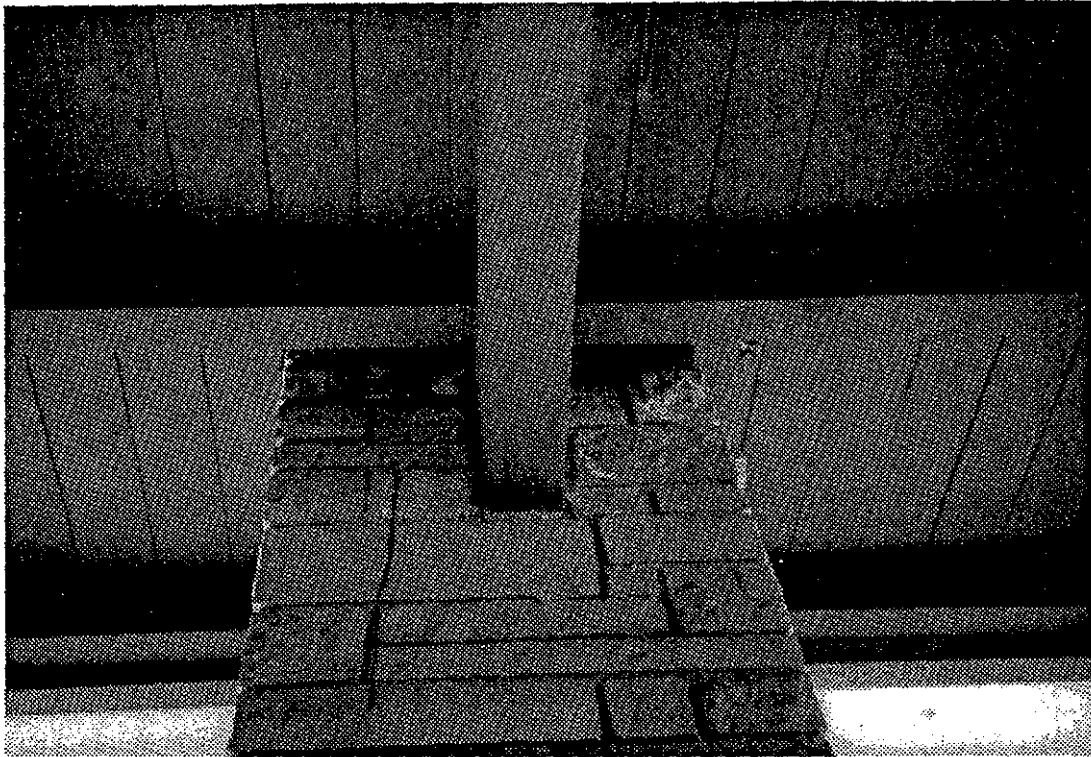
*Figure 21. Image shows efflorescence and water infiltration on pier at canopy junction.  
ARG Photo, dated May, 2000.*

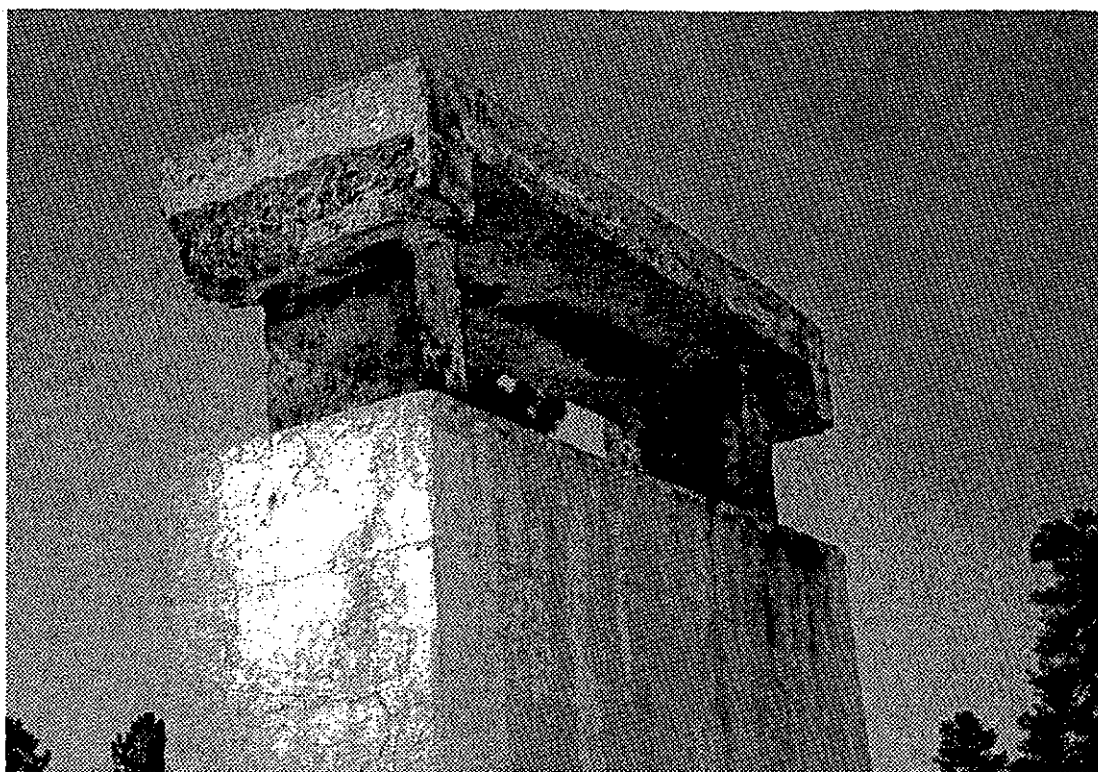
The foundation is poured-in-place concrete. The walls are constructed in concrete block masonry. The first floor is constructed primarily of structural concrete slab, over crawlspaces and on grade. The retaining walls and columns within the crawlspaces are concrete. The foundation is solid. The walls are plumb and in good condition. The concrete cap on top of the masonry wall is exhibiting signs of deterioration all around the perimeter and may require patching or replacement. The fireplace chimney and heating flue both have reinforced concrete caps that exhibit severe deterioration with exposed reinforcing steel. (See Appendix E, Figure 22)

*Figure 22. Deterioration at chimney flue. ARG Photo, dated May, 2000.*

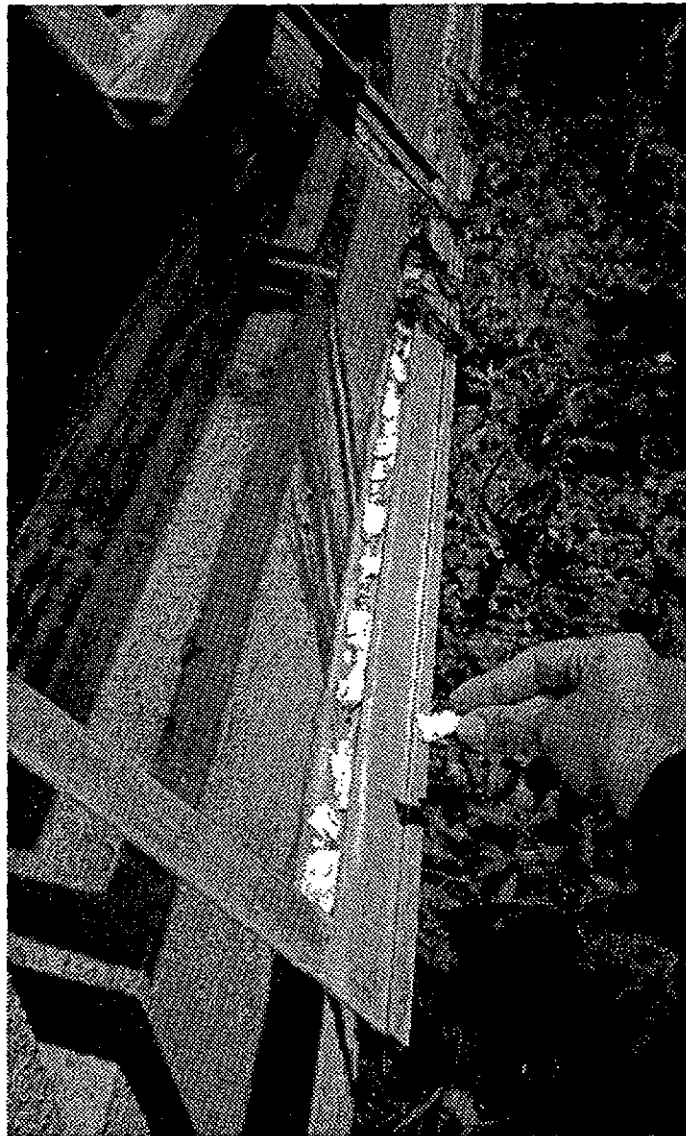
*Figure 23. Putty deterioration at window. ARG Photo, dated May, 2000.*

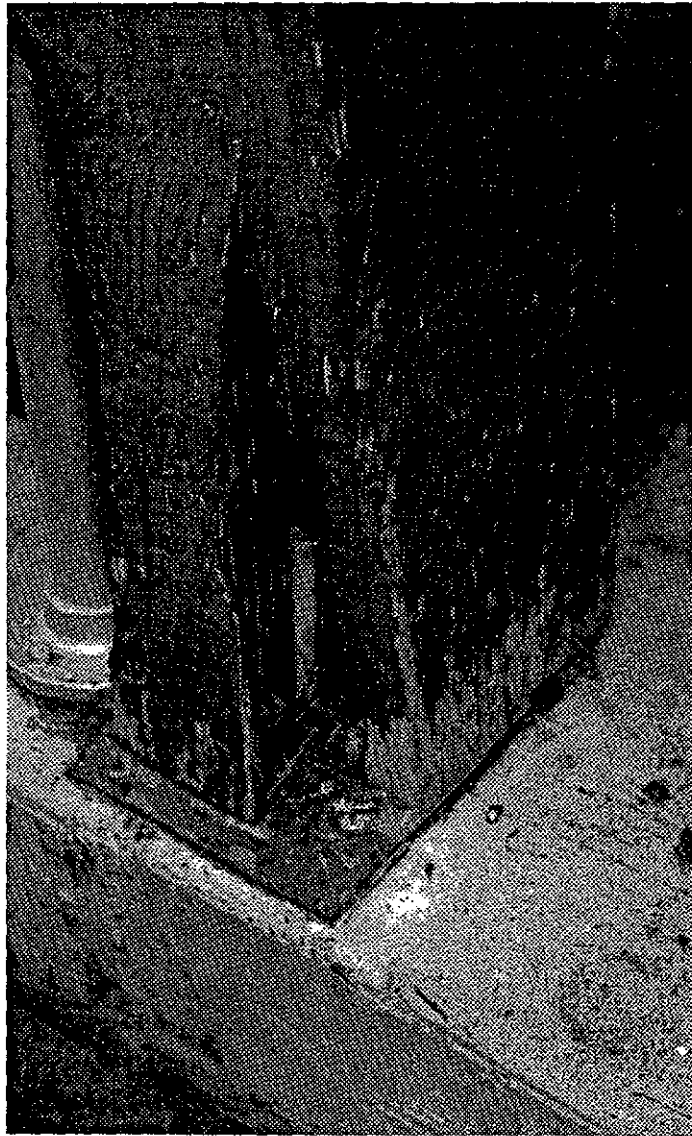
*Figure 24. Tapered column at north elevation, shifted off steel base plate, a large split at bottom and exposure of the vertical steel dowel within the column. Damage caused by car. ARG Photo, dated May, 2000.*

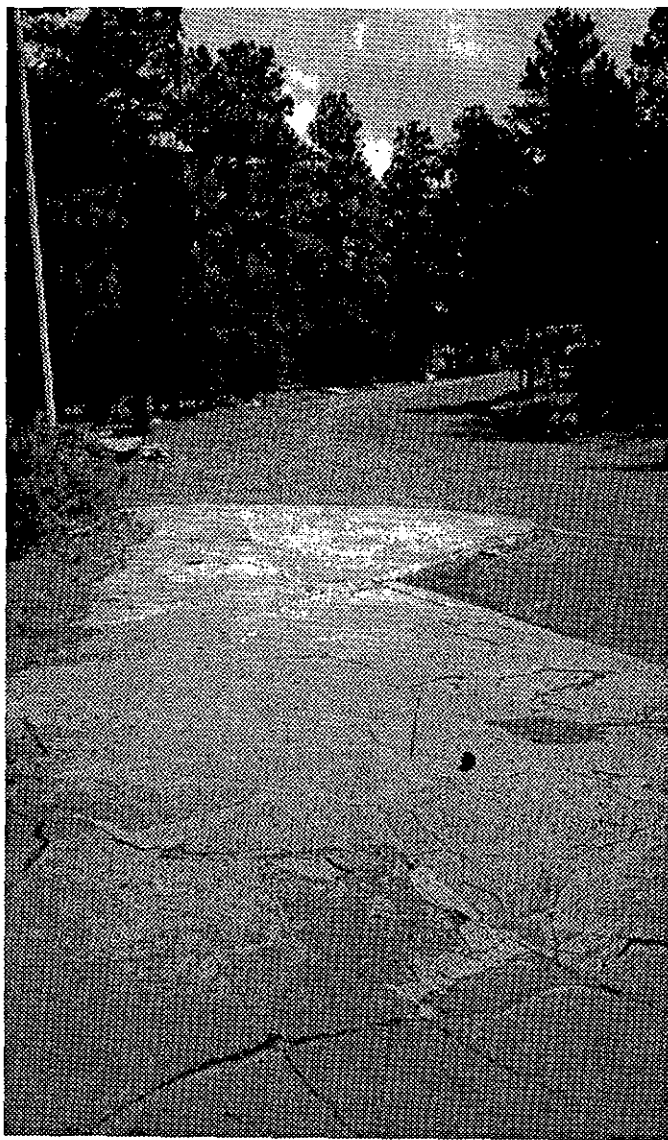
The flagstone paving at front of building and at the interior patio is worn, chipped, and damaged and in need of repair. (See Appendix E, Figure 25)

*Figure 25. Deterioration of flagstone paving at the building exterior. ARG Photo, dated May, 2000.*
