KIRK STREET AGENTS' HOUSE

Lowell National Historical Park

KIRK STREET AGENTS' HOUSE
HISTORIC STRUCTURE REPORT
Lowell National Historical Park
Lowell, Massachusetts

Maureen K. Phillips

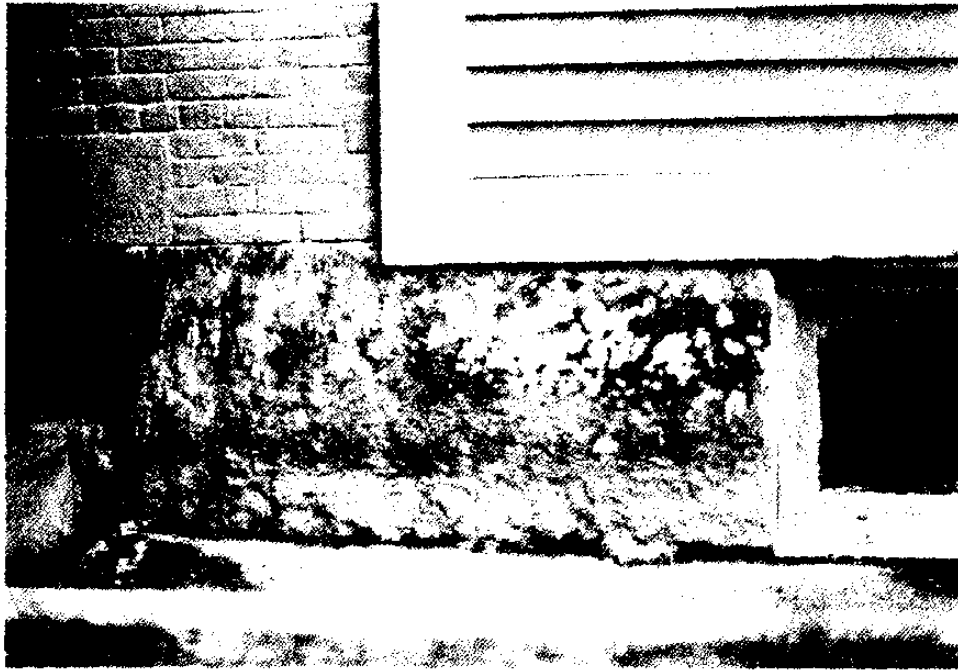
The facing stones of the stair towers' foundations extended beneath the wood sills of the ells (fig. 21). Due to several episodes of alterations to the ells, the original foundation-facing material of the ells' rear-yard and east elevations is not known.

Figure 21. Exterior South Elevation, Junction of Foundation of South-Unit Stair Tower and Ell.

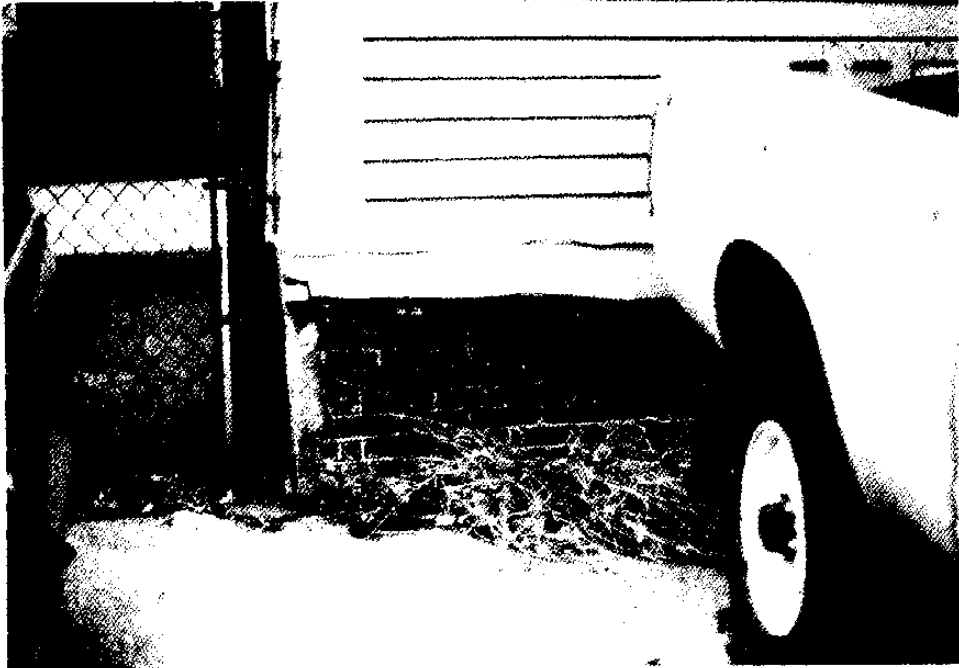
Figure 71. Ell, East Elevation: Foundation and Water Table at South End.

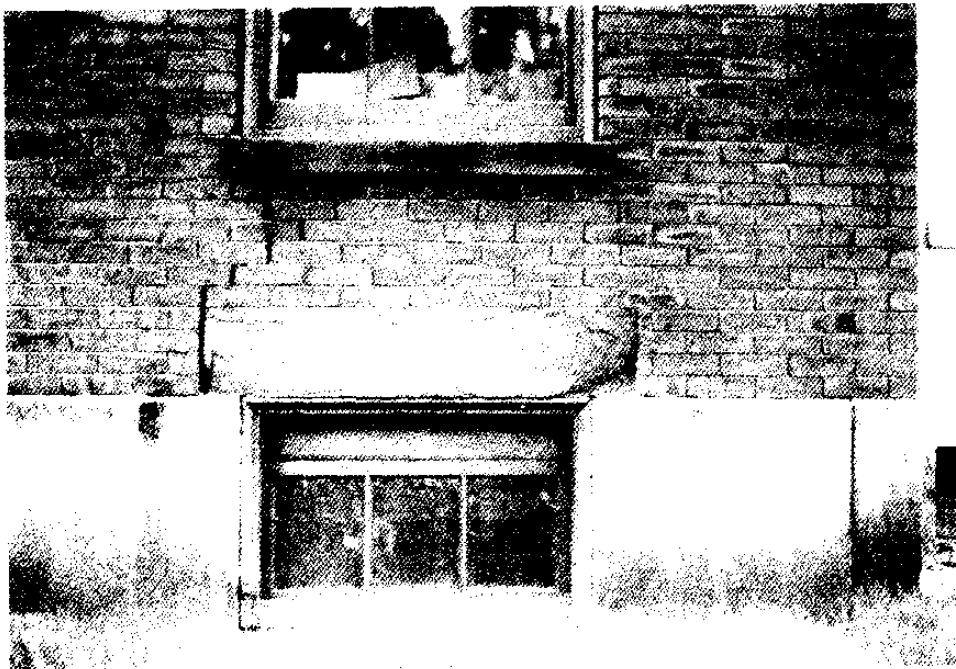
Figure 72. Main Block, South Elevation: Brownstone and Mortar Deterioration between Windows W002 and W111.

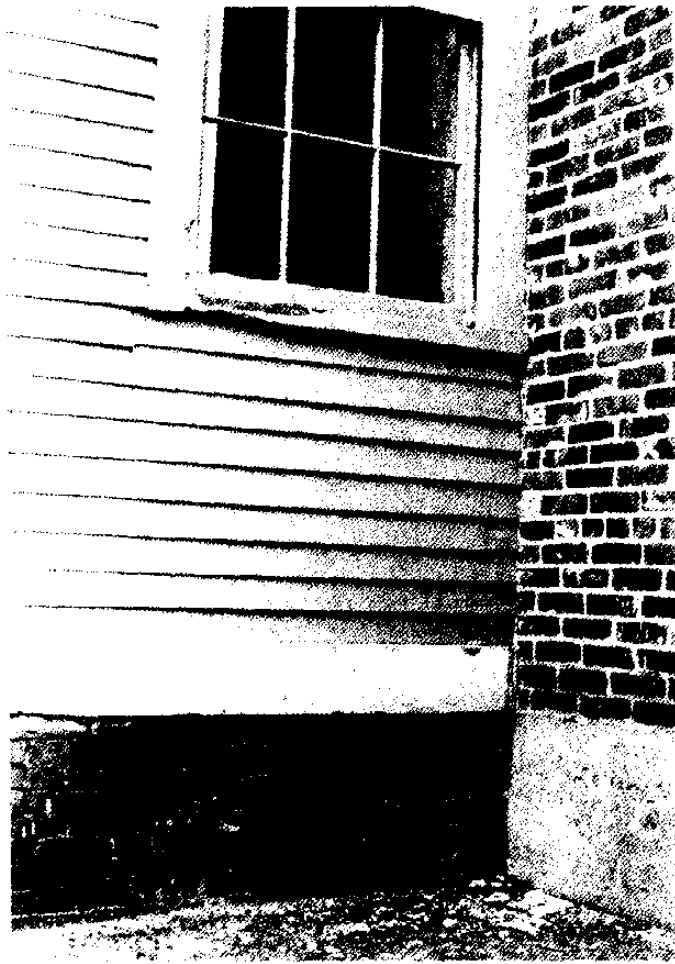
Figure 75. Ell, North (Rear-Yard Elevation): Foundation and Water Table.

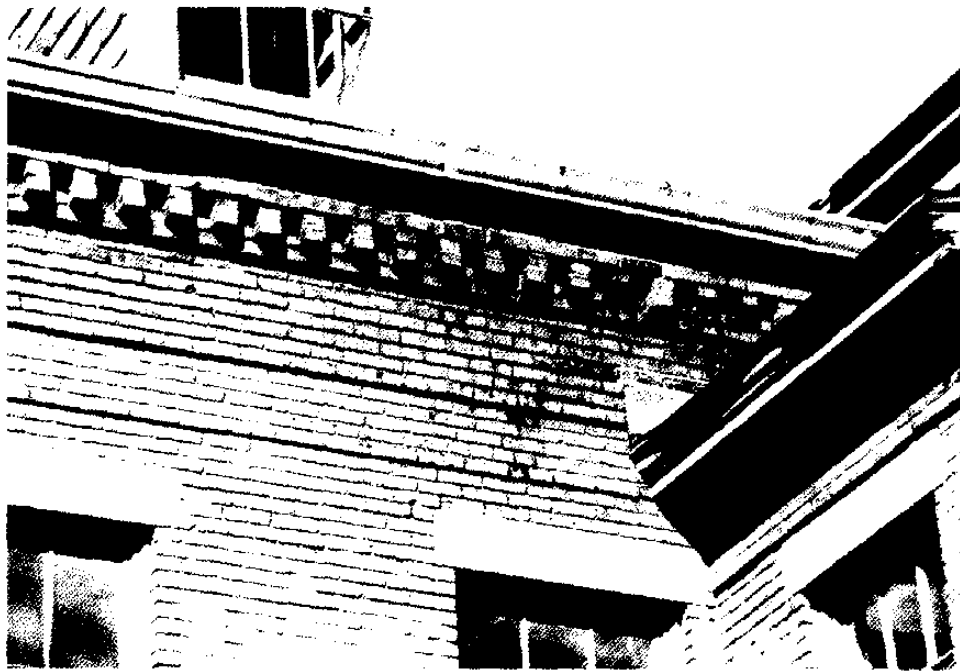
South (Rear-Yard) Elevation. As on the north side of the roof, a remnant of an early wood gutter can be seen under the extant roofing (fig. 76). It, too, was part of a gutter system that served the former roof over the stair tower and the north unit's ell.

Figure 76. Main Block, East Elevation: Cornice and Eaves at Stair Tower.

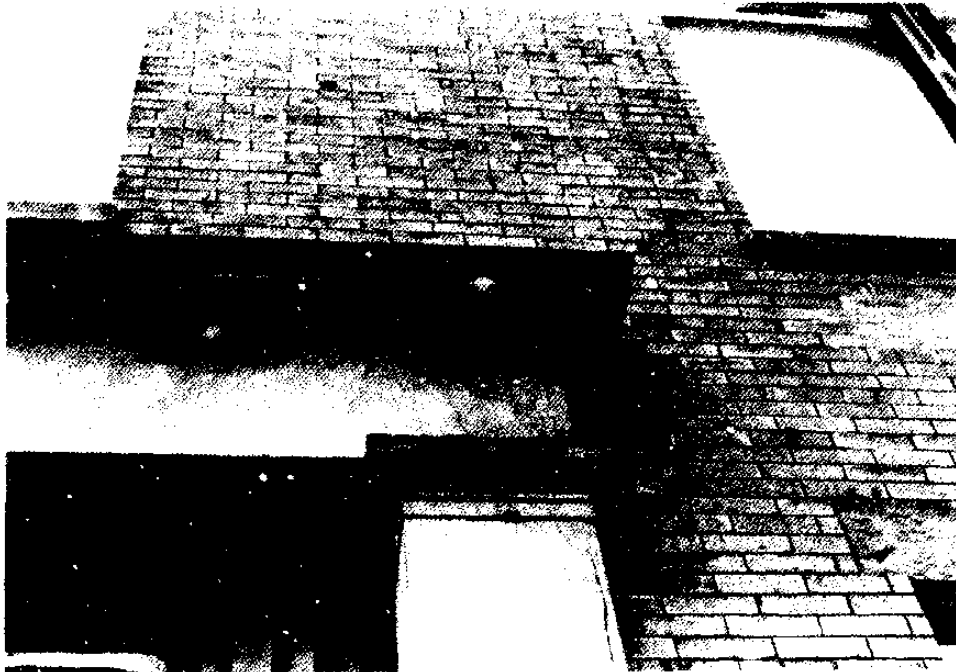
Figure 77. Main Block, West Elevation: Deteriorated Brownstone Surround of South-Unit Entrance.

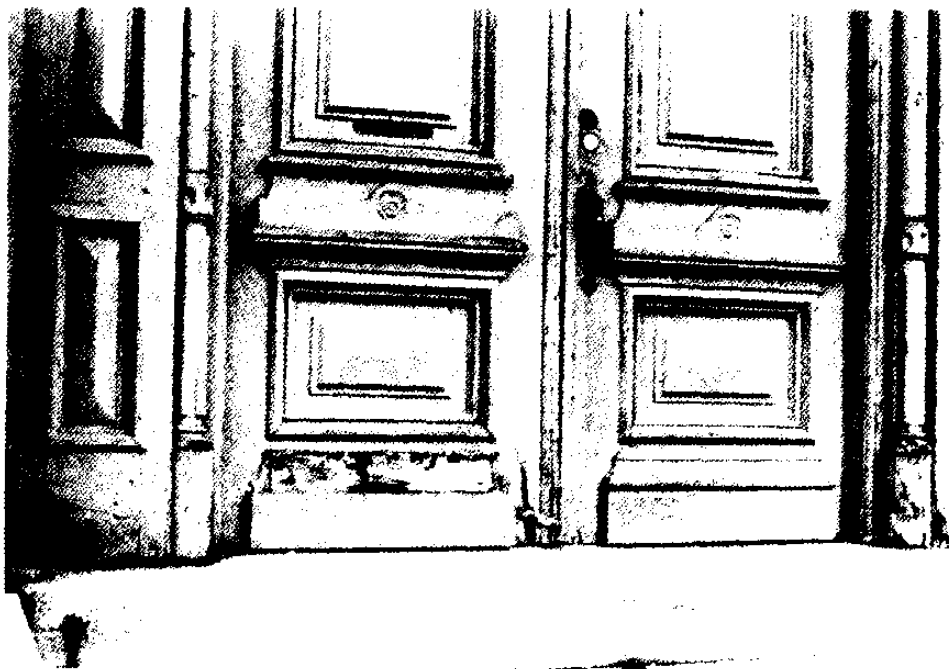
Figure 78. Main Block, West Elevation: Detail of Deteriorated South-Unit Entrance Door.

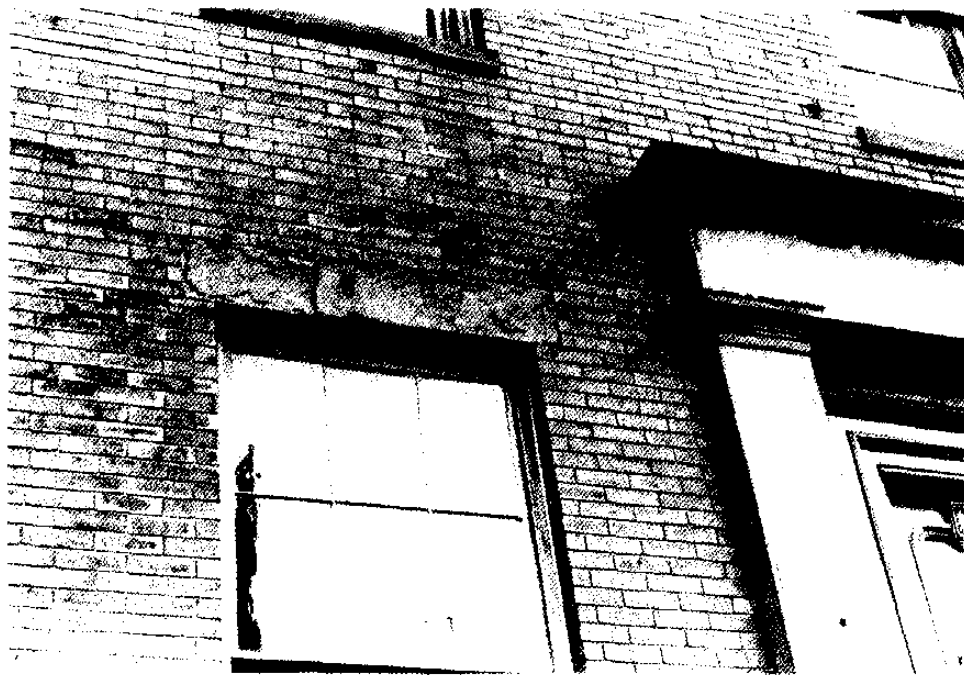
Figure 80. Main Block, West Elevation: Deteriorated Lintel over Window W106.
