Submerged Cultural Resources Site Report

NOQUEBAY

APOSTLE ISLANDS NATIONAL LAKESHORE

**SUBMERGED CULTURAL RESOURCES SITE REPORT:
NOQUEBAY**

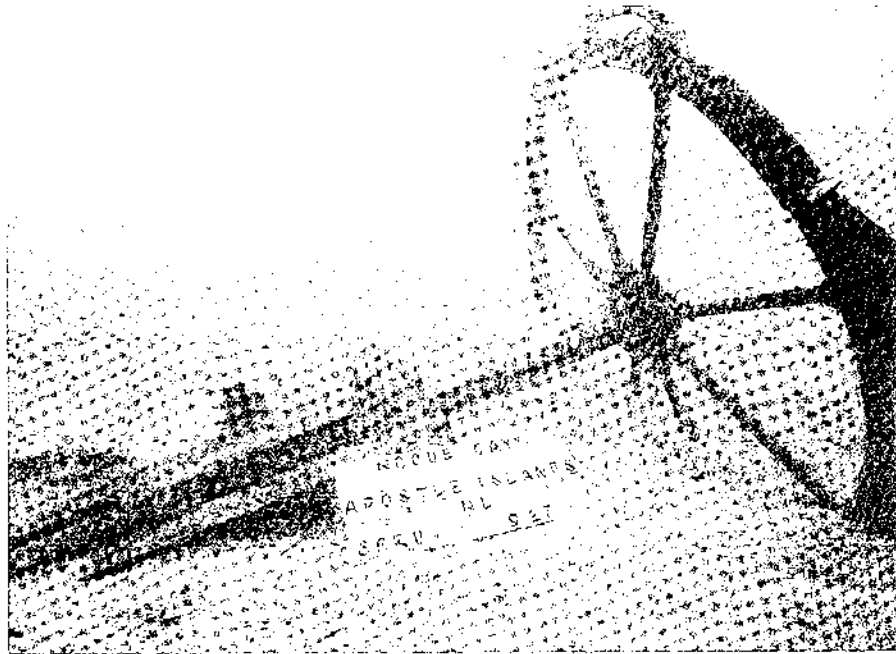
Plate 7: After excavation, the entire wheel and steering assembly were exposed. The mechanical, or "patent steering gear," came into use in the latter half of the 1800s. The wheel and worm gear are in an excellent state of preservation.

The mechanical steering gear and spindle (Figure 8), also called worm gear or screw gear, are made of steel or iron and are in an excellent state of preservation. The guide rods are in place as is the yoke and yoke bolt. The coupling rods are missing; however, the traverse nuts are in place. Only the cross head top plate was present. The spindle is 34-1/2 inches long, with 15 exposed right-left spindle threads at 1 per inch, and 8 exposed right-left spindle threads at 1 per 3 inches. The steering wheel spindle is 2-1/4 inches in diameter and it is 4 feet 4-1/2 inches long to the wheel. The overall length of the steering mechanism, including the wheel is 5 feet.

Following the mapping, photo, and video documentation of this feature, it was reburied. This was done to protect the wheel from winter storms, ice action, and possible vandalism.

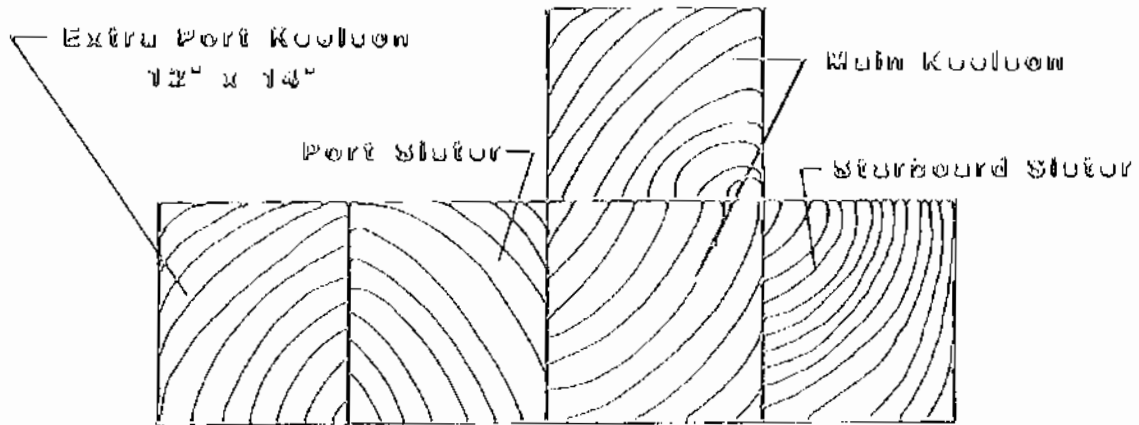
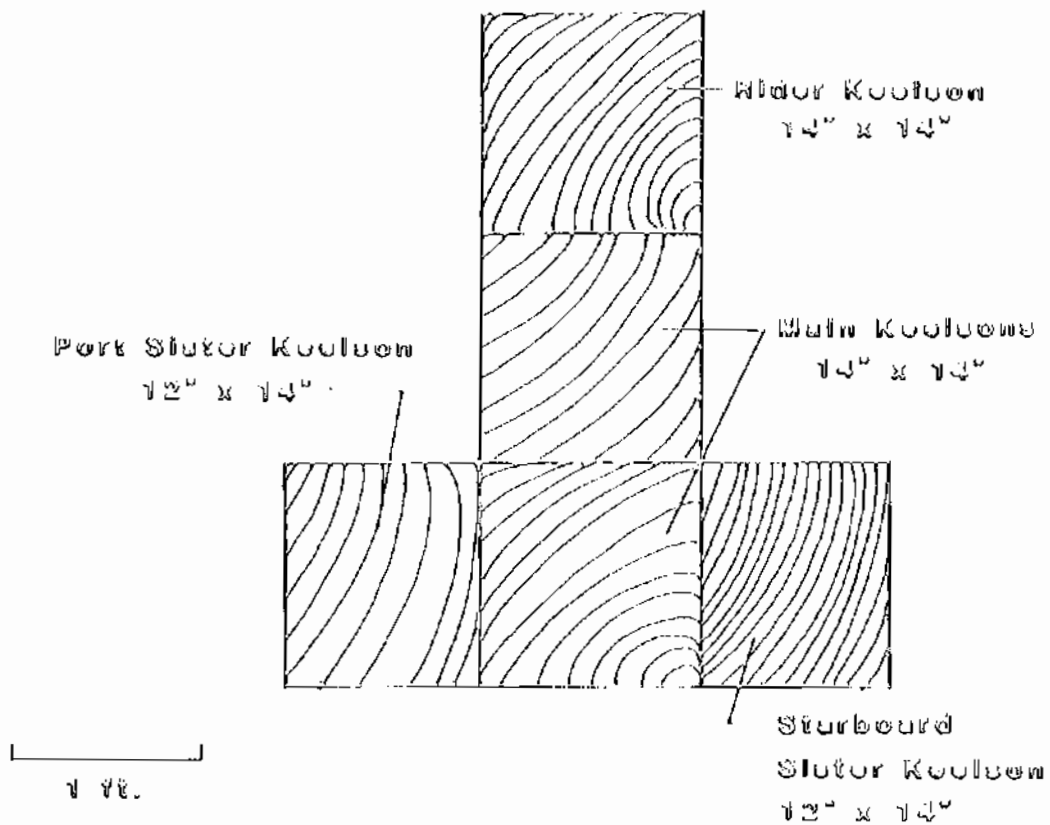
Figure 9: Centerline Keelsons Cross Section

The main keelson is composed of two stacked timbers, each 14 inches by 14 inches. The main keelson broke at a point of weakness, at the scarp in the stern. The scarp joint used on all of the keelsons is the same type, a hooked scarp. The scarps found on the vessel are a uniform 5 feet in length. This followed the ship building rule of the era which called for making the keelson scarps "equal to at least two frame intervals, that is double the room and space" (Desmond 1919:55).

The rider keelson, resting atop the main keelson timbers, is also 14 by 14 inches. A rider keelson is usually added to provide additional longitudinal strength. Its extant length on the vessel is 28 feet 6 inches. When the main keelson gave way, the rider apparently failed with it.

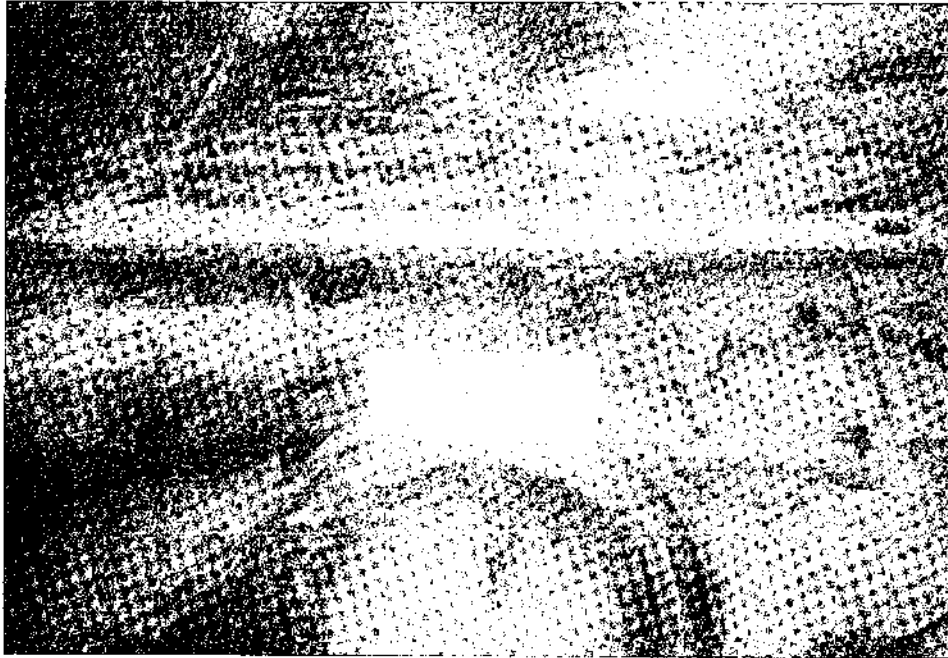
Plate 12: The bow deadwood, constructed of 4 stacked timbers each 16 by 14 inches, has two flat straps which straddle the timbers. These straps would have articulated with the truss rods as part of the vessel's hogging system. The driving wheel from the windlass is leaning up against the deadwood strap.
