SAGAMORE HILL HOME OF THEODORE ROOSEVELT

HISTORIC STRUCTURE REPORT

**Sagamore Hill National Historic Site
Oyster Bay, New York**

Written 1988

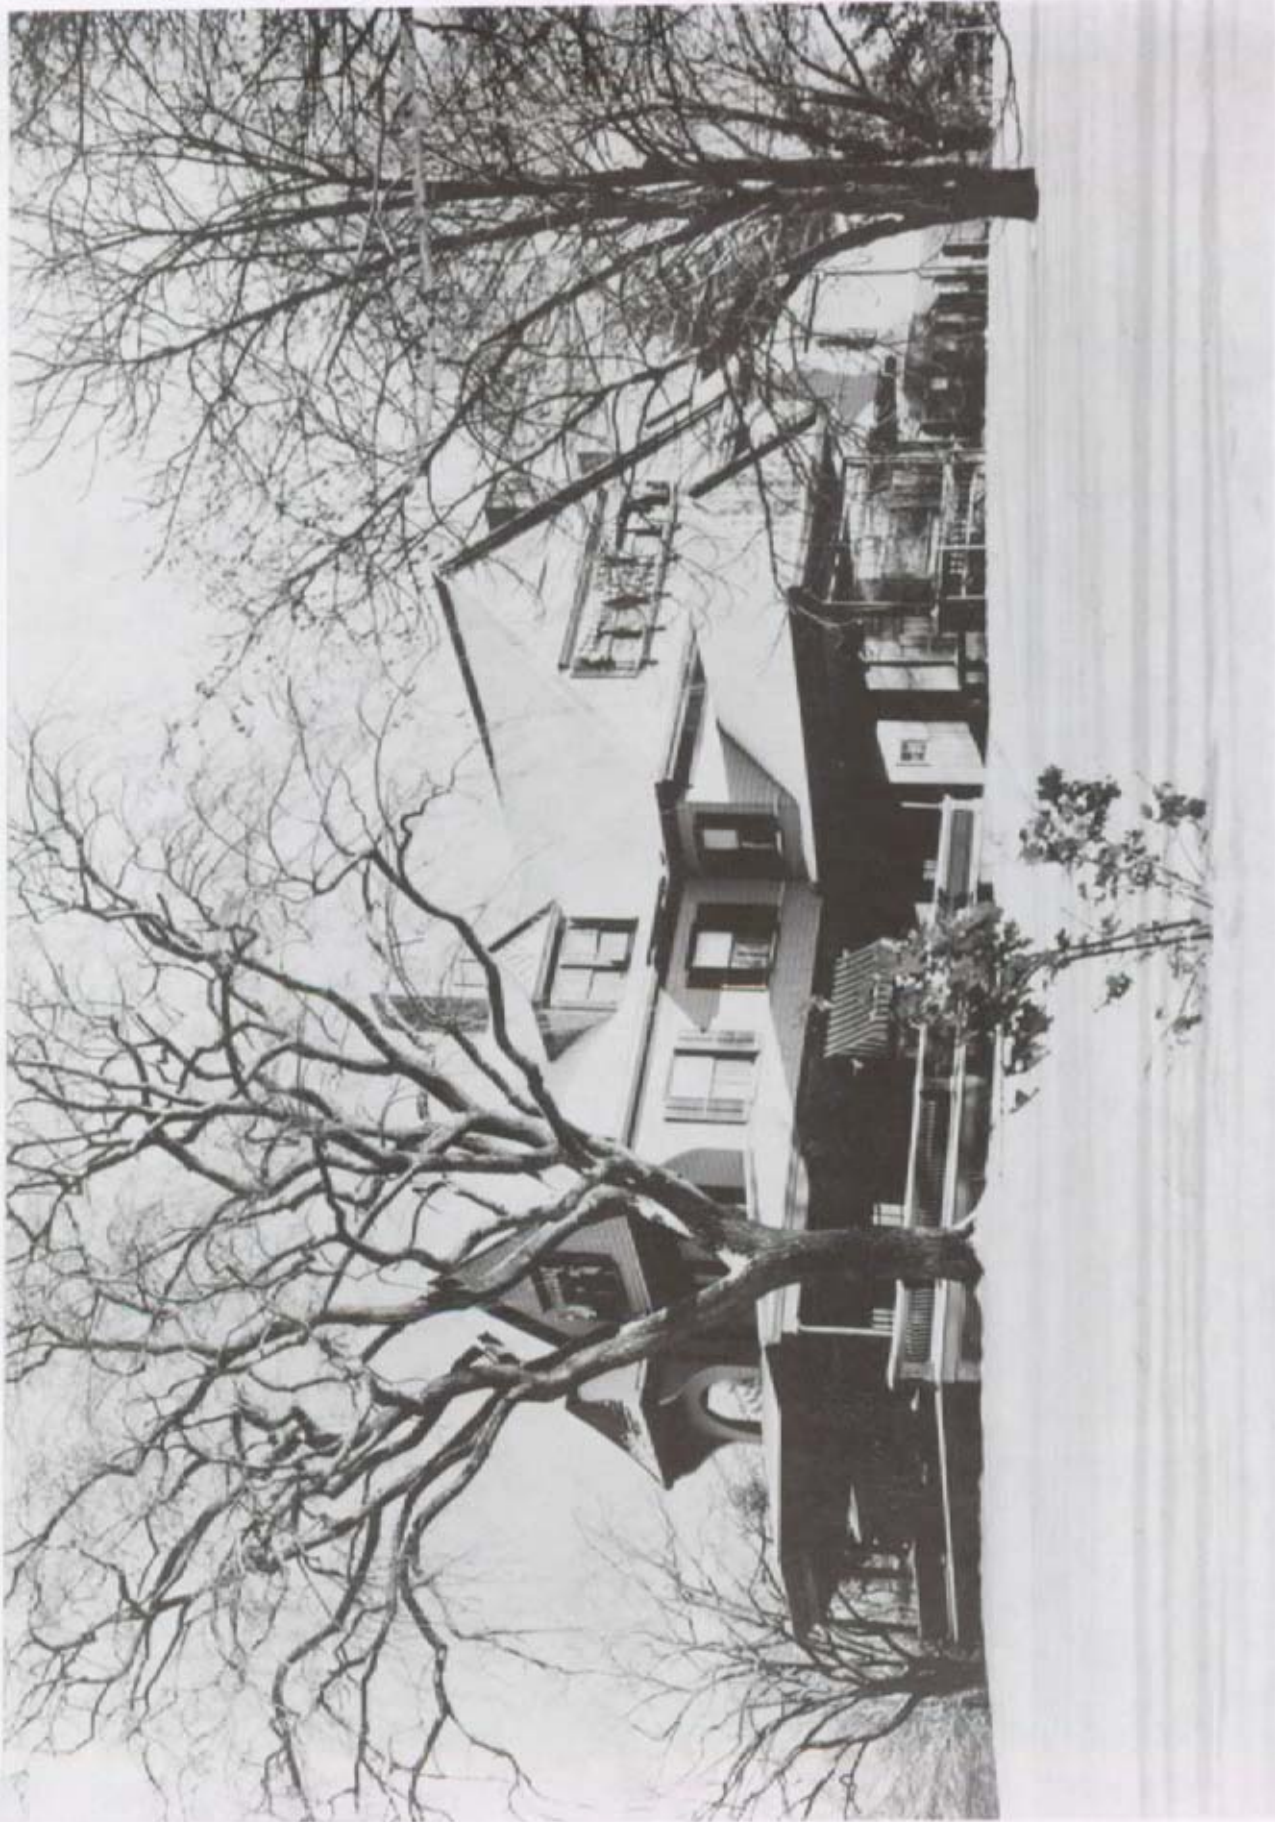
Figure 20. TR Home in winter, 1959. Storm shelter hides south entrance door.

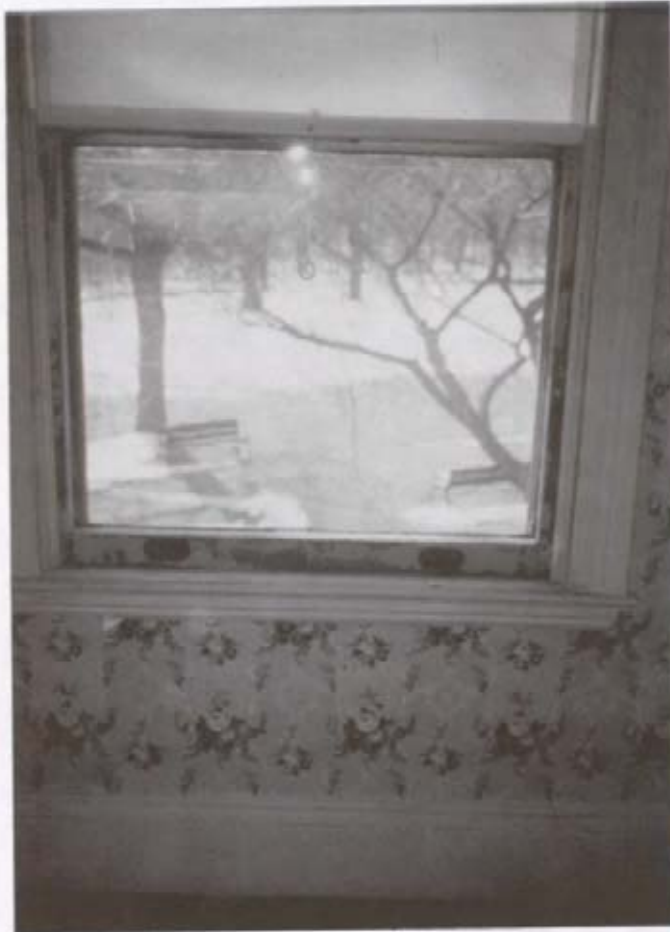
Typical Window Sash Condition Before Restoration

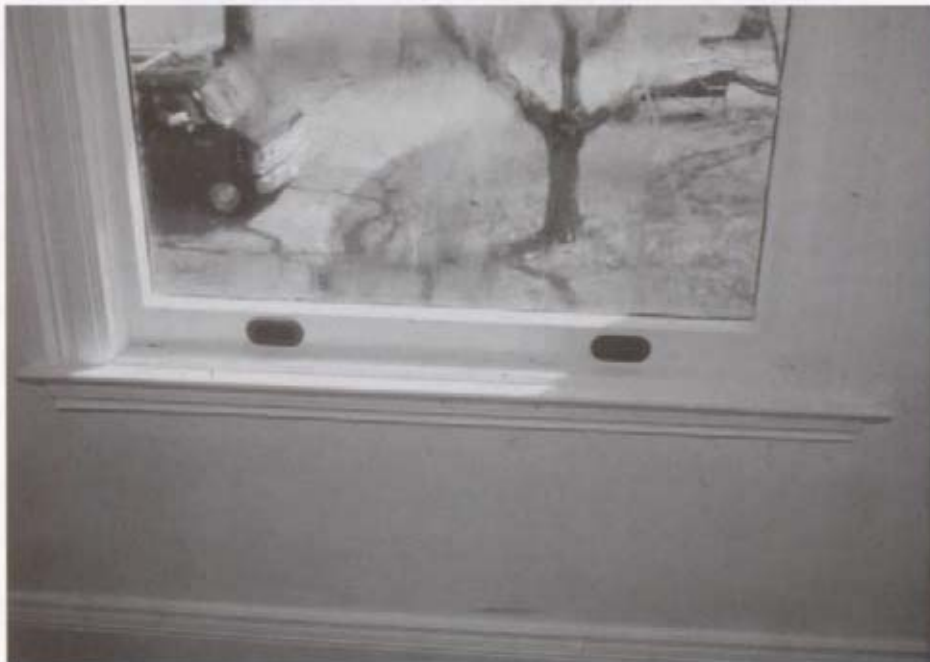
Typical Window Sash Condition After Restoration

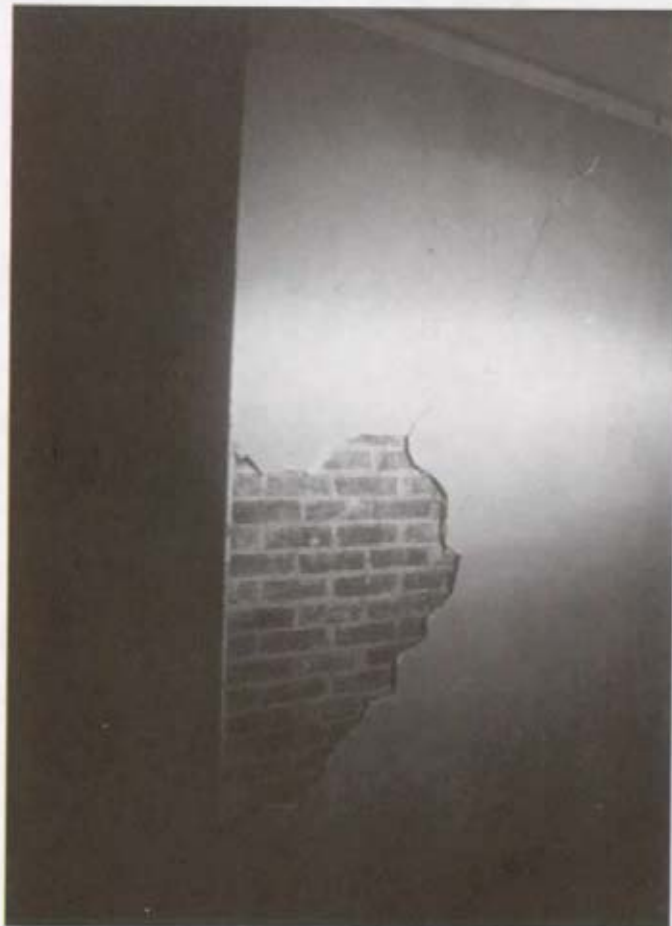
Alice's Room: Plaster Damage

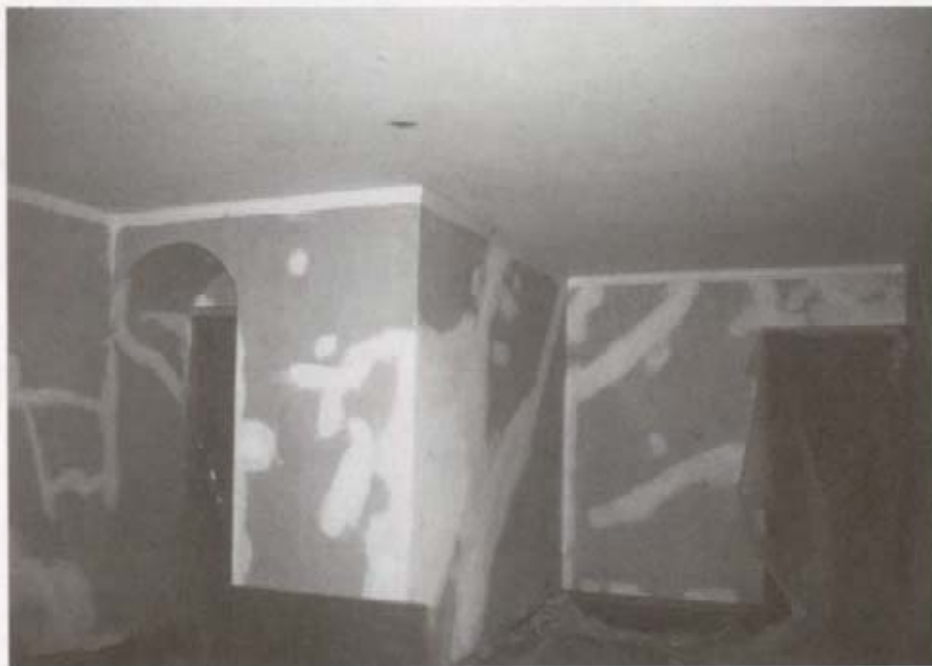
Alice's Room: After Restoration (plaster repaired,
ready for wallpapering).

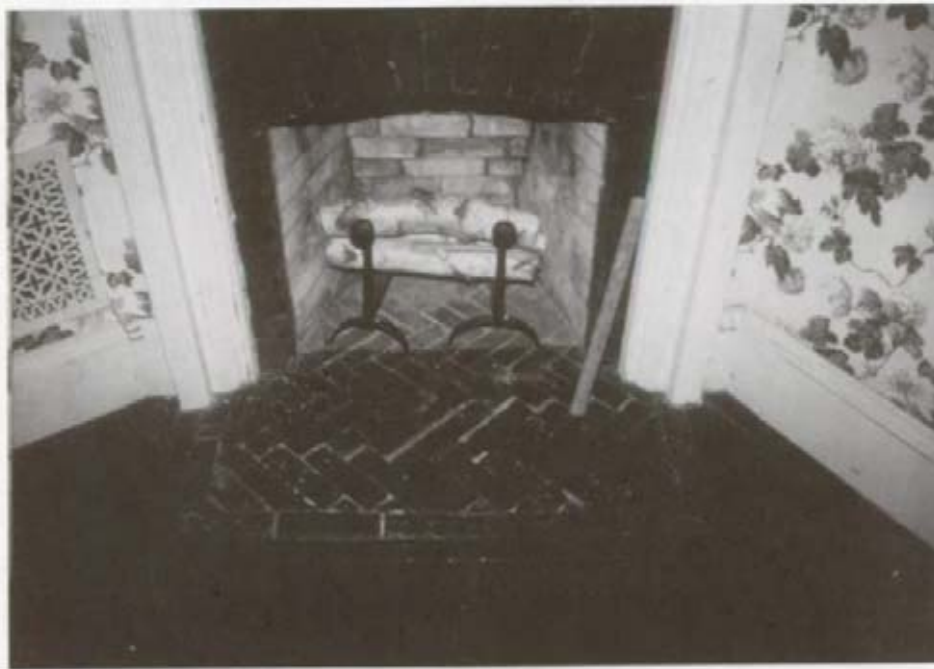
**Mother's Room: Condition of Fireplace Hearth
Before Restoration**

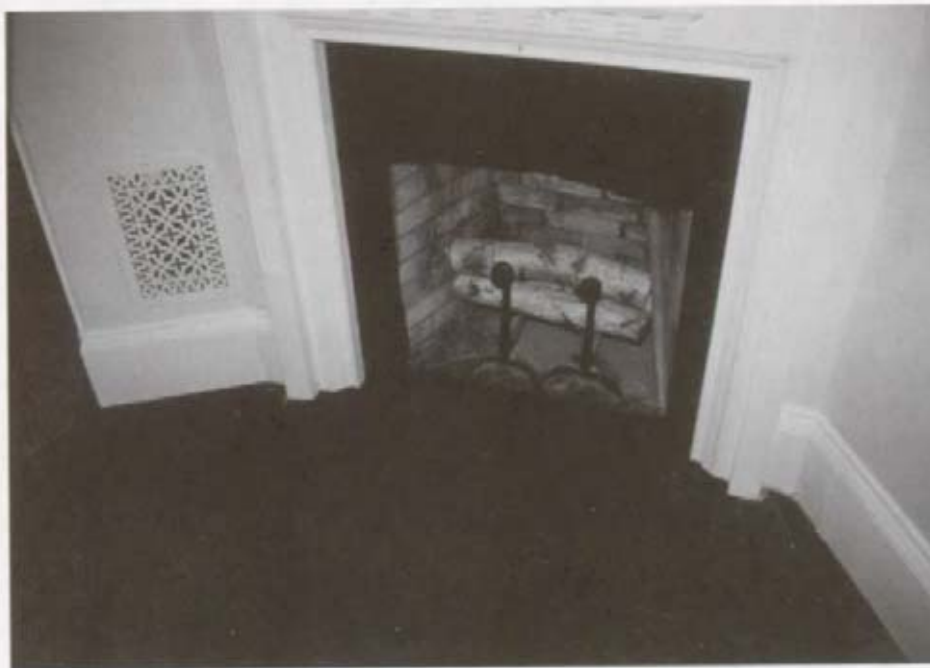
**Mother's Room: Condition of Fireplace Hearth
After Relaying, Repointing, and Repainting**

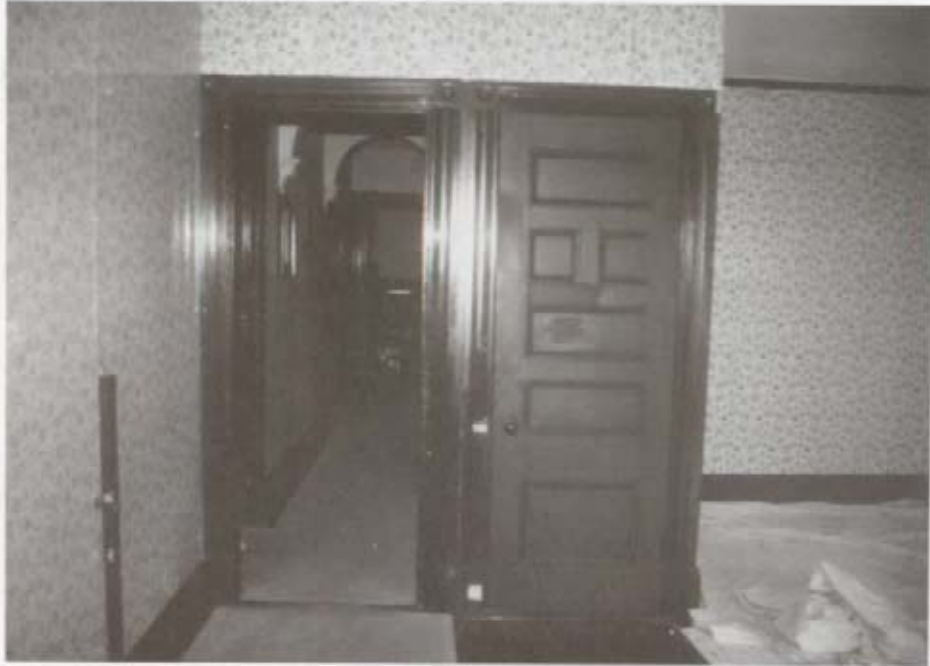
Typical Condition of Stained Woodwork

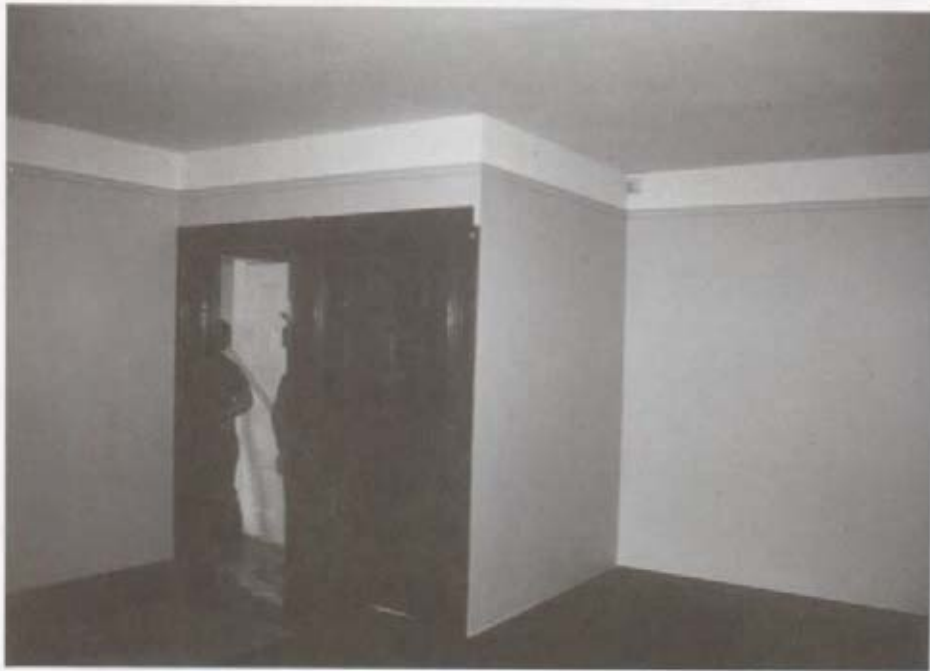
Typical Refinishing of Stained Woodwork

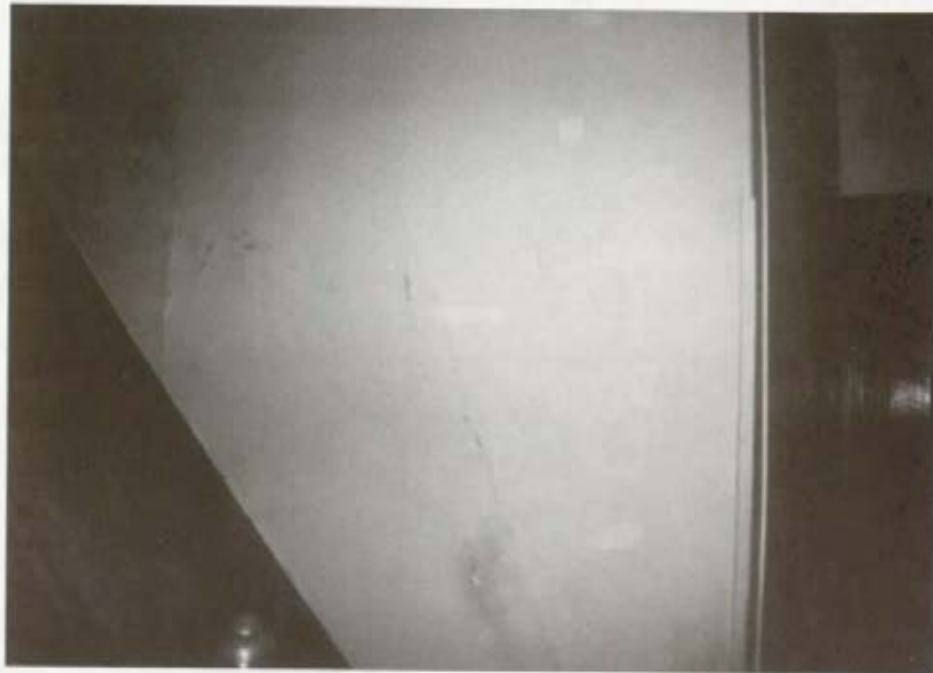
**Second Floor Rear Hall, Stairway: Before Restoration
(plaster severely deteriorated)**

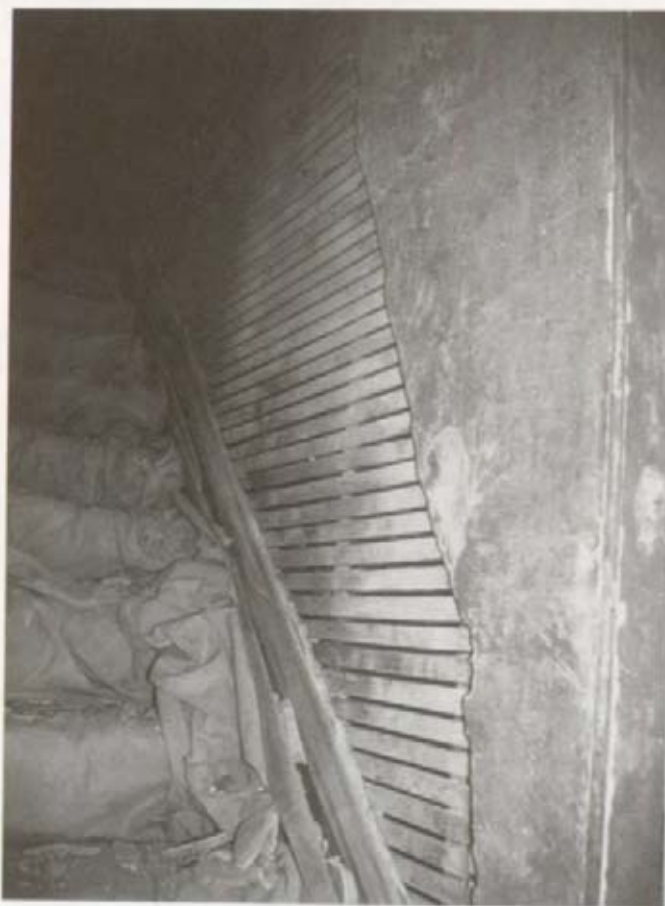
**Second Floor Rear Hall Stairway: During Restoration
(plaster removed)**
