ANSLEY WILCOX HOUSE

Theodore Roosevelt Inaugural
National Historic Site
Buffalo, Erie County, New York

HISTORIC STRUCTURE REPORT

October 2006

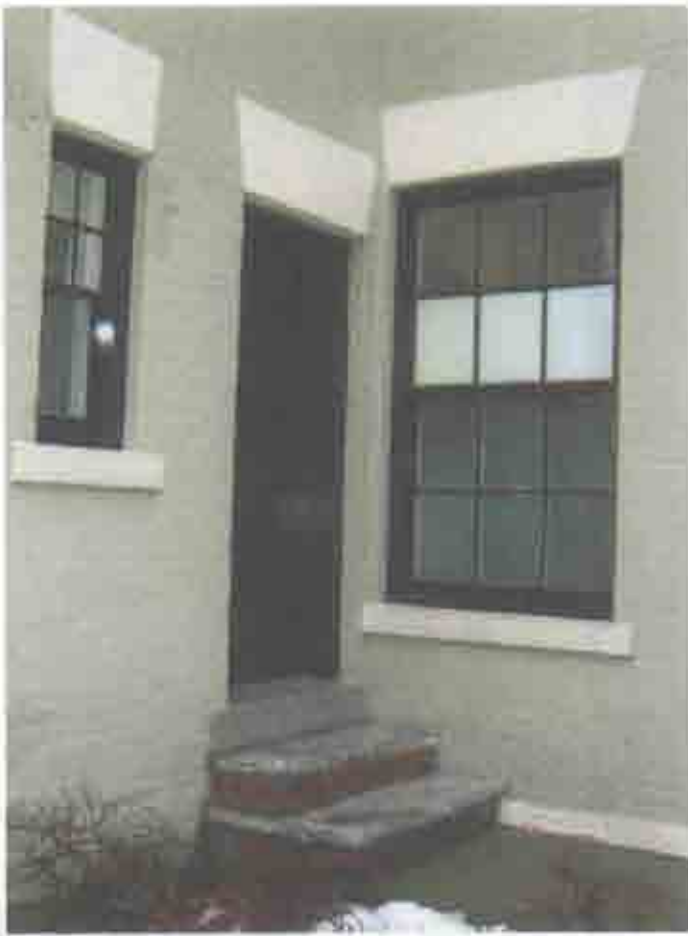
Figure 2.9. North elevation, ca.- 1971 glazing and missing basement window.

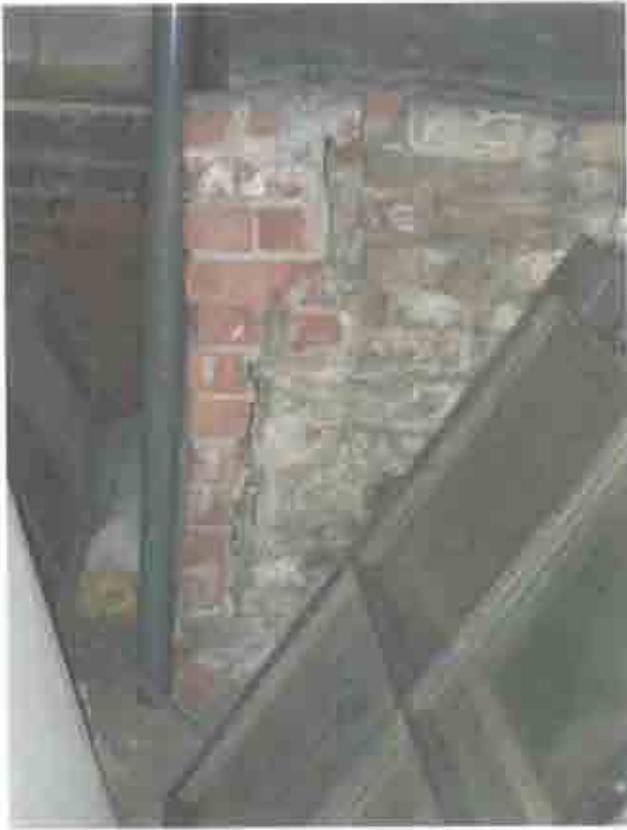
Figure 2.18. Room 001, southeast corner, damaged south retaining wall.

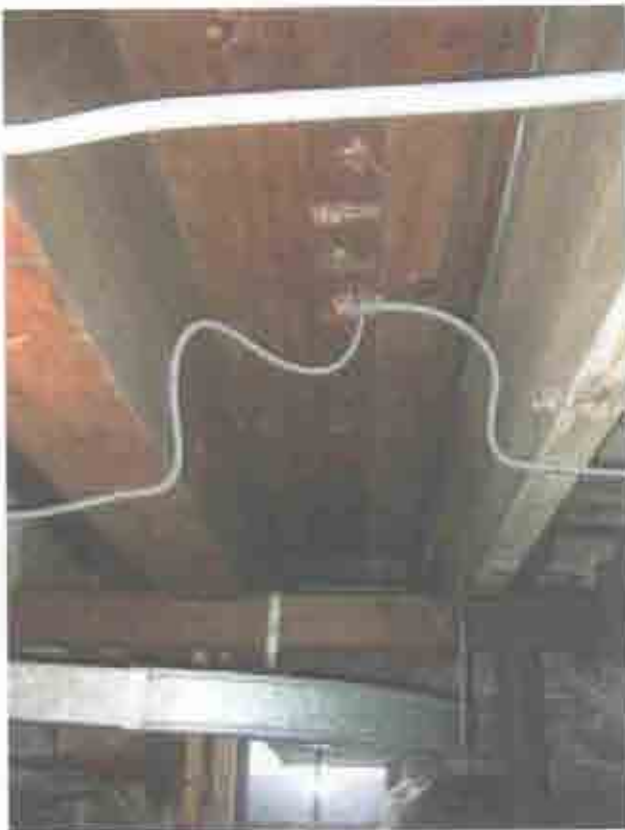
Figure 2.19. Room 001, ceiling duct remnant.

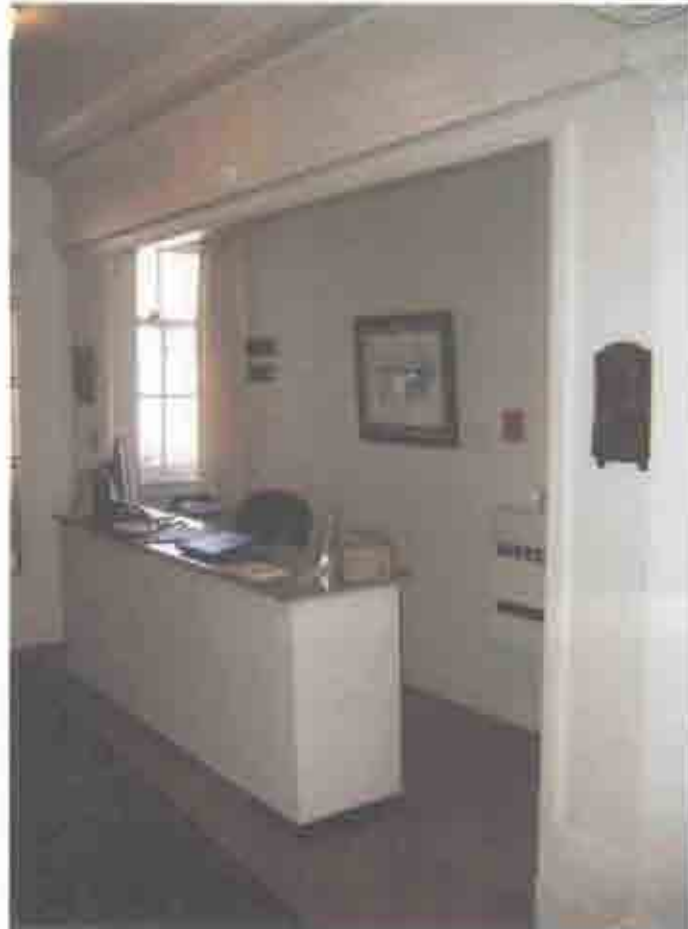
Figure 2.38 Room 106 (Side Hall), former location of missing east wall.

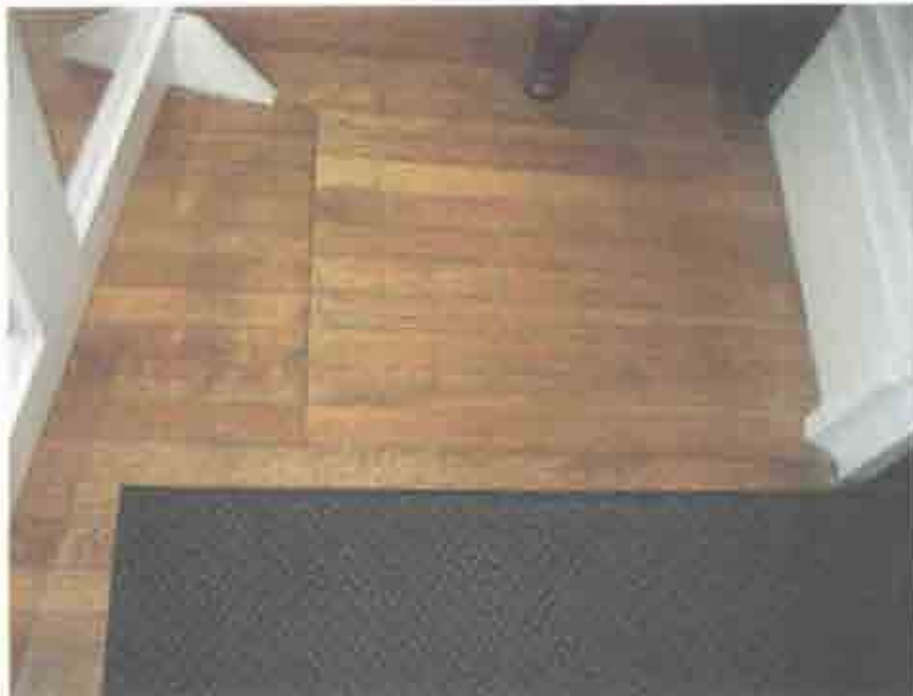
Figure 2.43. Room 108 (Dining Room), former location of missing floor register.

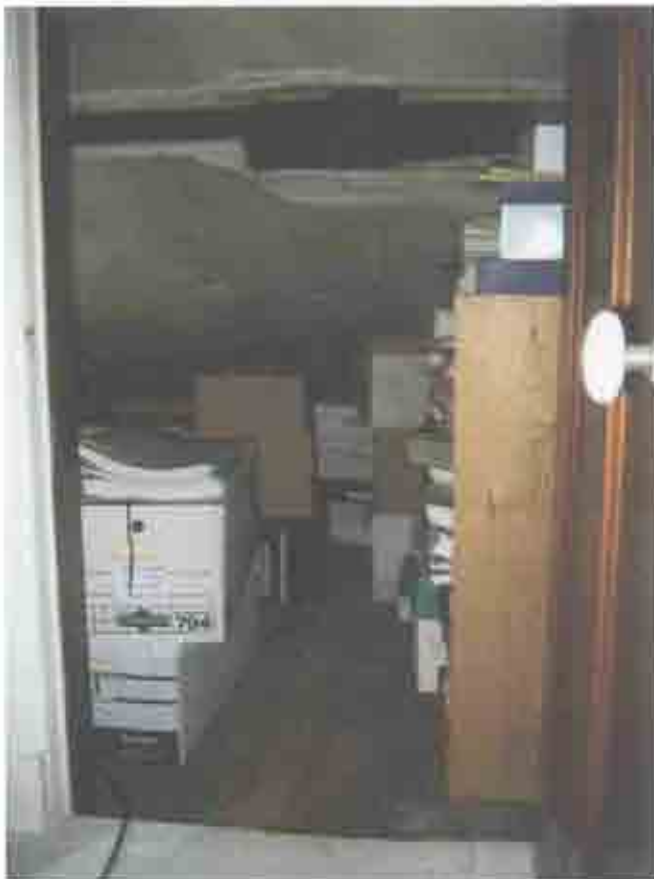
Figure 2.79. Room 305a, deteriorated plaster ceiling.
