historic structure report

U.S.S. CAIRO

U.S.S. CAIRO
VICKSBURG NATIONAL MILITARY PARK
VICKSBURG, MISSISSIPPI

United States Department of the Interior
National Park Service
Denver Service Center

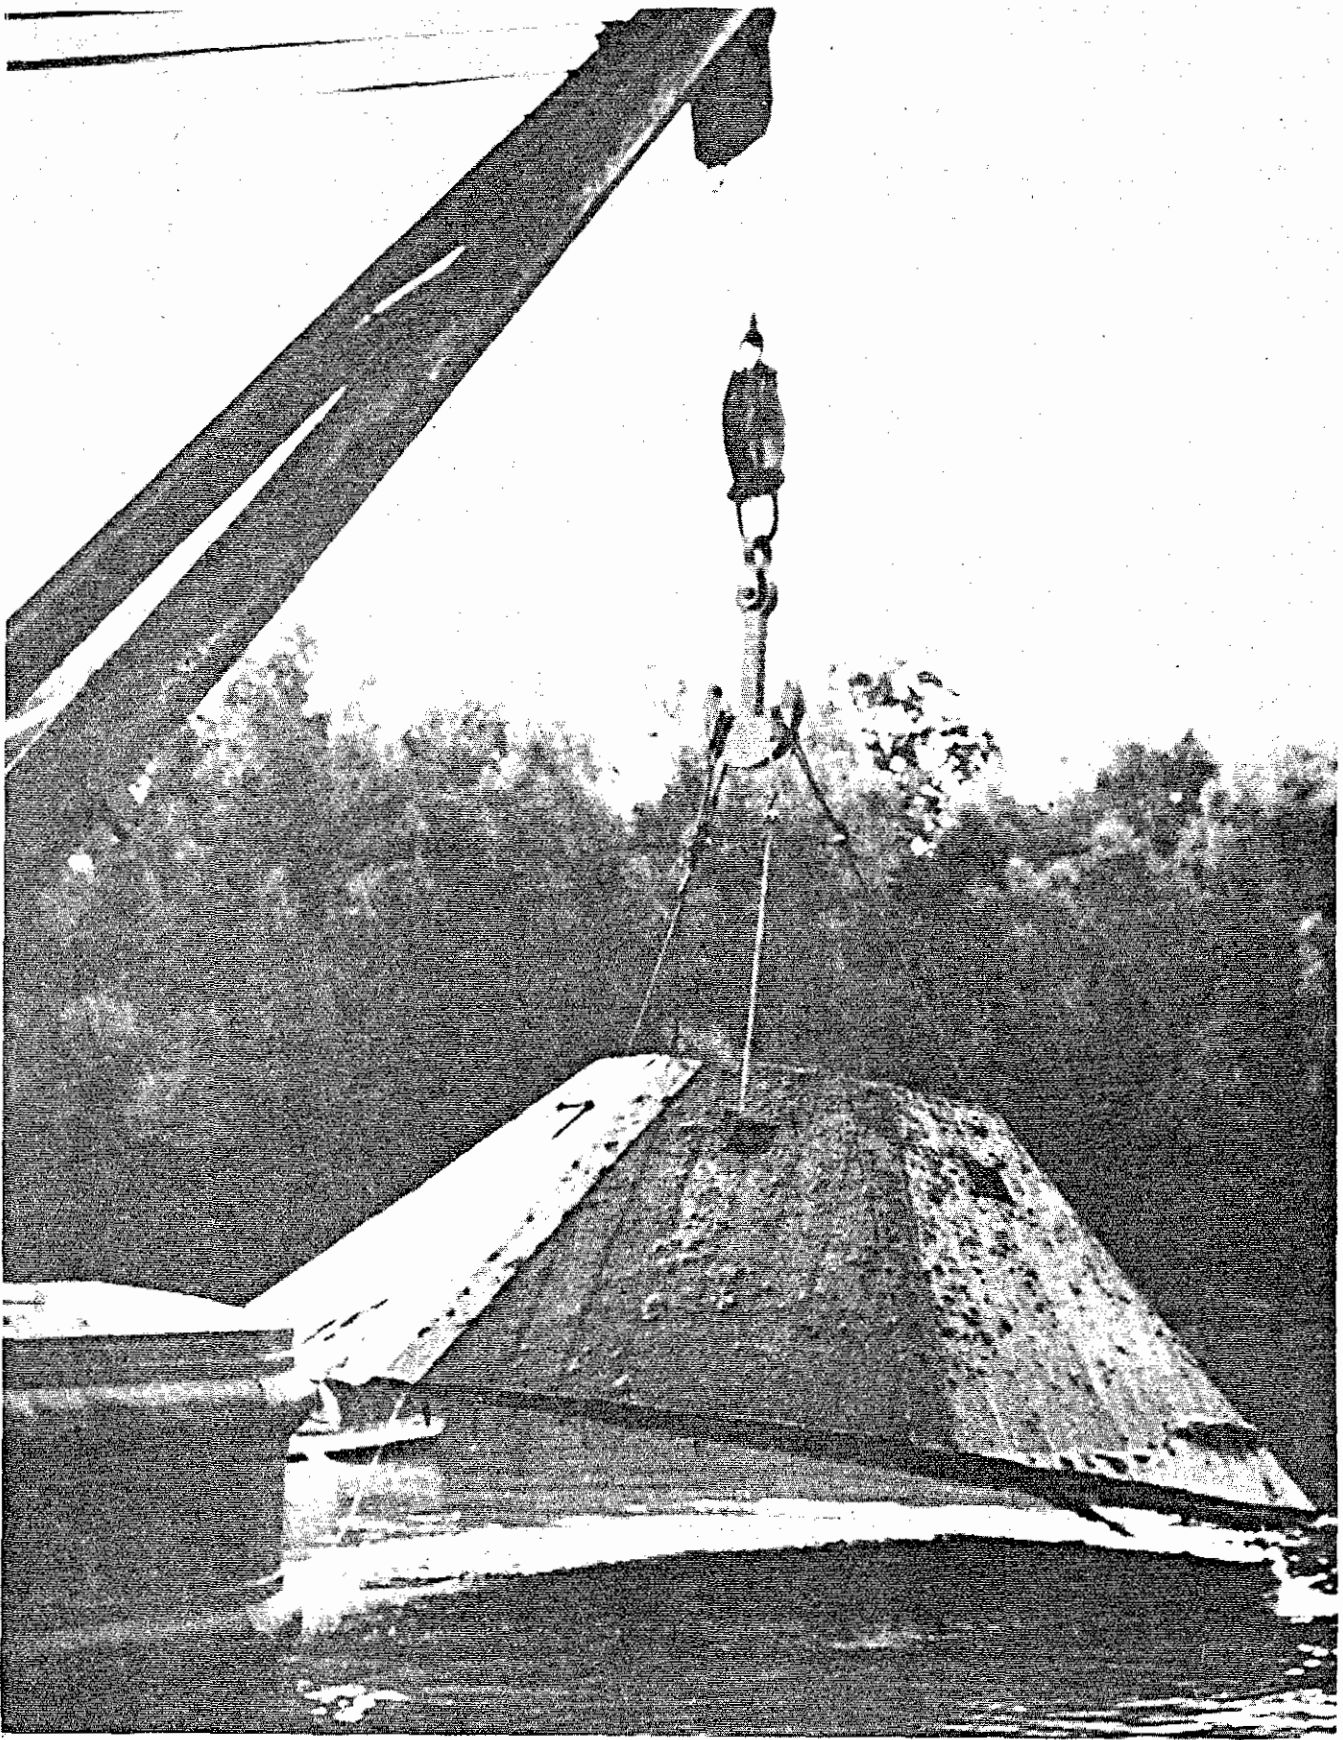
The next two items to surface were the pilothouse (figure 1) and an 8-inch naval cannon. Both were initially recovered intact, but the pilothouse is now in pieces, part of the tragic succession of broken and twisted objects from the Cairo's piecemeal recovery. Like those that were to follow, these objects received insufficient documentation, possibly some haphazard preservation treatment, and certainly nothing near adequate storage.

Figure 1: The pilothouse as it appeared immediately after removal from the hurricane deck in September 1960. Allowed to deteriorate since this photo, now only the armor sheathing survives. Mississippi Agricultural and Industry Board photo.

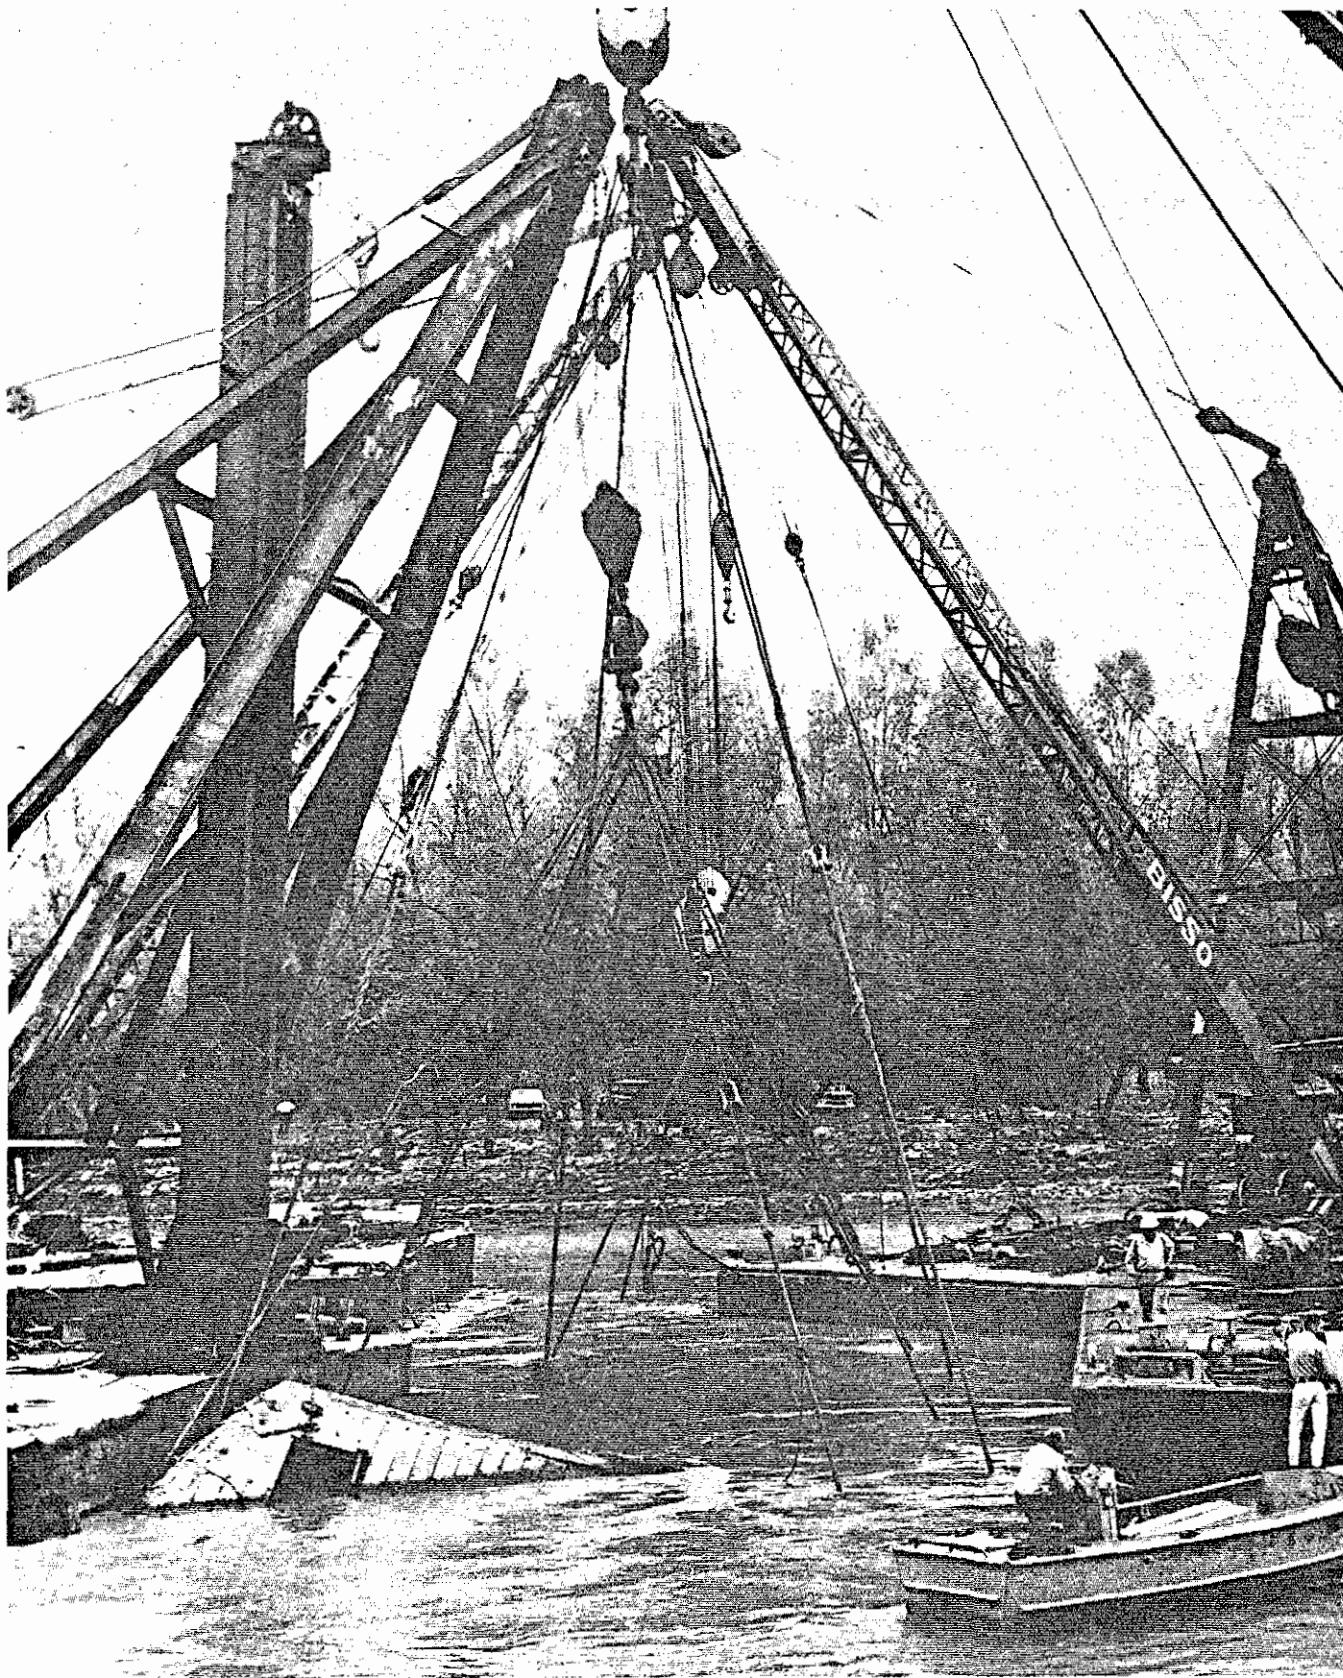
Figure 2: This awesome flotilla of river salvor's mechanical might was gathered above the sunken Cairo in 1964. It might have been better utilized under the direction of a nautical archeologist. Mississippi Agricultural and Industry Board photo.

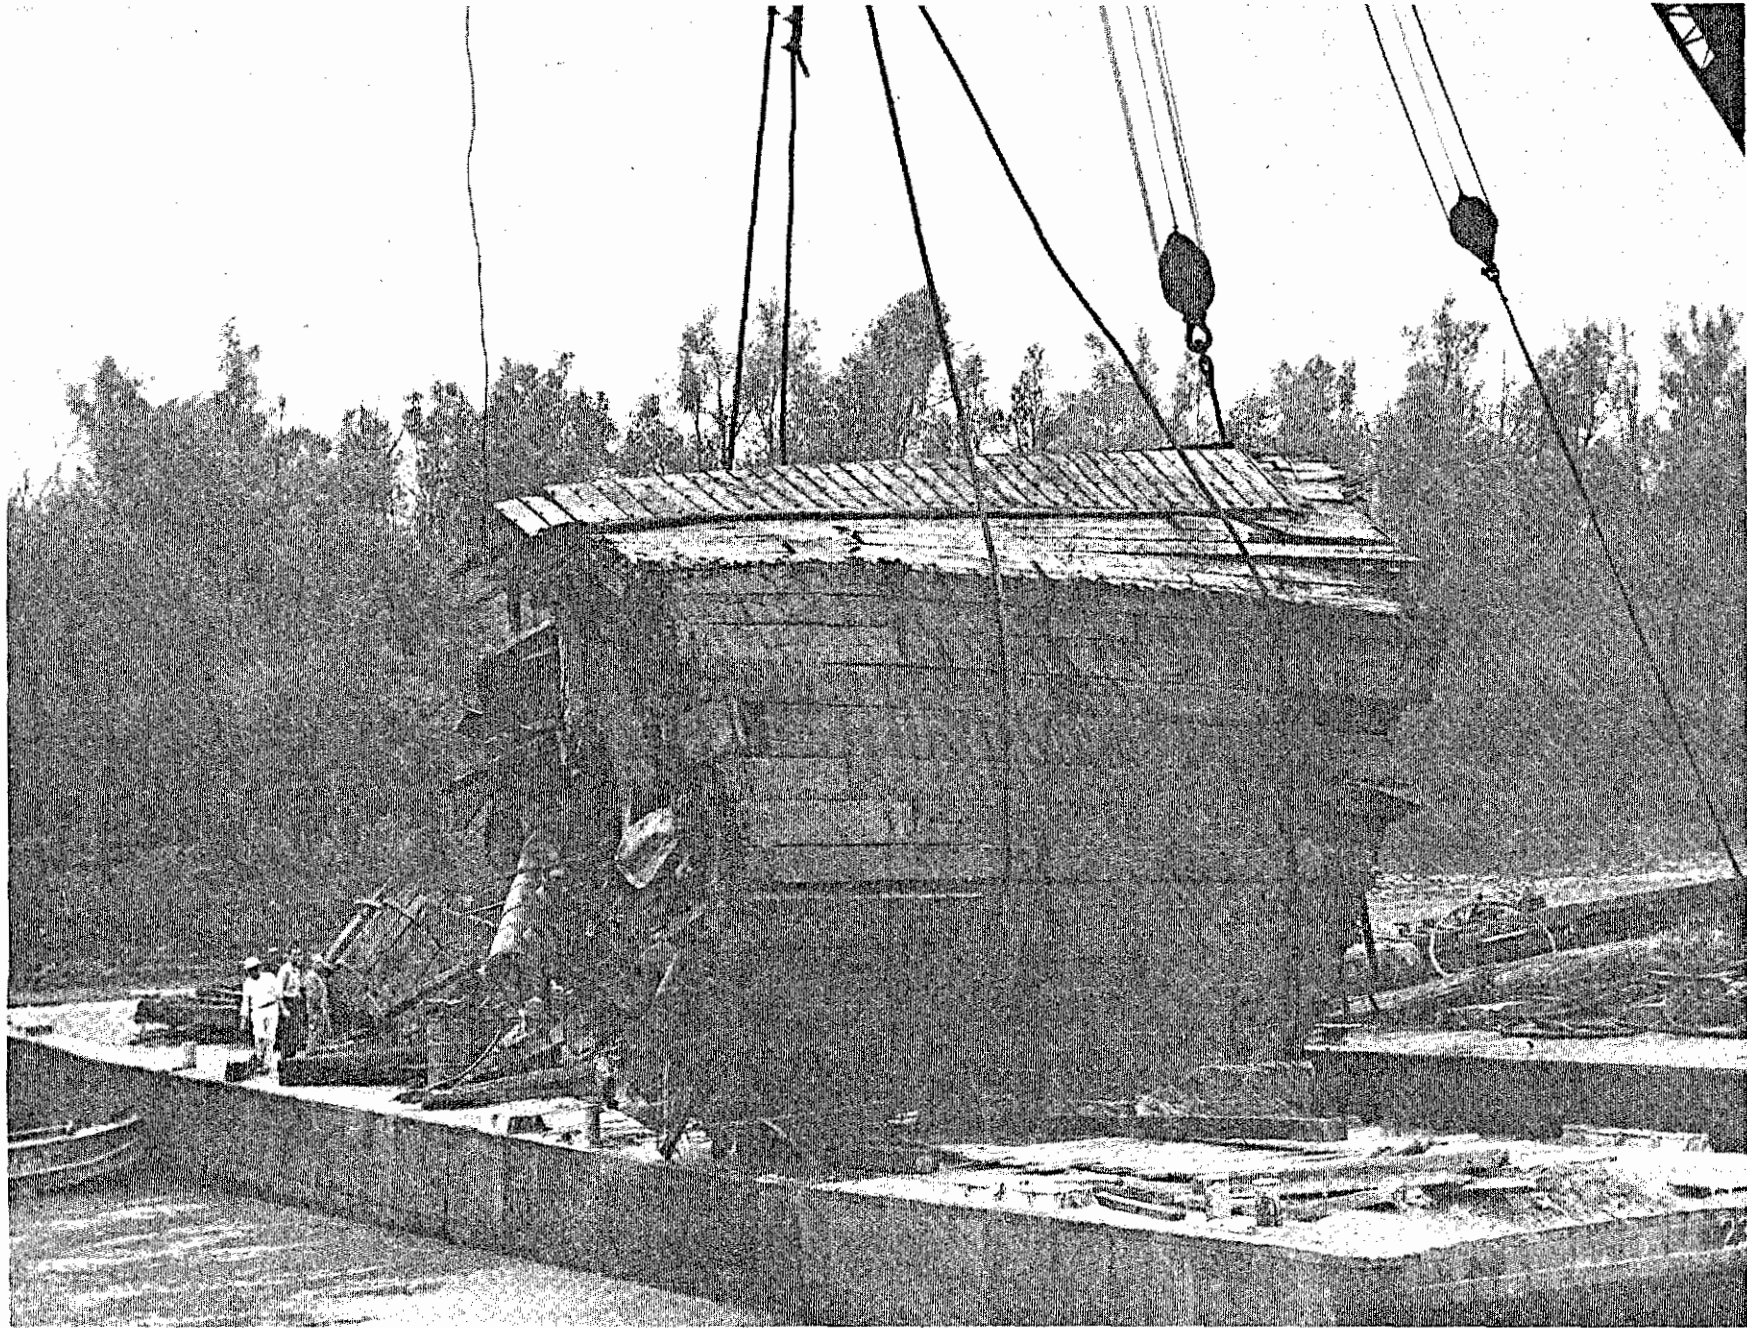
Although the bow section was recovered relatively intact with the exception of the missing hurricane deck, the midships part of the boat was almost totally demolished when raised (figure 3). When first surfaced, the stern section fared only slightly better than the midships section. The stern, unfortunately, slipped from its lifting slings back into the river, demolishing the casemates, cabins, and wheelhouse above the gun deck level. Further damage was done to the stern section at the fantail when it was separated into port and starboard catamaran sections as it fell back into the river.

Figure 3: This destructive handling of the midships section exemplifies the harm that can befall a historic shipwreck during recovery by non-archeologists. Mississippi Agricultural and Industry Board photo.

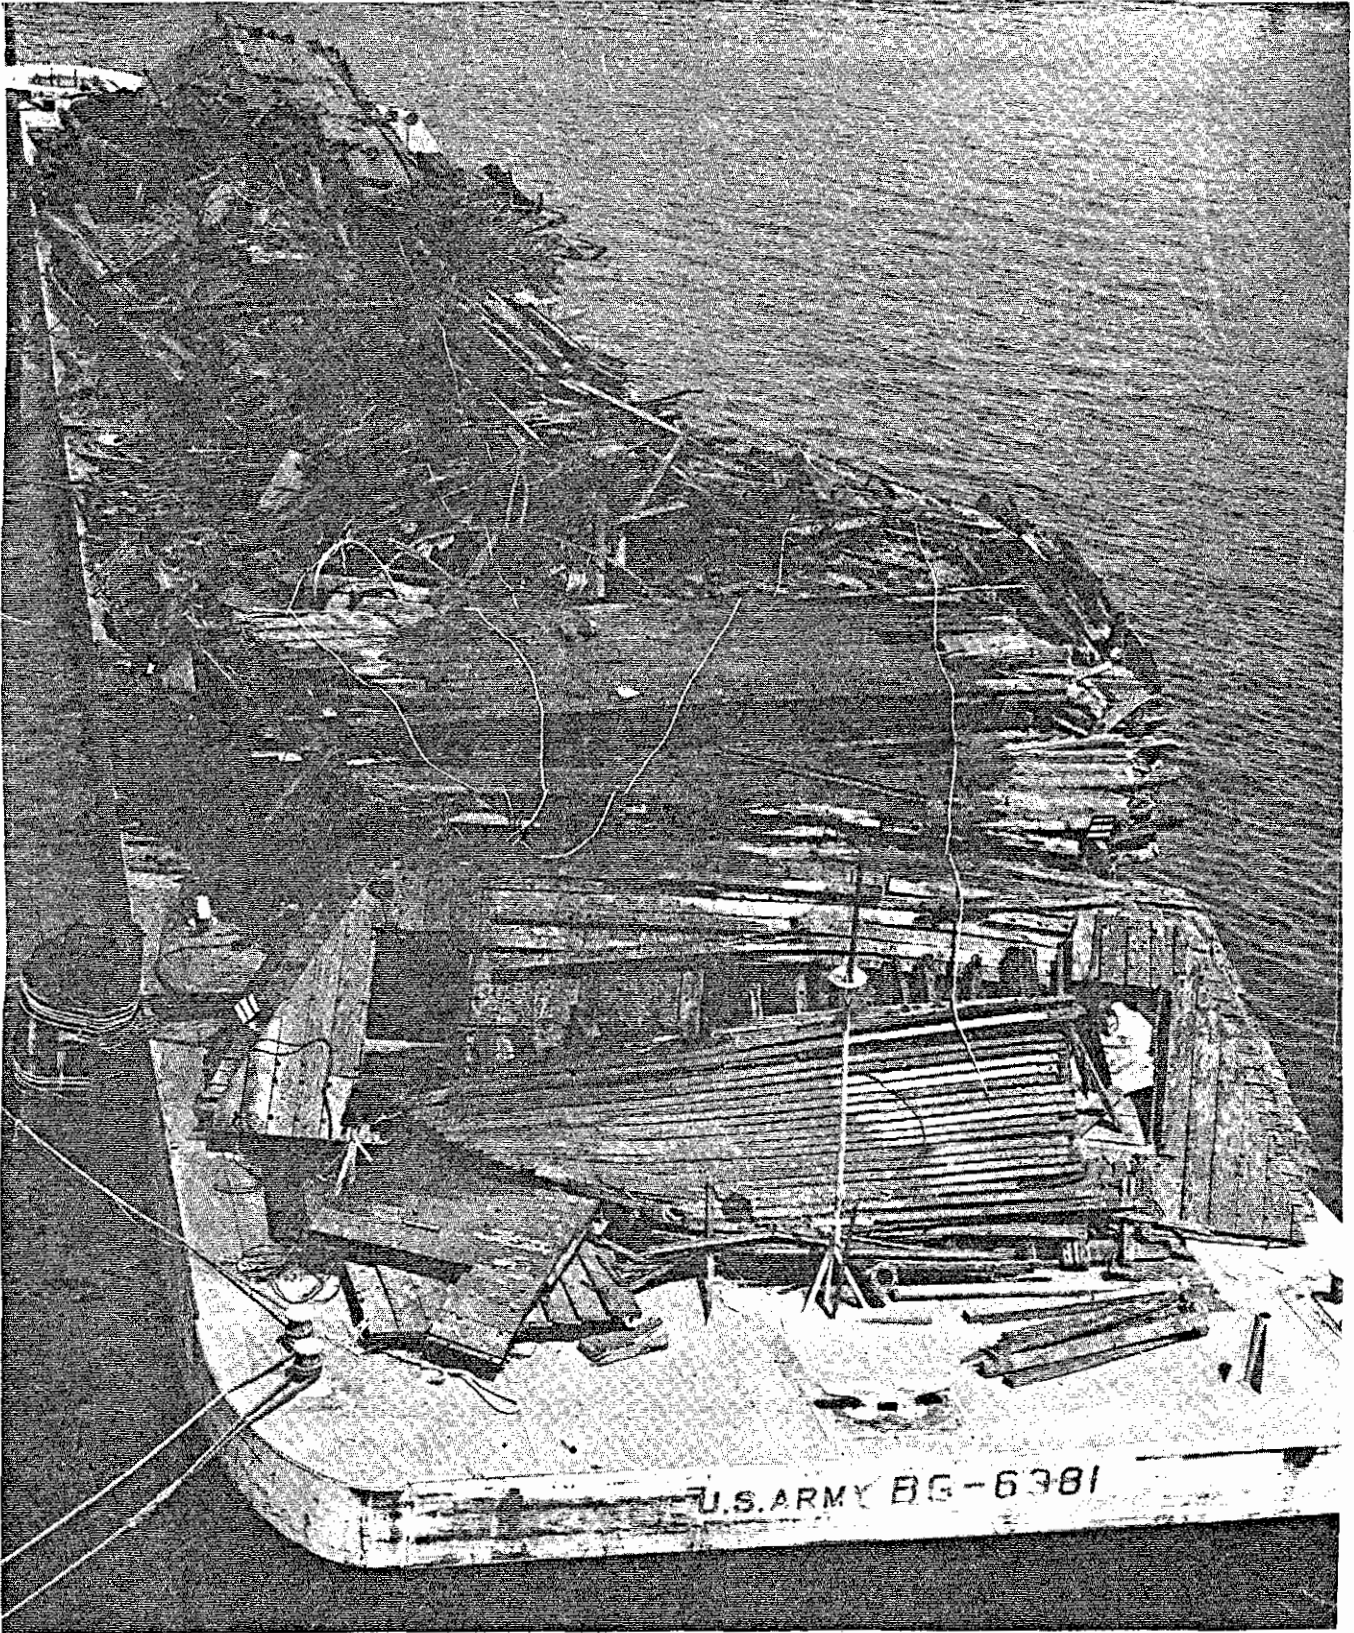
Figure 4: Cairo fabric upon arrival at Pascagoula in 1965. The undocumented dismantling of many components that later magnified the difficulty of an accurate restoration had not yet begun. Mississippi Agricultural and Industry Board photo.

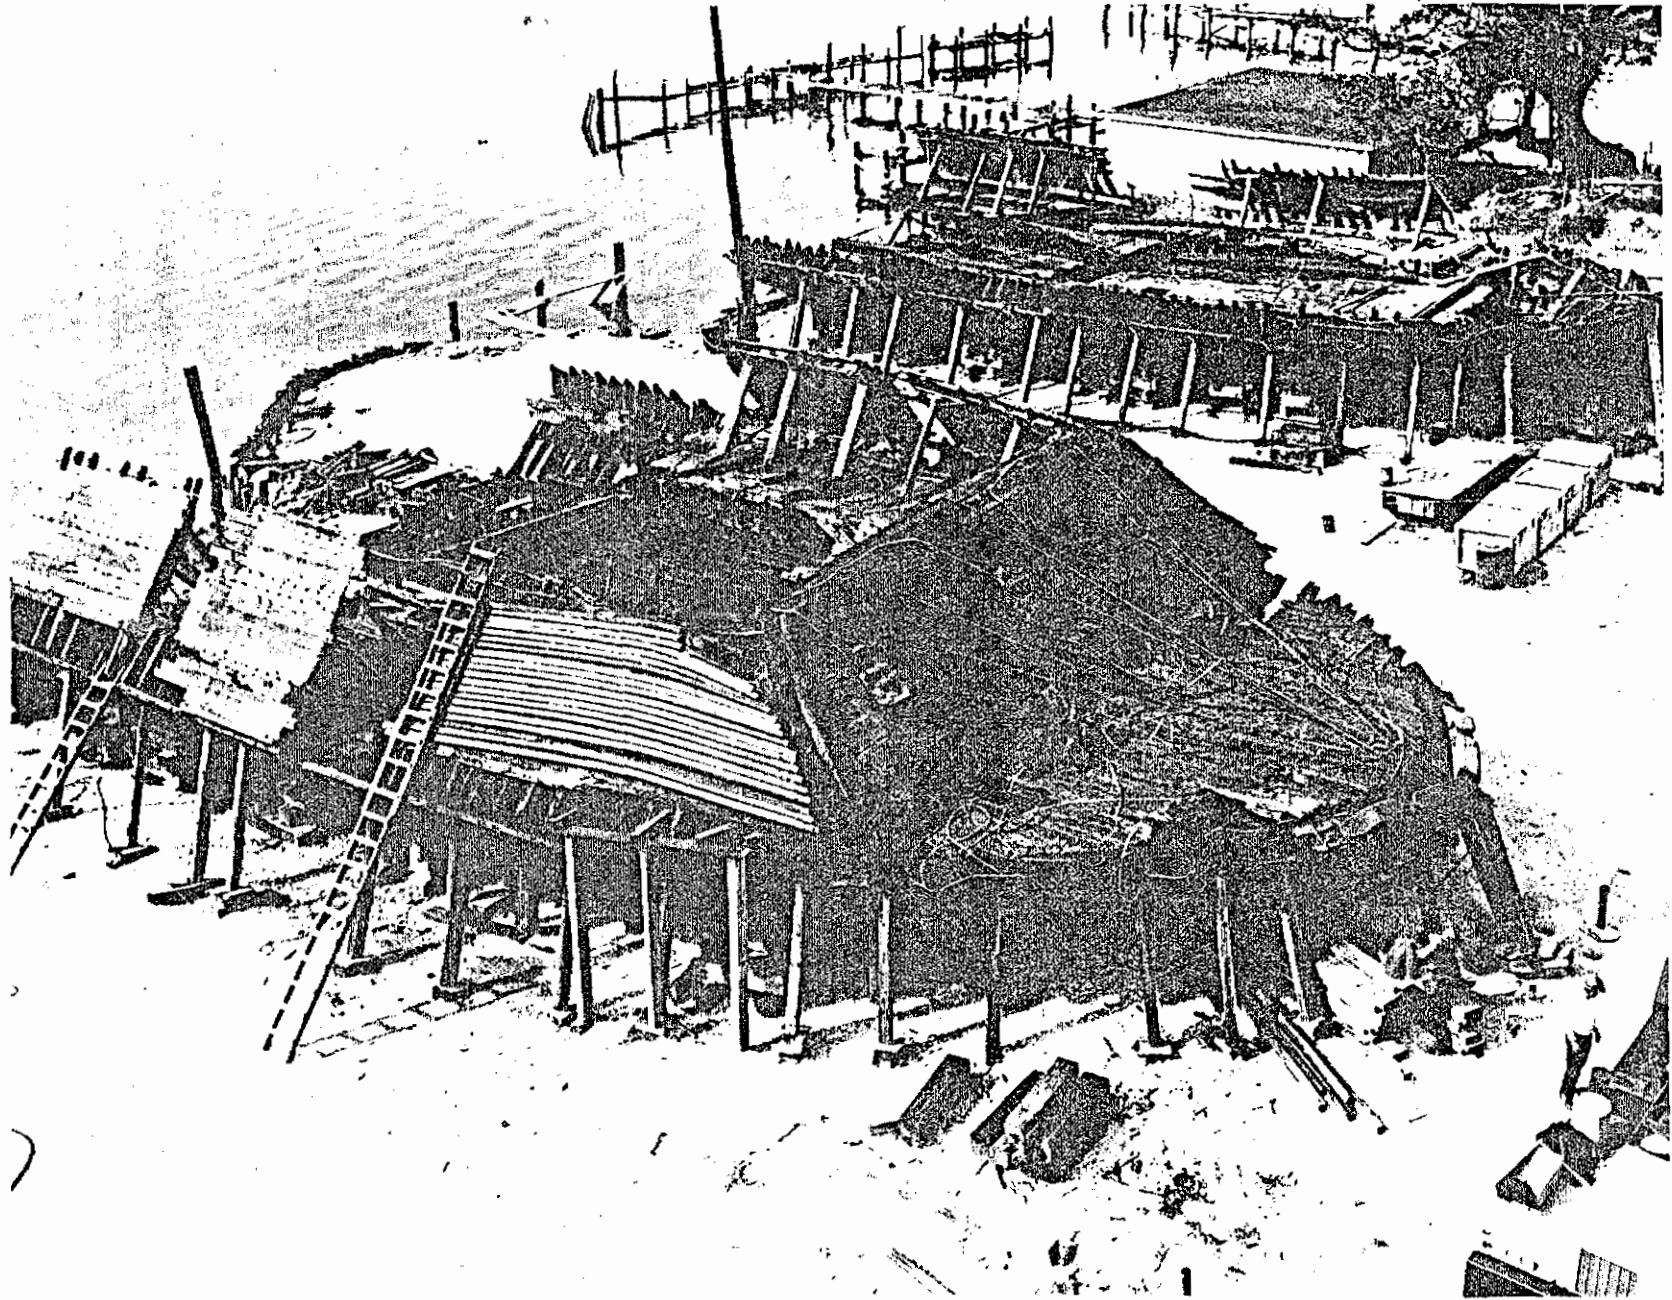
Figure 5: Cairo components after reassembly on the beach at Ingalls Shipyard in Pascagoula. Much of the historic wood fabric in this 1965 photo, particularly the side casemates and the pine decks, have completely rotted away since that time. Mississippi Agricultural and Forestry Experiment Station.

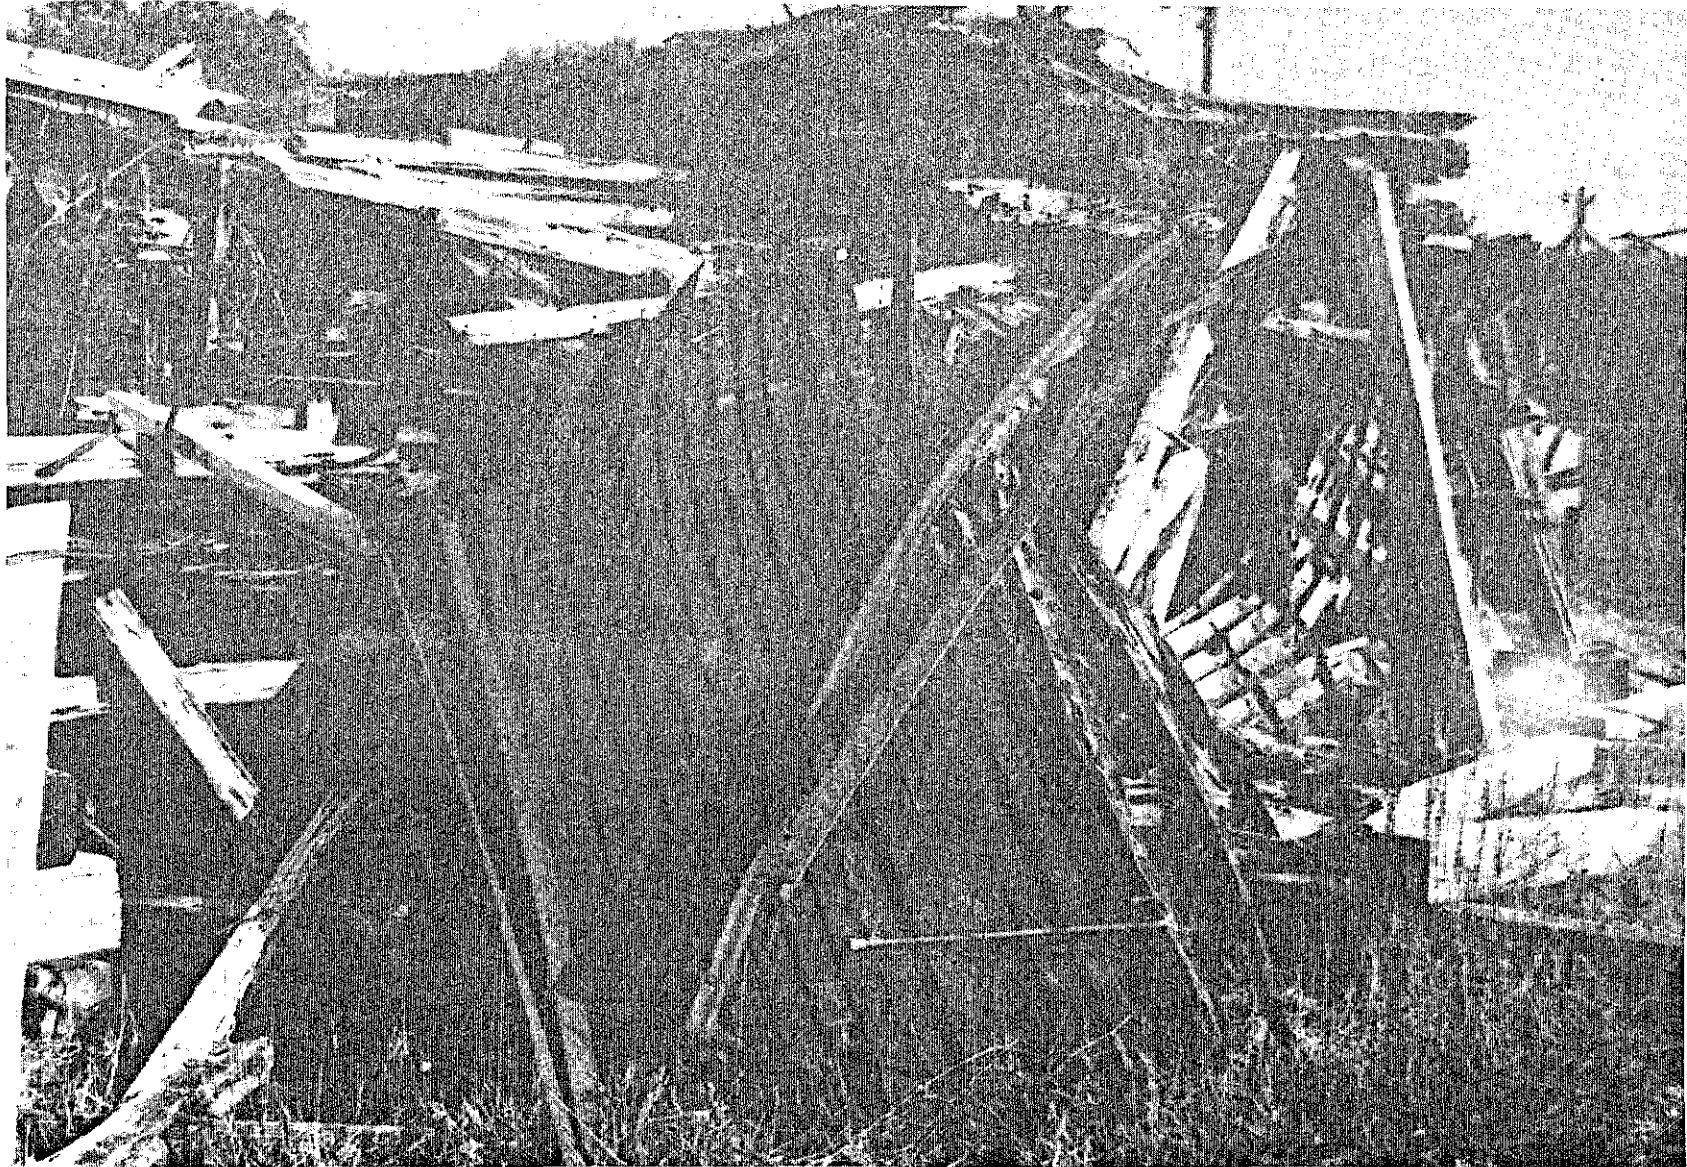
Figure 6: The reassembled Cairo had collapsed and was rotting by the time this 1977 photo was taken in Pascagoula. Note the pieces of garden hose in the upper left. NPS photo by Jim Smeal.

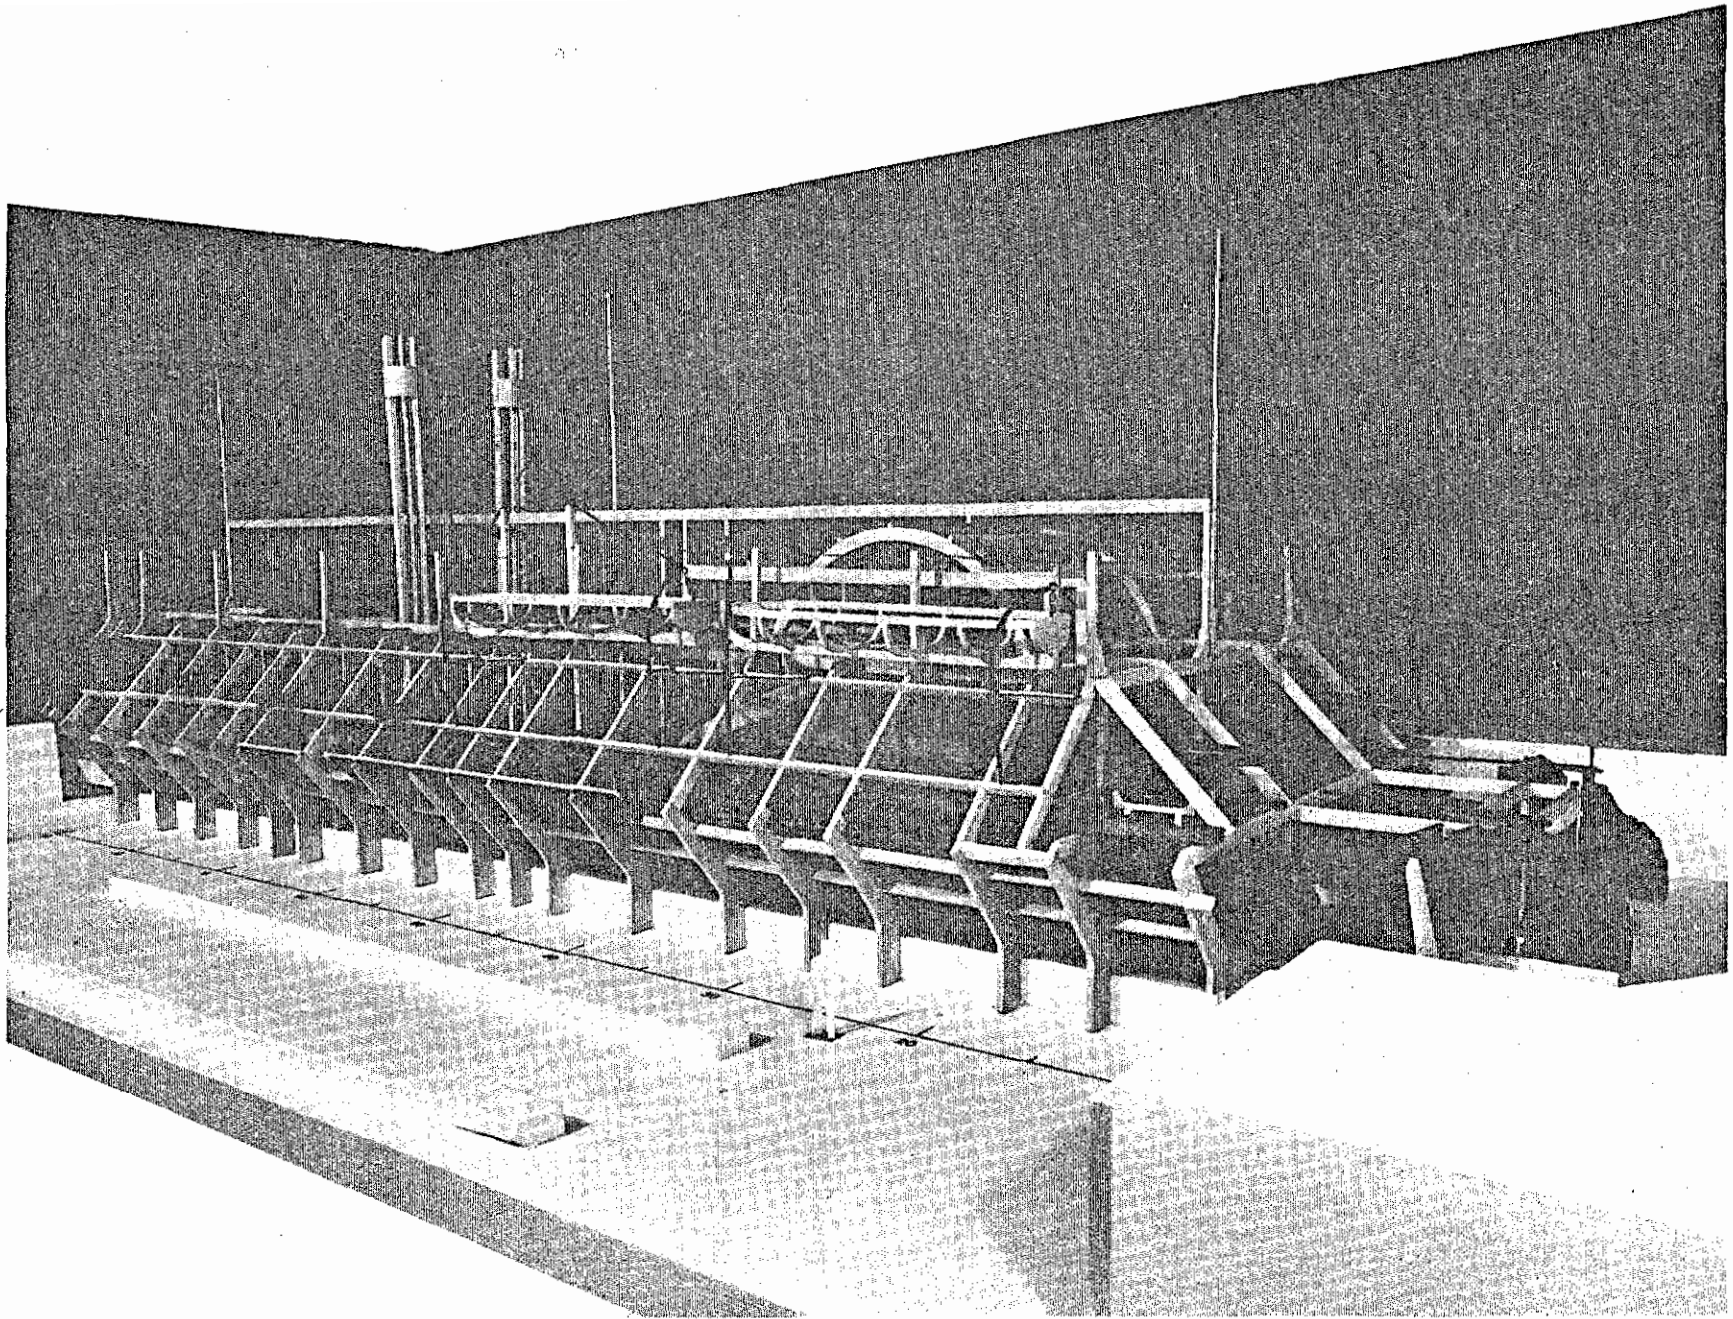
Figure 13: The scale torpedo (mine) blast hole in the port bow is evident in this photo of the model. Modelmaking was helpful in solving the oft-conflicting requirements of engineering, interpretive, and preservation problems that faced the architects. NPS photo by Les Siroky.
