TUGBOAT *HERCULES*

Historic Structure Report

San Francisco Maritime National Historical Park

Prepared by
Tri-Coastal Marine, Inc.
200 Burrows Street
San Francisco, California 94134

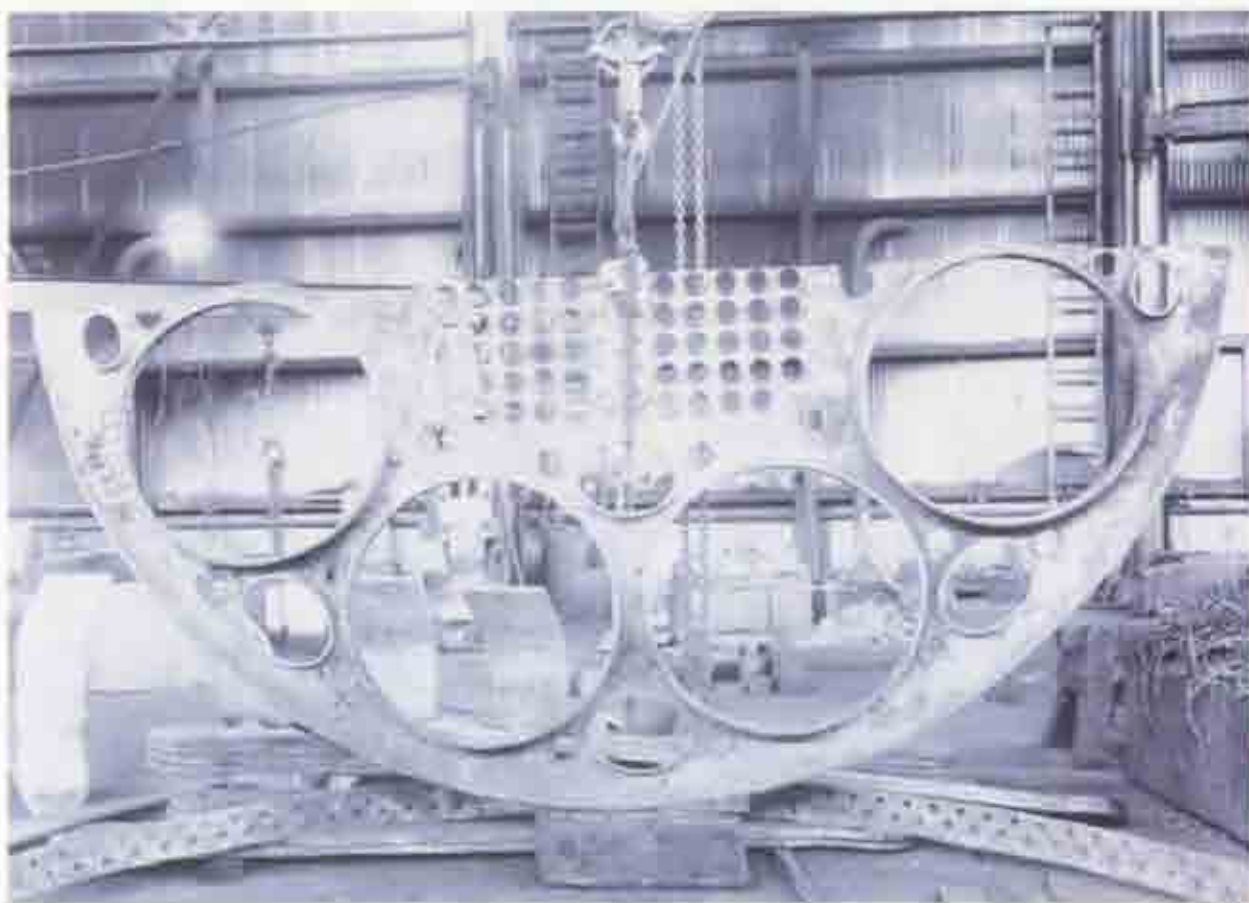
Fig. 6. "Tug HERCULES owned by Rolph Navigation & Coal Company. Showing lower front head removed from boiler. Repairs being made by the Moore Shipbuilding Company, Oakland, Cal. Oct. 2, 1919." (Photo Caption)

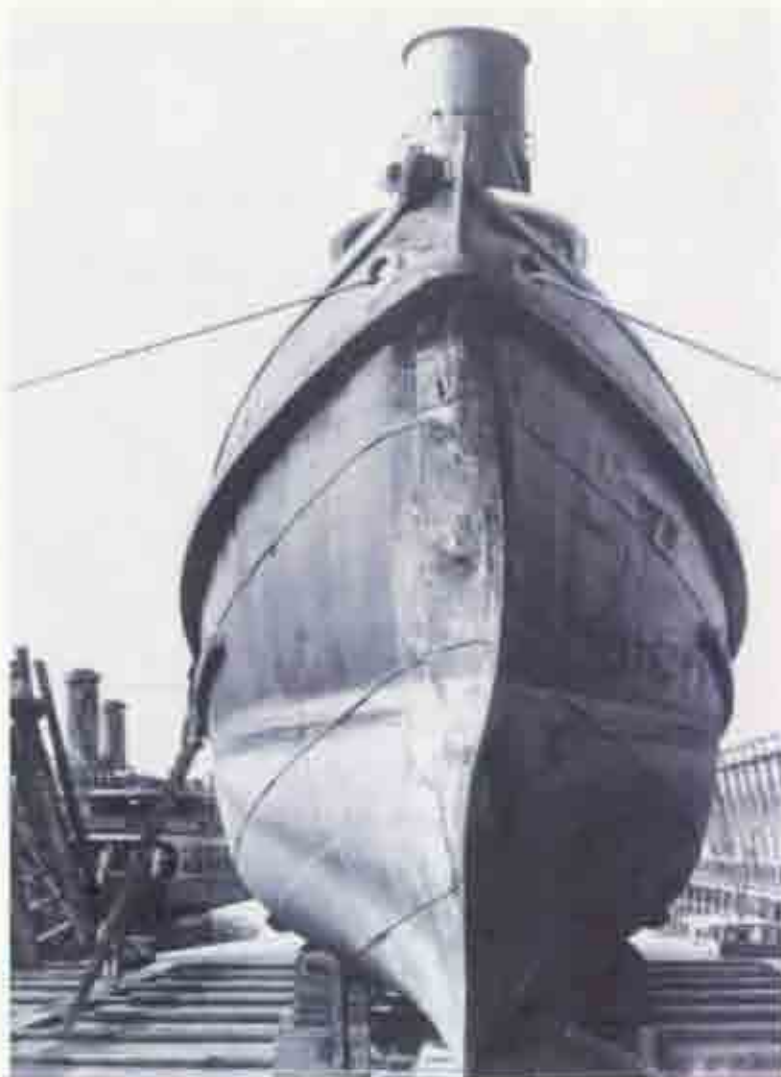
Fig. 9. HERCULES on dry dock following collision with steamer SAN PEDRO, 9 May 1933.

HERCULES in collision with McCormick lumber steamer POINT SAN PEDRO near Grove Street Terminal, San Francisco; tug sustains considerable damage to bow, propeller, stern frame, and rudder. Hauled out at Moore Drydock for repairs.

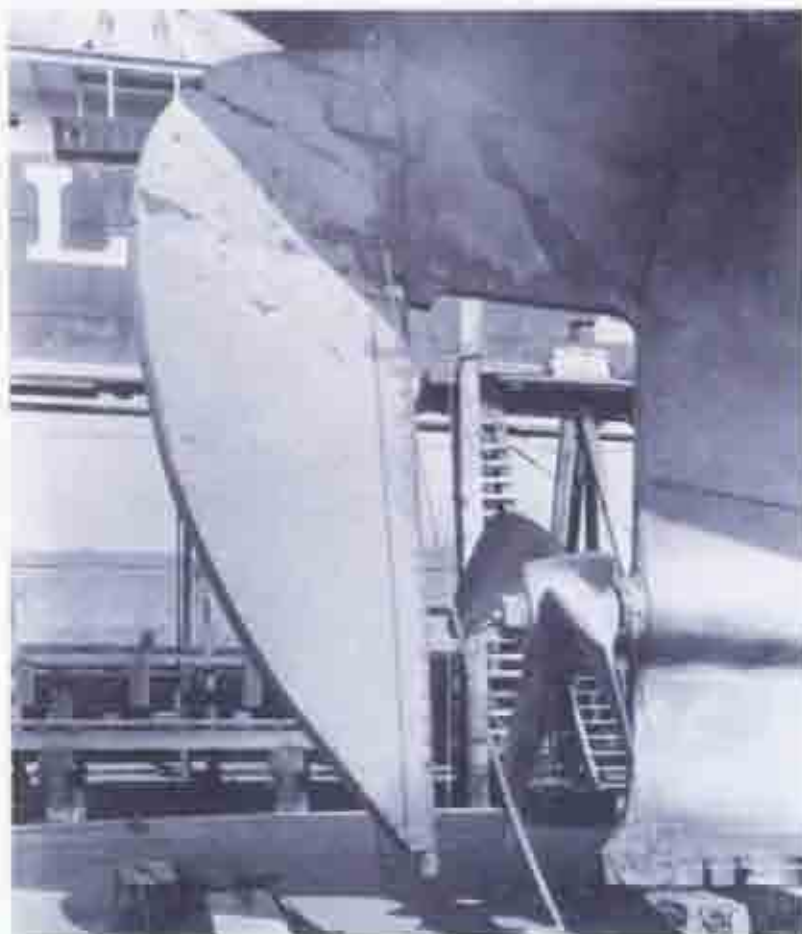
Fig. 10. Rudder and propeller damage resulting from collision with steamer SAN PEDRO.

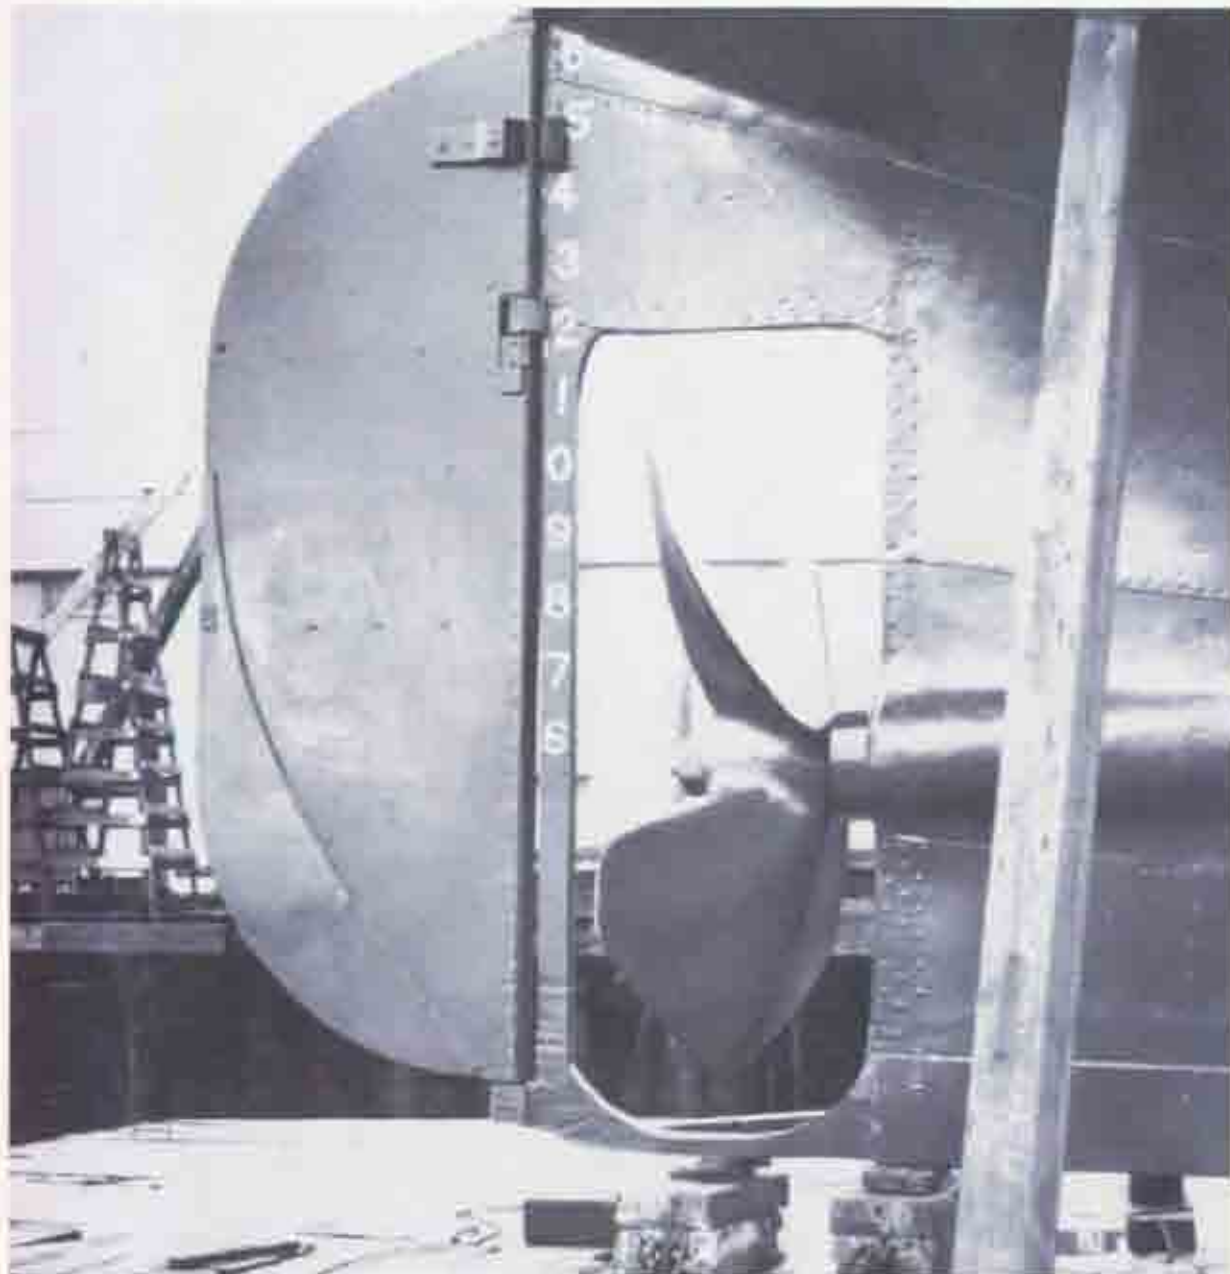
Fig. 17. HERCULES in drydock for enlargement of her rudder, Oakland, California, February 1940. Added portion can be seen at lower left side of rudder.

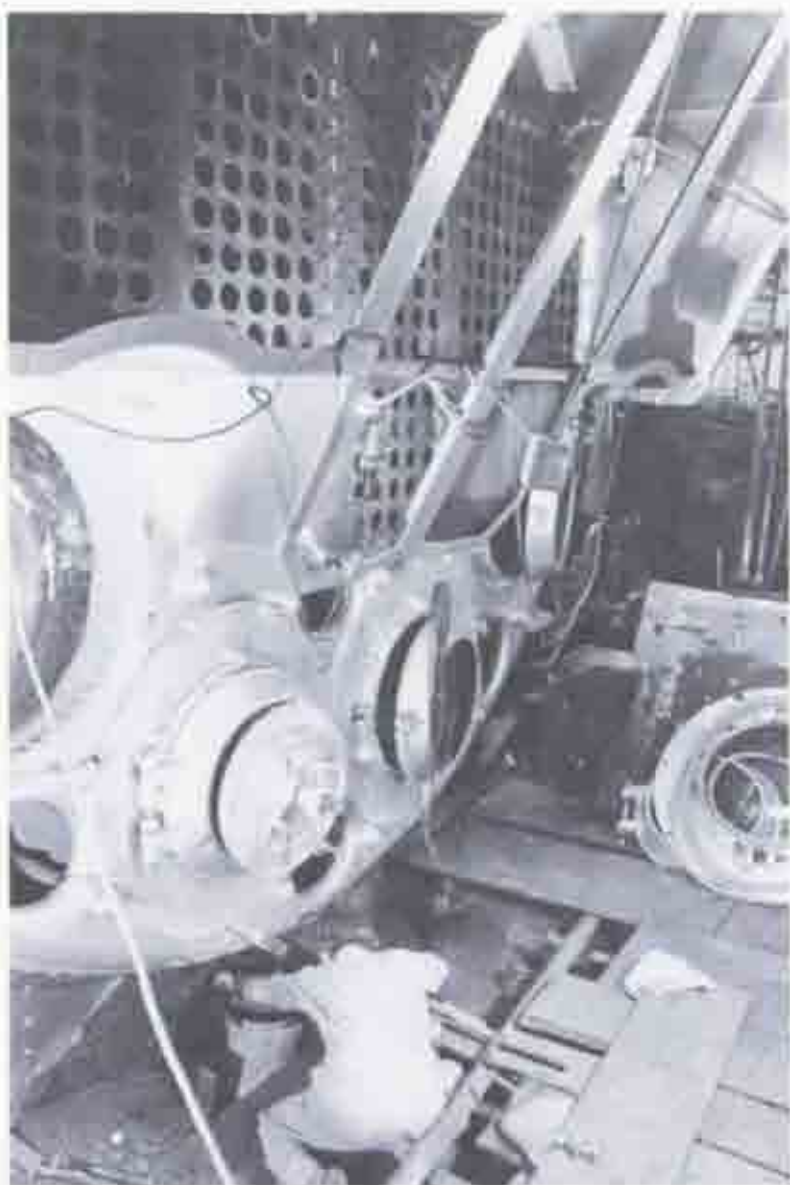
Fig. 22. View of the front end of HERCULES' boiler during restoration in the mid-1980s. Doors of the "front connection" have been removed for replacement of fire tubes.

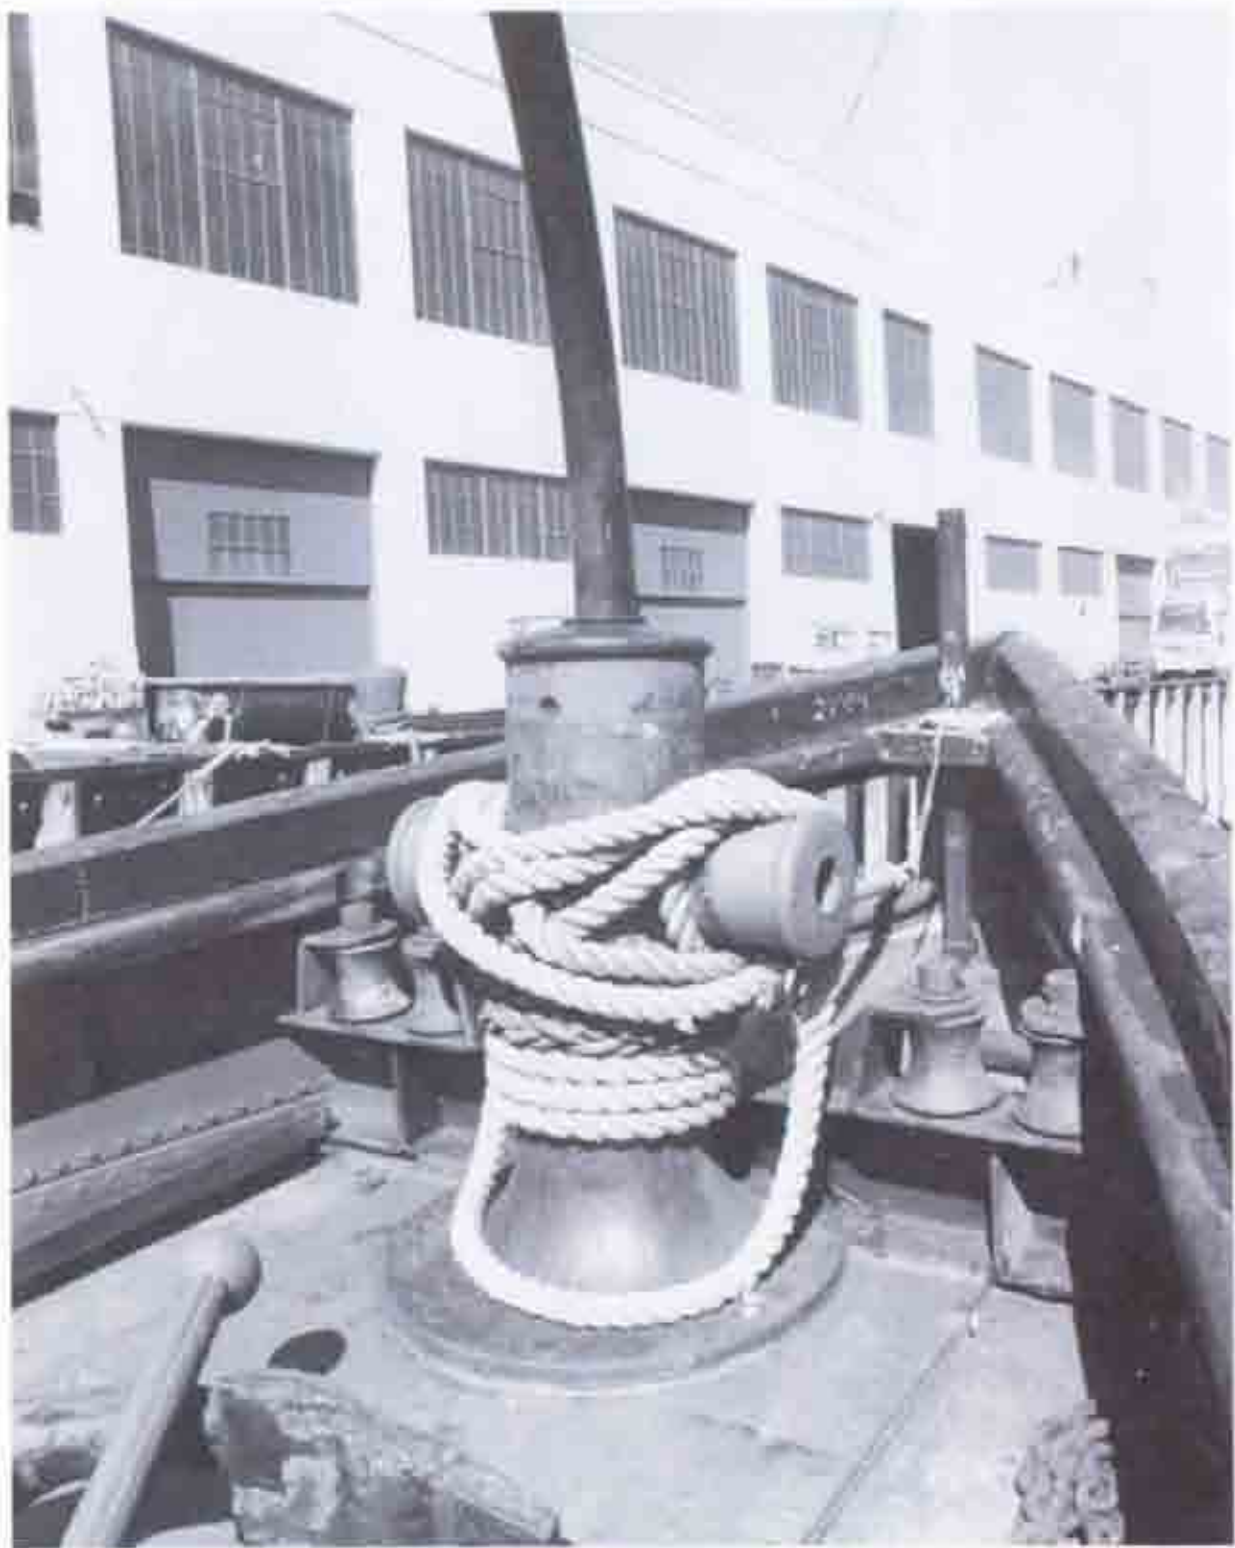
Custom Deck Fittings, Including Bow Bitt, Mooring Bitts, and Towing Bitts: Intact and original, with exception of the anchor davit mounted on the bow

Fig. 24. Kingpost bitt on foredeck, one of several original custom-made items HERCULES is fitted with. Roller-chocks to port and starboard of the bitt are a later addition.

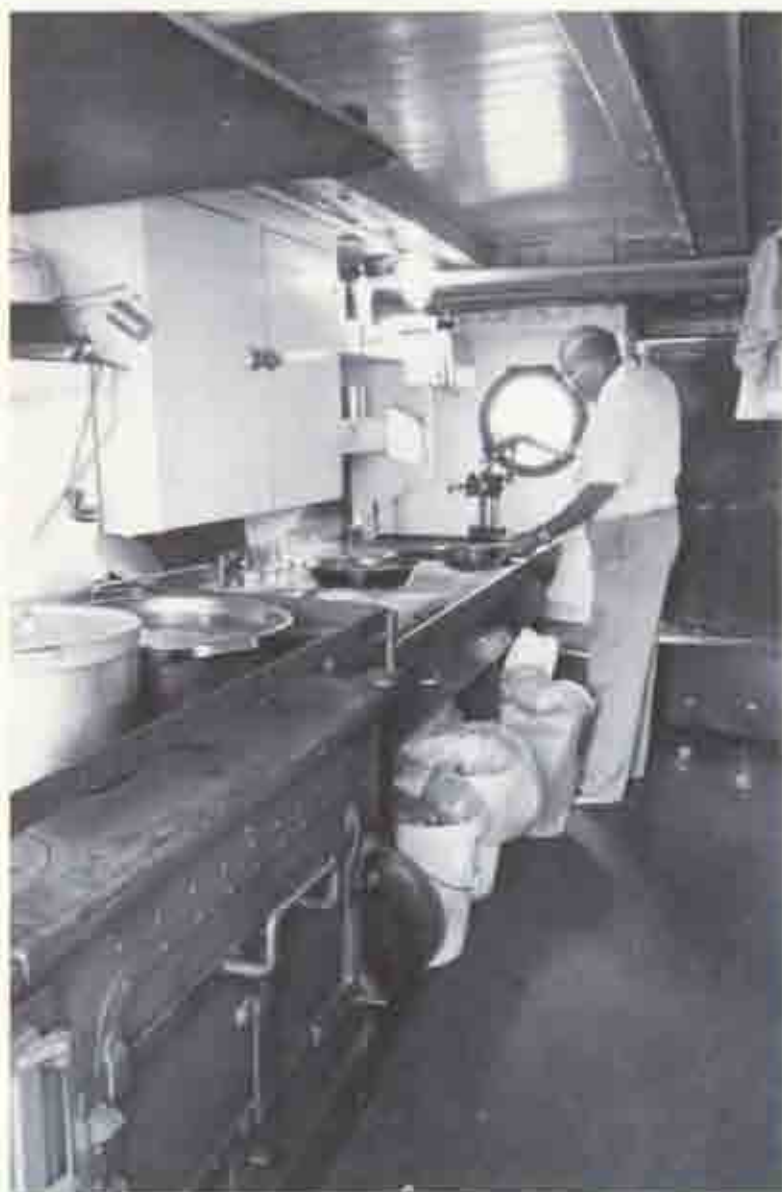
Fig. 28. The galley, as seen from the starboard entrance. The stove, sink, hand pump are operational.

Galley: Restore to configuration from oceangoing era after repair of steel deck beneath.
