Office of INSPECTOR GENERAL

Review of Building Security

Report No. IG-02-96

UNITED STATES INTERNATIONAL TRADE COMMISSION

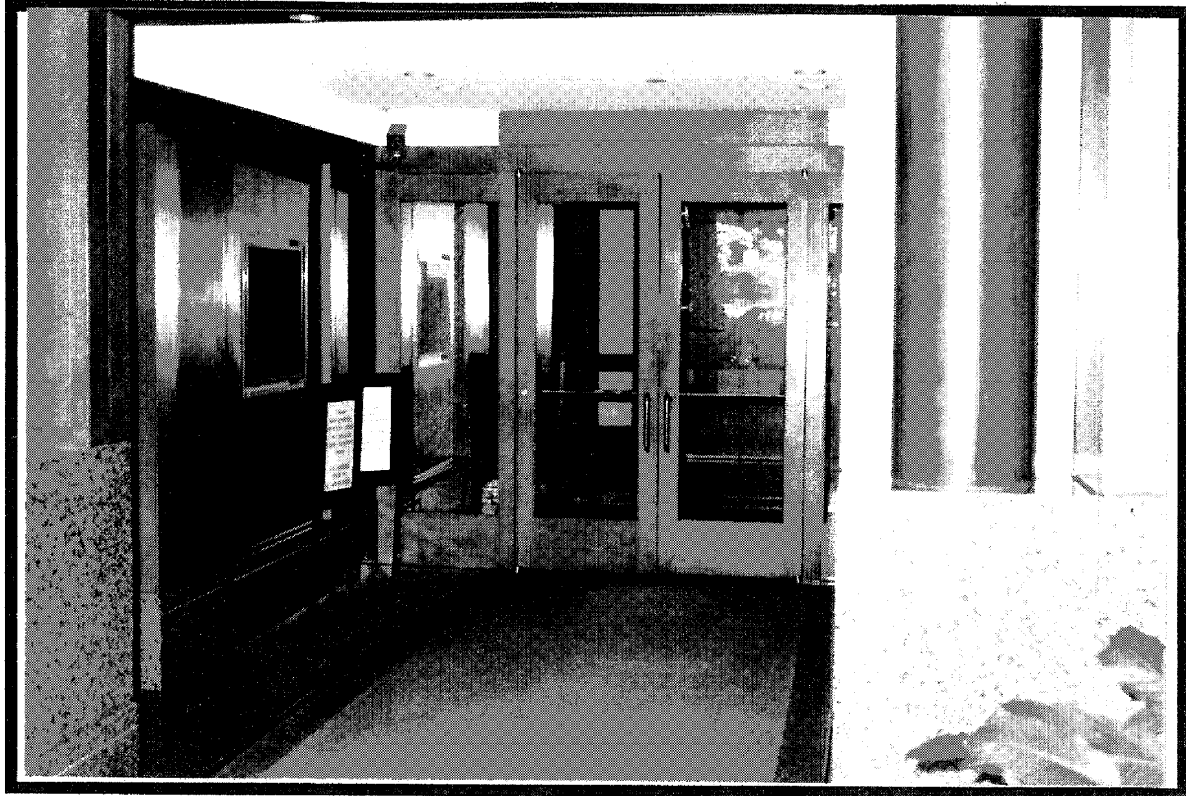
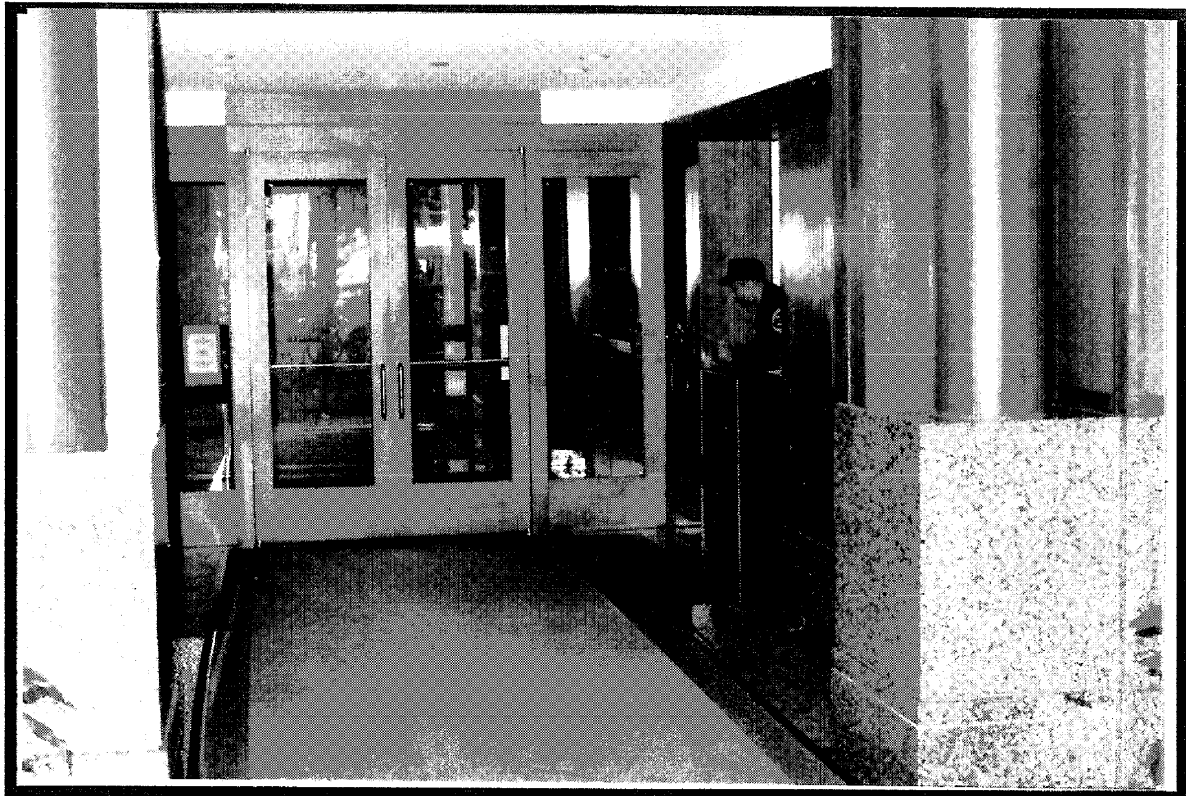
Lobby - ITC Entrance

Entrances/Exits: At the public entrance to the building, there is no magnetometer located within the lobby area. There also is no x-ray machine, either in the lobby or the mail room.

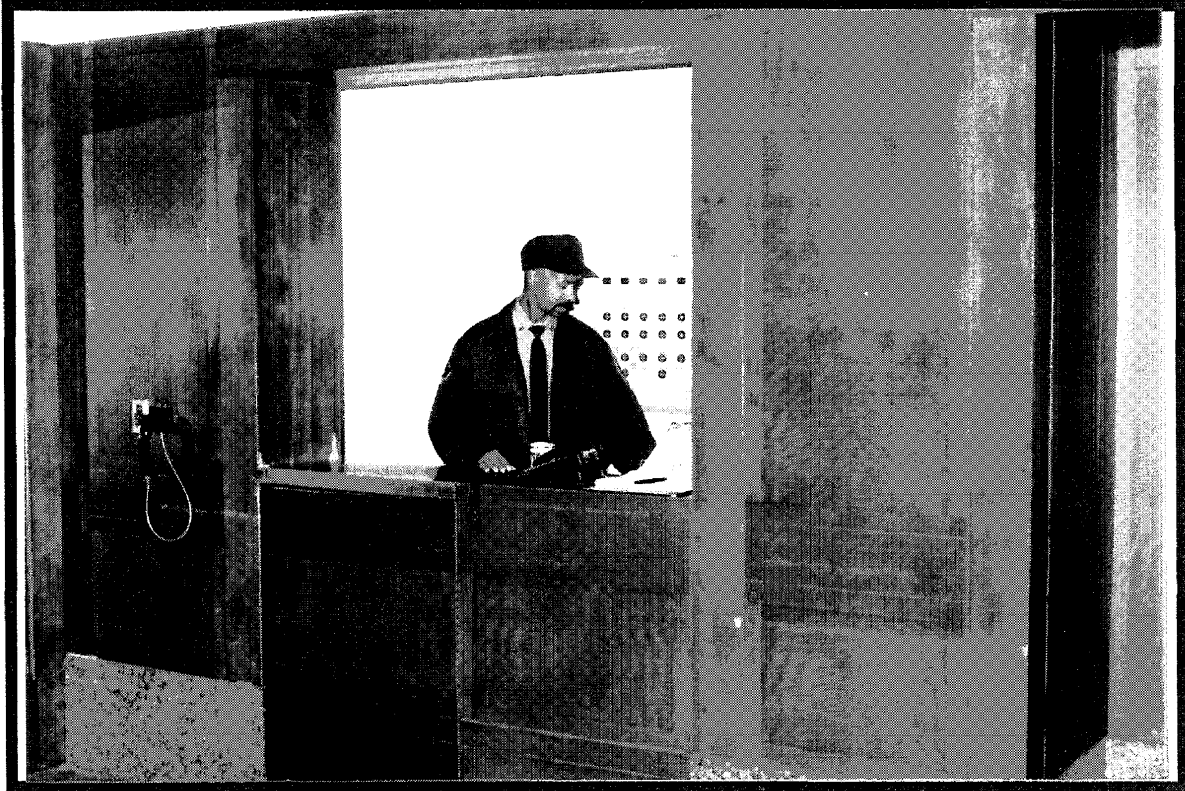
Lobby - Guard Booth

The guard post in the lobby is equipped with two CCTV monitors and a switcher for viewing pictures transmitted by the twelve cameras installed in the building. The control for the lobby door is also located in the guard booth.

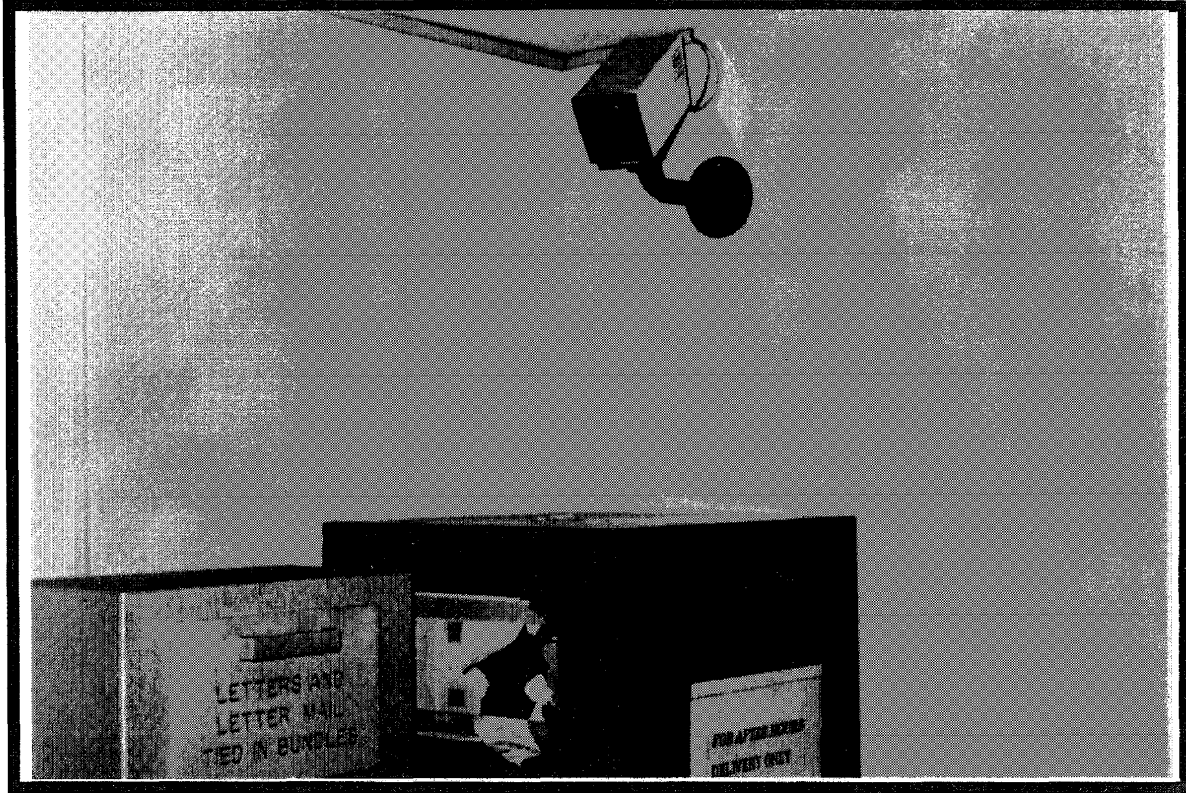
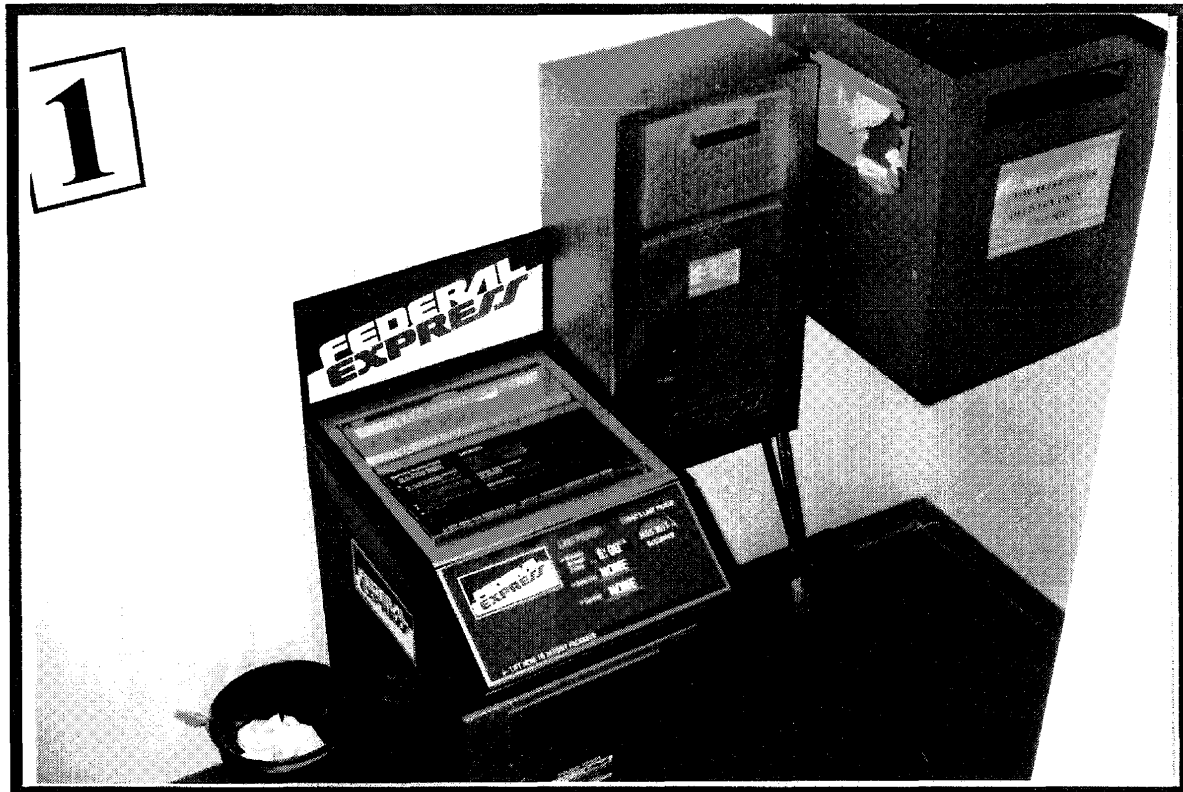
Stairwell – Package Drop-off Box

A night drop-off box is located next to the lobby area. This is used to deposit deliveries after offices are closed. We recommend elimination of this area as a drop-off box. All deliveries should be brought to the mail room and then put through an x-ray machine. The Federal Express drop off box should also be moved to a location that provides for better control.

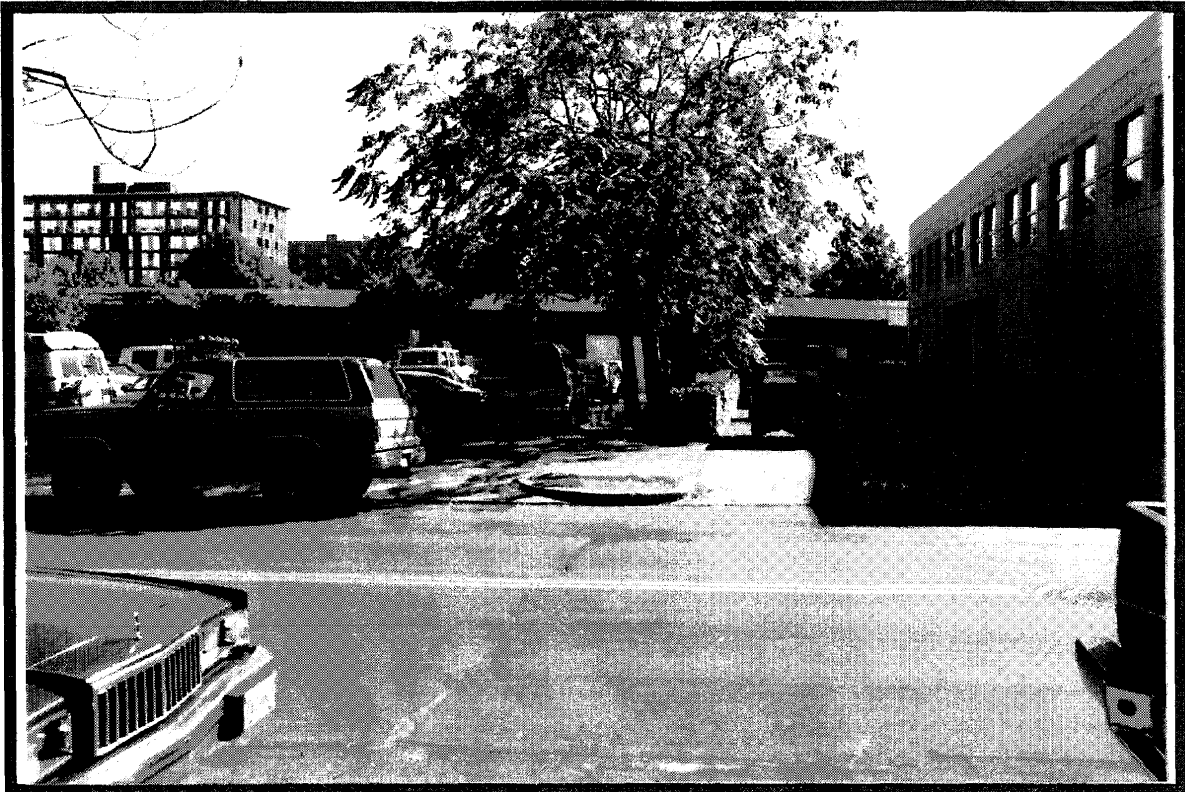
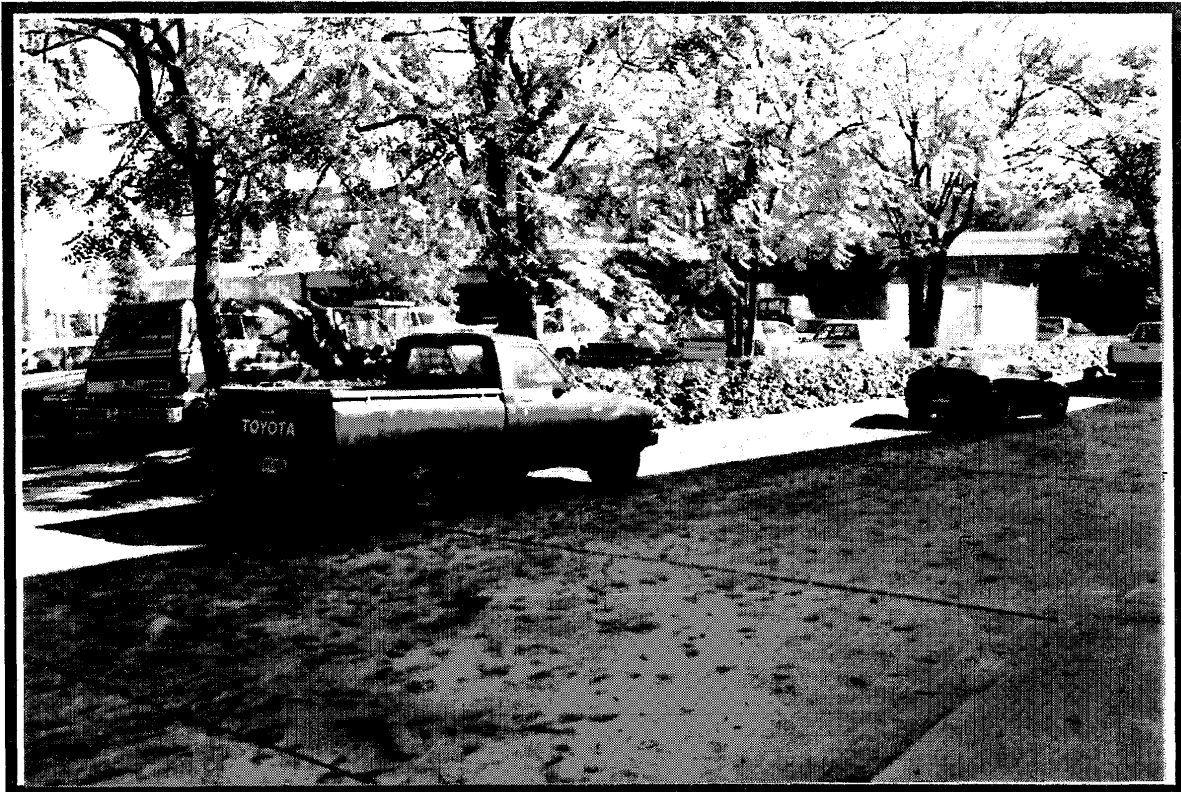
East Face - Delivery/Parking

Parking: There is no control of parking in the building or parking adjacent to the building. The parking concession, both in the building and on the empty lot on the 4th Street side of the building, is operated by Colonial Parking Inc. The vacant lot being leased by Colonial is owned by a local corporation. There are twelve parking passes for the underground parking held by ITC for use by employees on an as needed basis. Also, some of the ITC employees have their own parking passes and deal directly with Colonial Parking. This allows them 24-hour access to the parking garage. The Department of Justice report sets control of facility parking as a minimum standard.

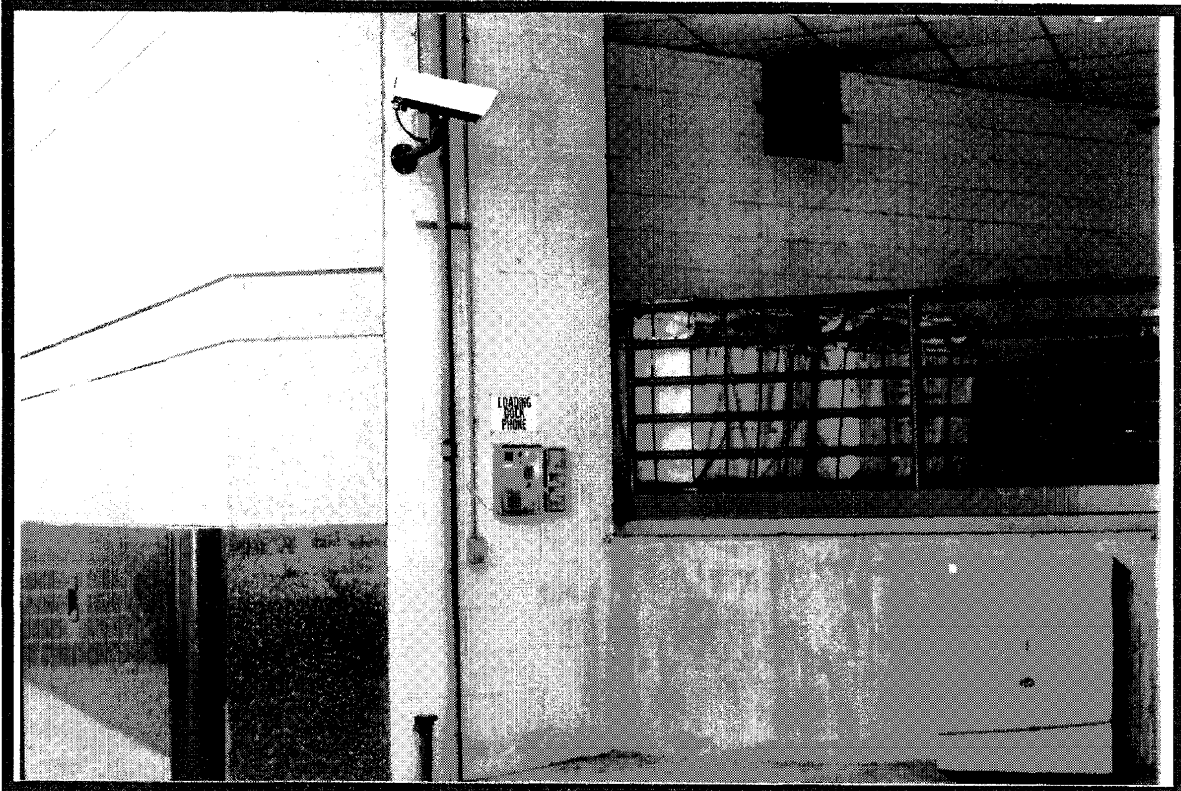
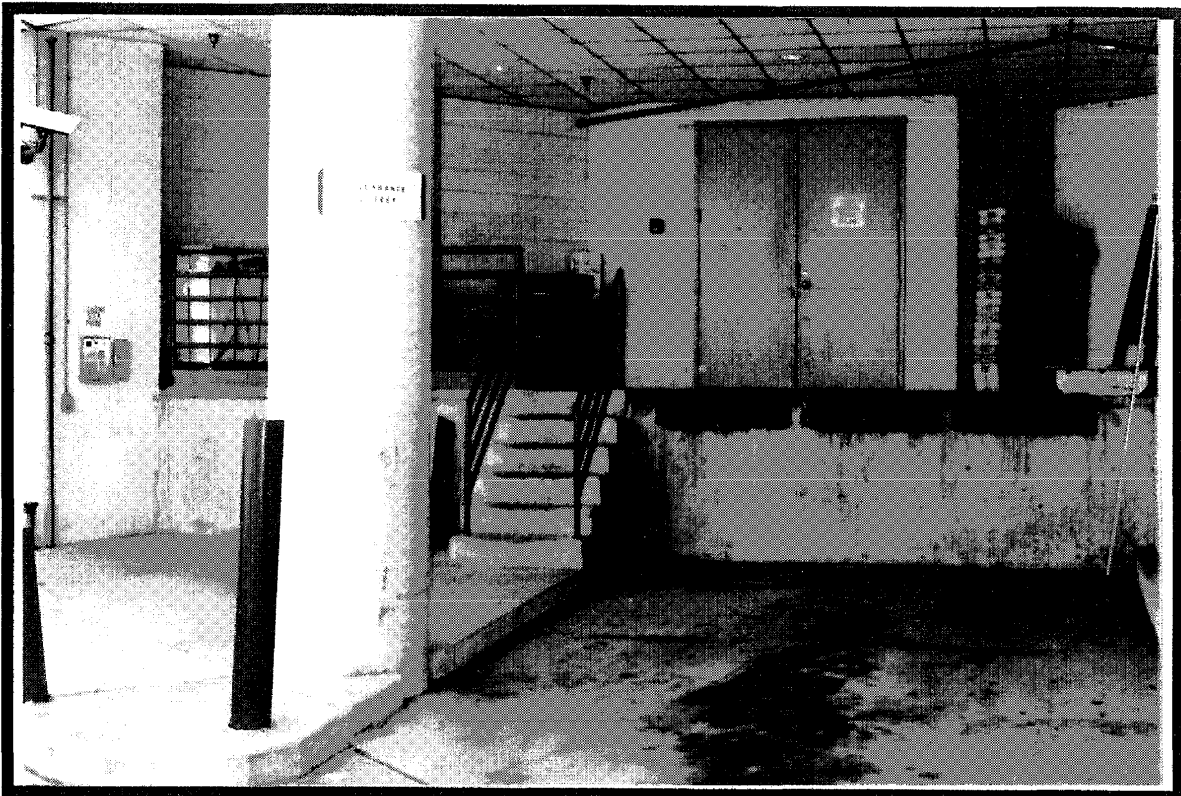
East Face - Loading Dock

CCTV Monitoring: There are no perimeter CCTV cameras at the ITC building, other than a loading dock camera that shows only a partial view of that area.

As witnessed during a visit to the site, one delivery in particular was for the landlord's building operations group. One of the landlord's engineers disabled the audible alarm on the loading dock doors, without notifying the guards, and proceeded to direct the driver as to the delivery of the shipment.

Recommendation: Perimeter CCTV cameras are required as a minimum for Level IV buildings. High resolution outdoor cameras with pan/tilt and zoom features should be installed on the rooftop. Pan/tilt zoom controls should be installed at the lobby guard post and the Facilities Management location. The trees in front of the building may need to be trimmed so as not to obstruct the view of the cameras.

The guard should be able to see a delivery truck approaching the dock by means of the perimeter CCTV camera which should be installed to cover the driveway area. After parking the truck, the driver should be able to contact the guard desk, at which time the roving guard will be dispatched to the dock area. After arriving at the dock area, the guard will disable the audible alarm and open the double doors to the dock. The driver should then be directed to his destination by the roving guard, who will watch over the area as long as the loading dock doors are open. After the delivery is completed, the guard should ensure that the doors are secured and the audible alarm is activated.
