ADVISORY CIRCULAR

43-16A

AVIATION MAINTENANCE ALERTS

**ALERT
NUMBER
367**

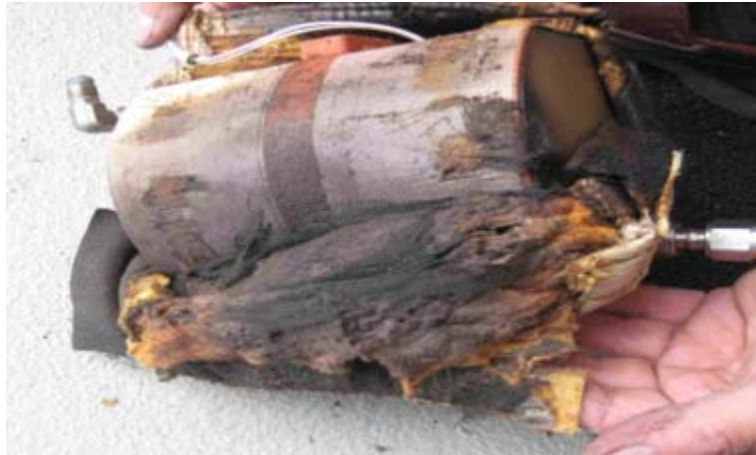
Transport Canada Civil Aviation (TCCA) has learned through the Service Difficulty Reporting (SDR) program that a Bombardier CL-600-2B16 (601-3R) Challenger's crew observed smoke coming out of the fuel control panel in the forward galley area. The aircraft declared an emergency and made a successful landing.

Investigation has revealed the water heater insulation blanket in the forward galley had evidence of heat damage. The heater (P/N 444-0007 or 500-0120-7-0) is part of a United States Supplemental Type Certificate (STC) – SA696GL and SA4370SW.

Further investigation revealed the thermostat on the heater had failed allowing the temperature to climb well above design limits causing the heater's insulation and the adjacent aircraft insulation to begin to overheat (smoke). There have been four (4) known previous events where the thermostat has failed with similar results.

Transport Canada recommends that all operators and Approved Maintenance Organizations review aircraft records and verify if their aircraft has had interior modifications carried out at either Gulfstream's (formerly KC Aviation) Appleton or Dallas facilities. Also, TCCA highly recommends a visual inspection be carried out for this heater installation and evidence of water heater overheating at the earliest possible opportunity.

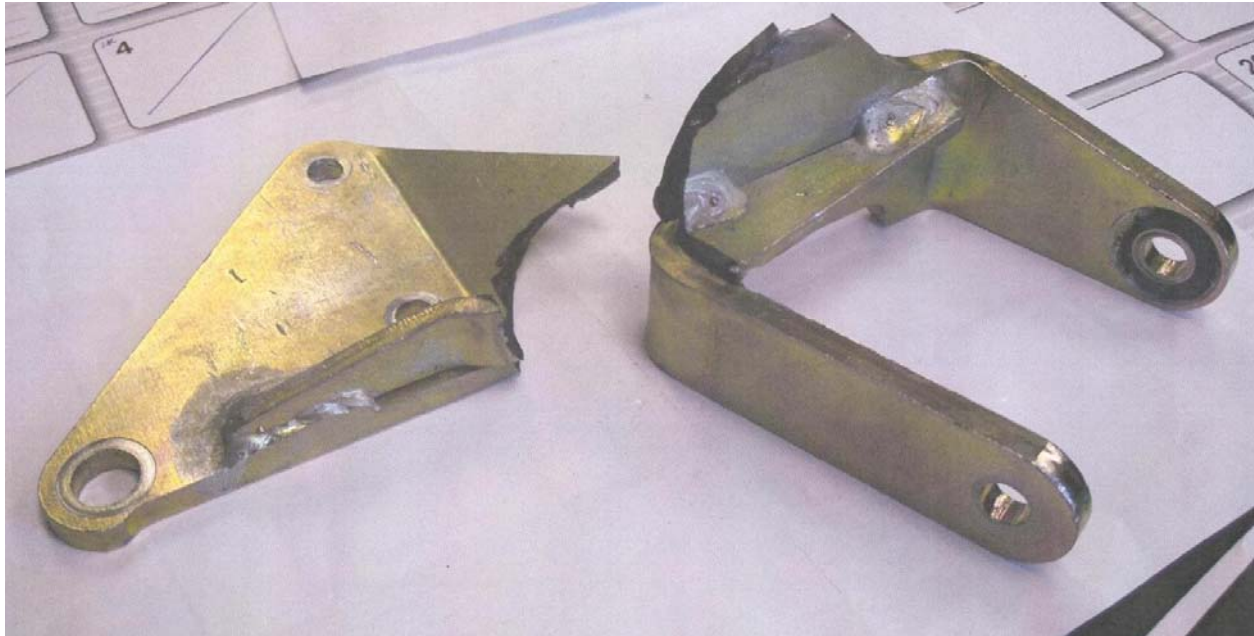
A mechanic says, "*(At an earlier date...)* I installed a Plane Power Alternator Conversion Kit (STC SA10682SC) on this aircraft. During an oil change I found the alternator bracket (*Plane Power P/N 10-9003*) cracked totally in half. This alternator had only been in use for three weeks at approximately 45 hours."

Part Total Time: 45.0 hour (approximately).

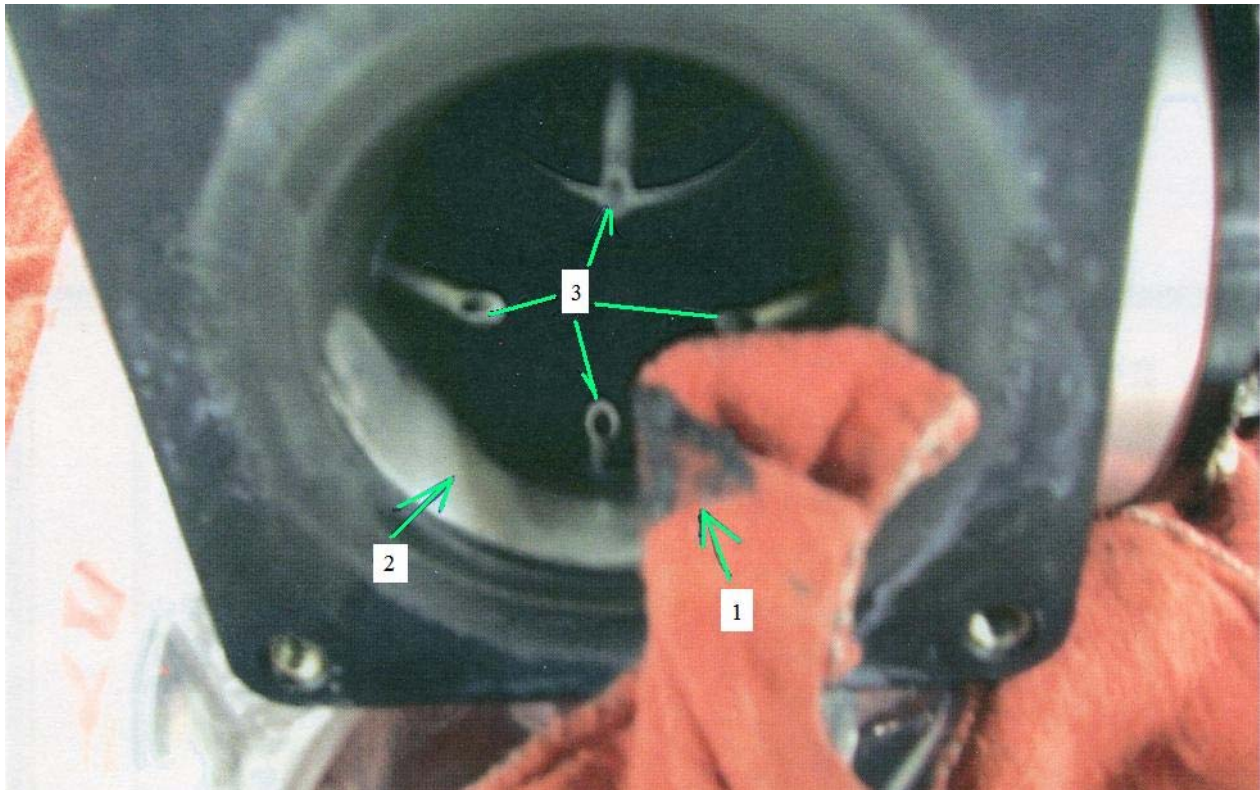
"While performing a 100 hour inspection," writes a mechanic, "fine metal particles were discovered covering the throat and valve of the fuel injection servo (P/N 2576568-1). The servo was sent to a repair facility to determine whether or not any of the metal particles entered the servo's blast tubes. It has been determined the metal originated from the chafing of the loose fitting inlet ring (item 220; P/N 7166-20-31) within the flange (item 20; P/N 7166-20-33). The loose fit is due to manufacturing. Diamond Aircraft has not come up with a fix as of this date. For now we are cementing the inlet ring to the flange while awaiting a permanent fix."

"Here you can see the metal adhering to the rag (1), and the resulting clean area at the inlet of the fuel injection servo (2). The particles coated the entire length of the throat and valve. We were concerned metal may have been ingested into the blast tubes (3). Upon inspection (*by an overhaul facility*), it was found that no metal had entered the blast tubes."

Part Total Time: 686.5 hours.
