**Federal Aviation  
Administration**

## ADVISORY CIRCULAR

# AVIATION MAINTENANCE ALERTS

**ALERT  
NUMBER  
369**

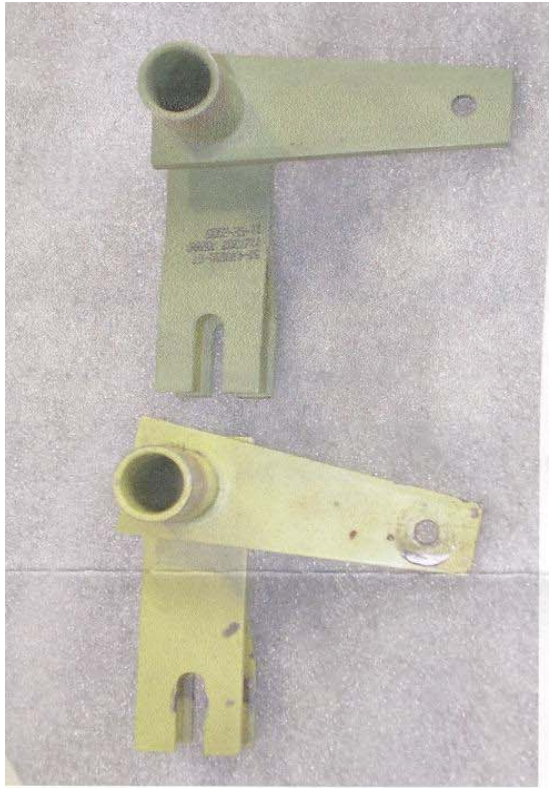
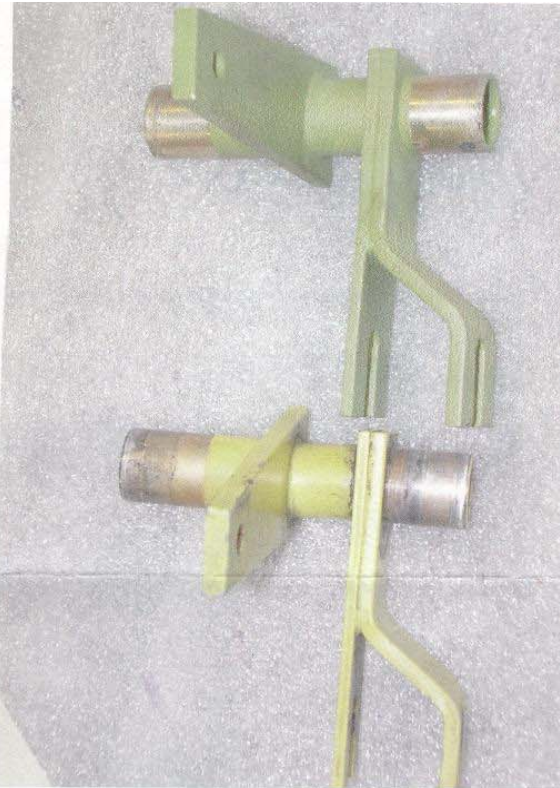
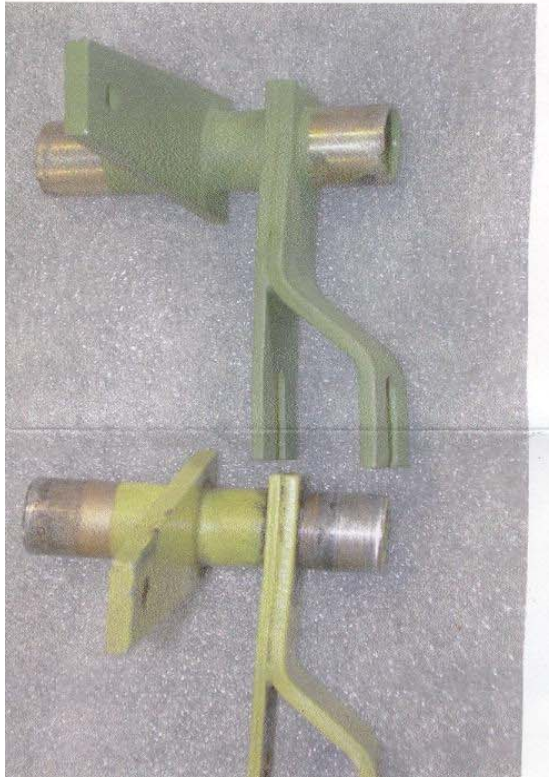
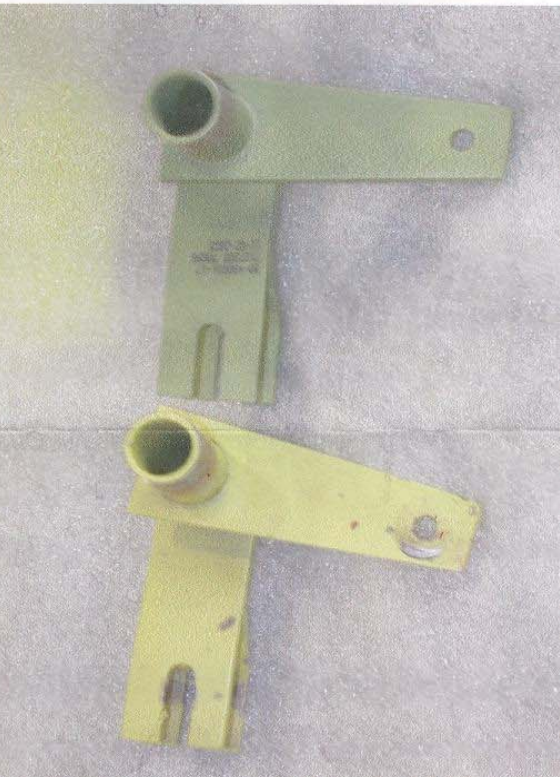
A technician for an air taxi operation states, "During a routine, Phase 3 inspection the main cabin door aft up-lock bell crank was found twisted about 10 degrees from *(that)* of a new bell crank *(P/N 50-430031-17)*. The up-lock bracket pivot bolt *(P/N NAS1103-21D)* was also noted to be slightly deformed. This *(condition)* was probably caused by the up-lock hook being *(improperly)* rigged. All effected parts were replaced and the up-lock hooks were *(then)* able to be rigged properly."

*(Slightly deformed? Nice comparison photos.)*

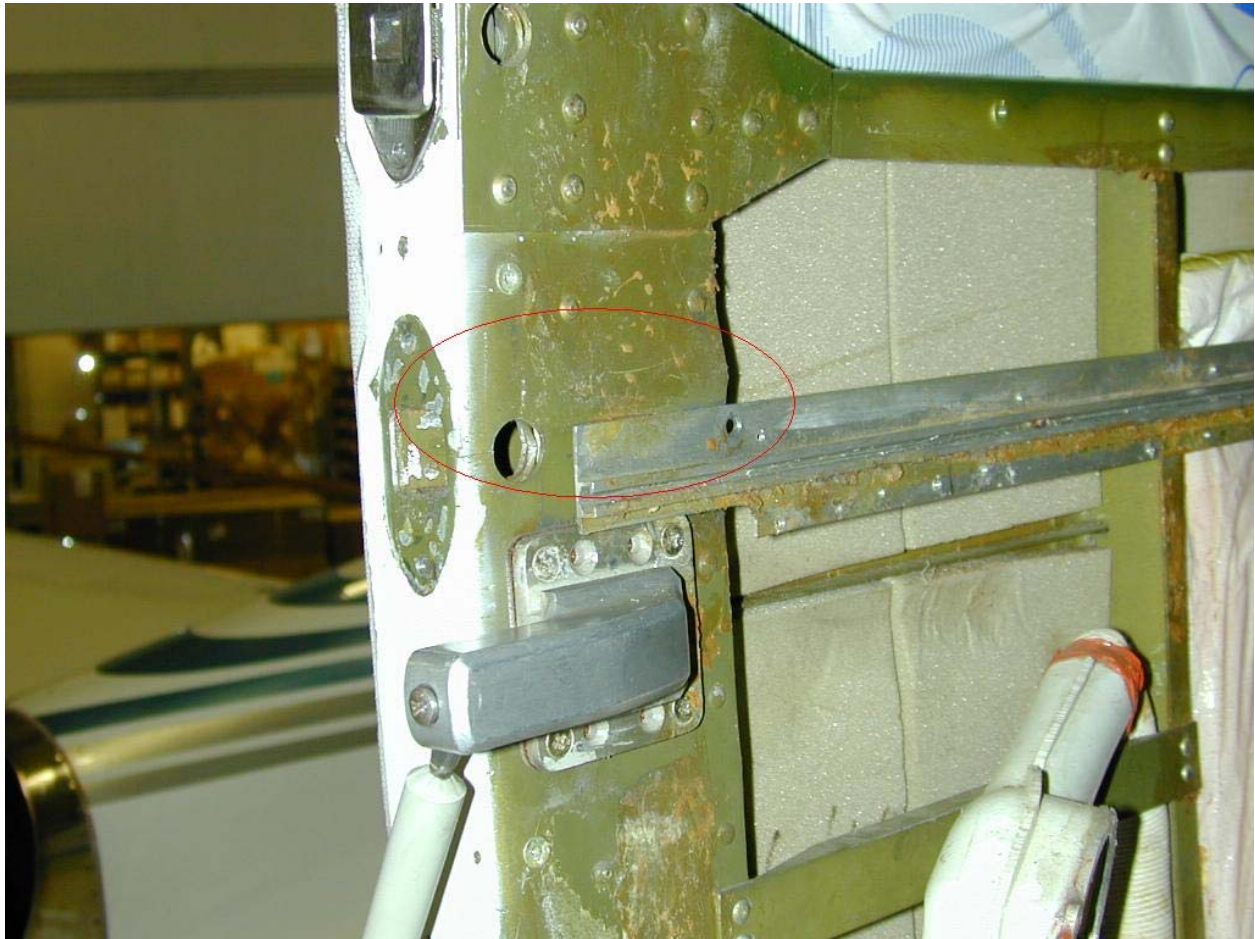
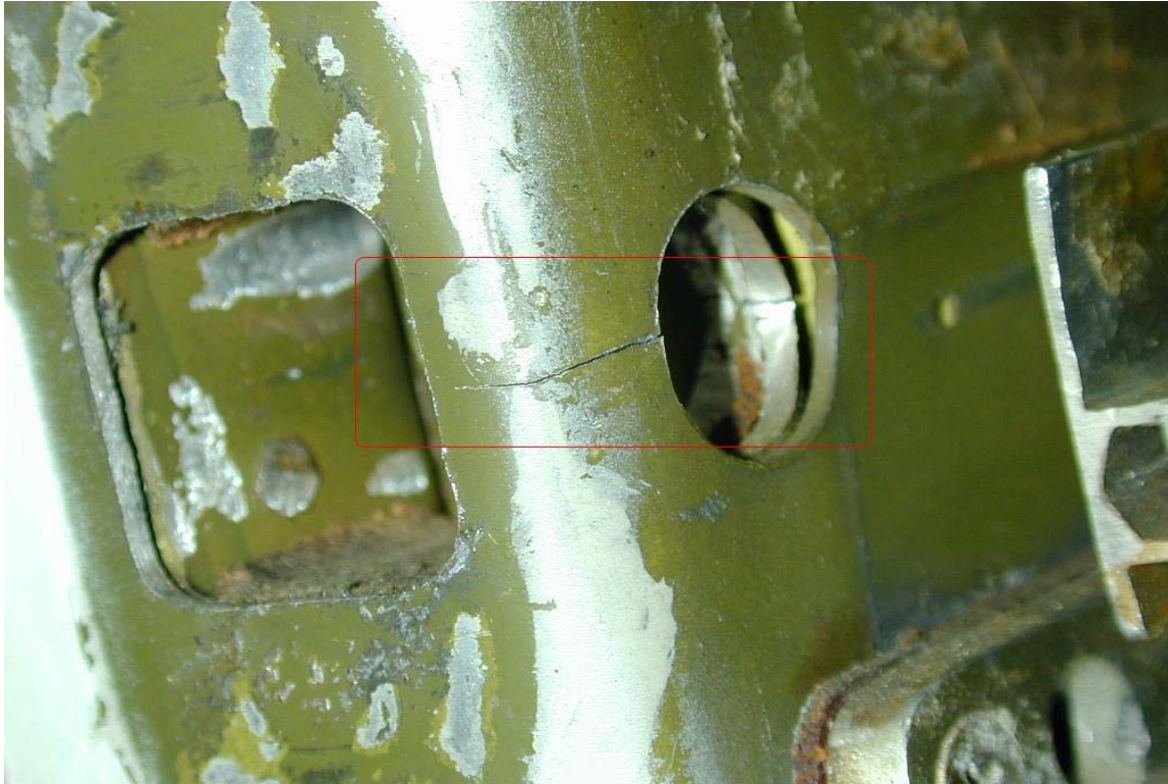
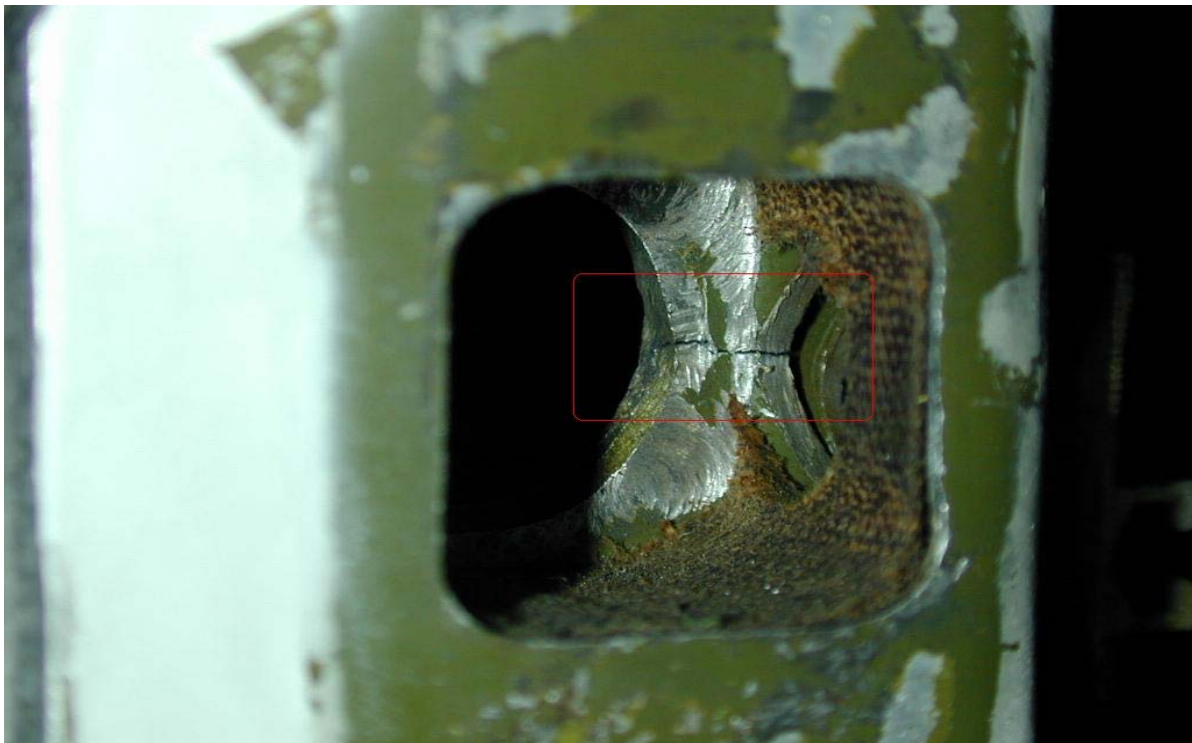
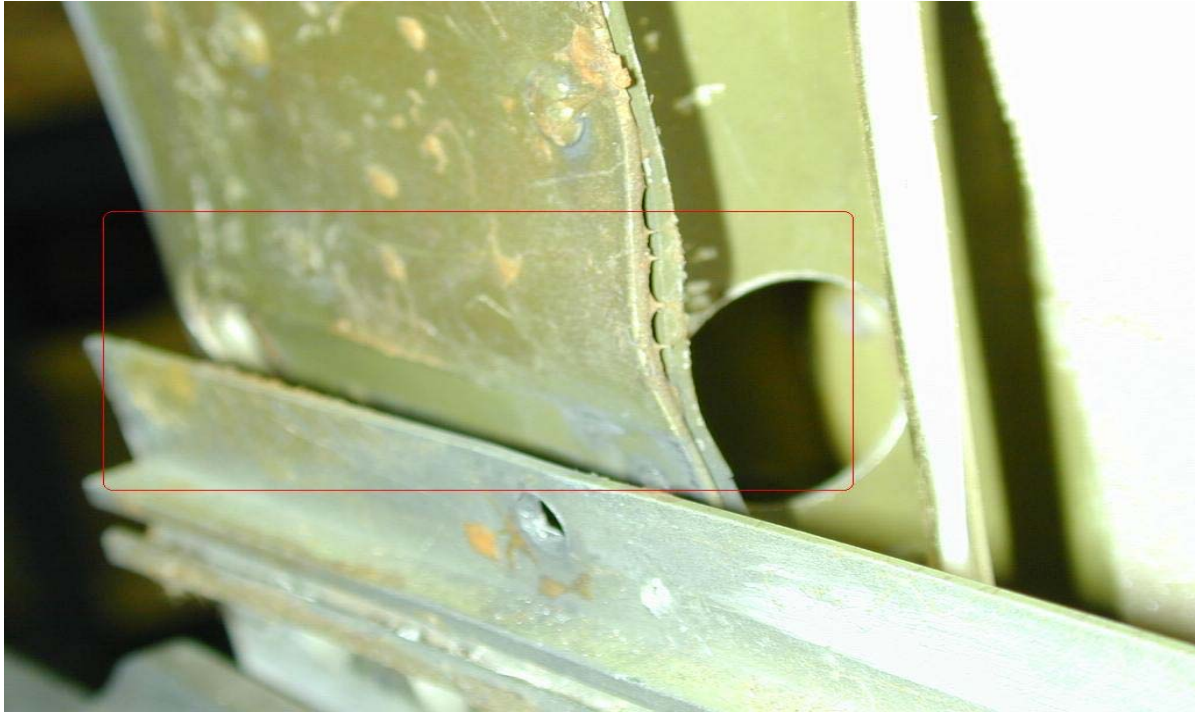
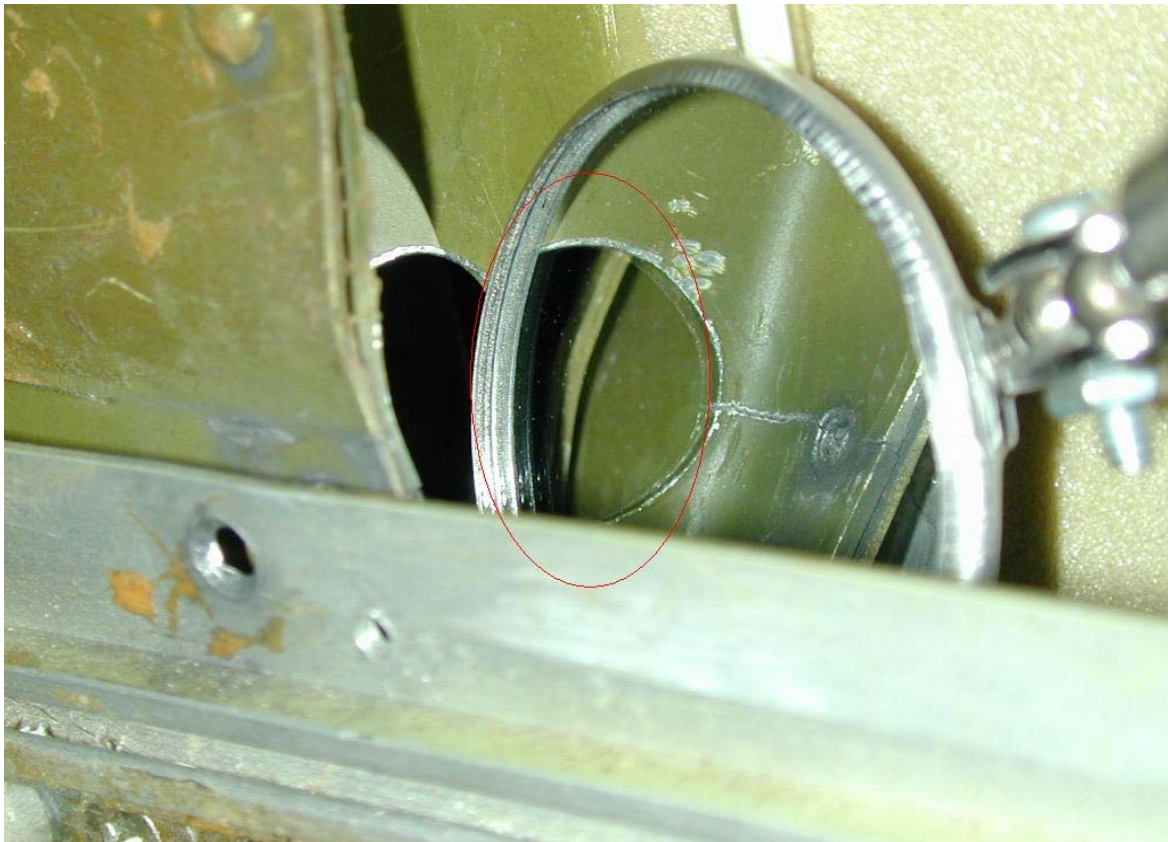
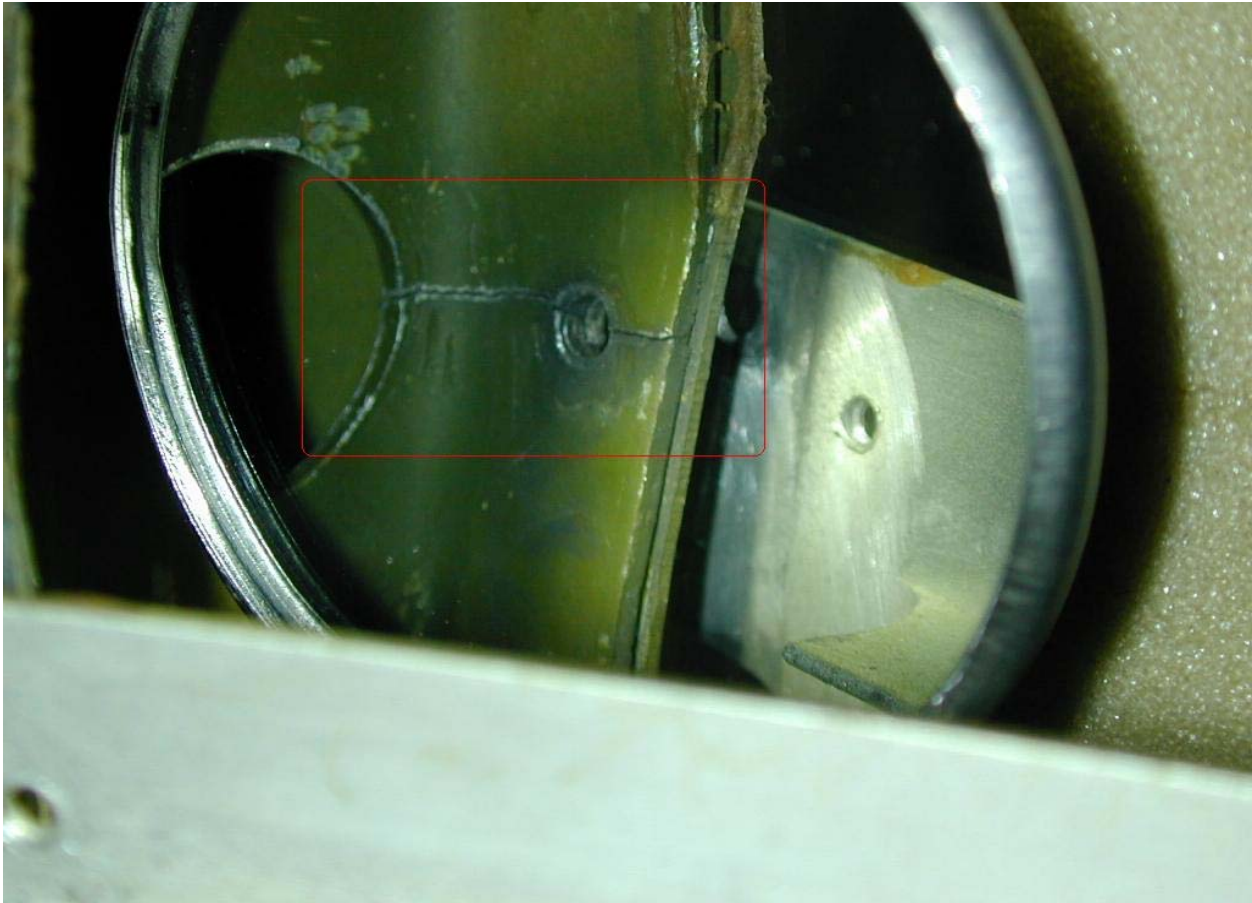
#### **Cessna: 441; Secondary Bulkhead Cracks; ATA 5312**

"During the SID (*shaft inspection device*) inspection," says an unknown submitter, "the fuselage bulkhead at the forward opening of the cabin door and secondary bulkhead were found cracked, buckled, and distorted. (*The only reason...*) this was found was the SID inspection requires removal of the door bayonet receptacles for inspection, and (*also*) the removal of the interior sidewall upholstery."

*(Bulkhead P/N 57111434345. Nice camera/mirror work—Ed.)*
