GE  
159 Plastics Avenue  
Pittsfield, MA 01201  
USA

August 29, 2008

**Re: GE-Pittsfield/Housatonic River Site  
1½-Mile Reach (GEC820)  
Report on 2008 Inspection of Riverbank Soil Restoration, Riprap, Aquatic Habitat  
Enhancement Structures and Ancillary Items**

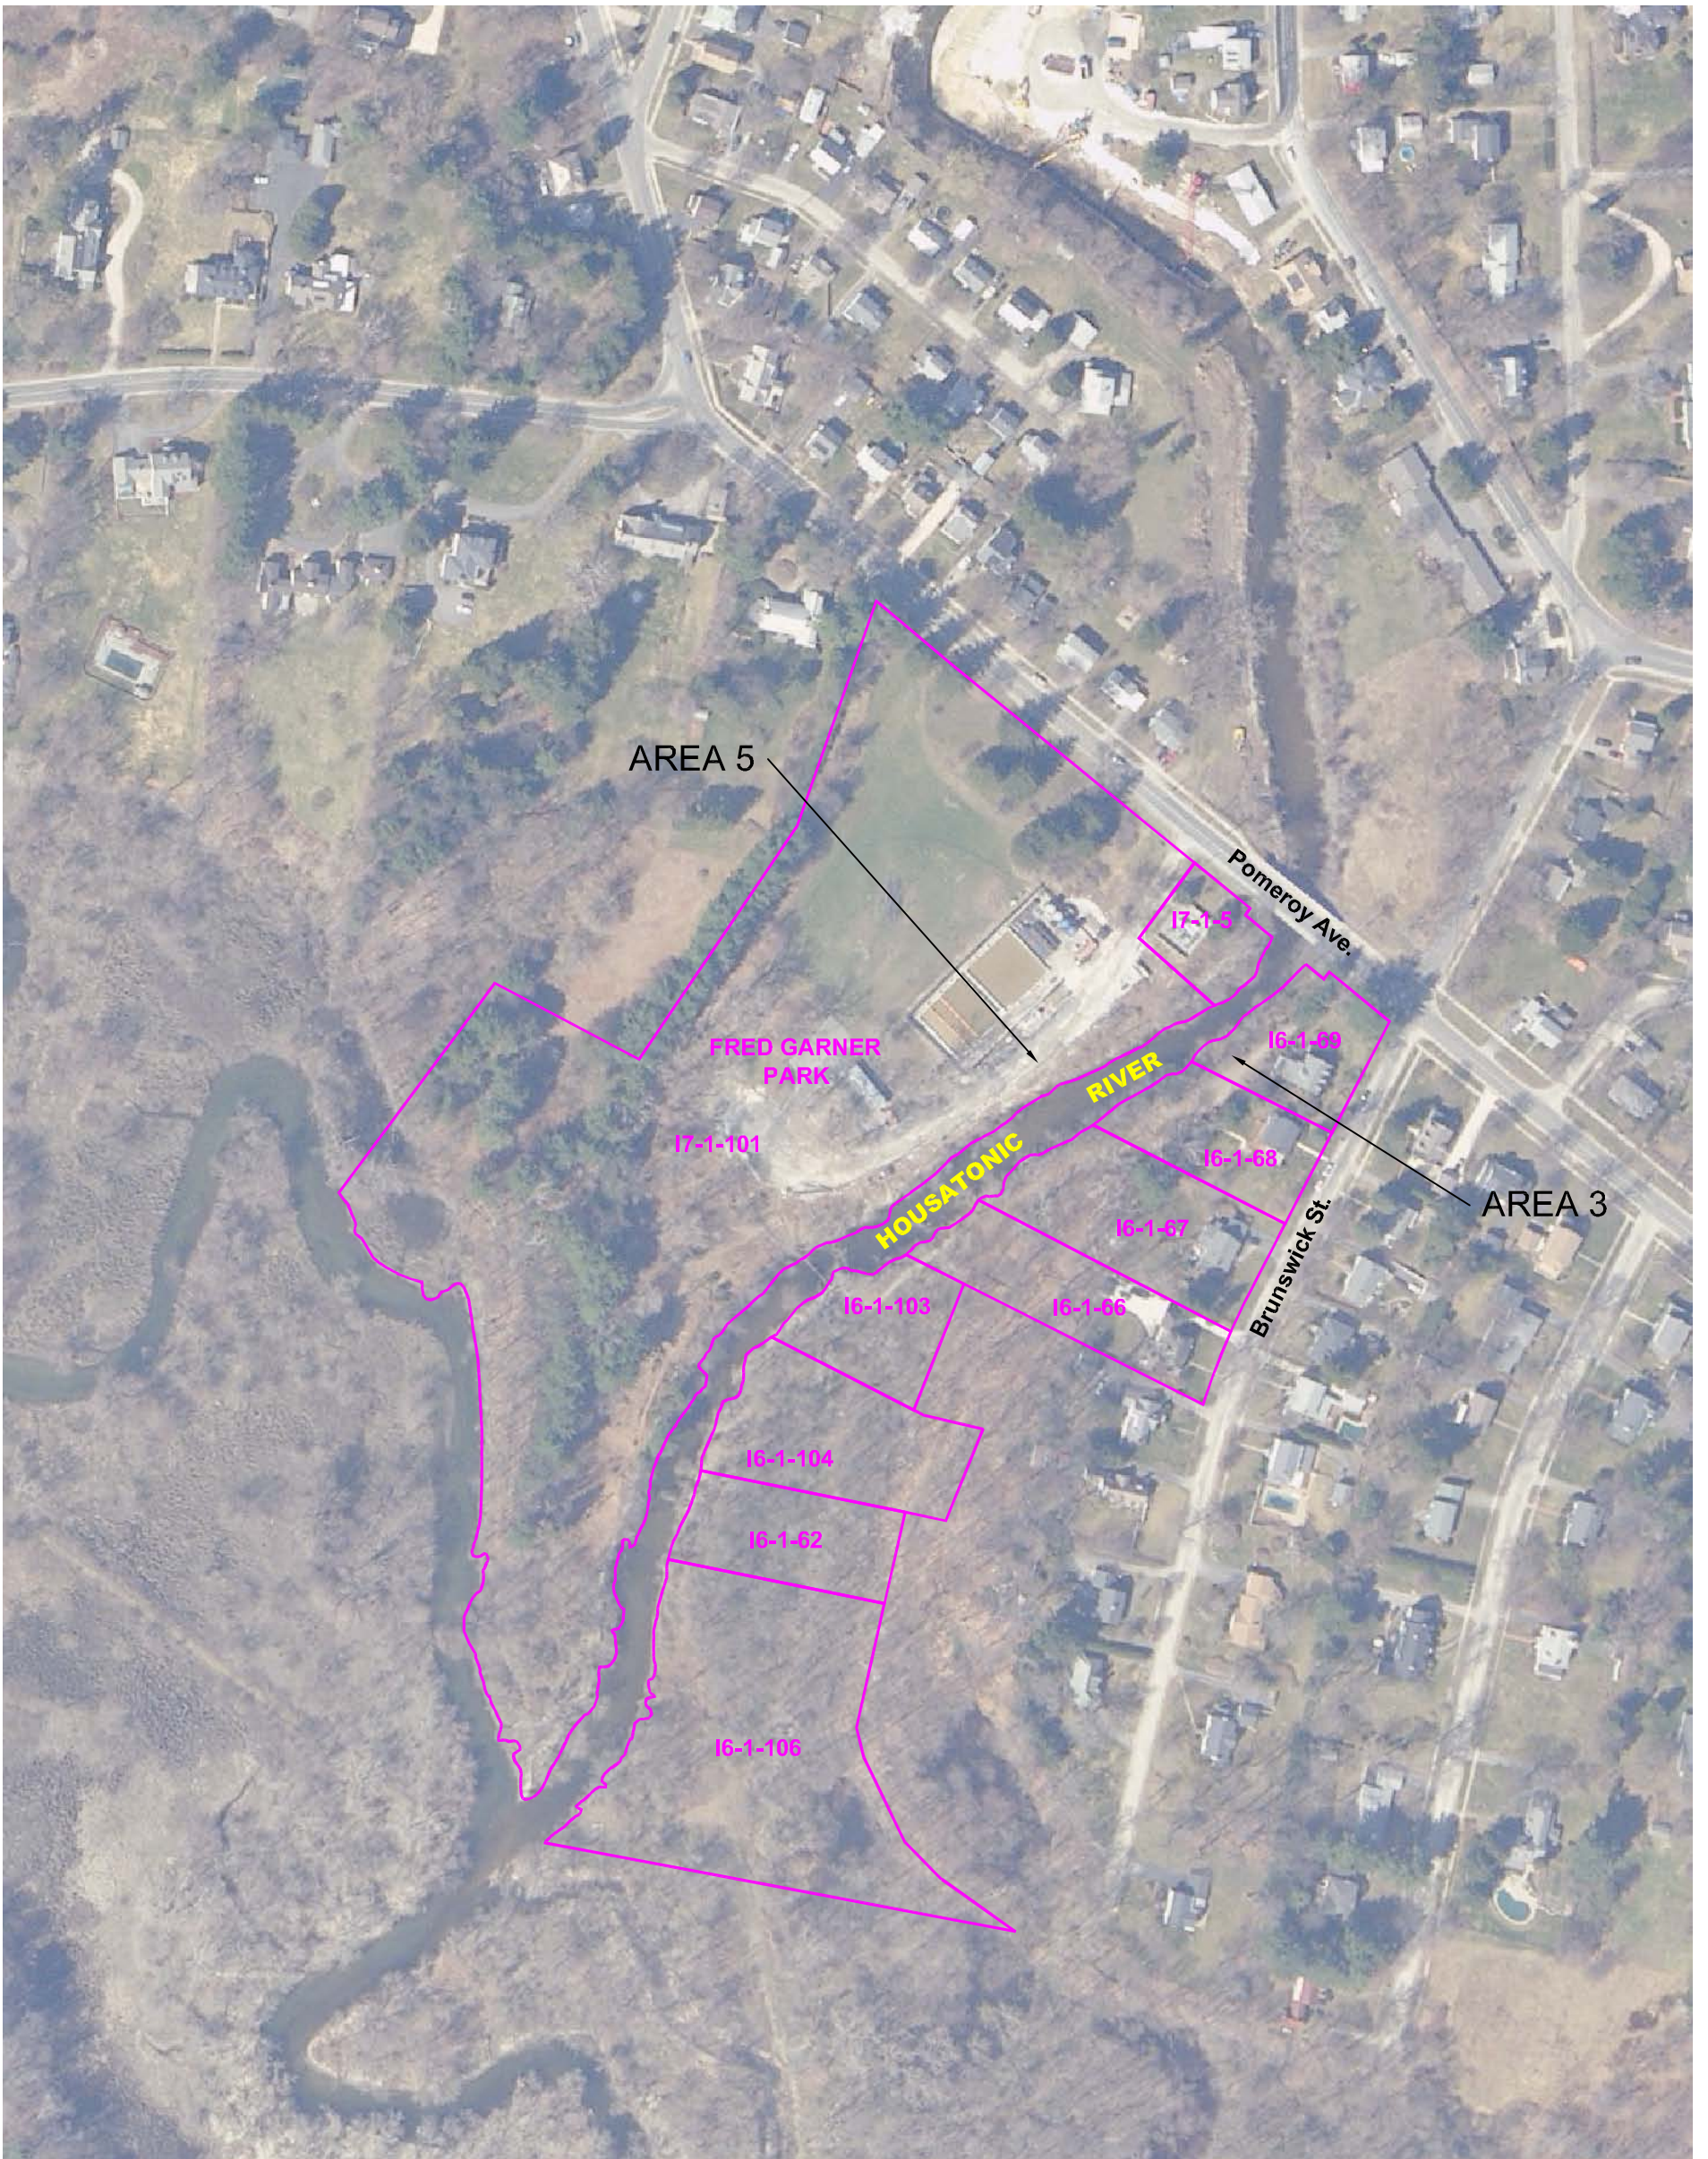
FIGURE  
**5**

*Area 5* – The backflow prevention valves at Fred Garner Park (Figure 5) had observable natural woody debris and leaf litter located within the valves. To maintain proper operation and to minimize the potential for future flooding events, the backflow valves will be cleaned out and/or flushed.

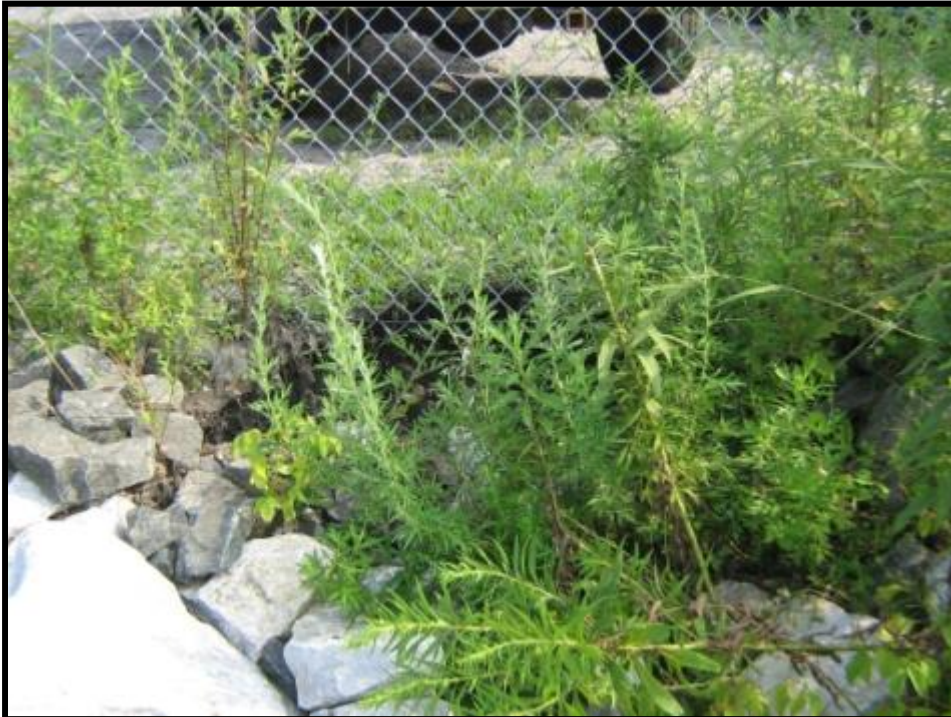
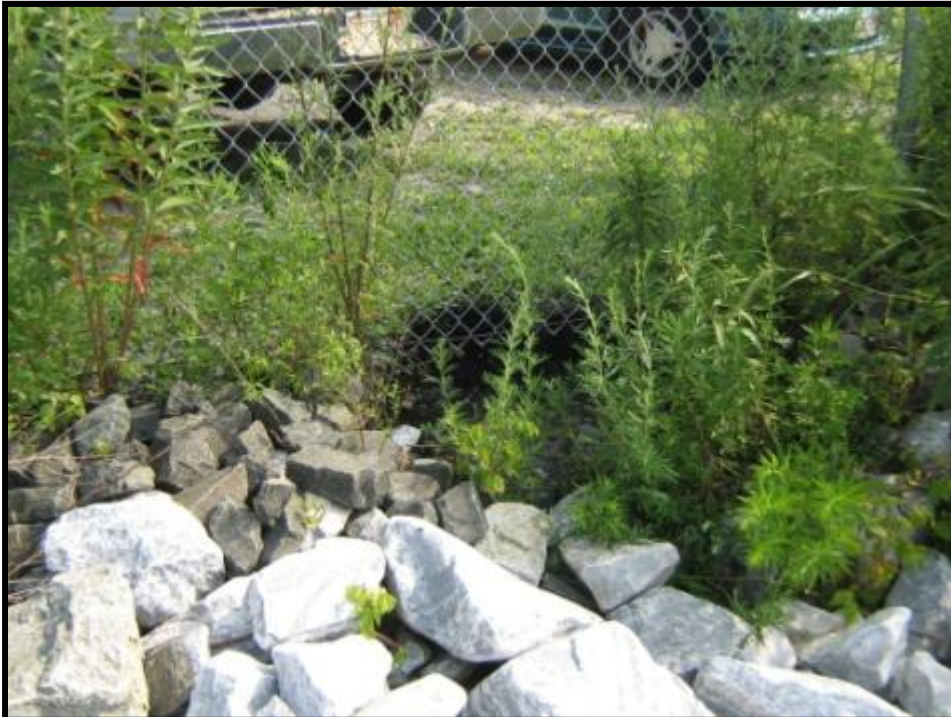
*Area 1* – This area consists of an area of erosion located near the top of bank on the west side of the river adjacent to on Parcel I9-4-203 (Figure 1; Attachment B, Photos 1 and 2). This erosion was likely caused by concentrated surface runoff from the parking lot located at the top of the bank. Less than 0.5 cubic yard (cy) of material loss was observed, and there was no evidence of eroded materials in the river. To reduce the potential for future erosion in this area, hay bales will be positioned, as appropriate, to help divert concentrated runoff, and riprap will be placed within the eroded area to restore the area to surrounding grades and protect it from future material losses.

Lyman St Bridge to Elm Street Bridge	Soil:	Area 1 – Top-of-bank erosion near Parcel I9-4-203. Less than 0.5 cy of material loss; no evidence of eroded material in river. Area 3 – Minor mid-bank erosion resulting in exposed Geoweb (near Parcel I8-23-4). Less than 0.5 cy of material loss; no evidence of eroded material in river.
	Riprap:	
	Enhancement Structures:	
Elm Street Bridge to Dawes Ave Bridge	Soil:	Area 2 – Top-of-bank erosion on Parcel I7-20-2. Less than 0.5 cy of material loss; no evidence of eroded material in river.
	Riprap:	
	Enhancement Structures:	
	ACB:	Observation of the transition between rock/shotcrete was hindered by elevated water level in river.
Dawes Ave Bridge to Pomeroy Ave Bridge	Soil:	
	Riprap:	
	Enhancement Structures:	
Pomeroy Ave to the Confluence	Soil:	Area 3 – Minor mid-bank erosion resulting in exposed Geoweb (south of Pomeroy Ave. Bridge); Less than 0.5 cy of material loss; no evidence of eroded material in river.

**Photograph 1: Area 1**

**Photograph 2: Area 1**

GE will implement the identified restoration, repair, and maintenance actions identified above and in Table 1 (i.e., placement of riprap and hay bales to address the erosion on the west bank of the river adjacent to on Parcel I9-4-203, repair or replacement of the fencing adjacent to the parking lot on Parcel I8-24-1, and cleaning of the backflow prevention valves at Fred Garner Park) within 30 days of EPA approval of the actions proposed herein. Further, within 30 days of completing those corrective actions, as required by the PRSC Plan, GE will submit a report describing the corrective action and any required follow-up measures. In addition, these monitoring activities and the corrective actions performed will be summarized in the forthcoming 2008 Annual Report on 1½-Mile monitoring activities.

<b>Areas/Items Not Meeting Maintenance Standards</b>	<b>Description</b>	<b>Proposed Response Action</b>
1 - West bank of river on Parcel I9-4-203	Top-of-bank erosion likely due to concentrated runoff from parking lot located at the top of the bank. Less than 0.5 cy of material loss; no evidence of eroded material in river.	Restoration activities will include installing riprap to restore affected area to surrounding grades and protect against further erosion, and placement of hay bales at top-of-bank to divert concentrated runoff.
2 - East bank of river on Parcel I7-20-2	Top-of-bank erosion likely due to concentrated runoff from road located at the top of the bank. Less than 0.5 cy of material loss; no evidence of eroded material in river.	Inspect during next monitoring visit.
3 - Areas of exposed Geoweb: Parcel I8-23-4 and Parcel I6-1-69	Minor mid-bank erosion has resulted in the exposure of some Geoweb. Less than 0.5 cy of material loss; no evidence of eroded material in river.	Inspect during next monitoring visit.

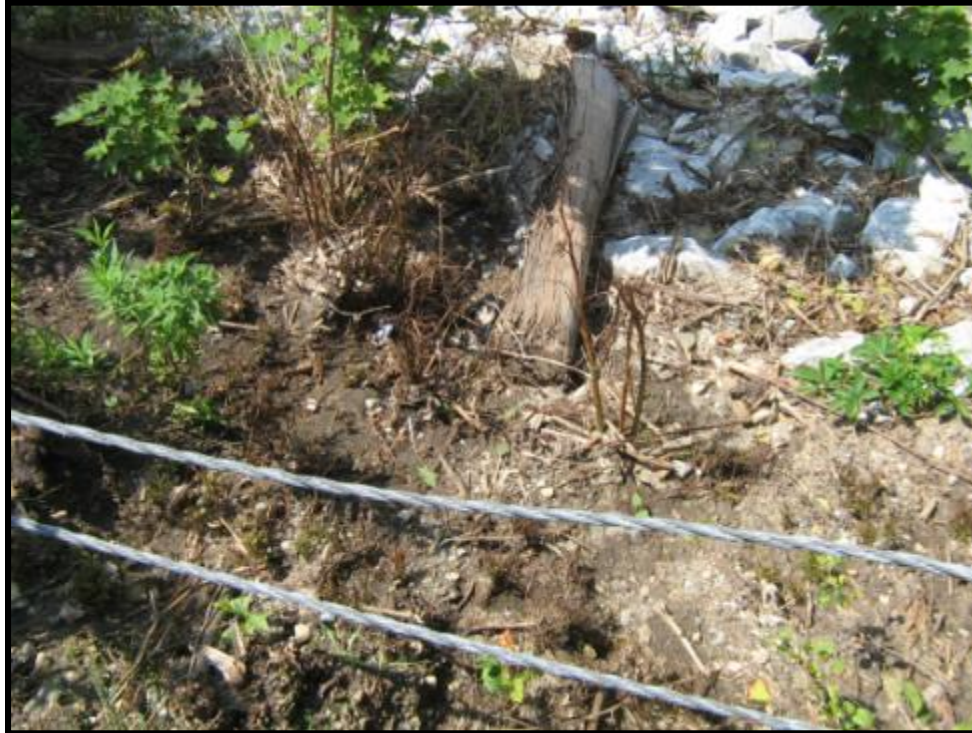
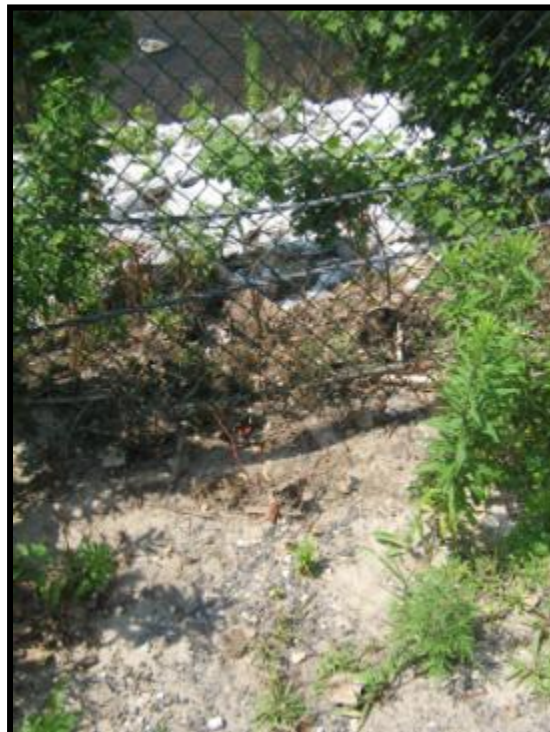
*Area 2* – This area consists of an area of minor erosion located near the top of bank on the east side of the river adjacent to on Parcel I7-20-2 (Figure 3; Attachment B, Photos 3 and 4). This erosion was likely caused by concentrated surface runoff from the road located at the top of the bank. Less than 0.5 cy of material loss was observed, and there was no evidence of eroded materials in the river. This area will be evaluated again during the 2009 annual inspection; and based on observations made during that inspection, remedial actions may be initiated if it appears that there is continuing erosion of bank soils in this area.

**Photograph 3: Area 2**

**Photograph 4: Area 2**

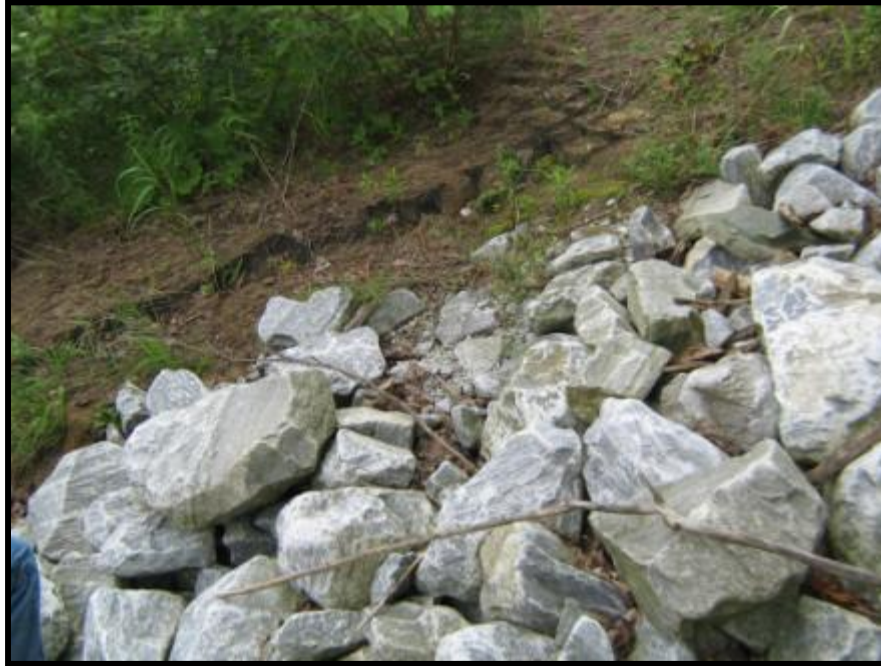
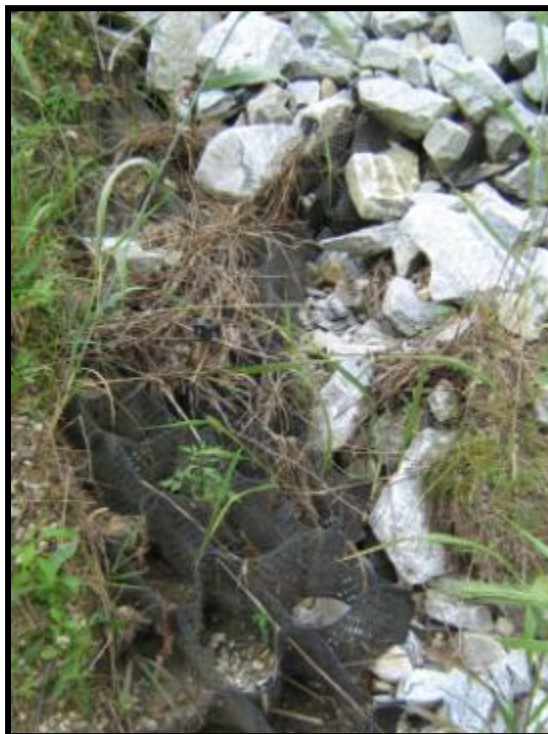
*Area 3* – Area 3 consists of minor erosion of surface bank soils at two general locations in the 1½-Mile -- near Parcel I8-23-4 and across the river from Fred Garner Park south of Pomeroy Avenue Bridge (Parcel I6-1-69). Surface soil losses in these areas have resulted in the exposure of segments of the Geoweb that was installed to promote slope stability (Figures 2 and 5; Attachment B, Photos 5 through 8). This erosion may have been caused by concentrated surface runoff from certain adjacent areas located at the top of the bank, and/or may be related to poorly compacted materials within the Geoweb at the time of installation. At these locations, a total of less than 0.5 cy of material loss was observed, and there were no indications of eroded

materials in the river. The areas of affected Geoweb appear to be stable. These areas will be evaluated again during the 2009 annual inspection; and based on observations made during that inspection, remedial actions may be initiated if it appears that there is continued soil loss or other signs of further degradation.

**Photograph 5: Area 3: Exposed Geoweb upstream of Swale near Parcel I8-23-4**

**Photograph 6: Area 3: Exposed Geoweb on Parcel I8-23-4**

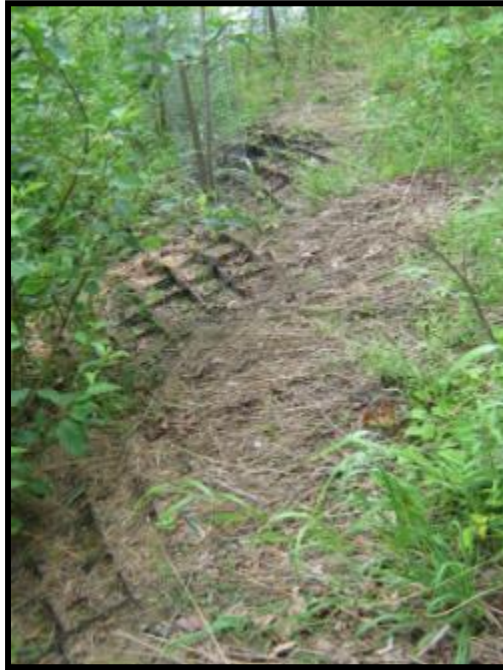
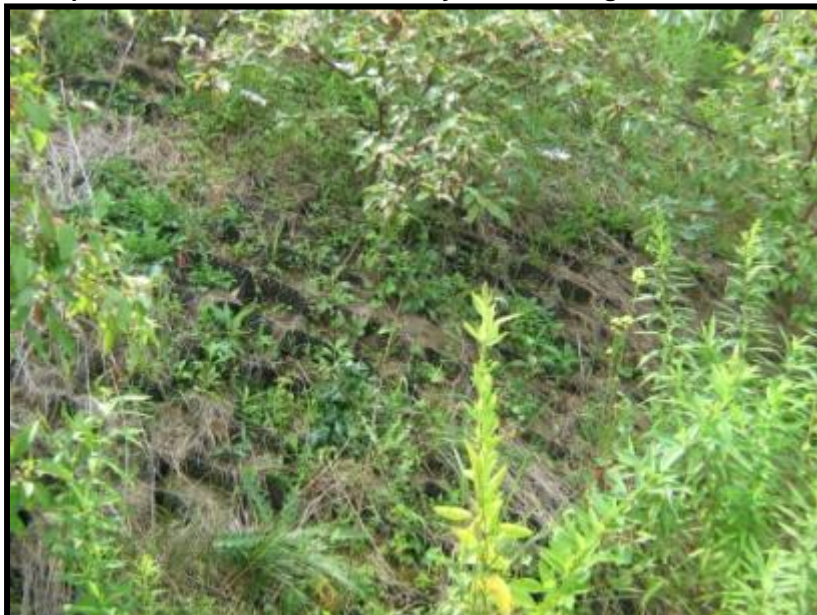
**Photograph 7: Area 3: Exposed Geoweb South of Pomeroy Avenue Bridge**

**Photograph 8: Area 3: Exposed Geoweb South of Pomeroy Avenue Bridge**

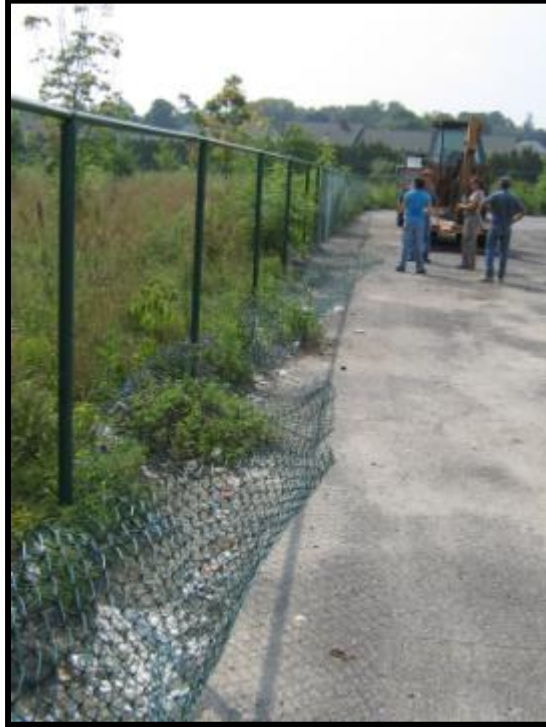
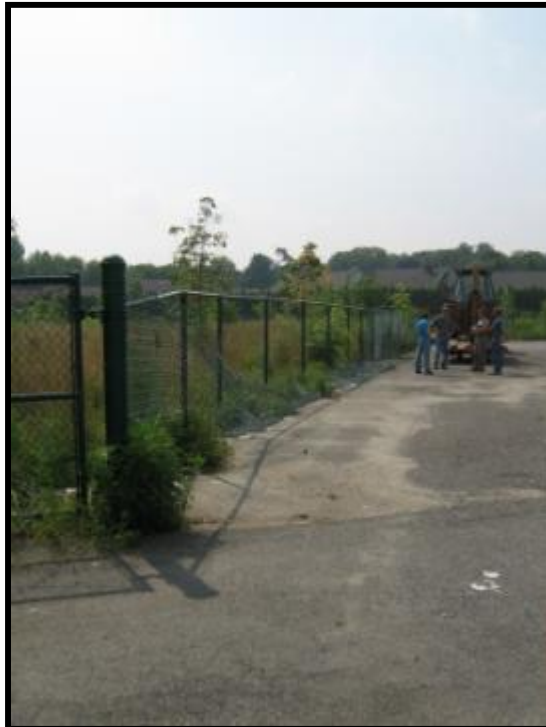
*Area 4* – A portion of the fencing adjacent to the parking lot on Parcel I8-24-1 was observed to be damaged (Figure 1; Attachment B, Photos 9 and 10), an apparent result of snow removal or plowing activities associated with the adjacent parking lot. As a result, the affected area of fencing will be repaired and/or replaced.

**Photograph 9: Area 4**

**Photograph 10: Area 4**

4 - Fencing around parking lot on Parcel I8-24-1	Portion of the fencing has been damaged and has fallen down, an apparent result of snow removal and plowing.	Repair and/or replace fencing.
5 - Backflow prevention valves at Fred Garner Park	Natural woody debris and leaf litter observed inside the valve.	Clean out and/or flush valves.
