**General Electric Company  
Pittsfield, Massachusetts**

**2008 Annual Monitoring Report**

**1½-Mile Reach of the Housatonic  
River**

January 2009

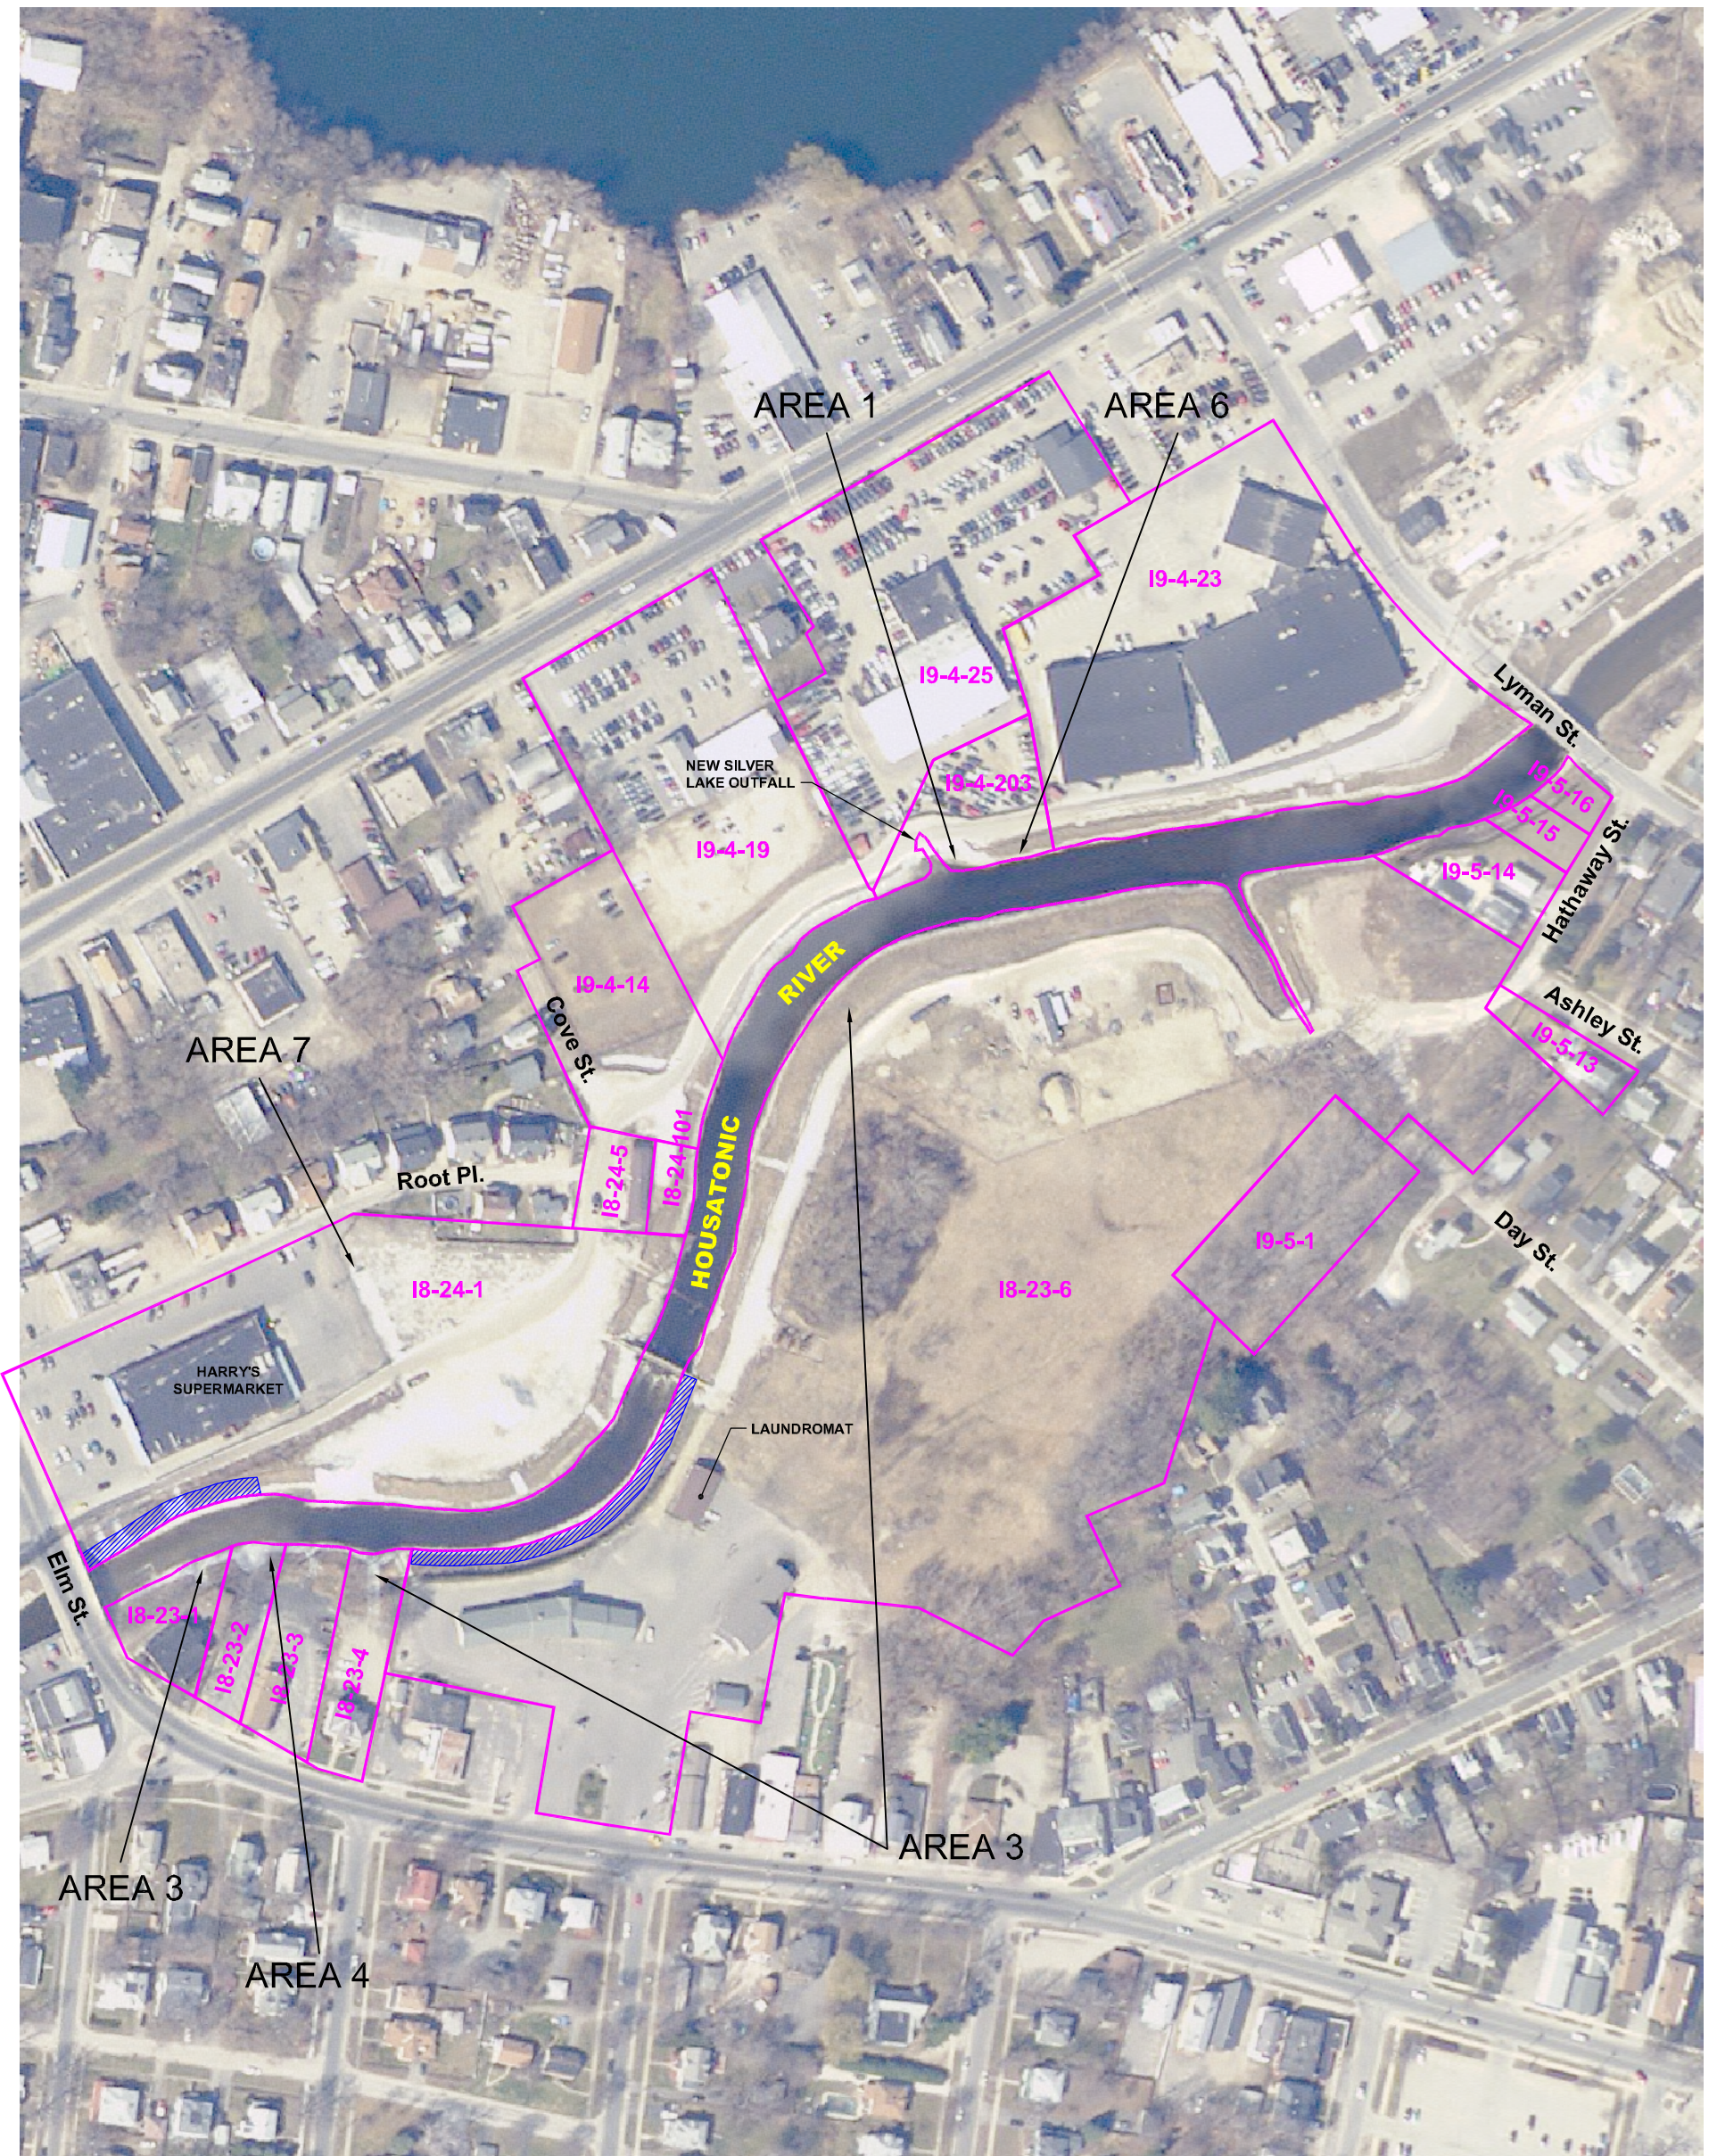
FIGURE <b>3-1</b>

*Area 1* – This area consists of an area of minor erosion located near the top of the bank on the west side of the River adjacent to Parcel I9-4-203 (Figure 3-1; Appendix A, Photos 1 and 2). This erosion was likely caused by concentrated surface runoff from the parking lot located at the top of the bank. Less than 0.5 cubic yards (cy) of material loss was observed, and there was no evidence of eroded materials in the River.

*Area 3* – Area 3 consists of minor erosion of surface bank soils at several locations near Parcels I8-23-6, I8-23-4, and I8-23-1 (Figure 3-1). Surface soil losses in these areas have resulted in the exposure of segments of the Geoweb that was installed to promote slope stability (Appendix A, Photos 5 through 7). This erosion appears to have been caused by concentrated surface runoff from certain adjacent areas located at the top of the bank, and/or may be related to poorly compacted materials within the Geoweb at the time of installation. At these locations, a total of less than 0.5 cy of material loss was observed, and there were no indications of eroded materials in the River. Although some material loss was observed, these areas appear to be generally stable.

*Area 4* – Area 4 consists of an area of minor erosion of surface bank soils near Parcels I8-23-2/3 (Figure 3-1). Surface soil losses in this area have resulted in the exposure of segments of the Geoweb that was installed to promote slope stability (Appendix A, Photo 8). This erosion appears to have been caused by stormwater generated by a recently installed drainage pipe associated with a recently renovated parking lot, and/or may be related to poorly compacted materials within the Geoweb at the time of installation. At this location, a total of less than 0.5 cy of material loss was observed, and there was no indication of eroded materials in the River. Although some material loss was observed, this area appears to be generally stable.

Additionally, during a bank inspection conducted by EPA after the annual monitoring event, an additional area of erosion was noted upstream of Area 1 on Parcel I9-4-203. This area is labeled Area 6, and is shown on Figure 3-1. At the request of EPA, GE placed riprap in this area in the fall of 2008 to restore the area to surrounding grades and protect it from future material loss.

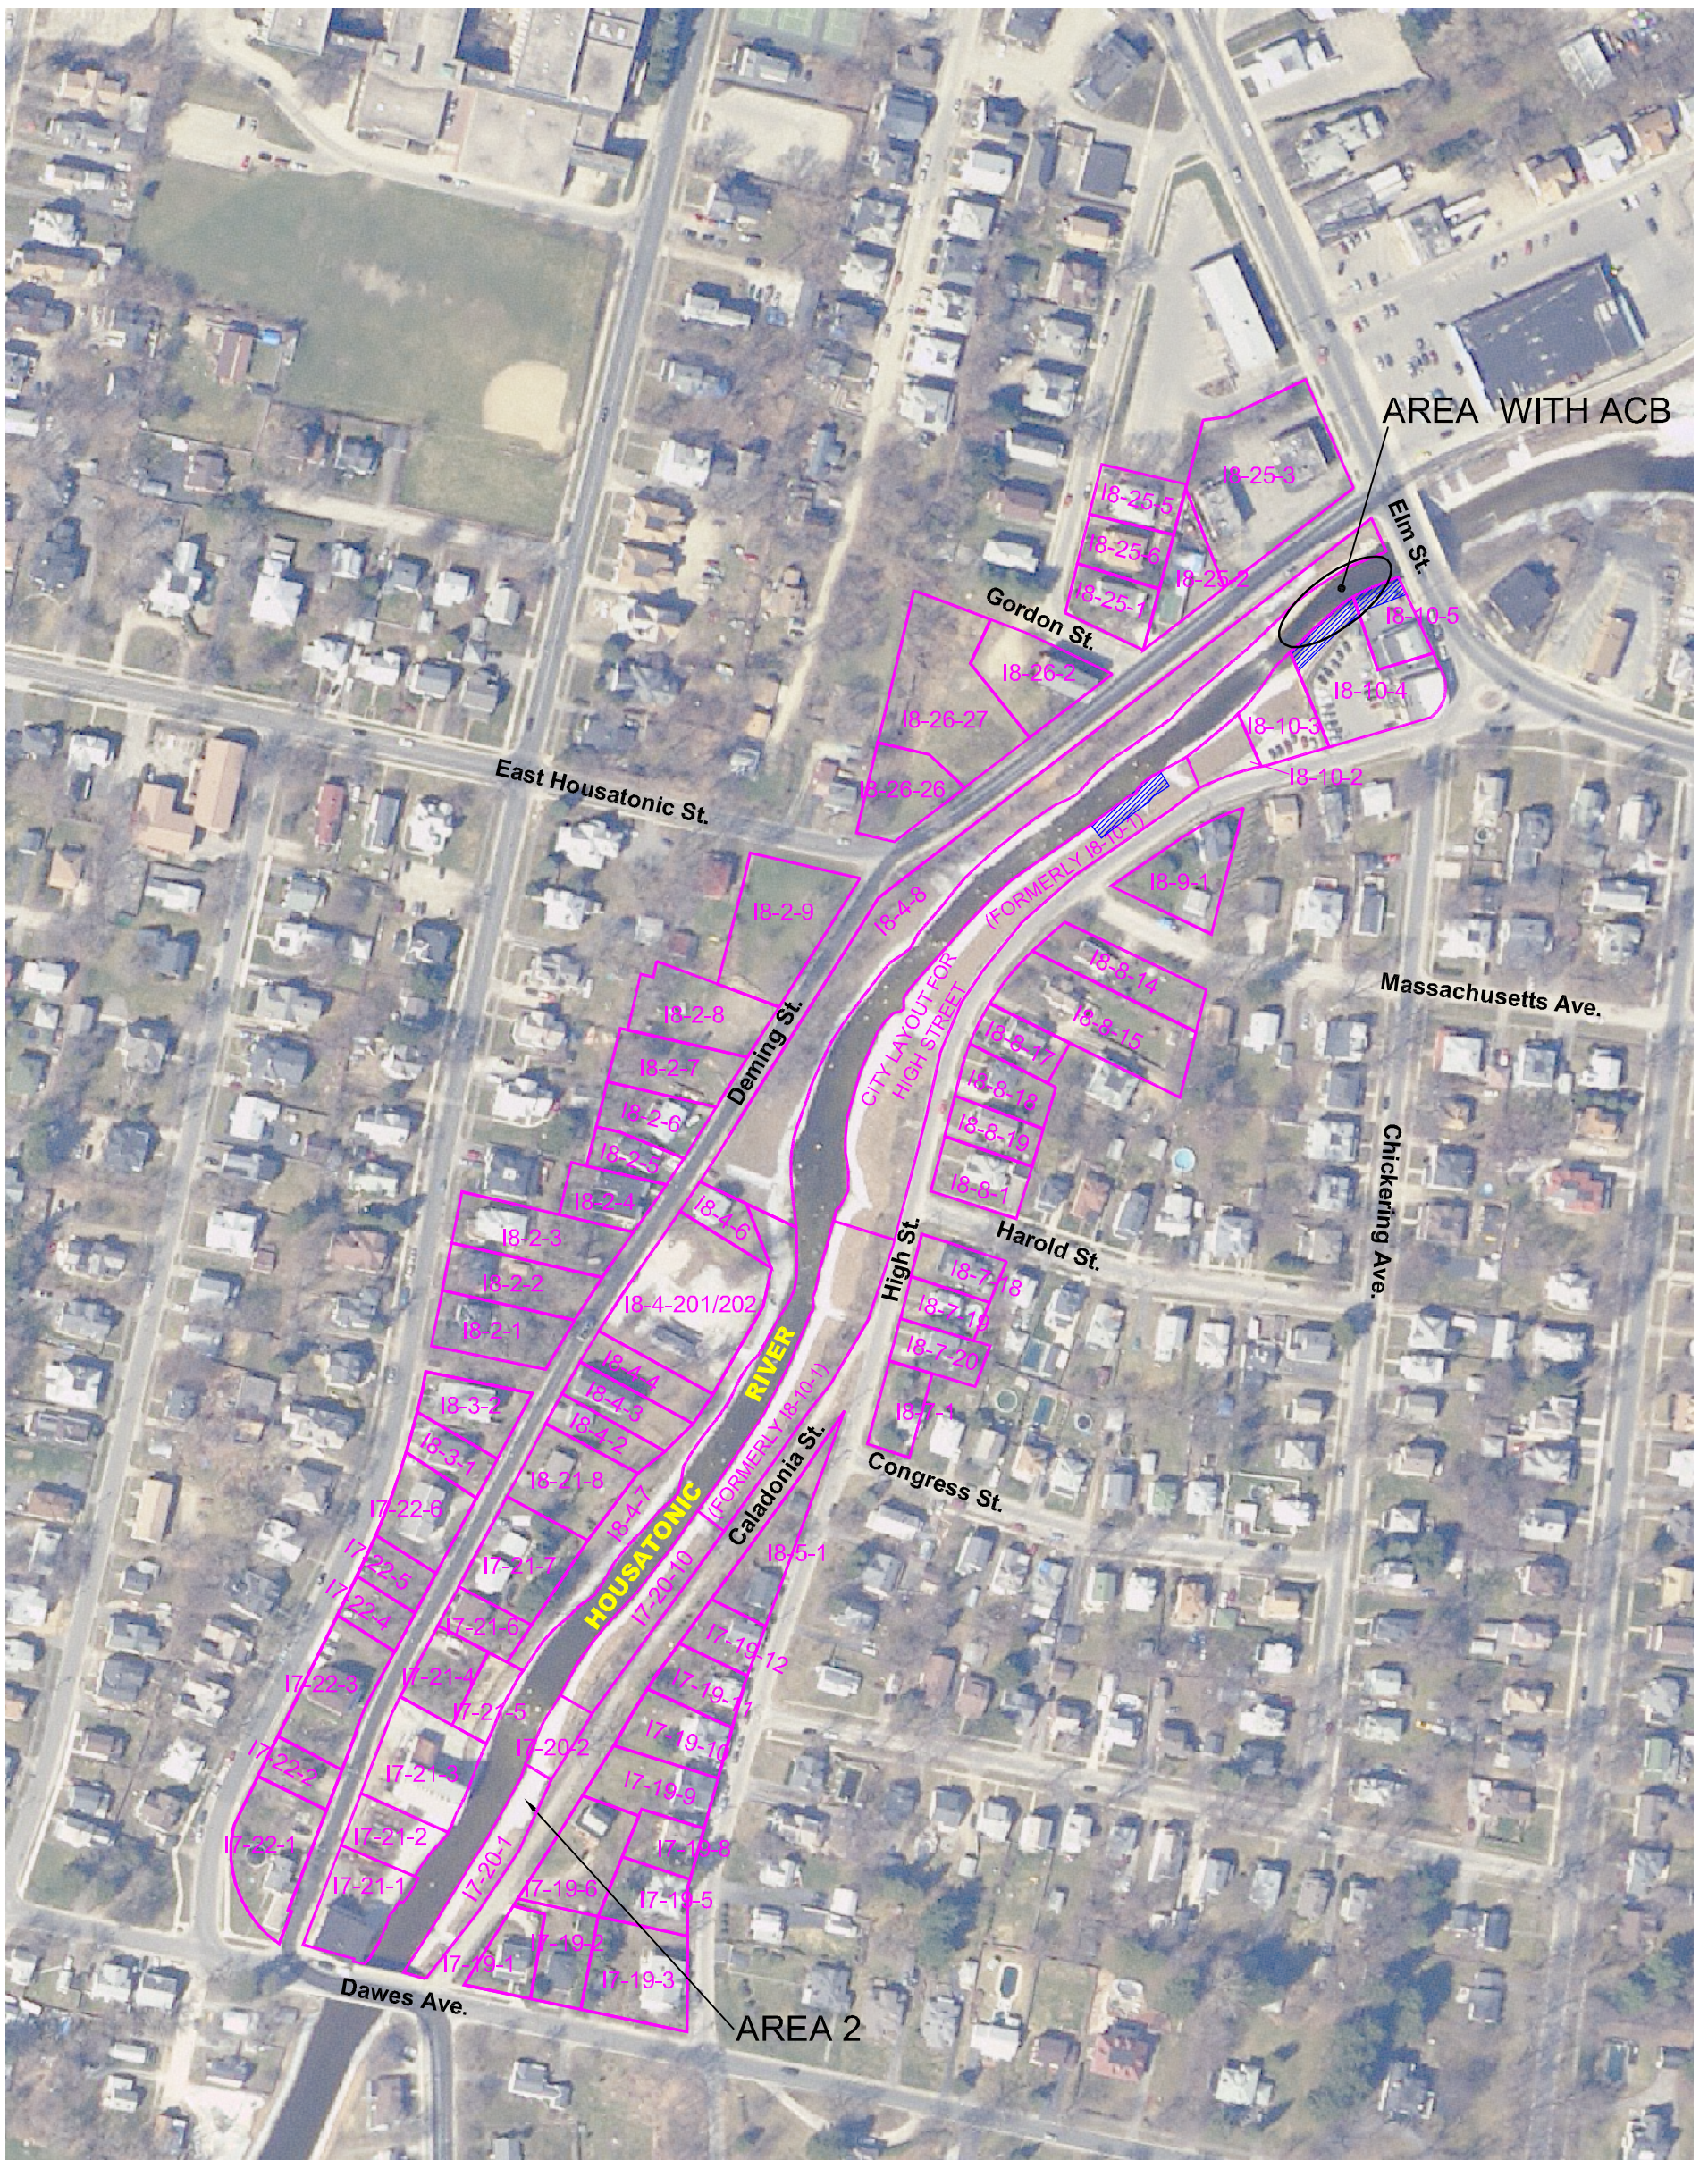
FIGURE  
**3-2**

*Area 2* – This area consists of an area of minor erosion located near the top of bank on the east side of the River adjacent to Parcel I7-20-1 (Figure 3-2; Appendix A, Photos 3 and 4). This erosion was likely caused by concentrated surface runoff from the road located at the top of the bank. Less than 0.5 cy of material loss was observed, and there was no evidence of eroded materials in the River.

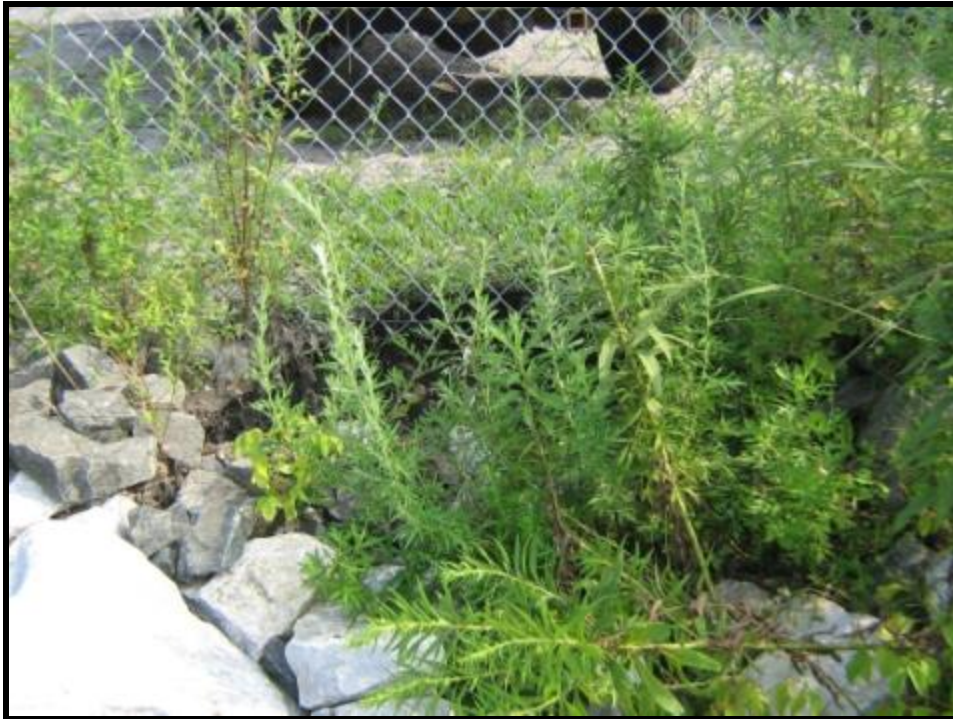
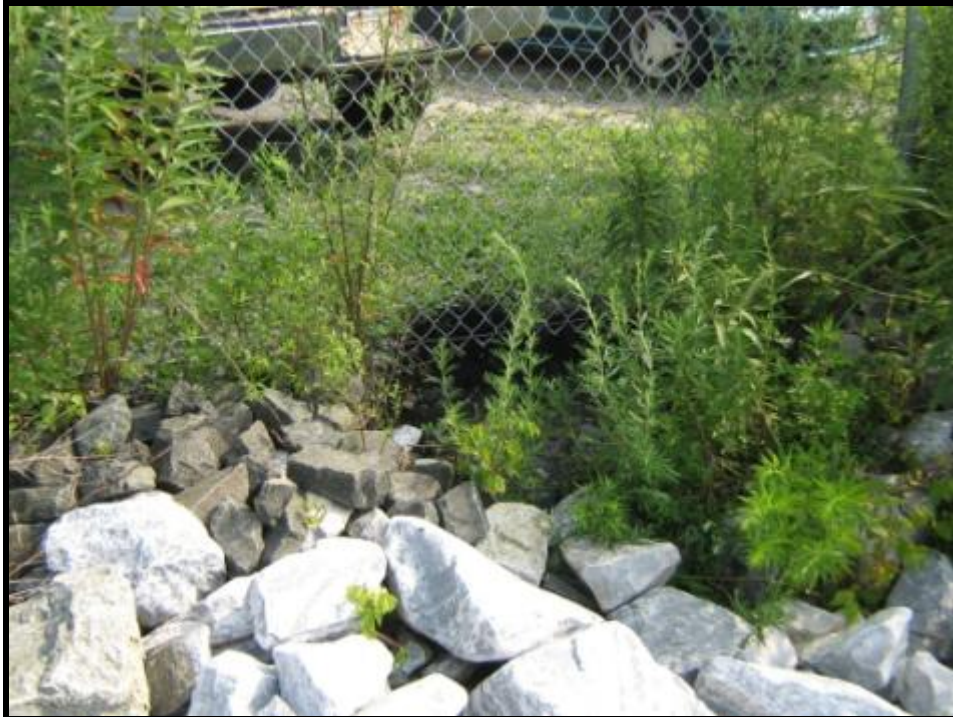
Photograph 1: Area 1

Photograph 2: Area 1

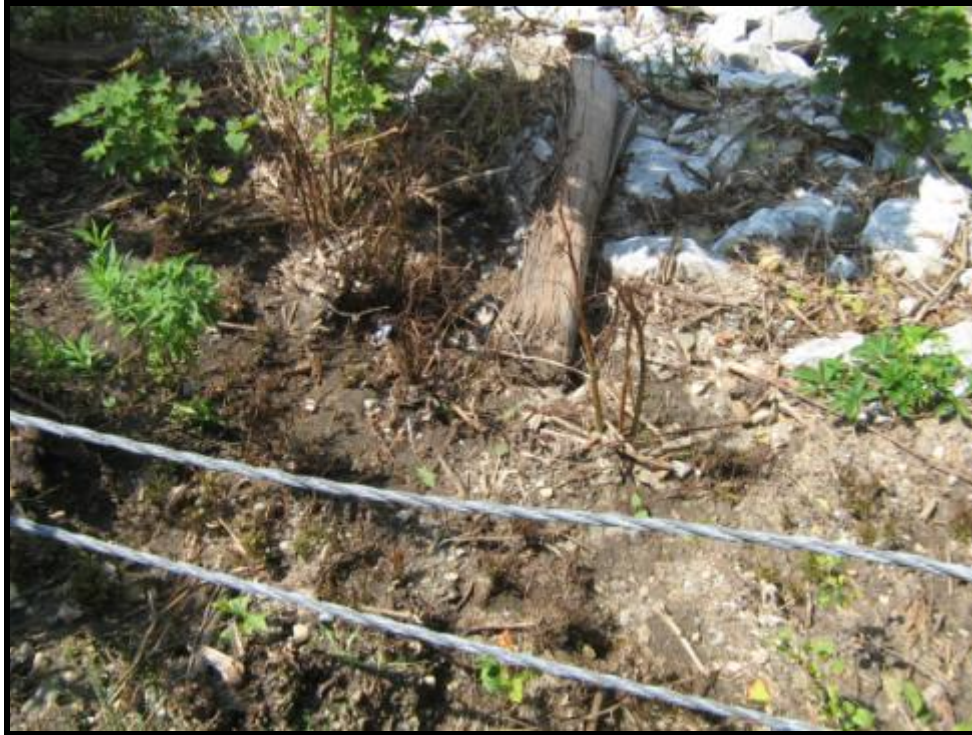
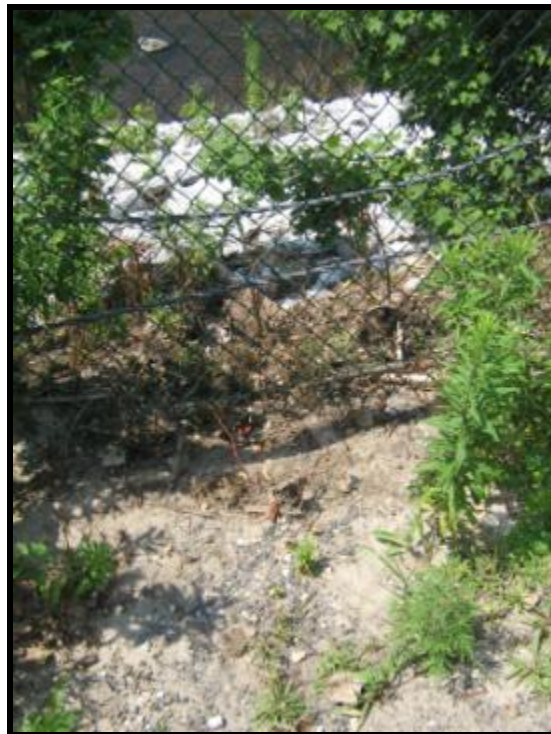
**Photograph 3: Area 2**

**Photograph 4: Area 2**

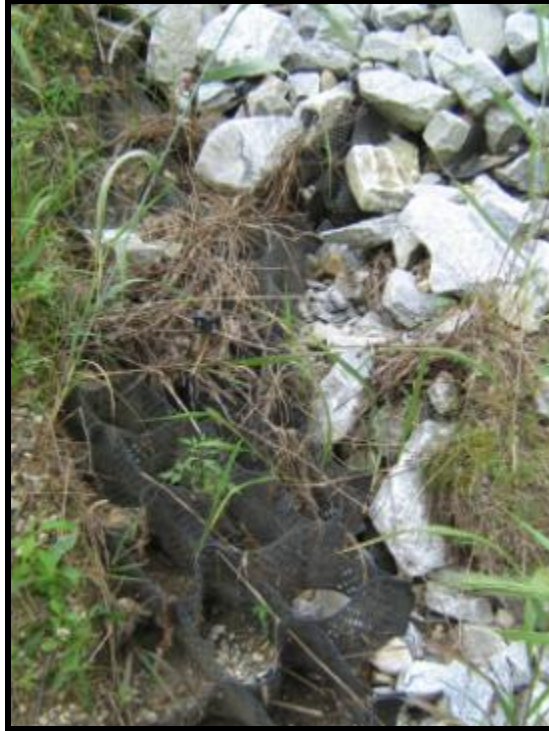
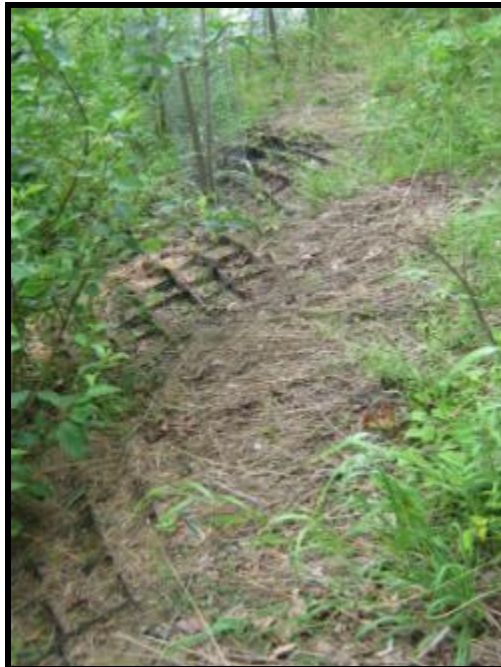
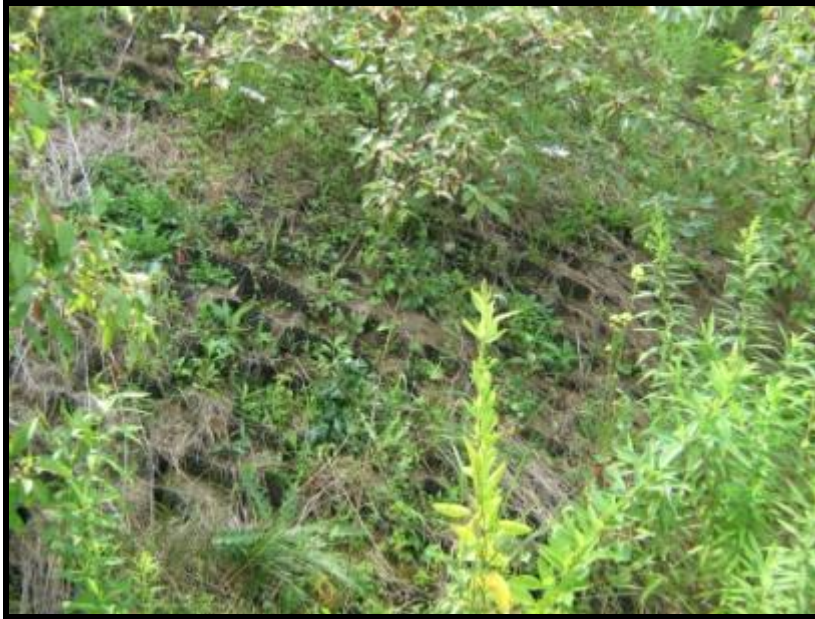
**Photograph 5: Area 3A: Exposed Geoweb on Parcel I8-23-4**

**Photograph 6: Area 3A: Exposed Geoweb on Parcel I8-23-6**

**Photograph 7: Area 3A: Exposed Geoweb South on Parcel I8-23-6**

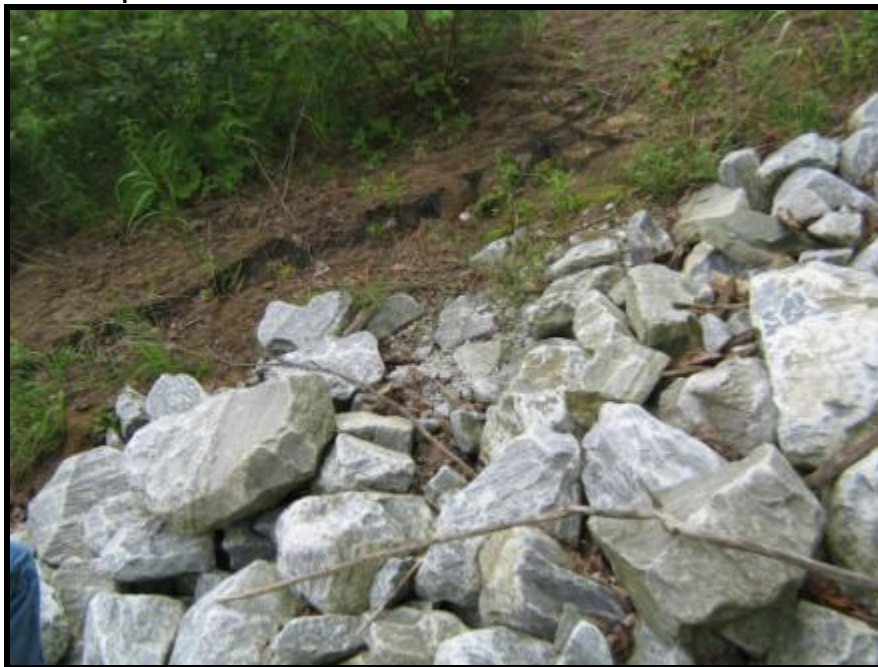
**Photograph 8: Area 3B: Exposed Geoweb on Parcel I8-23-2/3**

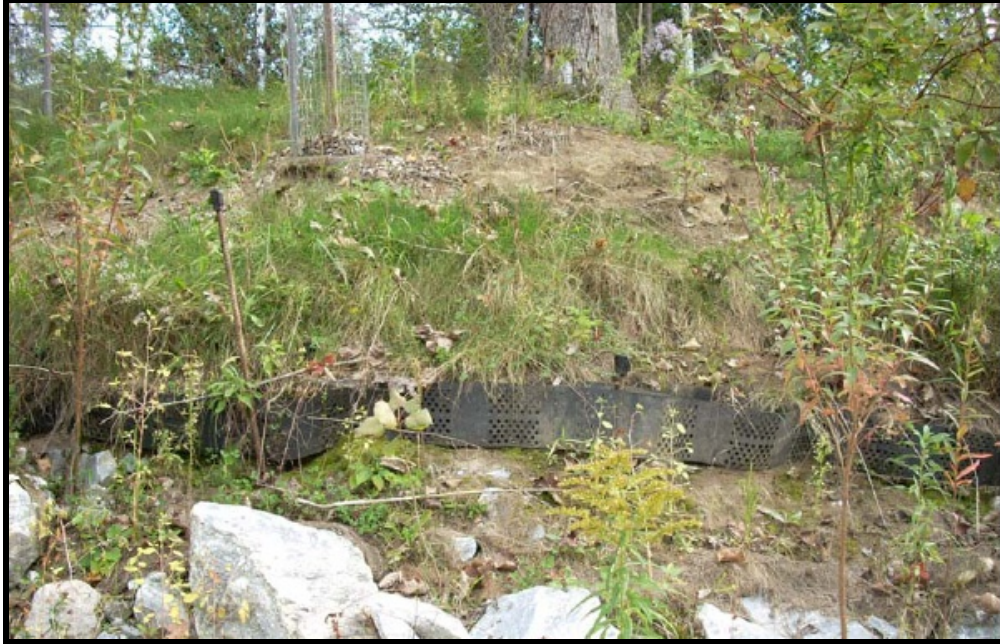
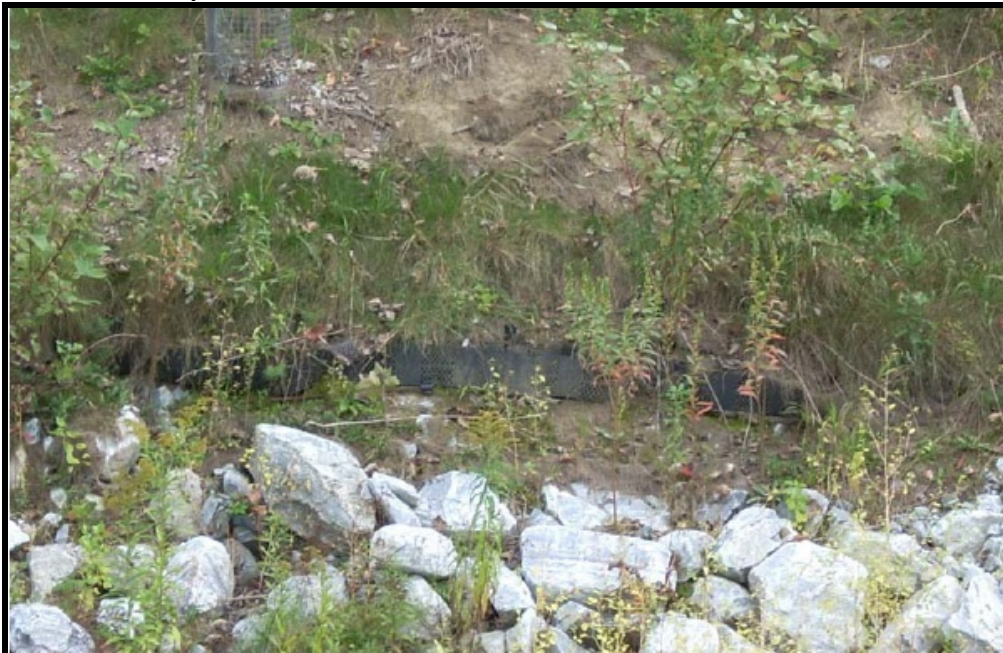
*Area 5* – Area 5 consists of an area of minor erosion of surface bank soils on Parcel I6-1-68 at the approximate property line with Parcels I6-1-68 and I6-1-67 (Figure 3-4). Surface soil losses in this area have resulted in the exposure of segments of the Geoweb that was installed to promote slope stability (Appendix A, Photos 9 and 10). This erosion appears to have been caused by concentrated surface runoff from certain adjacent areas located at the

top of the bank, and/or may be related to poorly compacted materials within the Geoweb at the time of installation. At this location, a total of less than 0.5 cy of material loss was observed, and there was no indication of eroded materials in the River. Although some material loss was observed, this area appears to be generally stable.

**Photograph 9: Area 3C: Exposed Geoweb on Parcel I6-1-68**

**Photograph 10: Area 3C: Exposed Geoweb on Parcel I6-1-68**

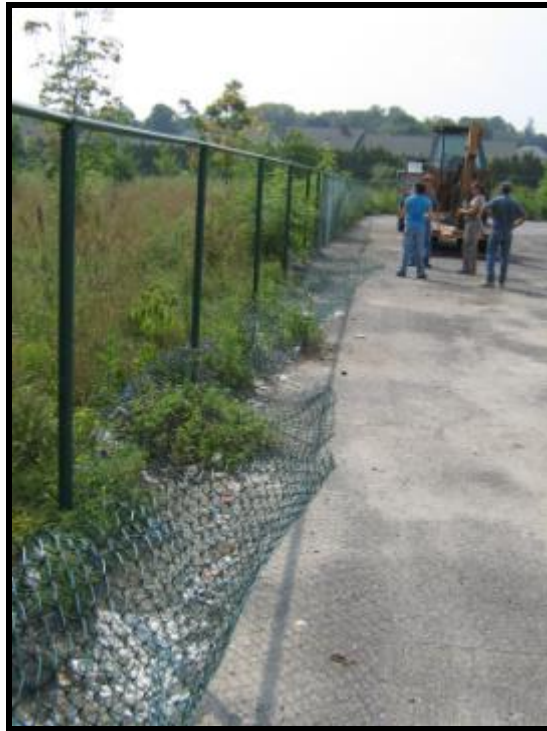
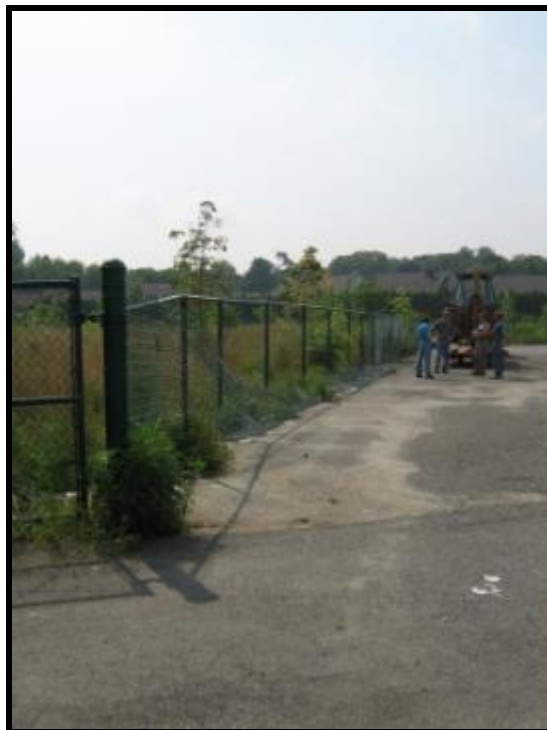
- A portion of the fencing adjacent to the parking lot on Parcel I8-24-1 was observed to be damaged (Area 7 on Figure 3-1; Appendix A, Photos 11 and 12), an apparent result of snow removal or plowing activities at the adjacent parking lot.
- The backflow prevention valves at Fred Garner Park (Area 8 on Figure 3-4) had observable natural woody debris and leaf litter located within the valves.

**Photograph 11: Area 4**

**Photograph 12: Area 4**

For the non-critical ancillary items, the area of damaged fencing identified as Area 7 was repaired in the fall of 2008, and the backflow prevention valves at Fred Garner Park (Area 8) were cleaned out and/or flushed on November 6, 2008, to maintain proper operation and minimize the potential for future flooding events. Further maintenance of these backflow valves, if necessary, will be performed by the City of Pittsfield. As a result of the above-described inspection and repairs, GE believes that the Maintenance Standard for non-critical ancillary items has been satisfied and that no further inspections are required for these items.
