**Re: GE-Pittsfield/Housatonic River Site
Former Oxbow Areas A and C (GEC410)
Summary of September 2008 Inspection Activities**

GENERAL ELECTRIC COMPANY
PITTSFIELD, MASSACHUSETTS
**FORMER OXBOW AREAS A AND C
REMOVAL ACTION**

**SUMMARY OF
TREE RESTORATION ACTIVITIES**

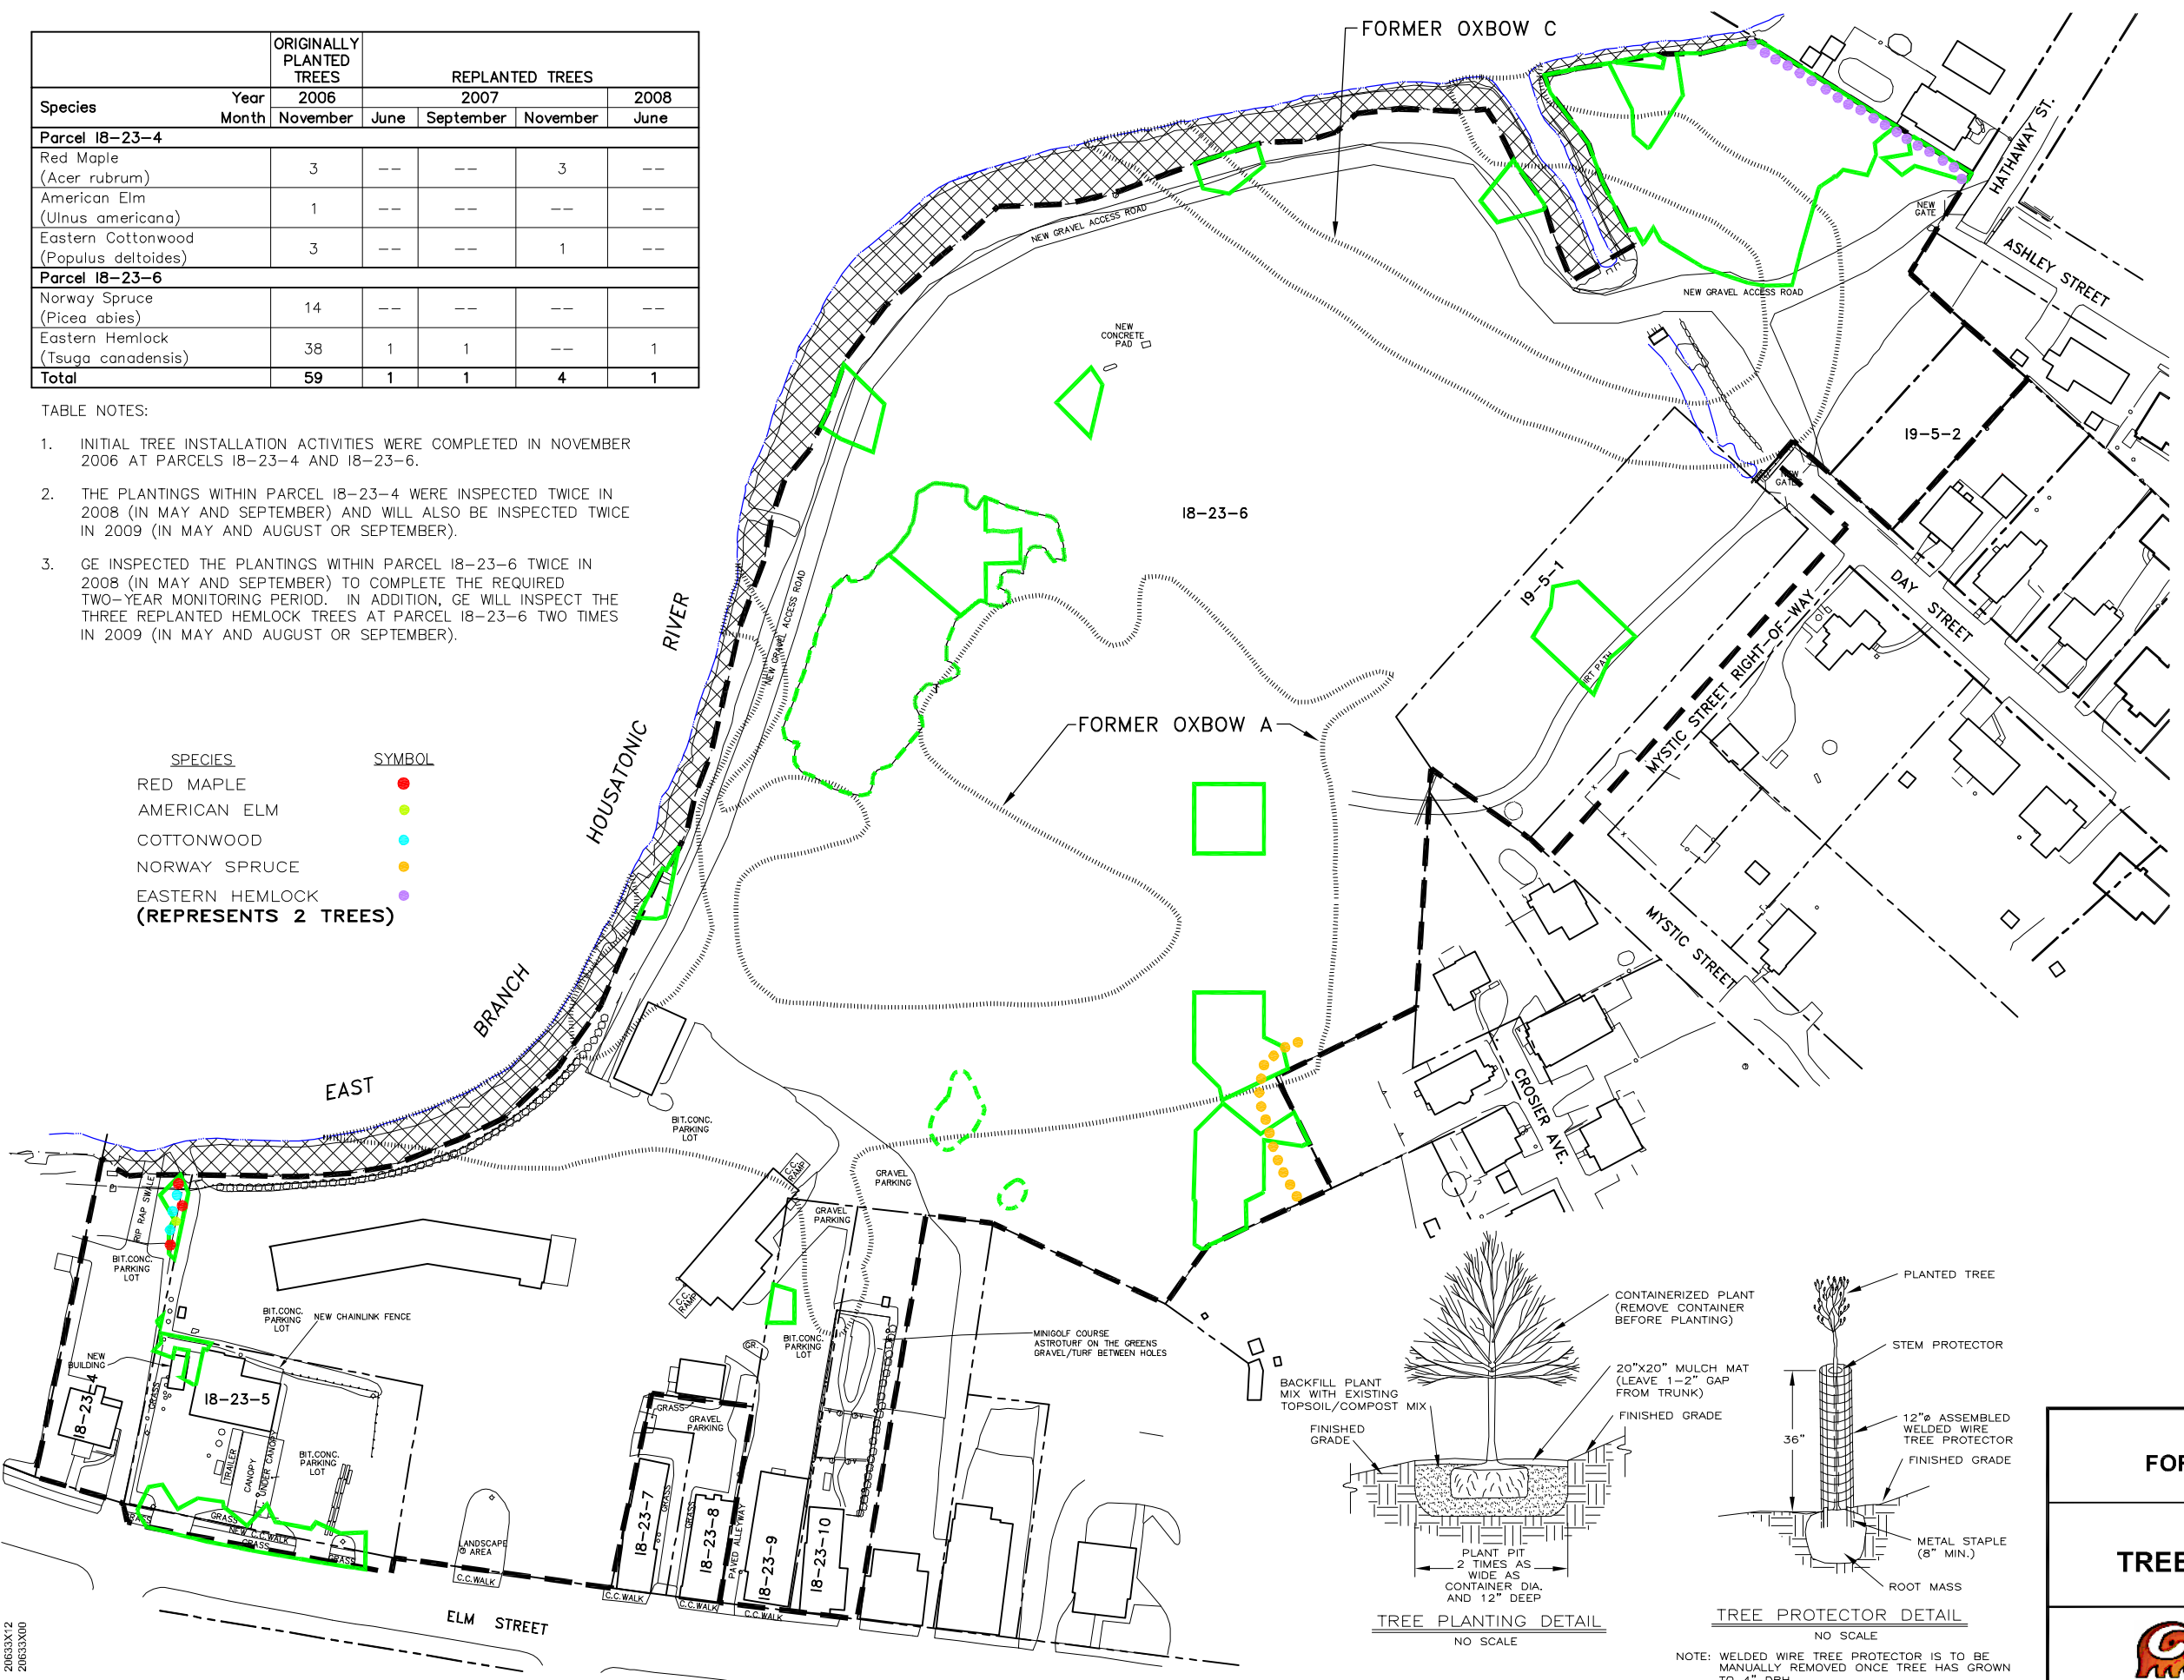
FIGURE
2

The results of the tree observations indicated that the trees planted were in good health with the exception of two trees at Parcel I8-23-4: one stressed eastern cottonwood and one stressed red maple. These trees will be monitored during the next inspection. Also, the three eastern hemlocks replanted in June 2007, September 2007, and June 2008 on Parcel I8-23-6 were missing tags identifying the species, installation date, and size at time of replanting. These tags will be replaced prior to the next inspection. Finally, as indicated on the tables in Attachment B, the tree guards, cages, and stakes (where present) on the trees on Parcel I8-23-4 were in good condition. (The trees on Parcel I8-23-6 do not have tree guards, cages, or stakes.)
