**Re: Floodplain GE-Pittsfield/Housatonic River Site
Floodplain Residential and Non-Residential Properties Adjacent to 1½ Mile Reach of
Housatonic River (GECD710 and GECD720)
Summary of August 2008 Inspection Activities for the Remediated Phase 2 Floodplain
Properties**

GENERAL ELECTRIC COMPANY
 PITTSFIELD, MASSACHUSETTS
AUGUST 2008 INSPECTION

**RESTORATION PLANTING PLAN
FOR PHASE 2**

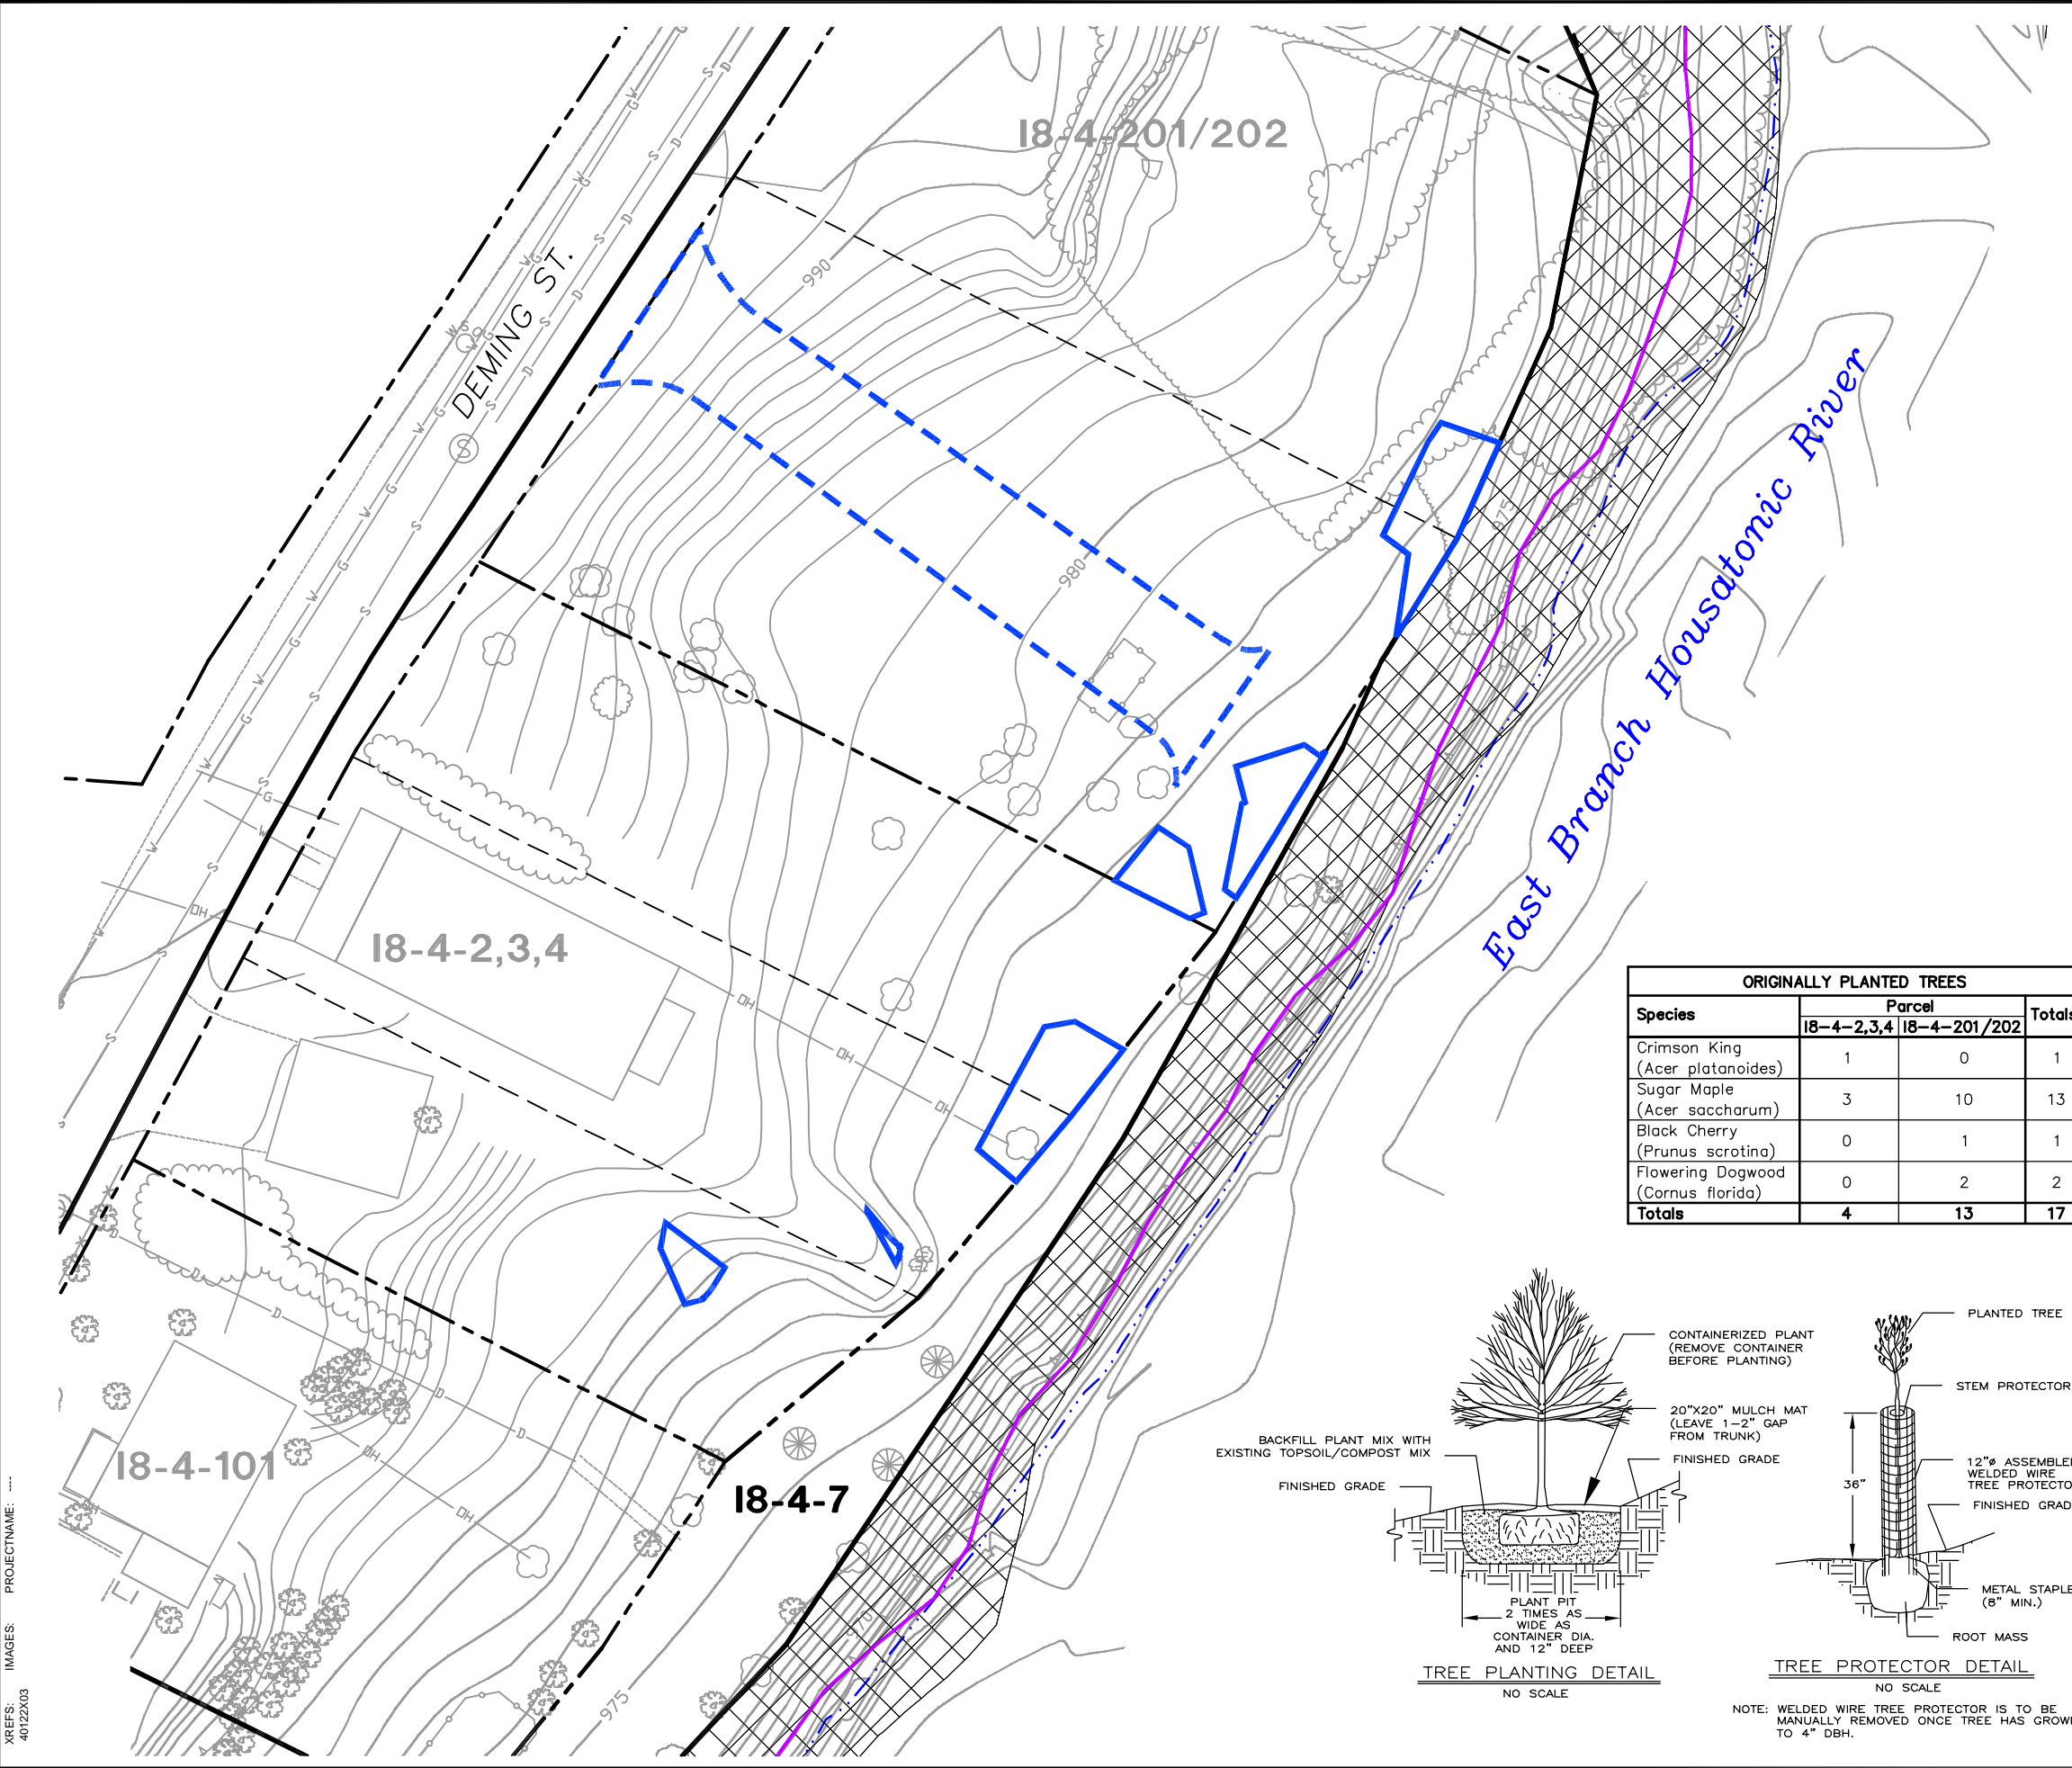
FIGURE
2

In addition, the August 2008 inspection included observations of the trees planted as part of restoration activities at Parcels I8-4-201/202 and Parcels I8-4-2,-3,-4 to ensure that they are in good general health. Figure 2 contains the restoration planting plan for Parcels I8-4-201/202 and Parcels I8-4-2,-3,-4, as presented on Figure H-1 from the 1½ Mile Residential Floodplain FCR. Figure 2 also provides information regarding replanted trees, including the species, installation date, and size at the time of replanting. As shown on that figure, one sugar maple tree was replanted on Parcels I8-4-2,-3,-4 in July 2008.

Based on the August 2008 observations at the Phase 2 properties, no further maintenance, repair, or replanting activities were identified, although the replanted maple tree on Parcels I8-4-2,-3,-4 was missing a tag identifying the species, installation date, and size at time of replanting. This tag will be replaced prior to the next inspection.

- Replace the tag on the replanted maple tree identifying the species, date of installation, and size at time of replanting.
