November 21, 2008  
Project No. J1447-01-02

**Semi-Annual Inspection  
Building Demolition Barrier Areas  
November 2008**

**20s and 30s Complexes  
William Stanley Business Park  
Pittsfield, Massachusetts**

RE: Building Demolition Barrier Areas Inspections

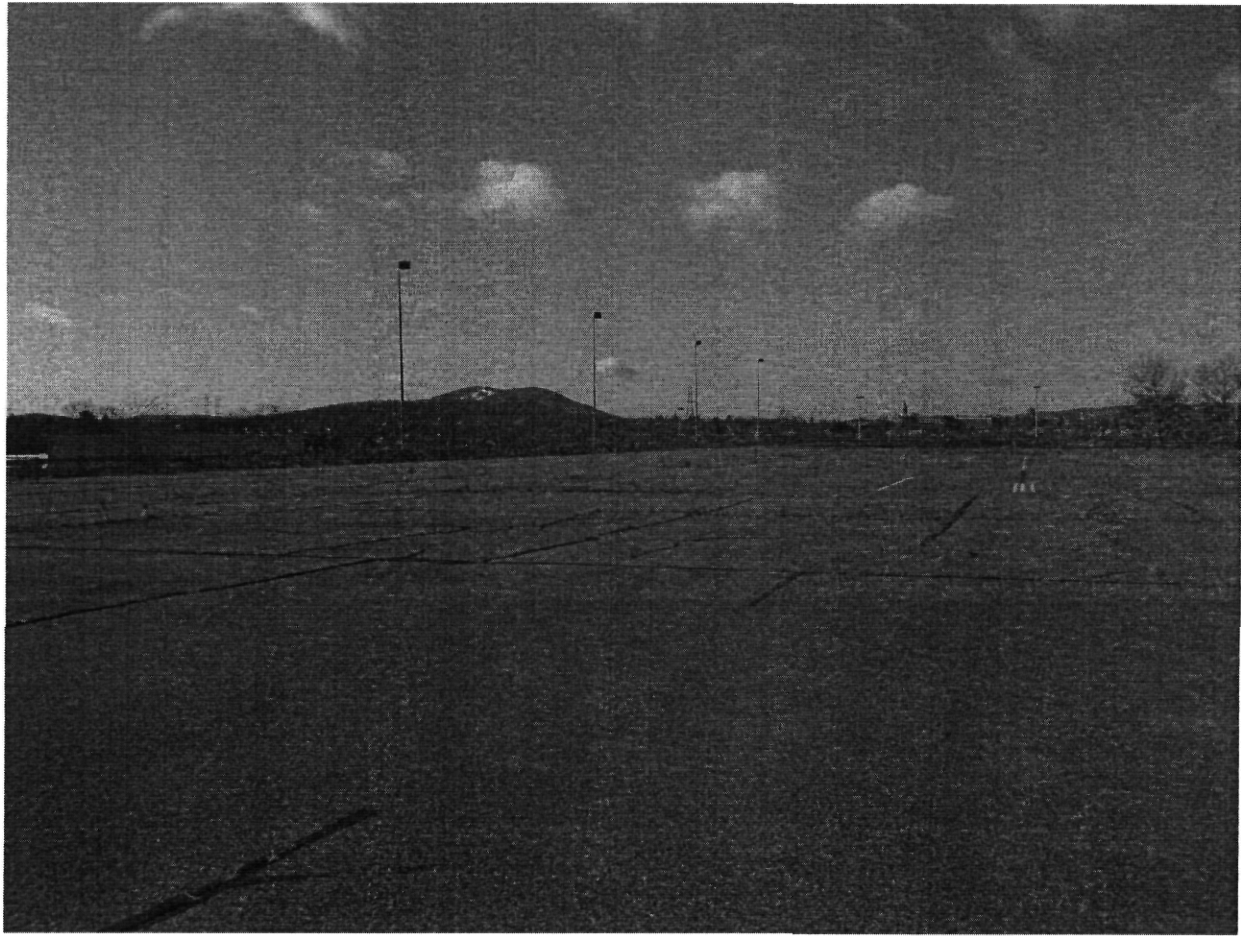
20s Barrier Area #1

View looking west  
November 21, 2008

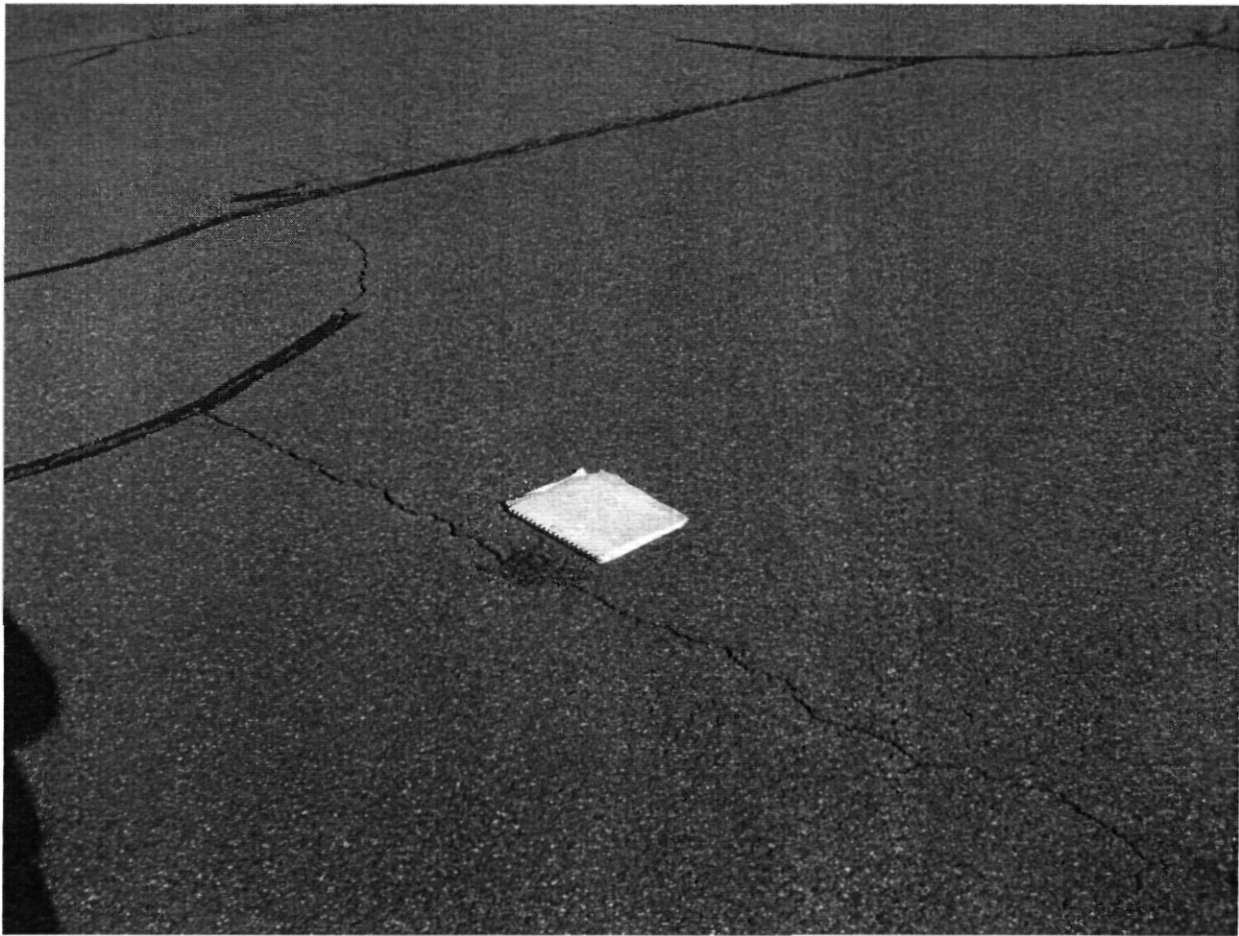
20s Barrier Area #1

- Description of any conditions or problems noted during the inspection which are or may be affecting the performance of the engineered barrier:  
No conditions were observed which are or may be affecting the performance of the engineered barrier. Minor vegetative growth was observed (see photos). The frequency and density of vegetative growth in small cracks seems to be increasing.

One-quarter inch to one inch crack in the northeastern portion of barrier area  
November 21, 2008

- Description of any measures that may need to be performed to correct any conditions affecting the performance of the barriers:  
Continued monitoring of minor cracking and minor vegetative growth. Repair of cracking and control of vegetation may be necessary if conditions deteriorate.

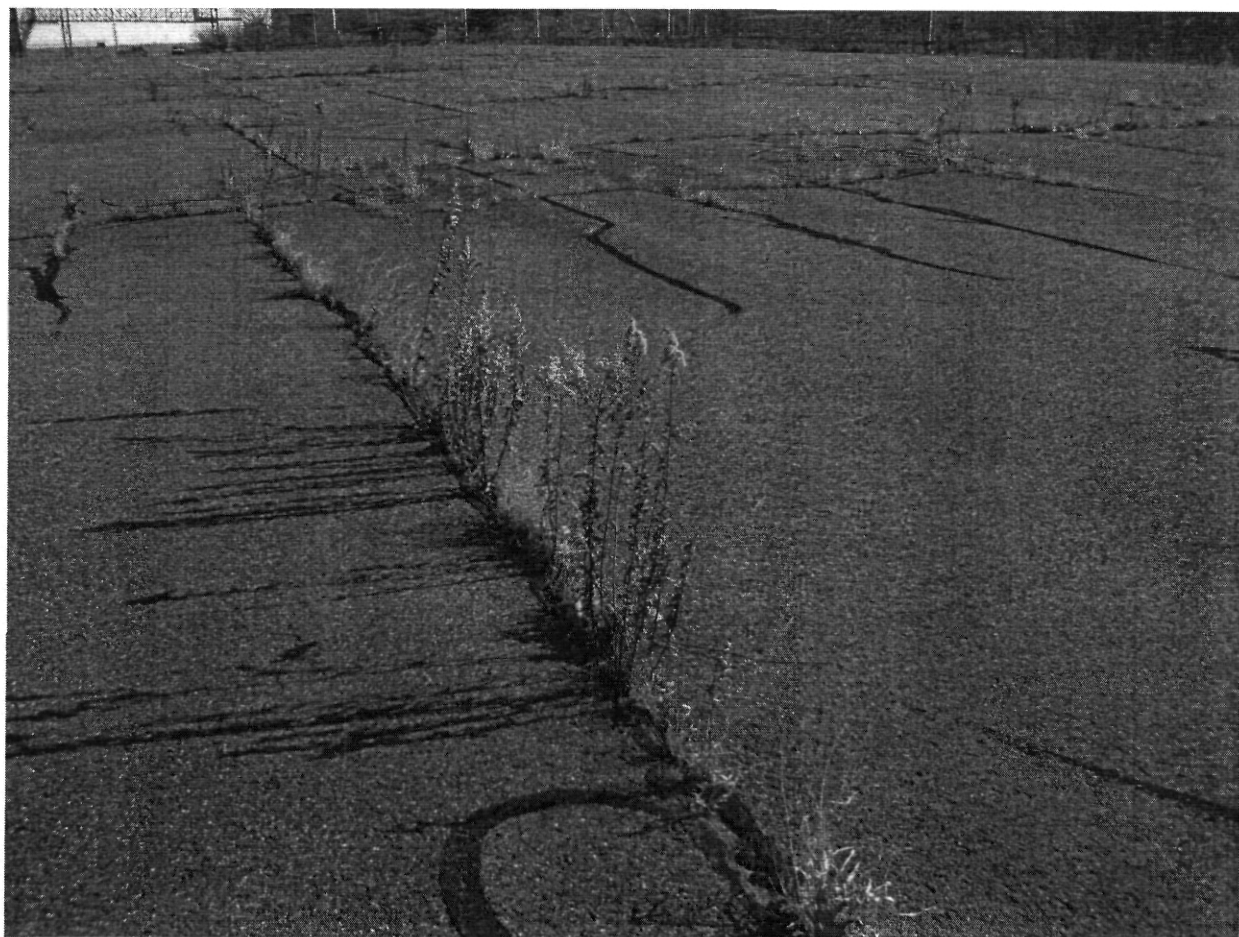
20s Barrier Area #1

Typical vegetation growth  
November 21, 2008

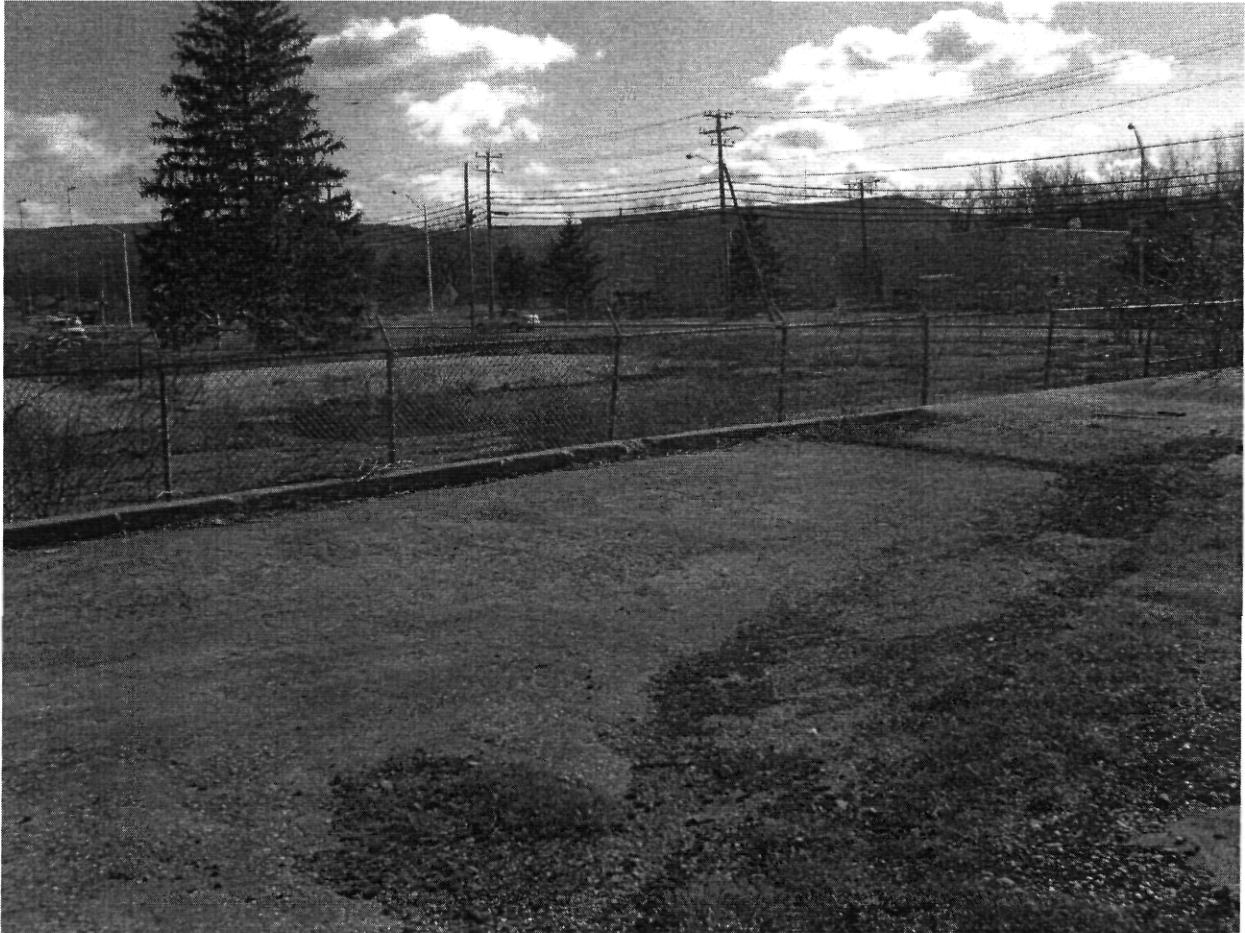
20s Barrier Area #2

View looking southeast  
November 21, 2008

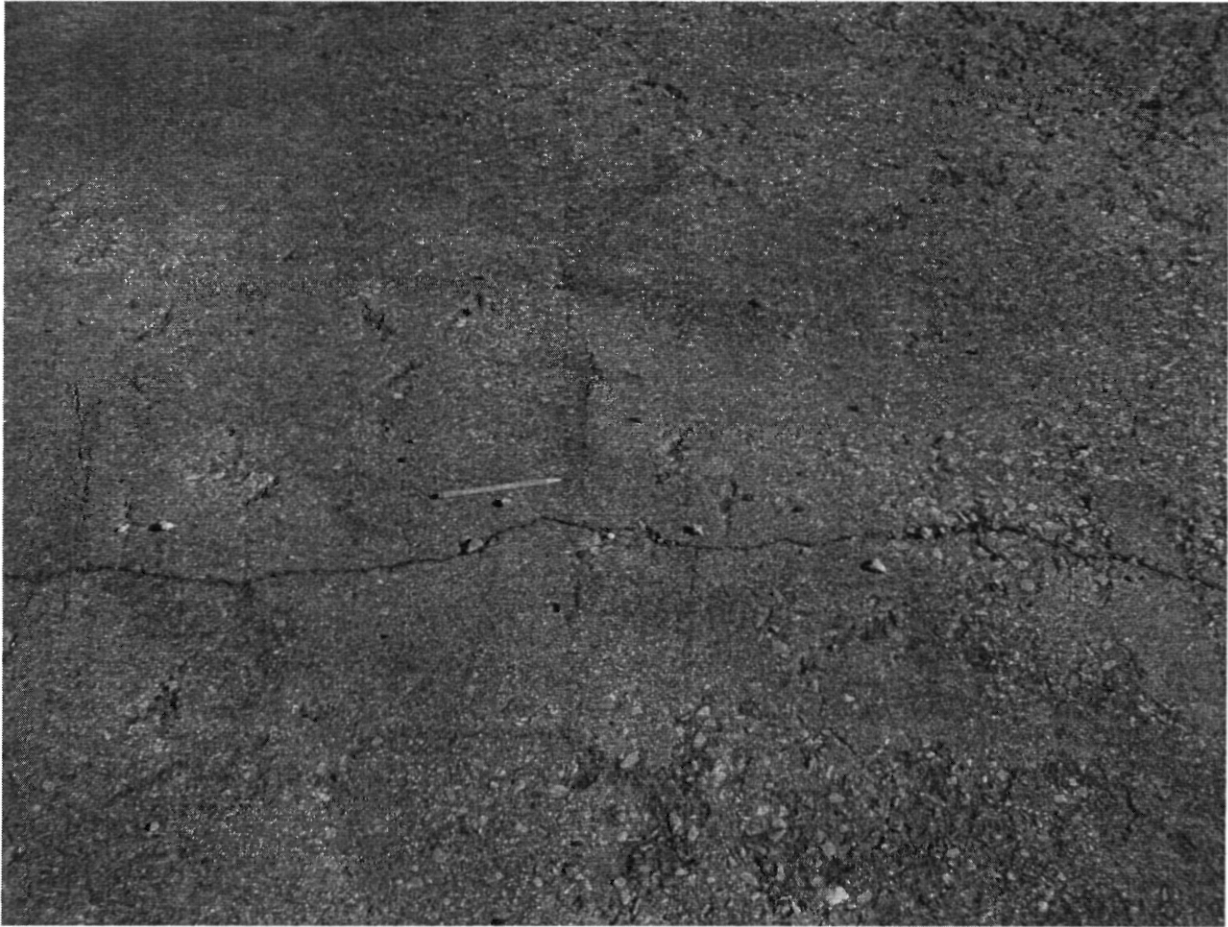
20s Barrier Area #2

One-quarter to one-half inch crack traversing the approximate center of the barrier  
November 21, 2008

- **Description of any measures that may need to be performed to correct any conditions affecting the performance of the barriers:**  
No corrective actions required at this time.

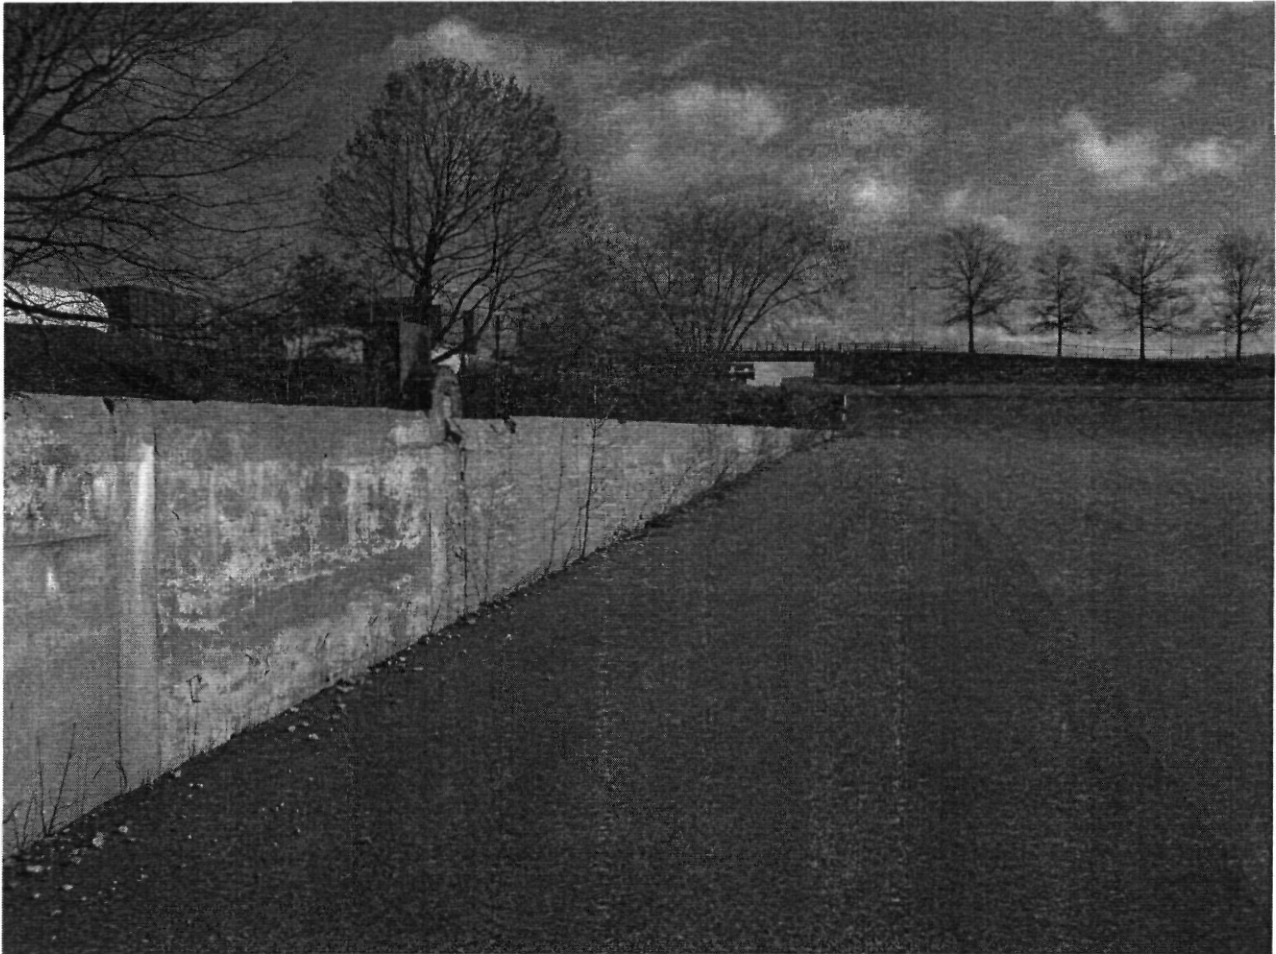
30s Complex Building Demolition Barrier Area

Minor vegetation growth along the north side of the barrier  
November 21, 2008

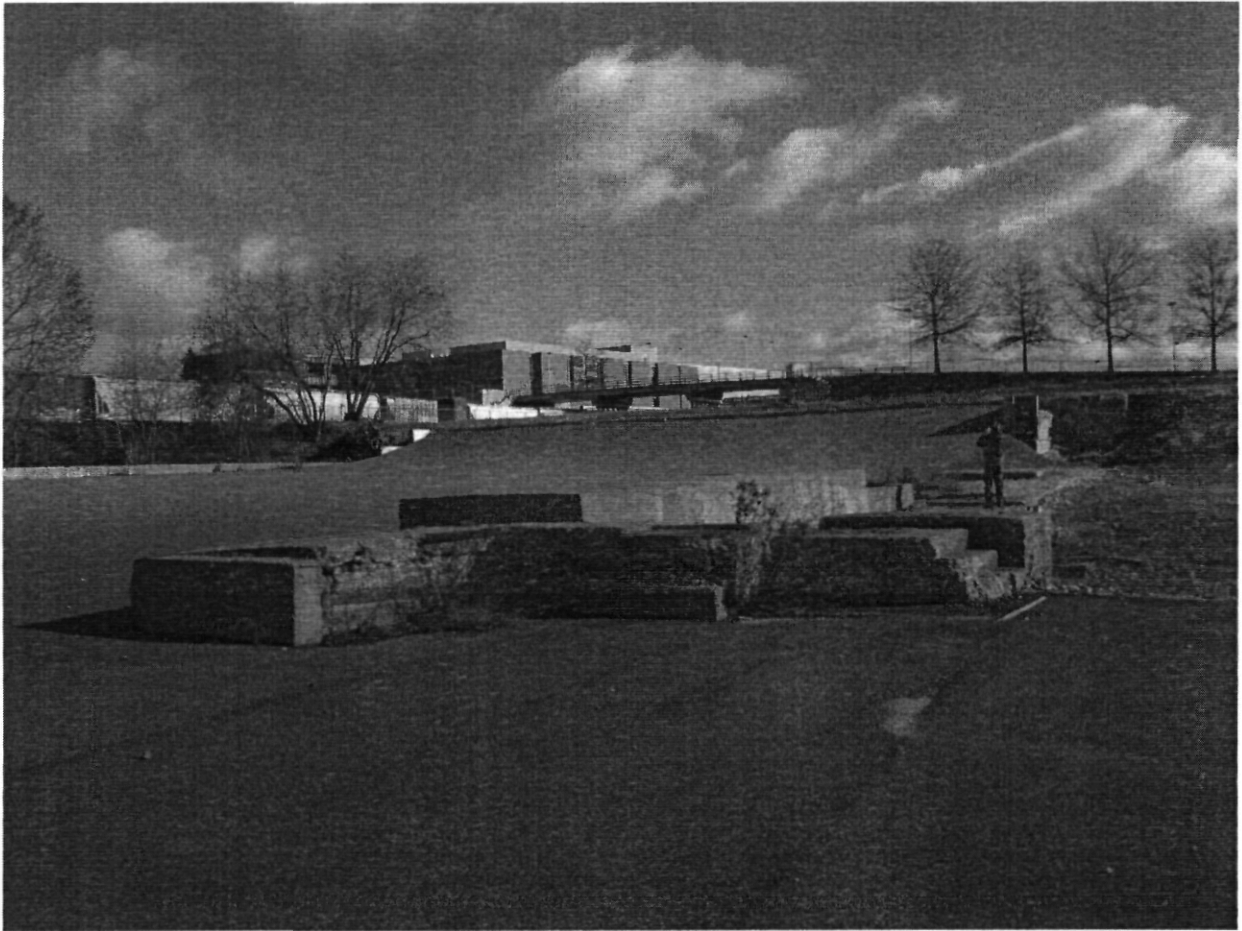
30s Complex Building Demolition Barrier Area

View looking northeast/east  
November 21, 2008

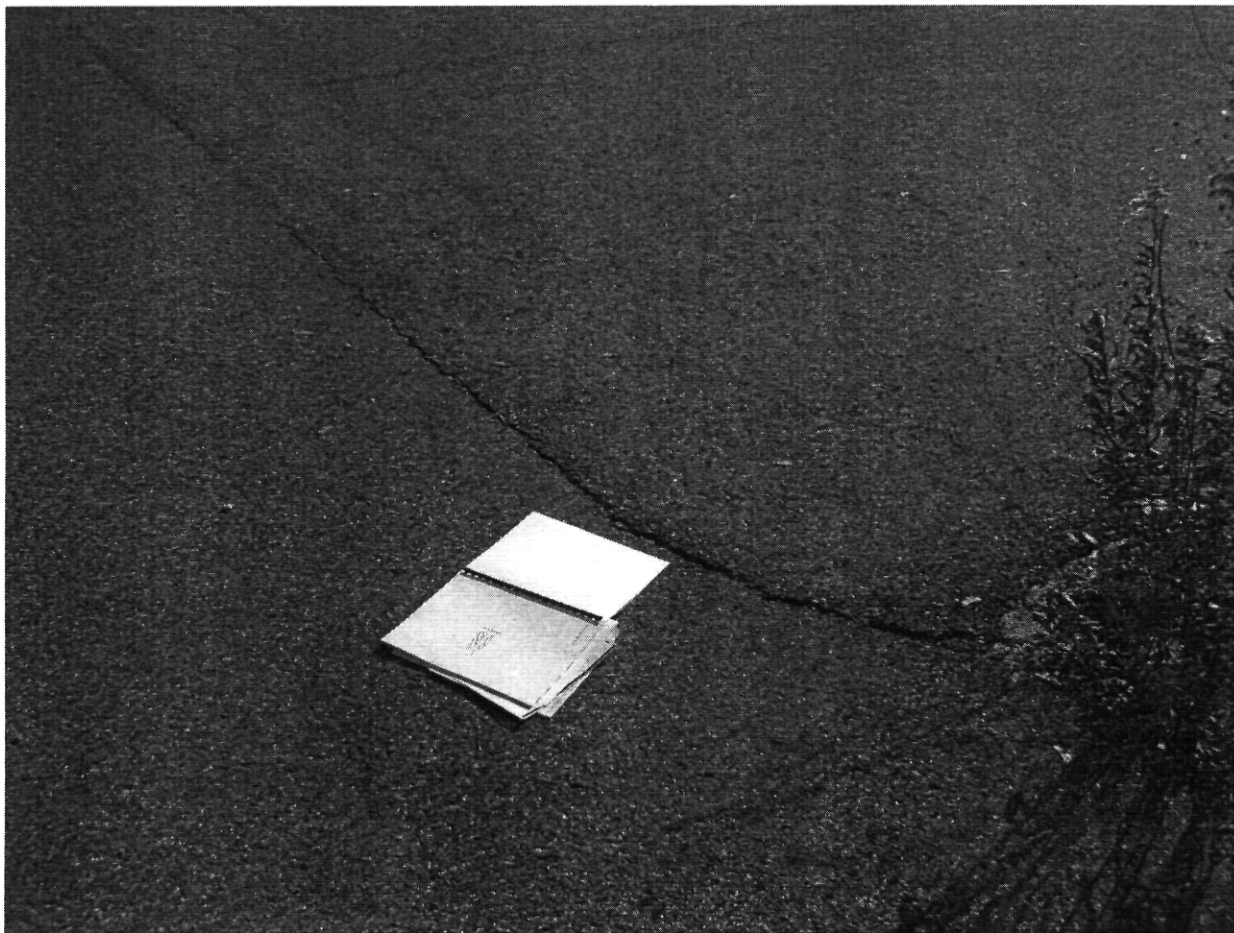
30s Complex Building Demolition Barrier Area

One-quarter to three-quarter inch crack at the northwest edge of the barrier  
November 21, 2008

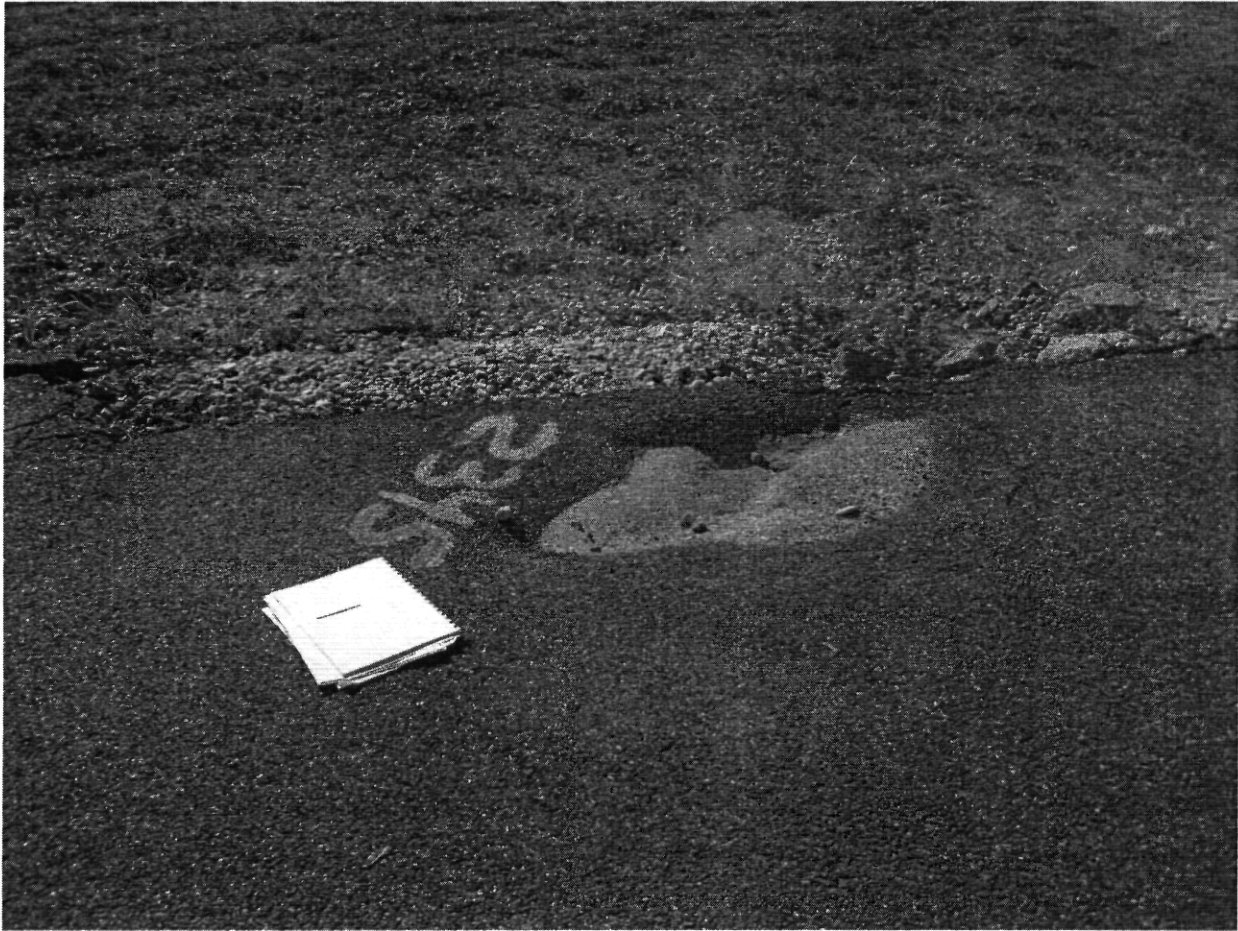
30s Complex Building Demolition Barrier Area

View of depression covered with dirt along southern border of the barrier area  
November 21, 2008

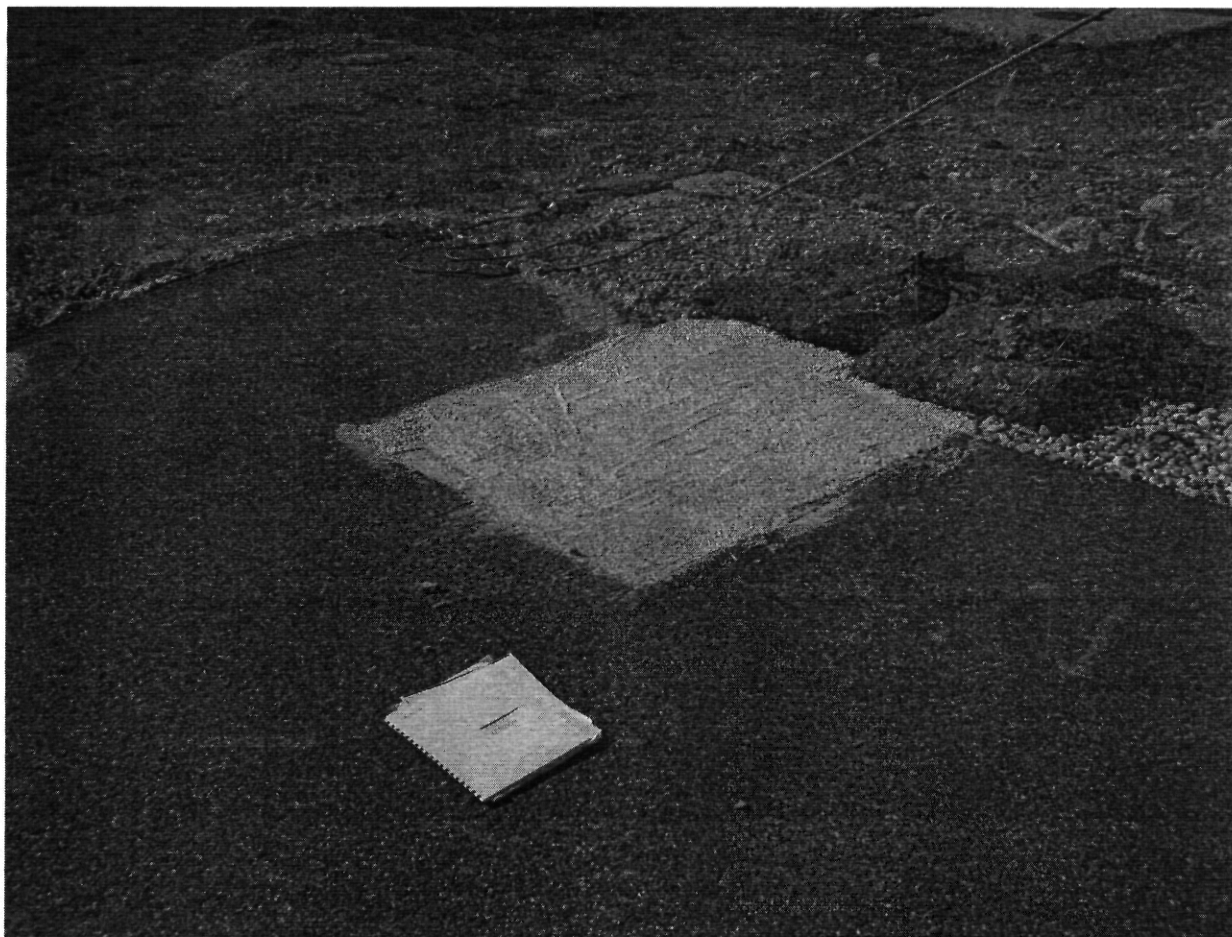
30s Complex Building Demolition Barrier Area

View of pothole repaired with concrete along southwestern border of the barrier area  
November 21, 2008
