GE  
159 Plastics Avenue  
Pittsfield, MA 01201  
USA

**Re: GE-Pittsfield/Housatonic River Site  
East Street Area 2-North (GEC140)  
Summary of August/September 2008 Inspection Activities**

INSPECTION SUMMARY AND CHECKLIST

EAST STREET AREA 2 - NORTH

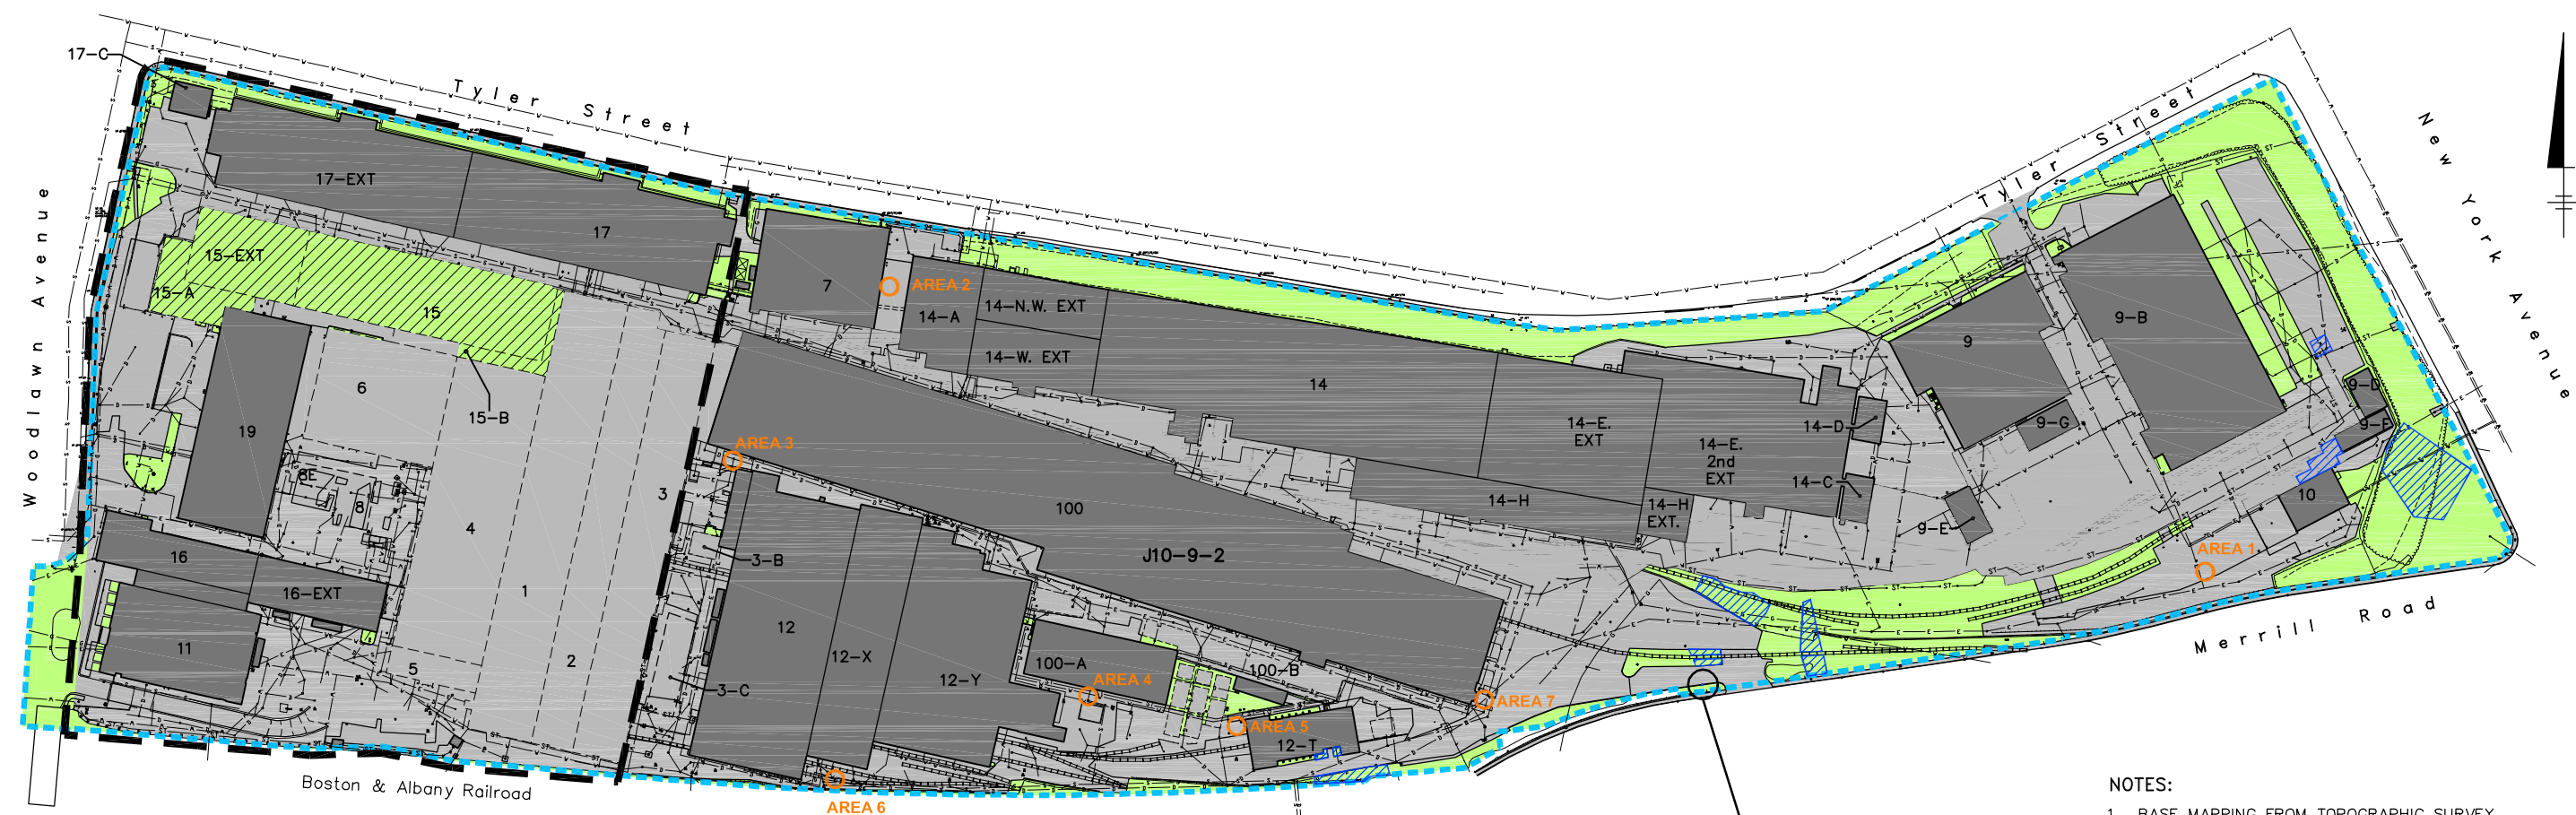
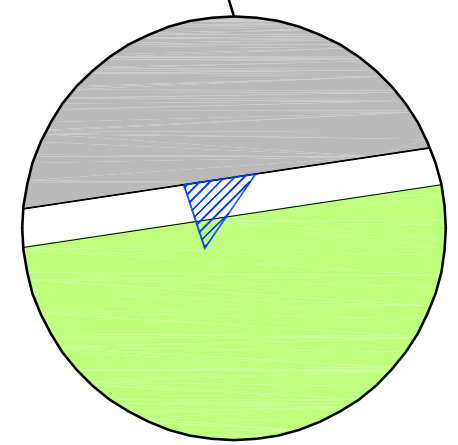
FIGURE  
**2**

As noted in the attached Inspection Summary and Checklist, the August 2008 inspection indicated that all backfilled/restored areas and all herbaceous vegetation planted were in good condition. In the other paved areas subject to inspection, the September 2008 inspection noted the following conditions:

- An area west of Building 10 was identified as needing to be paved (Area 1 on Figure 2);
- An area east of Building 7 and west of Building 14-A was identified as needing to be paved (Area 2 on Figure 2);
- A small paved area near the southwest corner of Building 100-A was identified as needing repair (Area 3 on Figure 2);
- An area south of Building 100-A was identified as needing to be paved (Area 4 on Figure 2);
- An area near the northwest corner of Building 12-T was identified as needing to be paved (Area 5 on Figure 2);
- A small hole was observed in the recently paved area behind Building 12-X (Area 6 on Figure 2); and
- An area near the southeast entrance of Building 100 that was identified as a paved area on Figure E-1 of the Modified Post-Removal Site Control Plan was observed to be unpaved and has been planted with trees and ornamental bushes (Area 7 on Figure 2).

- An area west of Building 10 was identified as needing to be paved (see Area 1 on Figure 2).
- An area east of Building 7 and west of Building 14-A was identified as needing to be paved (see Area 2 on Figure 2).

- A small paved area near the southwest corner of Building 100-A was identified as needing repair (see Area 3 on Figure 2).
- An area south of Building 100-A was identified as needing to be paved (see Area 4 on Figure 2).

- An area near the northwest corner of Building 12-T was identified as needing to be paved (see Area 5 on Figure 2).
- A small hole was observed in the recently paved area behind Building 12-X that was identified as needing repair (see Area 6 of Figure 2).

- An area near the southeast entrance of Building 100 that was identified as a paved area on Figure E-1 of the Modified Post-Removal Site Control Plan was observed to be unpaved and has been planted with trees and ornamental bushes (see Area 7 on Figure 2).

- Pave Areas 1, 2, 4, and 5 identified on Figure 2;
- Repair the small paved area near the southwest corner of Building 100-A (Area 3 on Figure 2); and
- Repair the small hole observed in the pavement behind Building 12-X (Area 6 on Figure 2).

In addition, GE will discuss with EPA the most appropriate method to address the unpaved and planted area near the southeast entrance of Building 100 that was identified as paved in the Modified Post-Removal Site Control Plan (Area 7 on Figure 2).

- Pave four areas identified as needing to be paved (see Areas 1, 2, 4 and 5 on Figure 2).
- Repair paved area near southwest corner of Building 100-A (see Area 3 on Figure 2).
- Repair small hole observed behind Building 12-X (see Area 6 on Figure 2).
- Discuss with EPA appropriate means to address the unpaved area near the southeast entrance of Building 100 (Area 7 on Figure 2).
