**General Electric Company  
Pittsfield, Massachusetts**

**2008 Annual Monitoring Report**

**Upper ½-Mile Reach of the  
Housatonic River**

January 2009

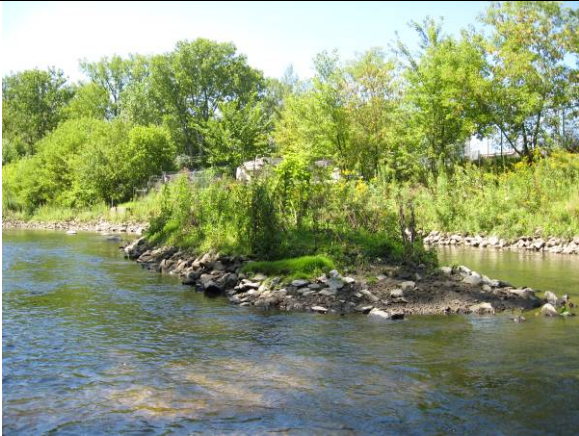
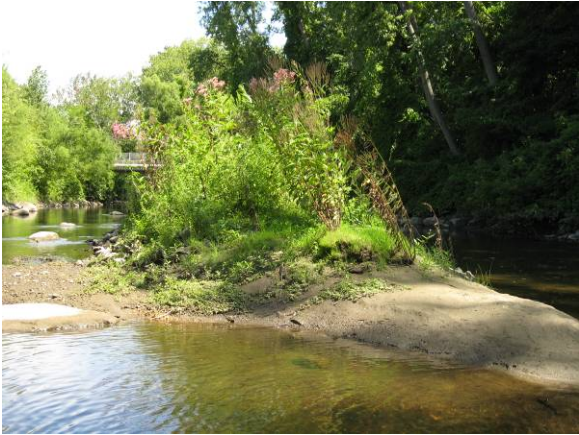
Cell	Aquatic Structures	Armor Stone Condition/General Biological Observations
C	<ol style="list-style-type: none"> <li>1. Boulders</li> <li>2. Island</li> </ol>	<div style="display: flex; justify-content: space-between;"> <div style="width: 45%;">

</div> <div style="width: 45%; border: 1px solid black; padding: 10px;"> <ol style="list-style-type: none"> <li>1. Structures appear stable</li> <li>2. Structure induced variations observed in areas immediately downstream of the island</li> <li>3. The island appears to be well vegetated with wetland herbaceous species</li> <li>4. Boulders near island appear to be causing scour in the immediate area; good cover</li> </ol> </div> </div>

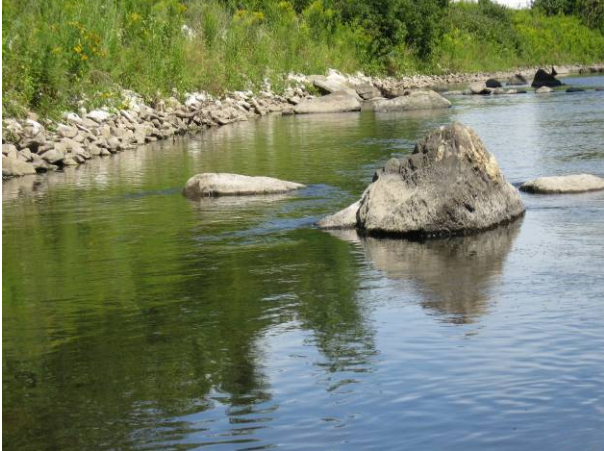
Cell	Aquatic Structures	Armor Stone Condition/General Biological Observations	
J1	<ol style="list-style-type: none"> <li>1. Two-boulder cluster</li> <li>2. Three-boulder cluster</li> <li>3. Single-boulder</li> </ol>

<ol style="list-style-type: none"> <li>1. Structures appear to be stable and providing diversity in habitat</li> <li>2. Good habitat, variations in velocity around structures and related variations in stream bottom topography</li> <li>3. Boulders observed to be being used as perches for feeding birds</li> </ol>
J2	<ol style="list-style-type: none"> <li>1. "J"- boulder formation</li> </ol>

<ol style="list-style-type: none"> <li>1. Structure appears to be stable and providing diversity in habitat</li> <li>2. Good habitat, variations in velocity around structure and related variations in stream bottom topography</li> </ol>

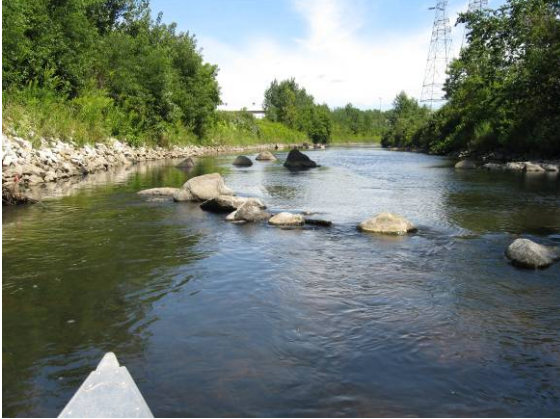
<div style="border: 1px solid black; padding: 10px;"> <ol style="list-style-type: none"> <li>1. Structure appears to be stable and providing diversity in habitat</li> <li>2. Good habitat, variations in velocity around structure and related variations in stream bottom topography</li> </ol> </div>

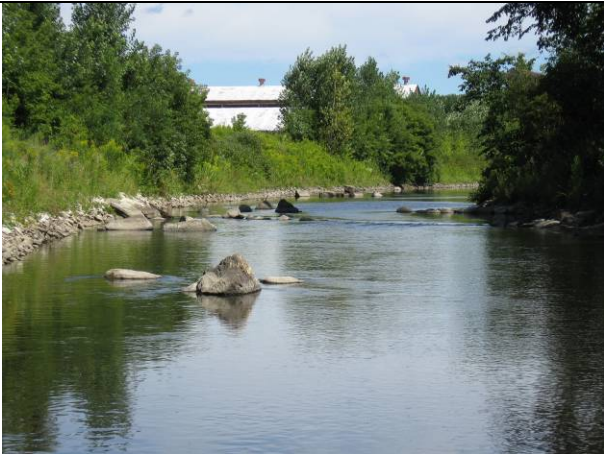
Cell	Aquatic Structures	Armor Stone Condition/General Biological Observations	
J3	<ol style="list-style-type: none"> <li>1. Boulder cluster</li> <li>2. Three-boulder cluster</li> <li>3. Three-boulder cluster</li> </ol>

<div style="border: 1px solid black; padding: 10px;"> <ol style="list-style-type: none"> <li>1. Structures appear to be stable and providing diversity in habitat</li> <li>2. Good habitat, variations in velocity around structures and related variations in stream bottom topography</li> </ol> </div>
