**Re: GE-Pittsfield/Housatonic River Site
Upper ½-Mile Reach of the Housatonic River (GECD800)
2008 Inspection of Restored Bank Vegetation and Aquatic Habitat Enhancement Structures**

SUBJ: 2008 Monitoring Visit Trip Report
Restored Bank Vegetation and Aquatic Habitat Enhancement Structures
Upper ½-Mile Reach of the Housatonic River

DATE: October 16, 2008

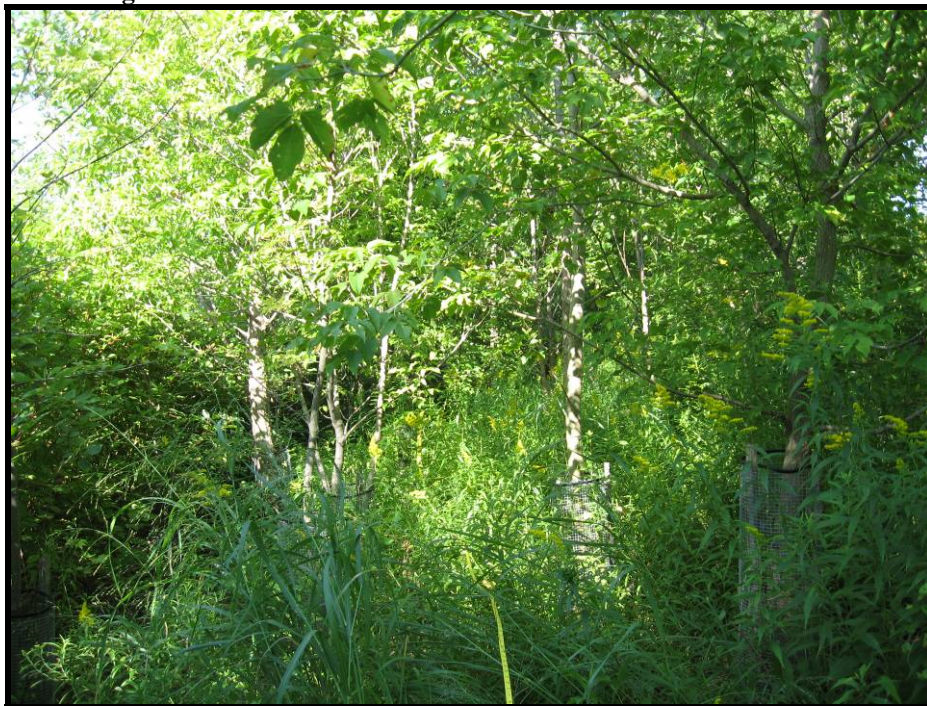
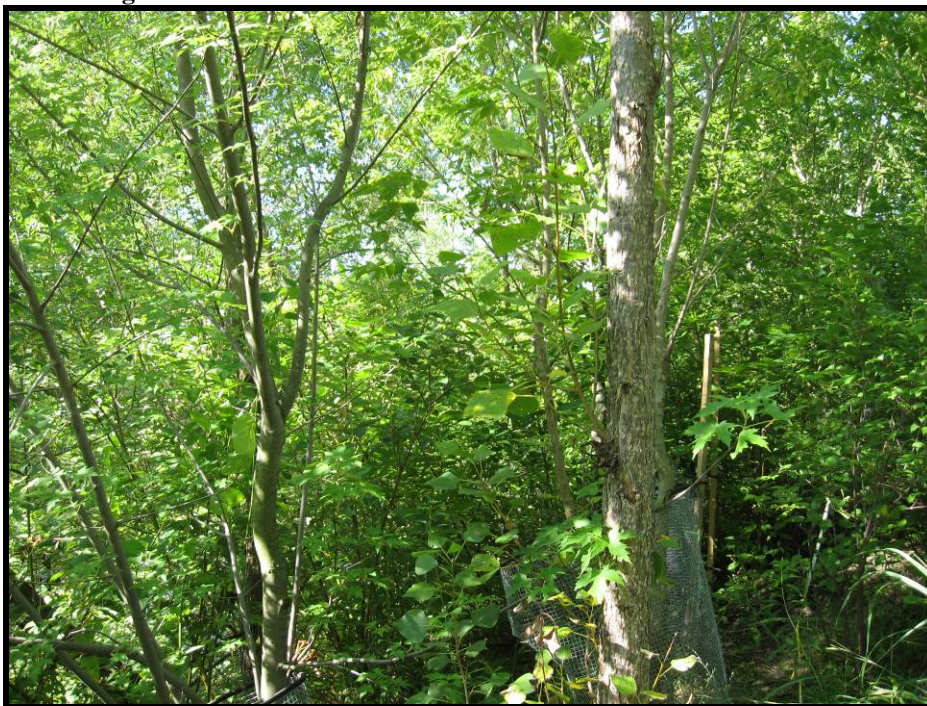
Photograph 1: Planting Area 4B

1. Planting area 4B showed excellent vegetative growth for all components of the restoration. Vegetative growth was robust and all strata of the community were well developed. In particular, the eastern cottonwood and the box elder specimens showed excellent growth with some diameter at breast height (DBH) measurements exceeding seven inches. All components of the vegetative community in this planting area, including canopy, understory, red-osier dogwood, grape vines, herbaceous cover, and invasive species, met their performance standards. This inspection constituted the 7th-year visit and is the last scheduled vegetation inspection for this planting area.

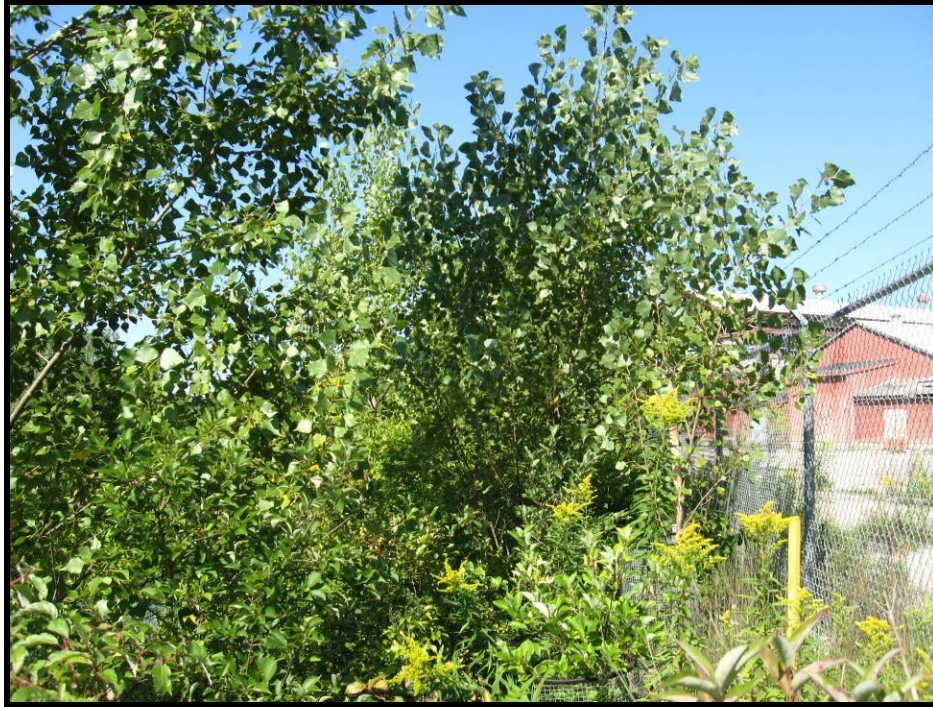
Photograph 3: Planting Area 10

2. Planting Area 10 showed good growth in each of the vegetative strata. All components of the vegetative community in this planting area, including canopy, understory, herbaceous coverage, and invasive species, met their respective performance standards (no red-osier dogwood specimens were planted in this area). This inspection constituted the 7th-year visit and is the last scheduled vegetative vegetation inspection for this planting area.

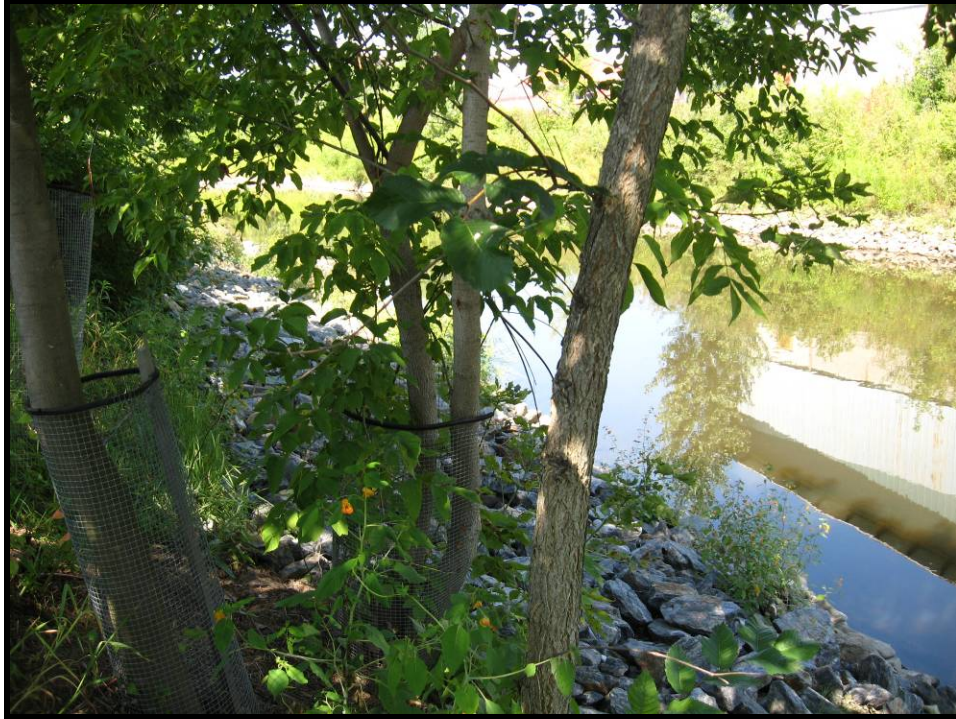
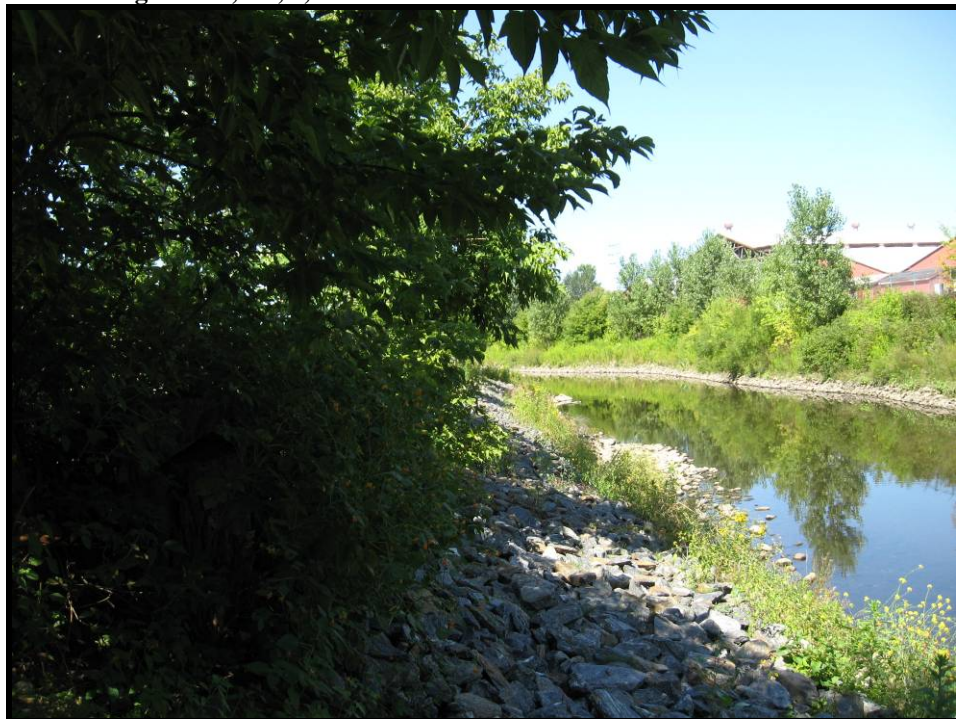
Photograph 5: Planting Area 6, 6A, 7, 8A

3. Composite Planting Area 6, 6A, 7, & 8A met the modified performance standards for the following components of the vegetative community: canopy, herbaceous coverage, and invasive species. With respect to the red-osier dogwood community, in response to the apparent erosion of bank materials identified in this area, additional armor stone has been installed in the upper bank area, resulting in the removal of much of the red-osier dogwood band that had previously been installed. However, following the completion of the remedial activities associated with this area in October/November 2007, and based on discussions with EPA, a replacement band of red-osier dogwoods was installed along the top of the new armor stone in the remaining space between the top of the newly restored area and the bottom of the adjacent Newell Street Area II engineered barrier. The 2008 inspection indicated that the new red-osier dogwoods appear to have survived the first winter following installation and to meet their performance standard. This inspection constituted the 7th-year visit and is the last scheduled vegetative vegetation inspection for this planting area.

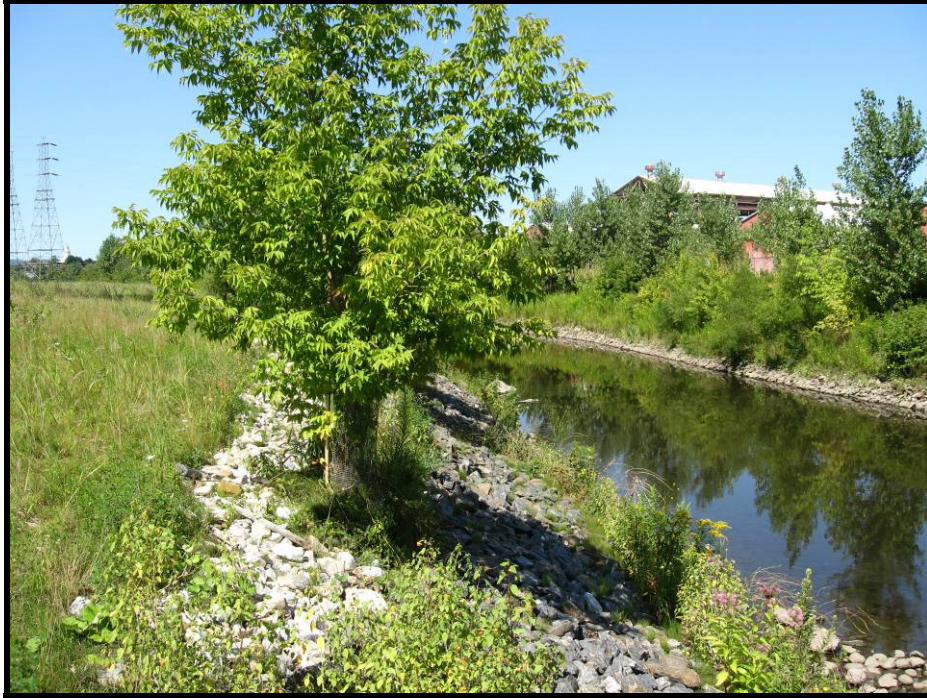
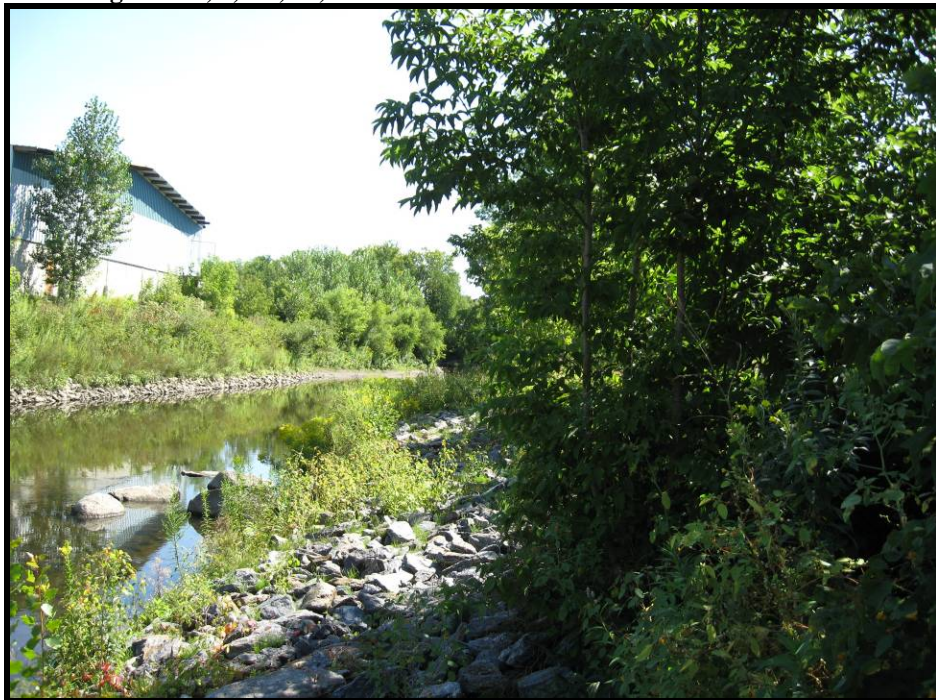
Photograph 7: Planting Area 8, 9, 9A, 11, and 11A

4. Composite Planting Area 8, 9, 9A, 11, & 11A met the modified performance standards for the following components of the vegetative community: canopy, grape vines, herbaceous coverage, and invasive species. With respect to the understory community, this planting area had a variance of 19 specimens, a likely result of disturbance associated with the Newell Street Area II remedial activities discussed above. These specimens will be replanted, as described below. With respect to the red-osier dogwood community, additional armor stone has been installed in the upper bank area in response to the apparent erosion of bank materials identified in this area, resulting in the removal of much of the red-osier dogwood band that had previously been installed. However, following the completion of the remedial activities associated with this area in October/November 2007, and based on discussions with EPA, a replacement band of red-osier dogwoods was installed along the top of the new armor stone in the remaining space between the top of the newly restored area and the bottom of the adjacent Newell Street Area II engineered barrier. The 2008 inspection indicated that the new red-osier dogwoods appear to have survived the first winter following installation and to meet their performance standard. Although this inspection constituted the 7th-year visit and was the last regularly scheduled vegetation inspection for this planting area, GE proposes to visit this area again in 2009 to assess the survivorship of the understory species to be planted in the fall of 2008.

As noted above, composite planting area 8, 9, 9A, 11, & 11A did not meet the performance standard for understory specimens, with a variance of 19 specimens. In addition, the 2007 Annual Report stated that replanting activities would be performed in spring 2008 at planting areas 5 and 16, which were found in the 2007 inspection not to meet their performance standards for canopy and/or understory species. However, seasonal constraints related to the timing of the completion of the remedial activities and riprap placement and the ensuing need for coordination with various contractors involved with the plantings delayed the planting schedule beyond the optimal planting season, resulting in the proposed replanting being postponed. As a result, planting area 5 is still missing 4 canopy specimens and 36 shrub specimens, and planting area 16 is still missing 2 canopy specimens. Supplemental planting associated with these previously identified variances – anticipated to include planting of 8 additional canopy specimens and 36 shrub specimens at planting area 5 and 4 additional canopy specimens at planting area 16 – will be included for performance with the proposed 2008 corrective measures.

Composite Planting Area 8, 9, 9A, 11, & 11A	19 shrub specimens
Planting Area 5	36 shrub specimens 8 canopy specimens
Planting Area 16	4 canopy specimens

The canopy plantings will be divided equally among the four species used at this site: box elder (*Acer negundo*), eastern cottonwood (*Populus deltoides*), silver maple (*Acer saccharinum*), and black willow (*Salix nigra*), depending upon species availability. The shrub/understory plantings will be divided equally among the four shrub species used at this site: northern arrowwood (*Viburnum recognitum*), silky dogwood (*Cornus amomum*), winterberry (*Ilex verticillata*), and choke-cherry (*Prunus virginiana*) depending upon species availability. Canopy species will be installed in open spaces in each respective planting area, while understory species will be planted in open areas within the respective shrub plots in

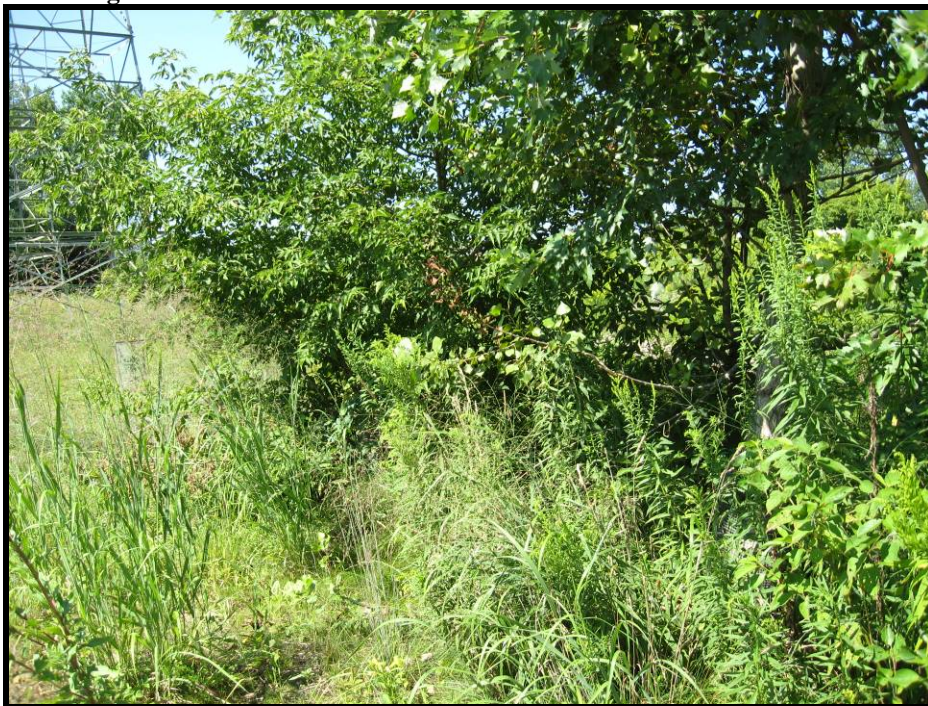
Photograph 9: Planting Area 13

5. Planting area 13 was revisited in 2008 to evaluate replanting activities that occurred following the completion of the remedial activities associated with Newell Street Area II. All components of the vegetative community in this planting area, including canopy, understory, red-osier dogwoods, herbaceous coverage, and invasive species, met their respective performance standards. This area will be inspected one final time in August 2009 to satisfy the normally scheduled 7th-year visit.
6. Protective screens had been placed around the canopy specimens in the fall of 2001. These screens continue to provide good protection from herbivorous animals.

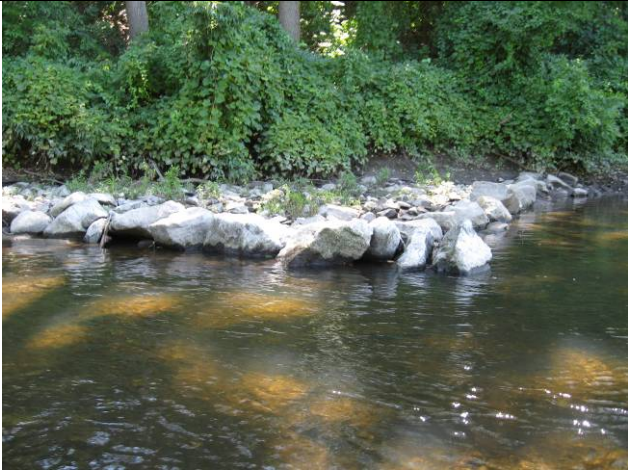
Cell	Aquatic Structures	Armor Stone Condition/General Biological Observations
B	1. Single wing deflector

<div data-bbox="1320 995 1871 1330" style="border: 1px solid black; padding: 10px;"> <ol style="list-style-type: none"> 1. Structures appear stable 2. Structure induced variations observed in areas immediately downstream of the deflector </div>

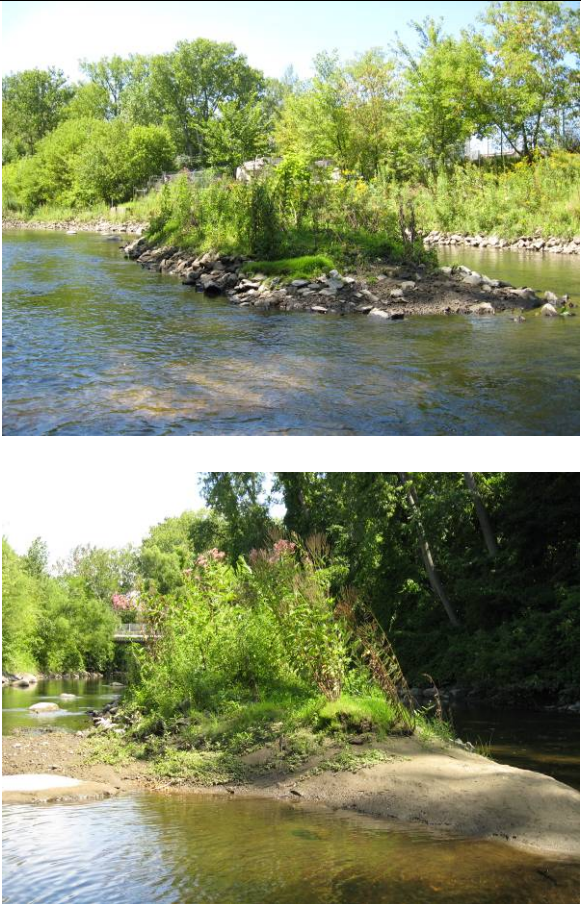
Cell	Aquatic Structures	Armor Stone Condition/General Biological Observations	
C	<ol style="list-style-type: none"> 1. Boulders 2. Island

<div style="border: 1px solid black; padding: 10px;"> <ol style="list-style-type: none"> 1. Structures appear stable 2. Structure induced variations observed in areas immediately downstream of the island 3. The island appears to be well vegetated with wetland herbaceous species 4. Boulders near island appear to be causing scour in the immediate area; good cover </div>

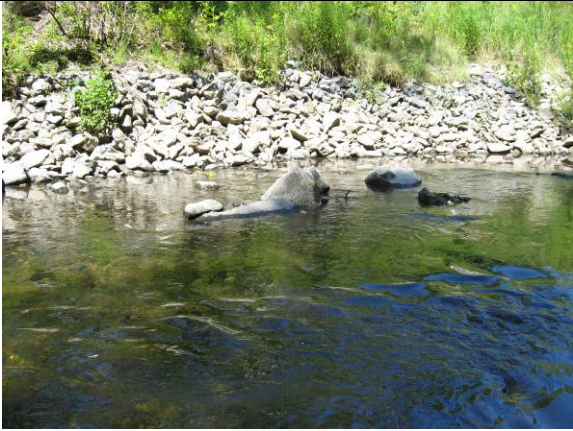
Cell	Aquatic Structures	Armor Stone Condition/General Biological Observations	
D	1. Boulders

<div style="border: 1px solid black; padding: 10px;"> <p>1. Structures appear to be functional and providing variation in habitat</p> </div>
G1	1. Boulder Cluster

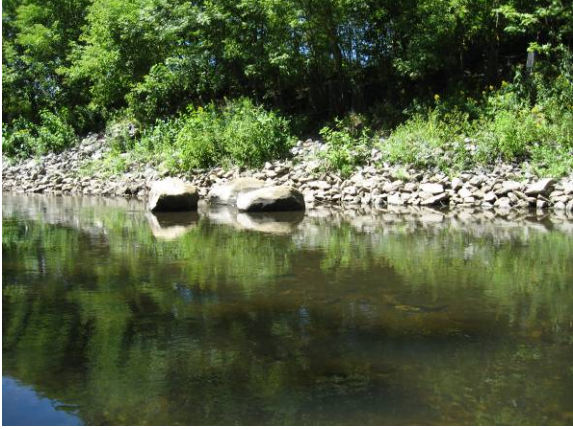
<div style="border: 1px solid black; padding: 10px;"> <p>1. Structures appear to be functional and providing variation in habitat</p> </div>

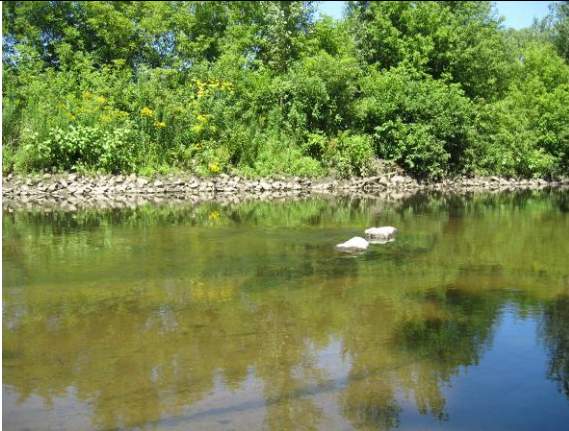
Cell	Aquatic Structures	Armor Stone Condition/General Biological Observations	
G2/F2	1. W-weir

<div style="border: 1px solid black; padding: 10px;"> <ol style="list-style-type: none"> 1. Much of the weir is buried in soft silt/sand; portion that is present appears to offer good cover for aquatic organisms </div>
G3	1. Three-boulder cluster

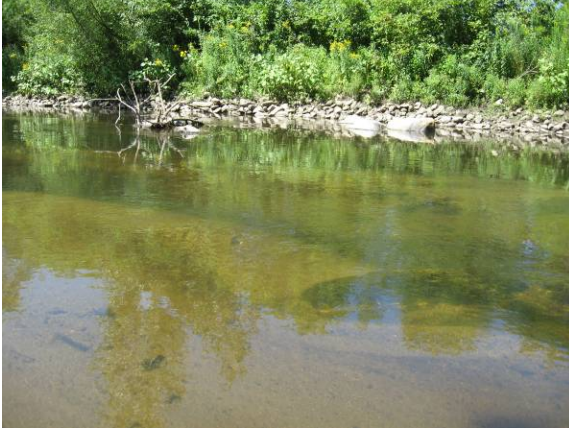
<div style="border: 1px solid black; padding: 10px;"> <ol style="list-style-type: none"> 1. Structure appears stable, no issue or concern 2. Structure appears to be functional and providing variation in habitat </div>

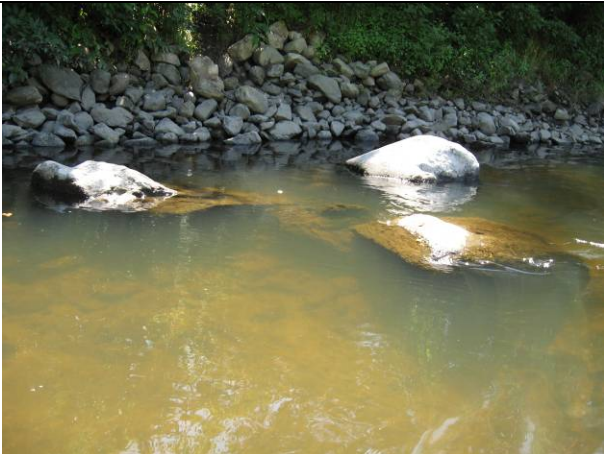
Cell	Aquatic Structures	Armor Stone Condition/General Biological Observations
F3	<ol style="list-style-type: none"> 1. Three-boulder cluster 2. Two-boulder cluster 3. Three-boulder cluster

<div data-bbox="1203 496 1871 664" style="border: 1px solid black; padding: 5px;"> <ol style="list-style-type: none"> 1. All structures in this cell appear stable. 2. Structures appear to be providing diversity in habitat </div>
H1	<ol style="list-style-type: none"> 1. Boulder cluster 	<ol style="list-style-type: none"> 1. Structure appears to be stable and providing diversity in habitat 2. Good habitat, variations in velocity around structure and related variations in stream bottom topography

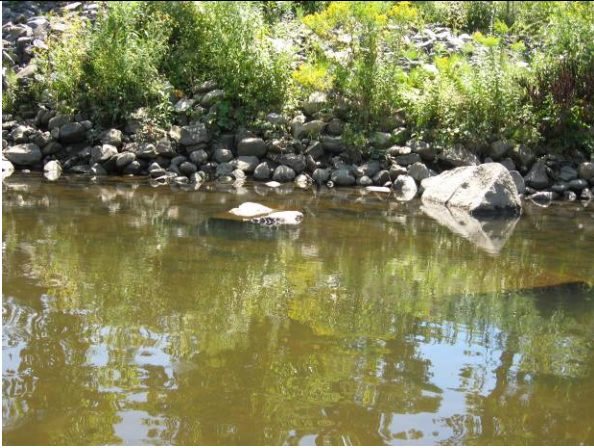
Cell	Aquatic Structures	Armor Stone Condition/General Biological Observations
I1/J1	1. Vortex weir

<div style="border: 1px solid black; padding: 5px; margin-top: 10px;"> <ol style="list-style-type: none"> 1. Much of the weir is buried in soft silt/sand 2. Structure appears to be stable and providing diversity in habitat 3. Good habitat, variations in velocity around structure and related variations in stream bottom </div>
H2	1. Single boulder	<ol style="list-style-type: none"> 1. Structure appears to be stable and providing diversity in habitat 2. Good habitat, variations in velocity around structure and related variations in stream bottom topography

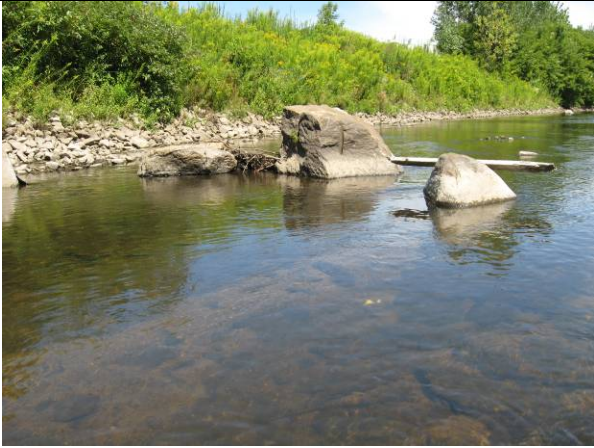
Cell	Aquatic Structures	Armor Stone Condition/General Biological Observations	
J1	<ol style="list-style-type: none"> 1. Two-boulder cluster 2. Three-boulder cluster 3. Single-boulder

<ol style="list-style-type: none"> 1. Structures appear to be stable and providing diversity in habitat 2. Good habitat, variations in velocity around structures and related variations in stream bottom topography 3. Boulders observed to be being used as perches for feeding birds
J2	<ol style="list-style-type: none"> 1. "J"- boulder formation

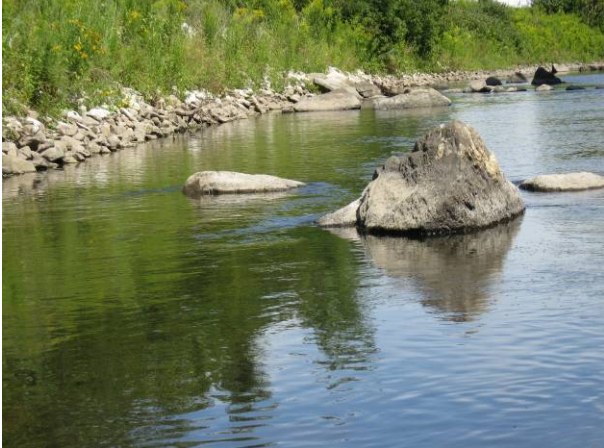
<ol style="list-style-type: none"> 1. Structure appears to be stable and providing diversity in habitat 2. Good habitat, variations in velocity around structure and related variations in stream bottom topography

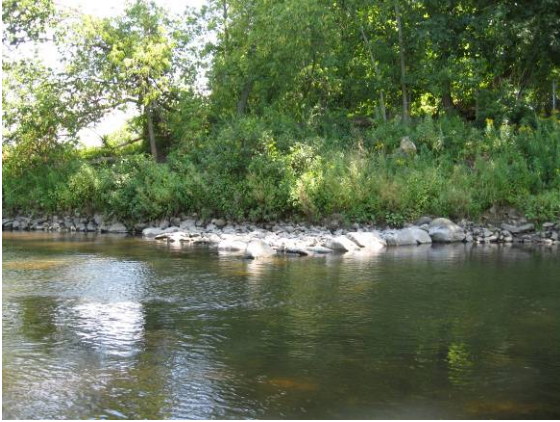
Cell	Aquatic Structures	Armor Stone Condition/General Biological Observations	
I3	1. Single-wing deflector

<div style="border: 1px solid black; padding: 10px;"> <ol style="list-style-type: none"> 1. Structure appears to be stable and providing diversity in habitat 2. Good habitat, variations in velocity around structure and related variations in stream bottom topography </div>
I3/J3	1. Vortex rock weir

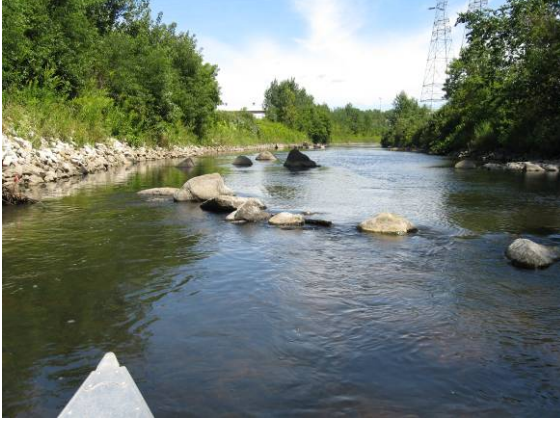
<div style="border: 1px solid black; padding: 10px;"> <ol style="list-style-type: none"> 1. Structure appears to be stable and providing diversity in habitat 2. Good habitat, variations in velocity around structure and related variations in stream bottom topography </div>

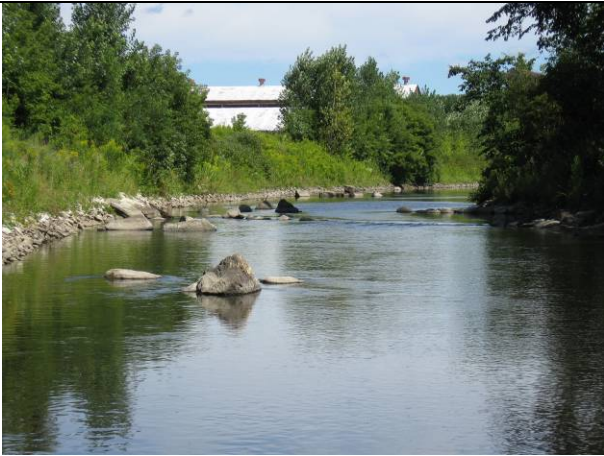
Cell	Aquatic Structures	Armor Stone Condition/General Biological Observations	
J3	<ol style="list-style-type: none"> 1. Boulder cluster 2. Three-boulder cluster 3. Three-boulder cluster

<div style="border: 1px solid black; padding: 10px;"> <ol style="list-style-type: none"> 1. Structures appear to be stable and providing diversity in habitat 2. Good habitat, variations in velocity around structures and related variations in stream bottom topography </div>
