**Interim Monitoring Report for
Blackwood Creek Restoration Phase I and II:
Fish Ladder Removal and Barker Pass Road
Crossing Replacement,
Period of Record 2003-2008**

USDA Forest Service

Lake Tahoe Basin Management Unit

March 2009

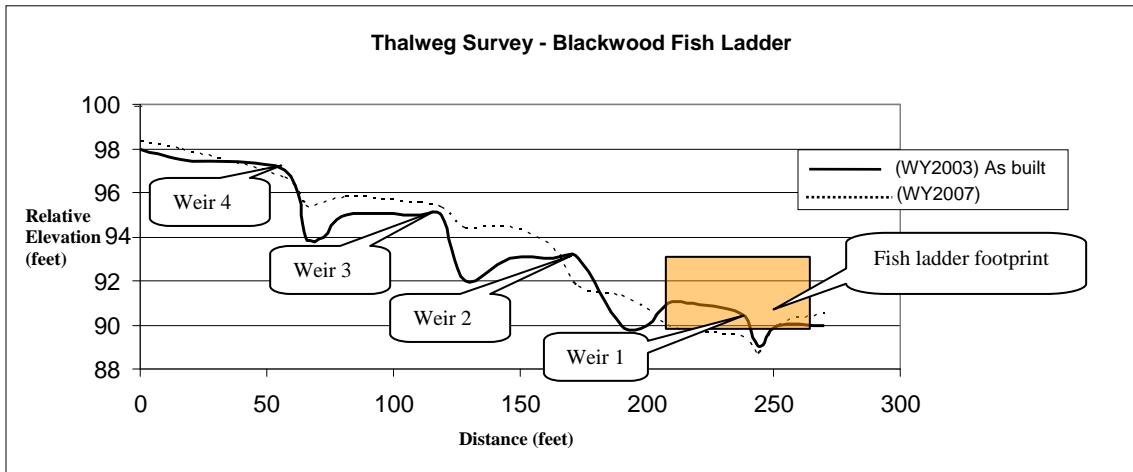
Figure 3. Fish ladder thalweg profile

A graph of the thalweg profile in Figure 3 verifies photo evidence and observations showing the winnowing and settling of weirs 1 and 2, and aggrading along weirs 3 and 4.

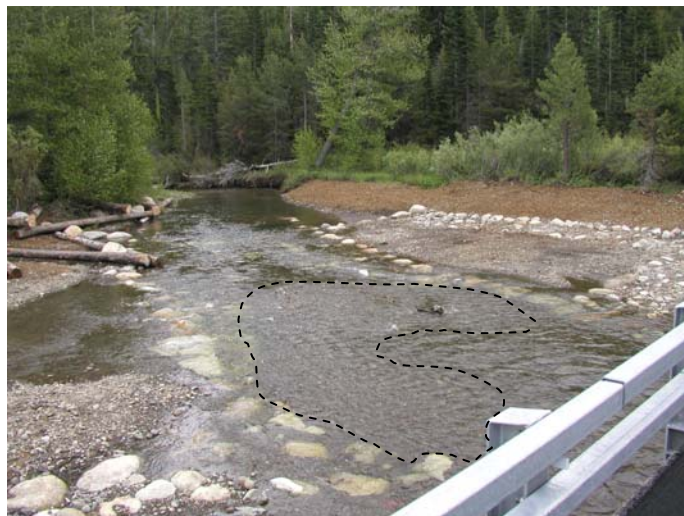
As expected, spring snowmelt flood flows in 2007 winnowed much of the finer fraction (2-305mm) of substrate from constructed riffles upstream of the bridge as illustrated in the photo points. This snowmelt flood, however, was not sufficient in magnitude or duration to transport this material any further than the pool and riffle just downstream of the bridge (Figure 4).

Figure 4. Bed sediment deposit in the channel downstream of bridge

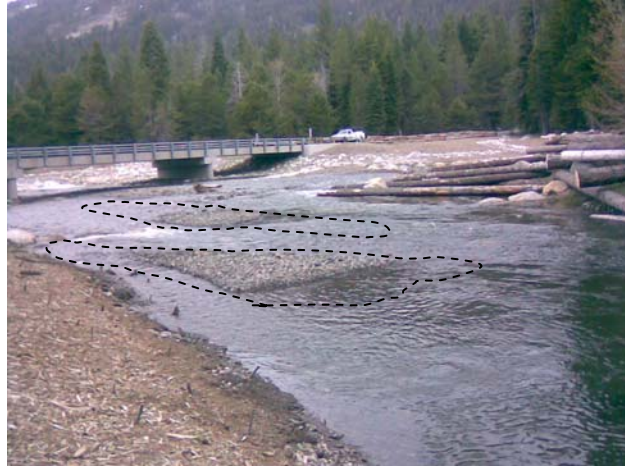
In 2008, spring flows continued to move that sediment downstream, sorting the sediment into a series of lateral bars downstream of the constructed channel (Figure 5). Wininging continued in the riffles upstream of the bridge; however, bed load sediment has also begun to invade the upper end of the constructed channel, similar to what is occurring at the fish ladder site.

Figure 5. Lateral bar formation downstream of bridge

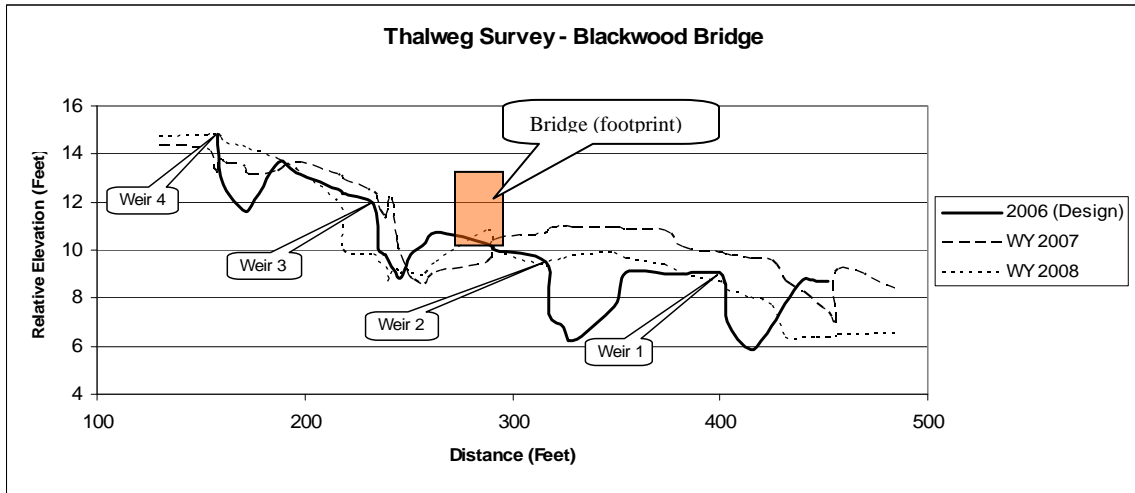
Figure 6. Thalweg profile of channel at Barker Pass Road crossing

A graph of the thalweg in Figure 6 above verifies photo point evidence and observations showing channel fill below the bridge, scour above, and lateral bar formation below the constructed channel.

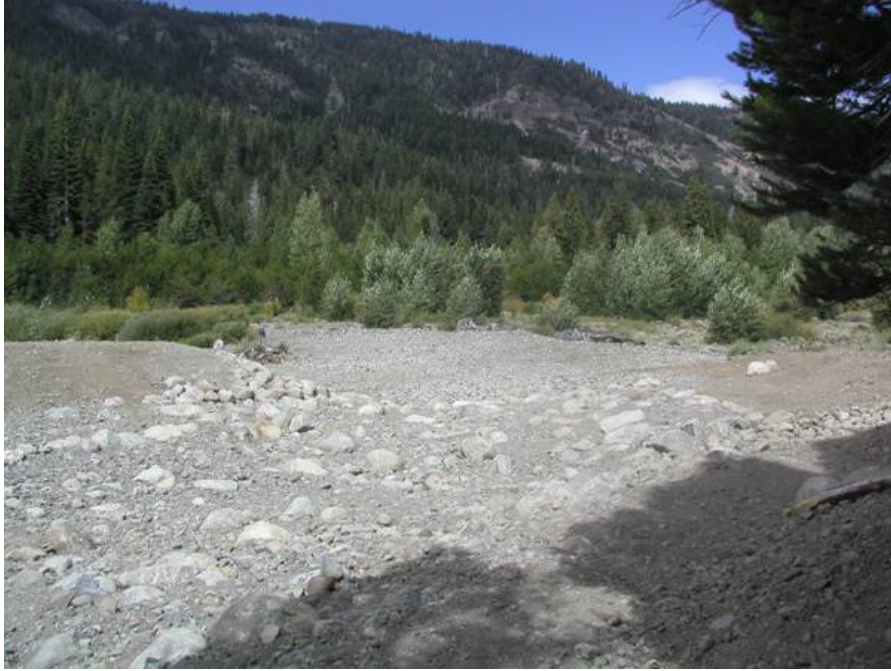
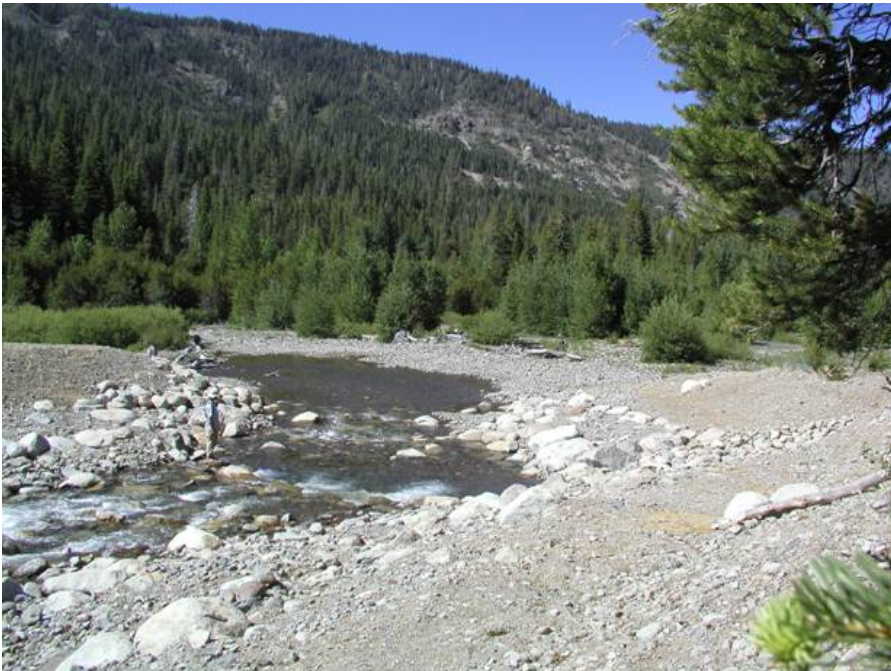
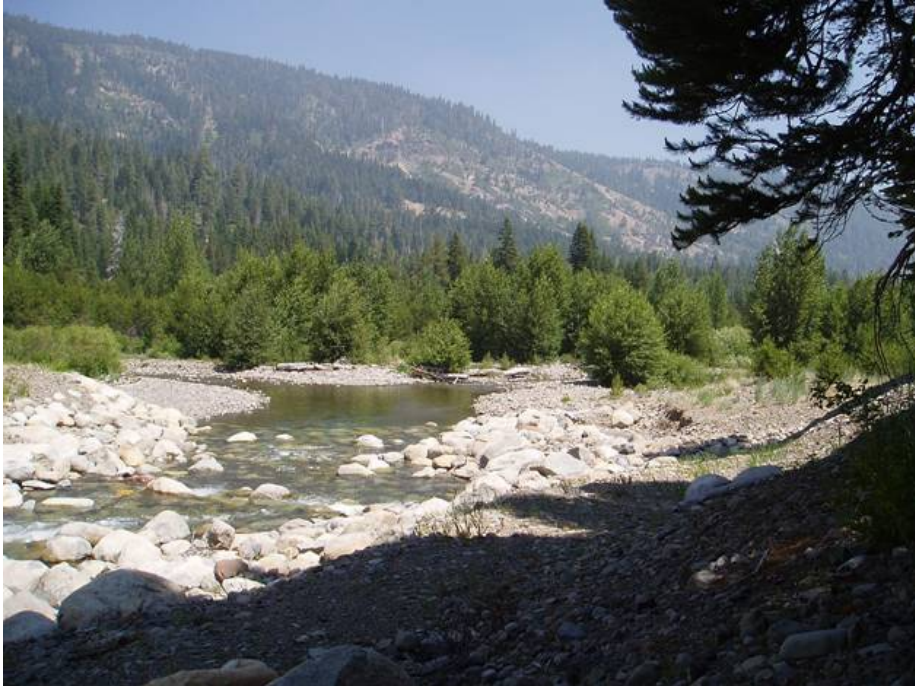
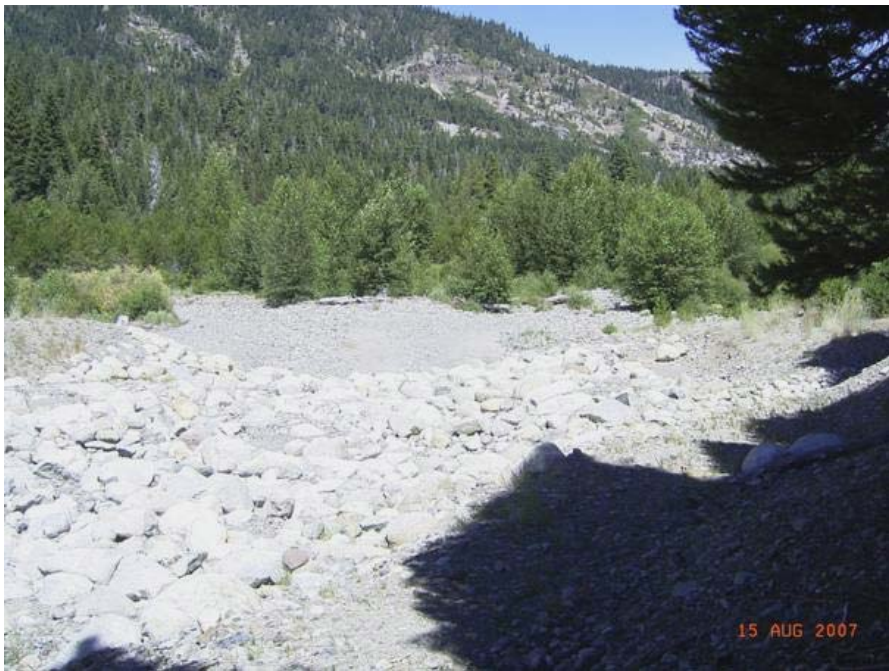
Photo Series at Photo Point #1. Photo taken on right bank looking down stream at grade control weirs #1 & #2. Compass Bearing (15° declination in the Tahoe Basin): 5°

As expected, flows in 2004 through 2008 washed out much of the finer fraction (2-305mm diameter) of channel substrate along the lower two-thirds of the fish ladder site, a process known as “winnowing.” Some of this finer substrate fraction is still present in the channel (located on the downstream end of large boulders) and was placed during construction; some of this finer substrate probably represents some incoming bed load sediment. However, photo evidence suggests that, since construction, this portion of the channel has experienced an increase in the median grain diameter overall, a process known as “coarsening.” The photo sequence from photo point #1 (2003-2007) in Appendix A, shows this coarsening occurring over time. In 2004, a minor downward shift (a drop of about one foot at the downstream end) in the thalweg profile elevation was observed. This shift represents settling at boulder weirs 1 and 2 following construction. Settling along the lower two-thirds of the constructed channel has not occurred since. Some minor erosion occurred along a 30-foot section of terrace above the right bank of the bank-full channel at the downstream end of the project. This erosion was a product of the December 2005 flood and no floodplain erosion has occurred since.

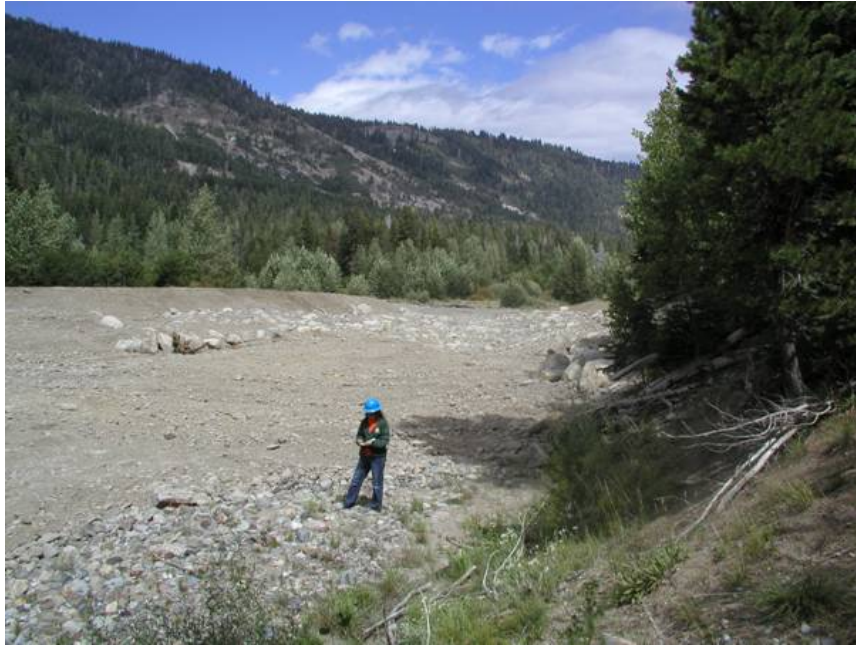
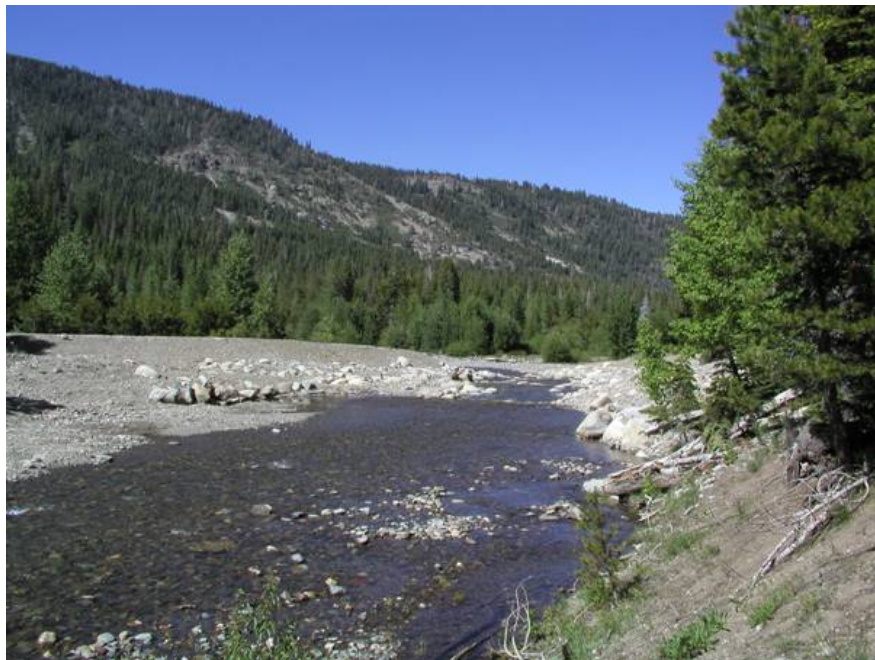
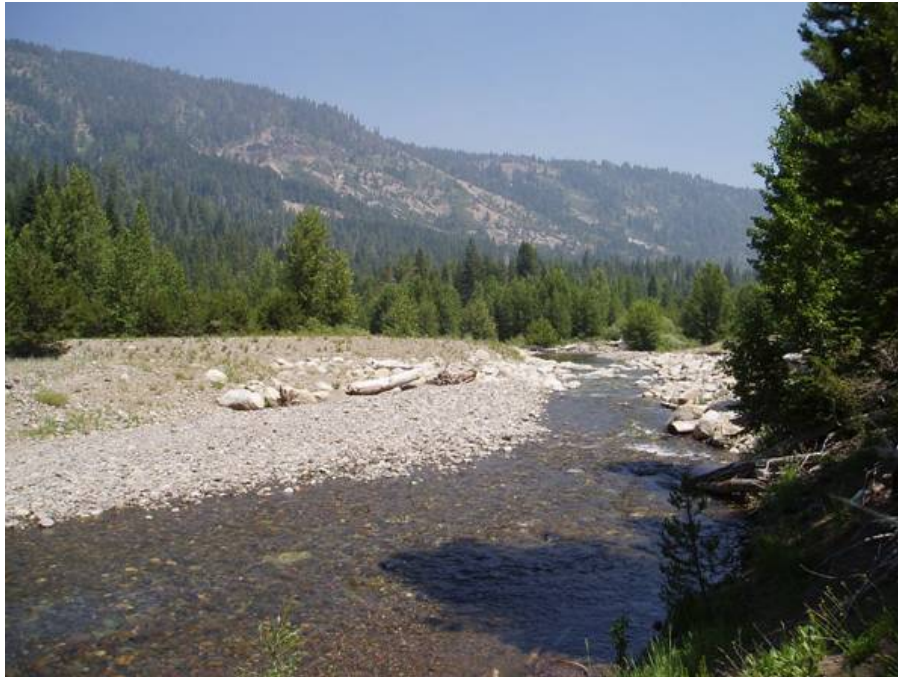
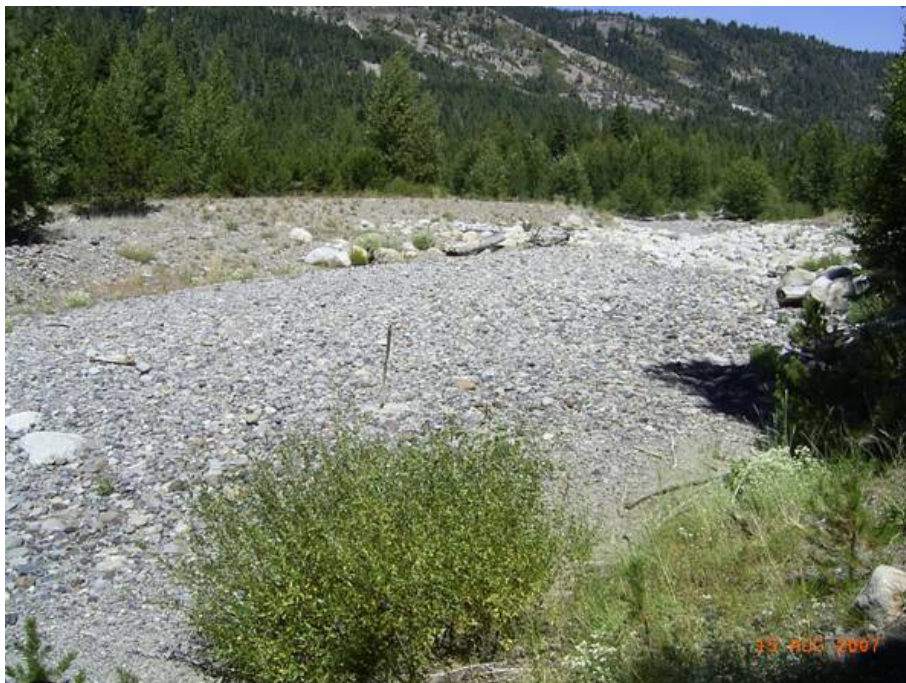
Photo Series at Photo Point #4. Photo taken on right bank looking downstream at grade control weirs #3 & #4. Compass Bearing (15⁰ declination in the Tahoe Basin): 29⁰

Along the upper 1/3 of constructed channel illustrated in photo point #4 (2003-2007) in Appendix A, some winnowing occurred early (2004 and 2005), followed by deposition of gravel-cobble size bed load invading from upstream (2006 through 2008). A lateral bar has formed upstream of weir 4 as the channel upstream of the project area aggrades. A slight increase in thalweg elevation occurred along weirs 3 & 4 and supports the observations of bed load invasion and deposition from sources upstream.

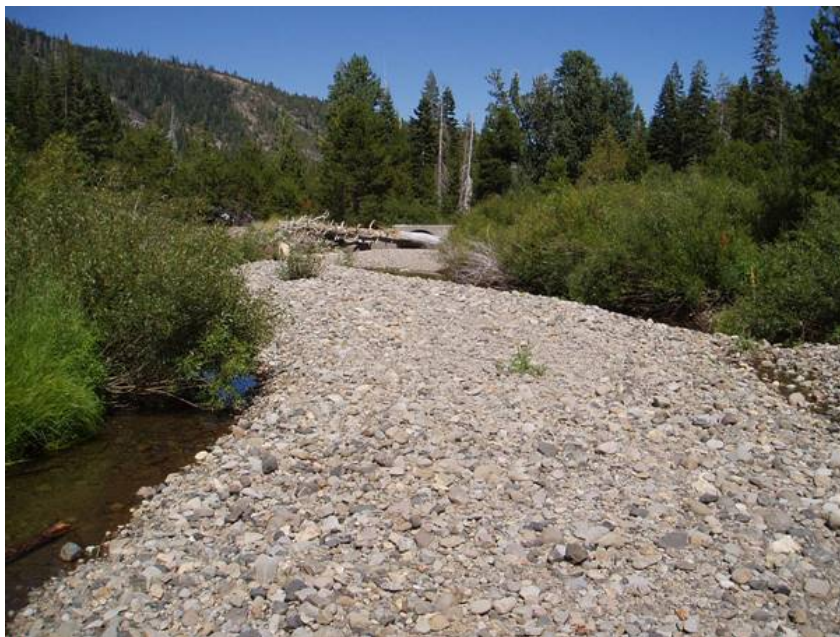
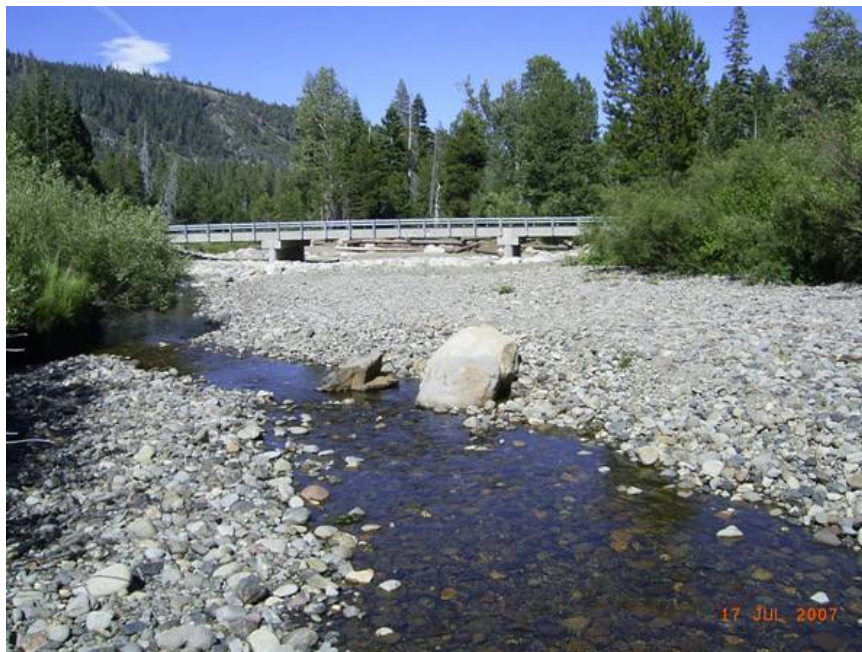
Photo Series at Photo Point #4. Photo taken in center of channel, atop a large immobile boulder (no monument), upstream of project. Compass Bearing (15° declination in the Tahoe Basin): 55°

Upstream of the constructed channel, photo point #3 (2007-2008) in Appendix A illustrates that the thalweg appears to be shifting laterally as it adjusts to the new conditions. These types of shifts will occur as the system begins to equilibrate.
