**Final Monitoring Report for
Marlette Creek Dam Removal and
Restoration Project,
Period of Record 2002 to 2008**

USDA Forest Service

Lake Tahoe Basin Management Unit

March 2009

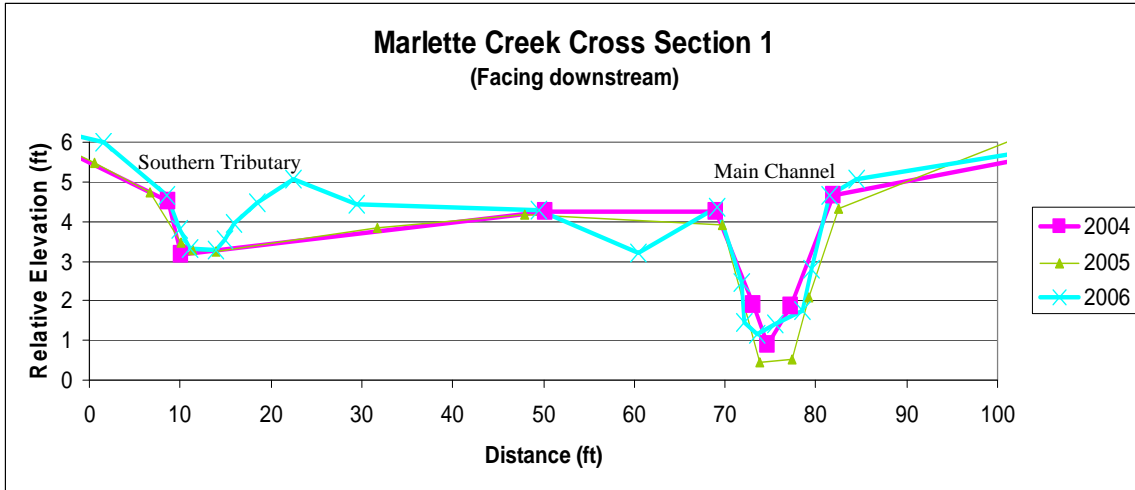
Figure D2. Marlette Creek Cross Section comparison graphs.

- Cross section #1- the floodplain and channel seem to have changed very little at this location since project implementation.
- Cross section #2 - main stem channel depth increased from 1.4 ’ to 5’ and width increased from 13’ to 29’.

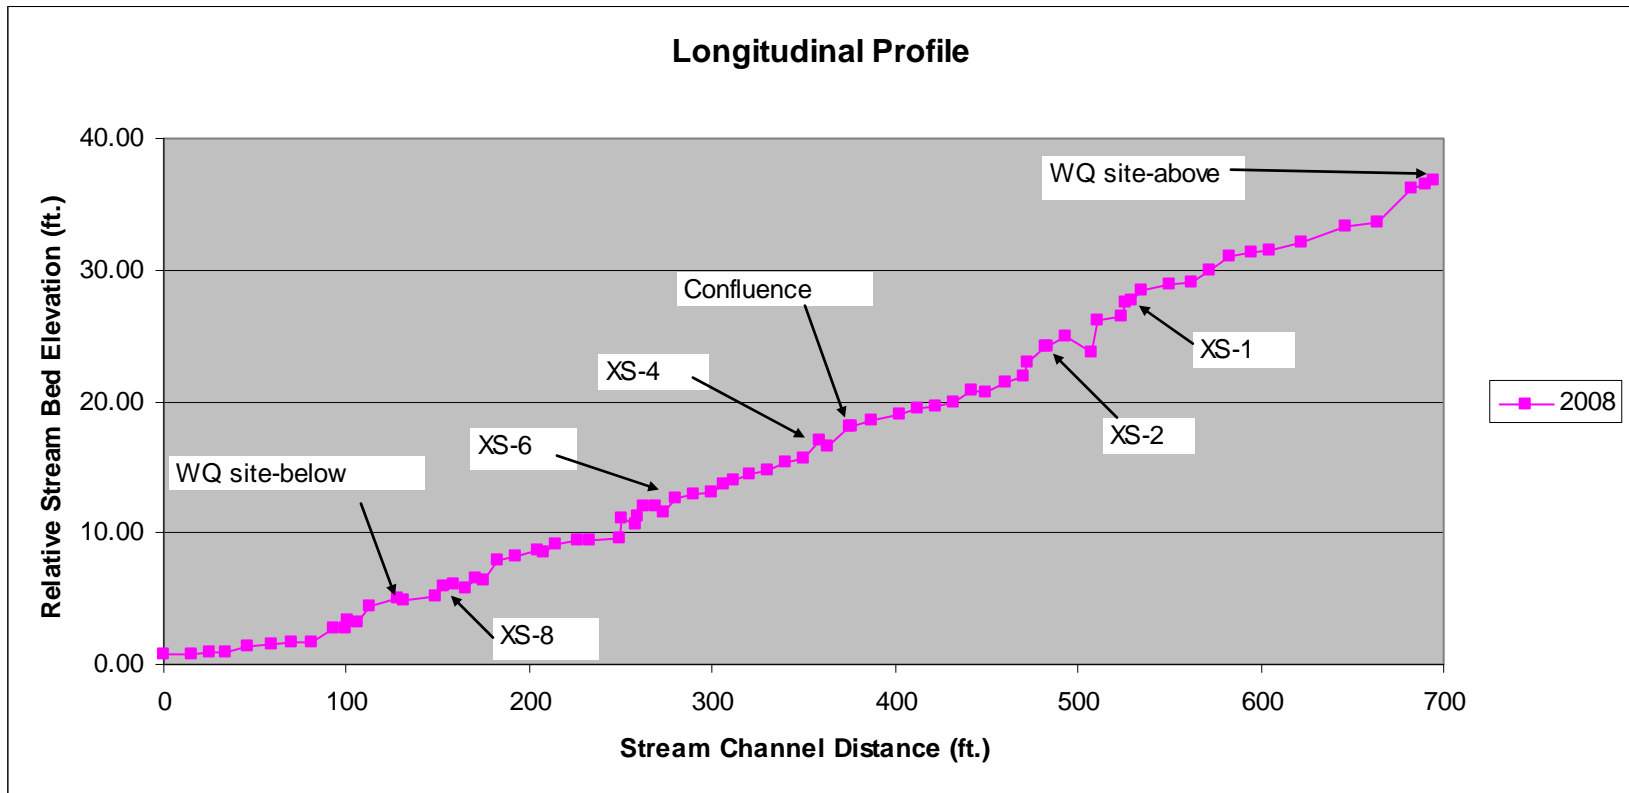
Figure D10. 2008 longitudinal profile.

In addition, a longitudinal profile was conducted along this reach of Marlette Creek in order to track channel bed changes after dam removal (Figure D10). Field observations since 2004 have identified multiple headcuts in the channel upstream of the confluence, which seem to be slowly migrating upstream. These were observed to still be present and had increased in affected channel length in 2005. A longitudinal profile was repeated in November 2008. However when this data was analyzed it was determined that no permanent and identifiable beginning and end markers were given in the 2004 survey, and the distance and elevation of the upper water quality monitoring station relative to the confluence between the two years of data were unaccountably different. Other critical reference points were also not given in the 2004 survey. For these reasons, the 2004 data was discarded. The accuracy of the 2008 survey was confirmed by the closure measurements and its starting point is easily identifiable. Therefore, when a longitudinal profile is repeated in the future, a meaningful comparison of the changes in the stream bed can be made at that time.

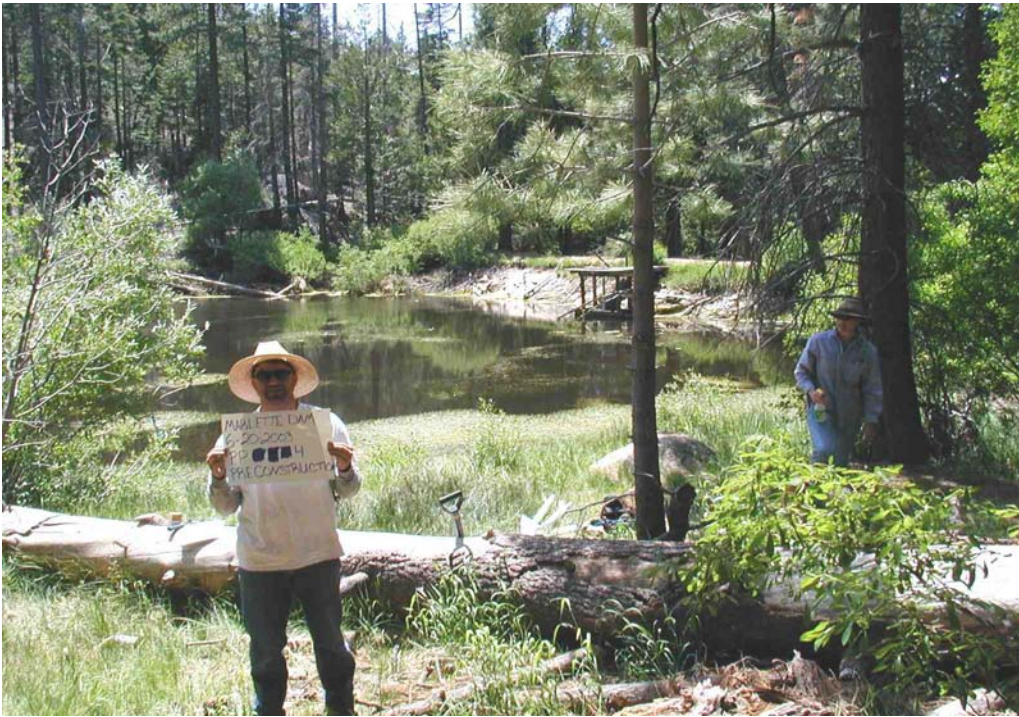
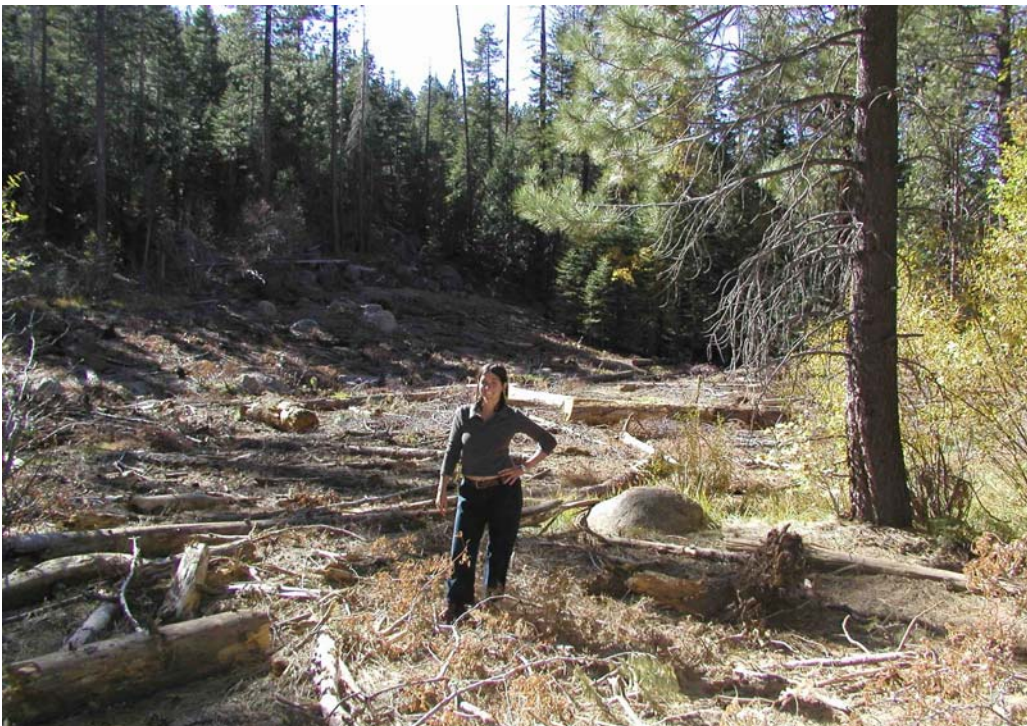
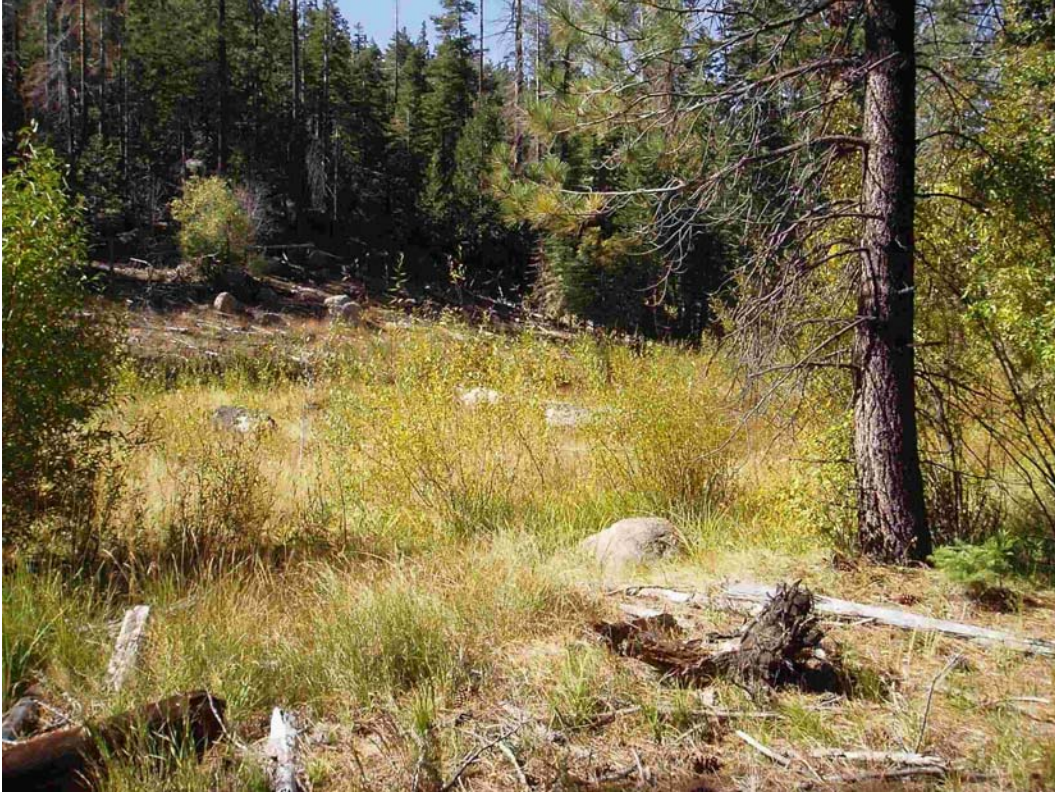
Photo #1. Reservoir prior to dam removal (June 2003) at pp4 (view to W - 270°).

Photo #2. Two months after project completion (Oct. 27, 2003) at pp4 (view to W - 270°).

Photo #3. Three years after project completion (Oct. 12, 2006) at pp4 (view to W - 270°).

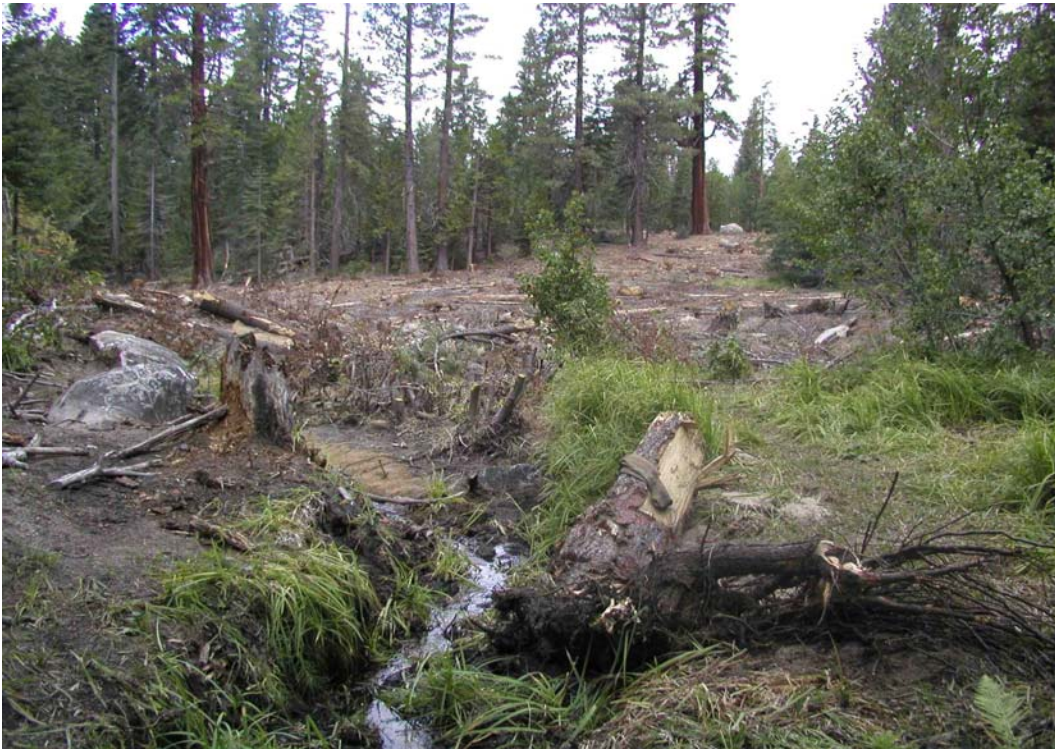
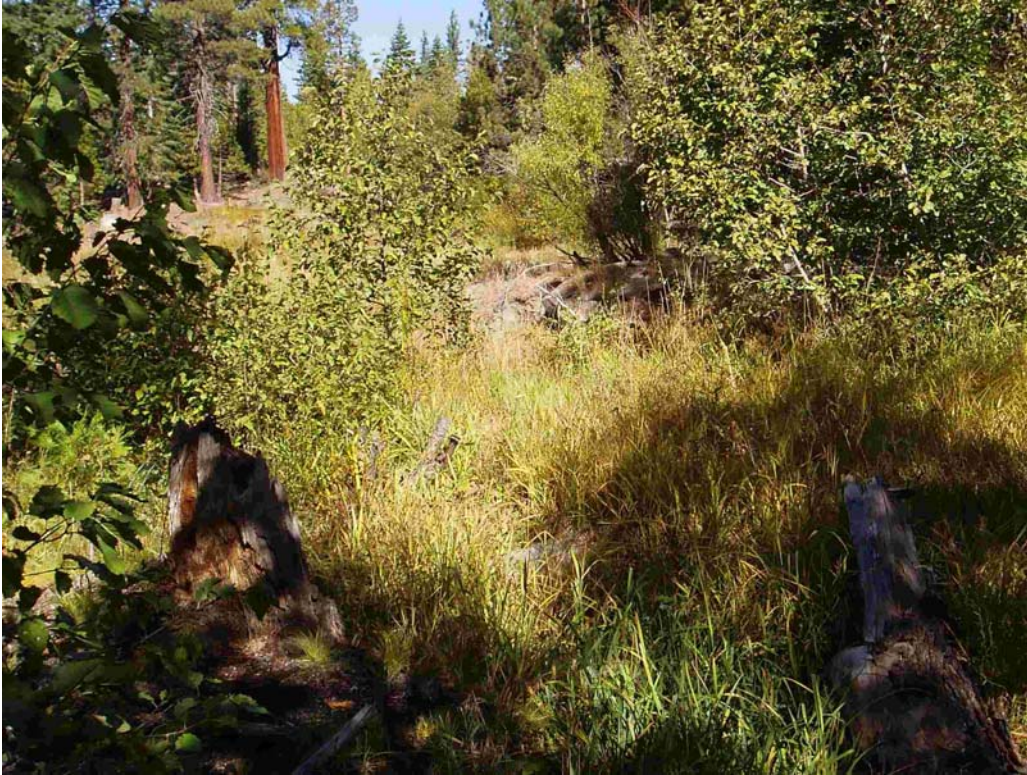
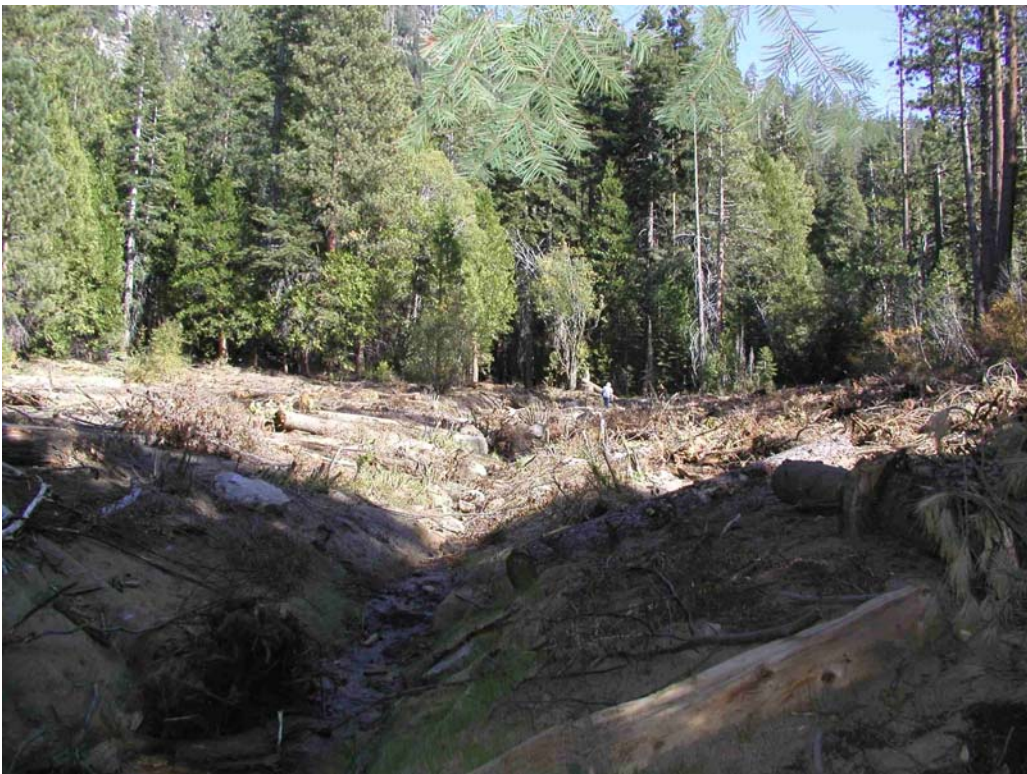
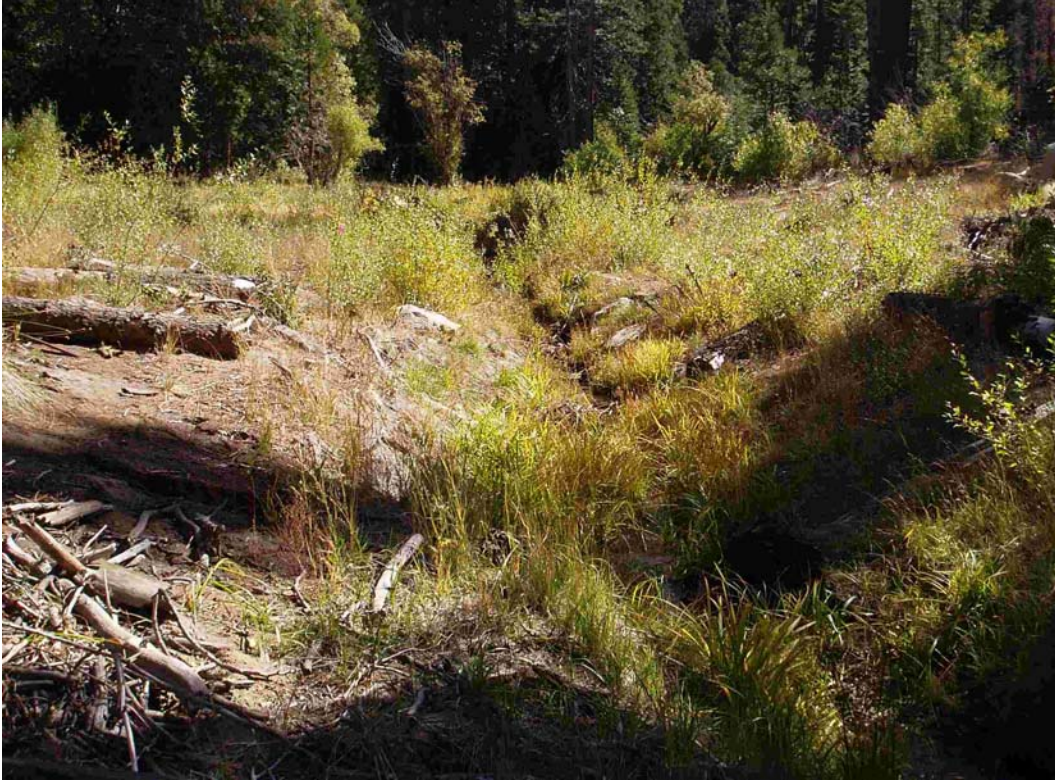
Photographic documentation was conducted at nine photo points before, during, and immediately after project implementation, and for two years after project completion (2004 and 2006). Additional photographs were taken to document problems and maintenance that occurred after implementation of the project. Photo point locations are shown in Figure D1 and photos are displayed in Appendix E. The pre-project view of the reservoir and dam are shown in Appendix E, Photo #1. Photos #2 and 3 show the same location two months and 3 years after project completion, respectively. Most of the photo points show vegetation establishment to be successful and improving (Appendix E, Photos #4 through #7).

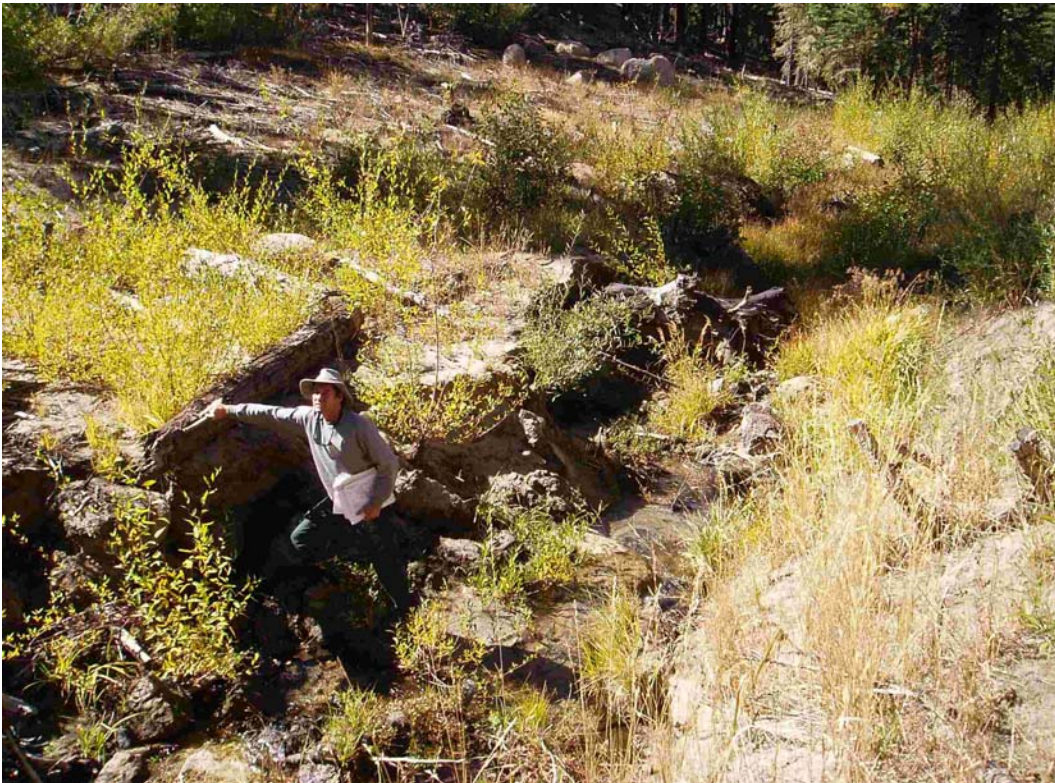
Photographs at locations other than the established photo points document significant erosion problems that have occurred. Photos from 2004 through 2006 show significant problems with bank erosion and scour (which often resulted in boulders falling into the stream), stream channel down-cutting (also evidenced in cross-section graphs), and under-cutting of the coconut matting which was placed to prevent erosion (Photos #8-10). Specifically, scour around several boulders has allowed them to topple into the stream (Photo #9) and cause bank failure and channel widening. Photo #8, near photo point 3, at the upper end of the former lake looking downstream shows erosion that occurred between August 2004 and October 2006.

Photo 8. Significant bank erosion has occurred at pp 3a, Oct. 12, 2006.

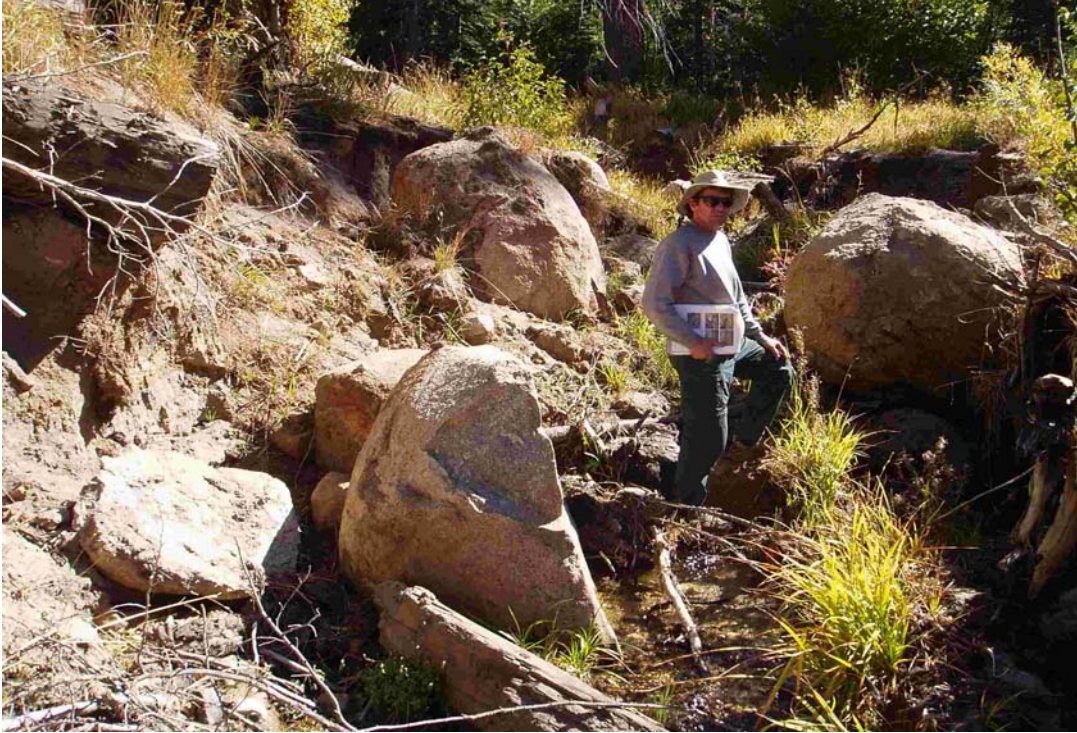
The boulders in this case were large, and were not keyed in with smaller rocks, so when they rolled into the creek they pulled stream bank material with them. The boulders settled into the channel, allowing the creek to erode sediment from around the sides of the boulders thereby contributing to an increase in lateral and vertical cutting. The boulders used for this project were also too large to create step-pool sequences in the channel, which would have contributed to overall stream stability.

Photo #9. Erosion around boulders has resulted in boulders toppling into stream, Oct. 12, 2006.

Structures (i.e. large boulders) placed in the stream banks for stabilization were installed without being underlain or keyed into position using smaller rock material. Course materials such as gravel, cobbles, and small boulders can provide support for larger rock material, and reduce the likelihood of dislodged boulders. Cobbles in the 8 to 11 inch category are also often self-leveling and can perpetuate grade over time. Structures that are “keyed in” are much more resistant to erosion and can be used to confine a creek both laterally and vertically within its banks. These structures can help to establish self-adjusting riffle/pool and cascade pool sequences. Large rocks placed on the bottom of

the creek should also have rock structures placed on the adjacent banks to keep the water from falling to either side or bypassing the structure entirely. Keying all structures into the floodplain or above the high water line discourages stream avulsion and stream bank erosion.

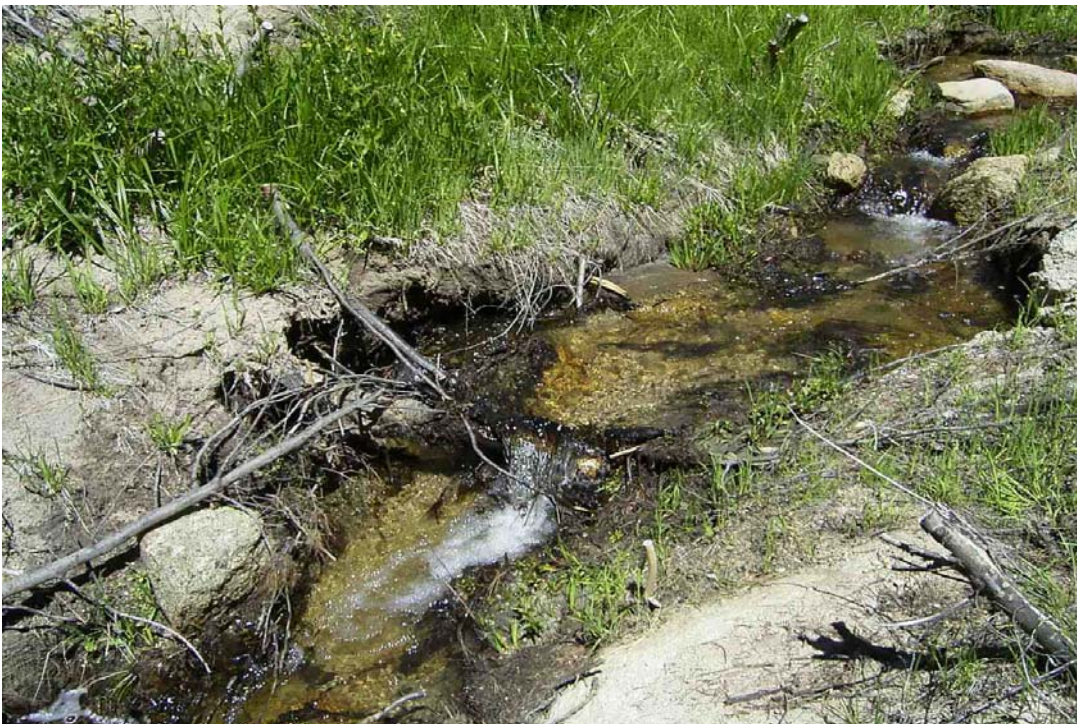
In July 2004, monitoring staff noted that the northern tributary to the South Fork of Marlette Creek within the project area, just upstream of the confluence, had begun undercutting the restored stream banks (Photo #10). In addition, down-cutting of approximately 6 to 18 inches in the channel bed substrate was observed at this location. In response to these observations, the Restoration Field Crew re-contoured the stream banks and hillsides, planted sod, and installed coconut matting for erosion control later that year (2004). In 2005, streambank erosion continued and the headcuts progressed upstream. Headcuts upstream of the project area were observed during field visits; however, these appear to be historic and have not been influenced by this project. In January 2006, an interim report was completed to evaluate the success of these additional attempts to stabilize the channel. The interim report concluded that the relatively steep grade and loose, unconsolidated substrate made the restoration construction designs inappropriate for this site, resulting in considerable streambank erosion and down-cutting as the stream adjusted to its new conditions (Valentine and O'Connell, 2006).

Photo #10. Headcuts developing upstream of reservoir site and above confluence. June 14, 2005.
