USDA Forest Service

Aviation Safety Summary August 2002

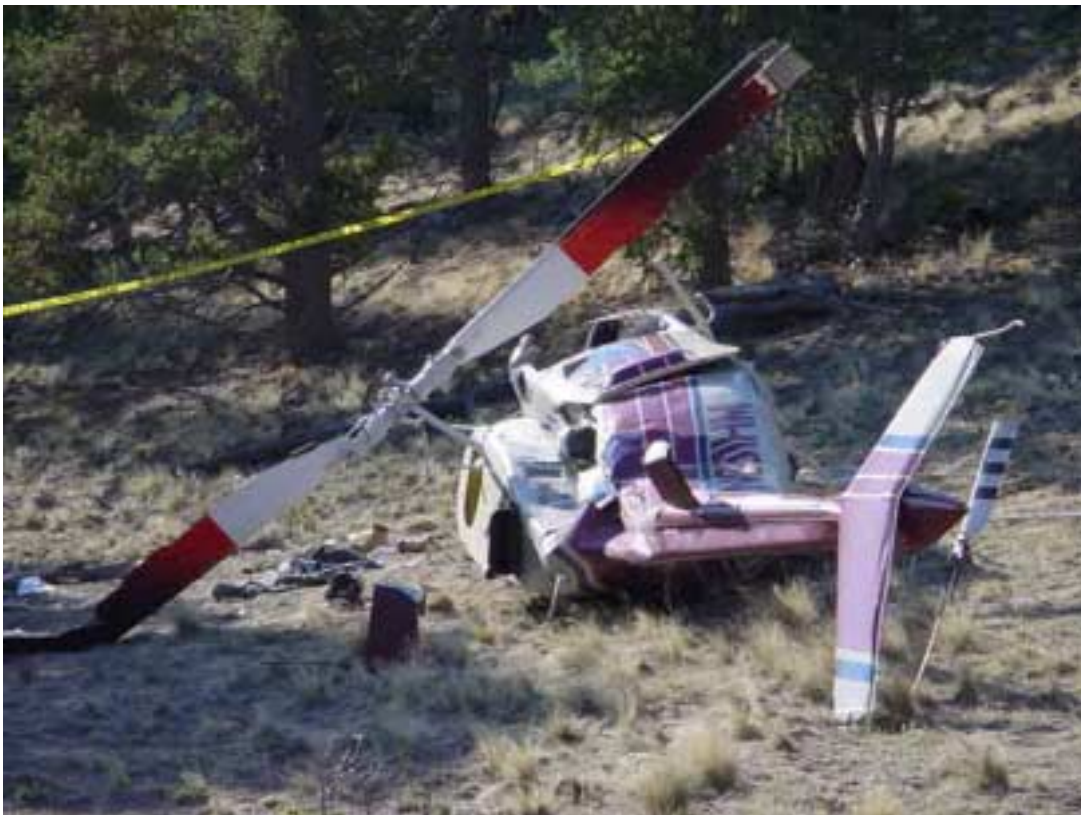
Region 2, Rio-Grande NF, Trickle Mountain Fire
Mission: Water Dropping Bucket Operations

Witnesses reported the helicopter was approaching to land in gusty wind conditions when it started spinning to the right. It collided with trees, struck the ground, and rolled over.

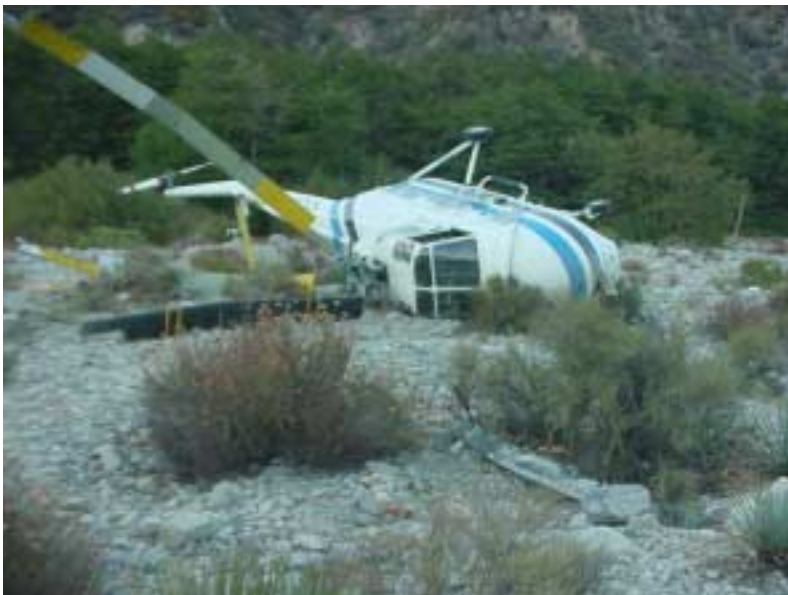
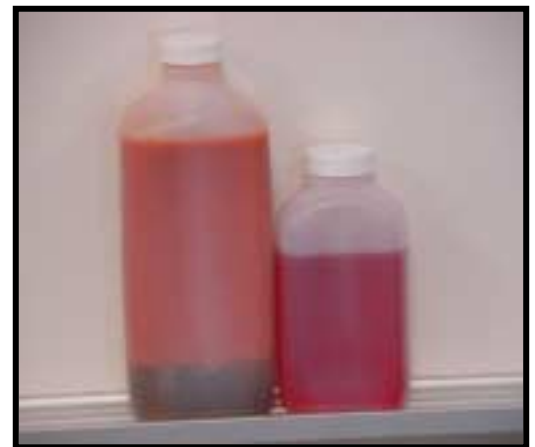
Region 5, San Bernardino NF, Lytle Fire
Mission: Water Dropping Bucket Operations

The operator reported that the pilot stated that a hydraulic warning light illuminated and the flight controls became stiff. The pilot began an approach to an open area. About 10 feet above the ground, the cyclic flight control moved "hard over" and the pilot was unable to regain control before the rotors made contact with a rocky shelf.

Post crash examination of the wreckage by the Forest Service investigation team did not reveal evidence of ruptured hydraulic lines. They took a sample of hydraulic fluid from the reservoir and stated that it appeared to be severely contaminated. The fluid will be sent to a laboratory for testing.

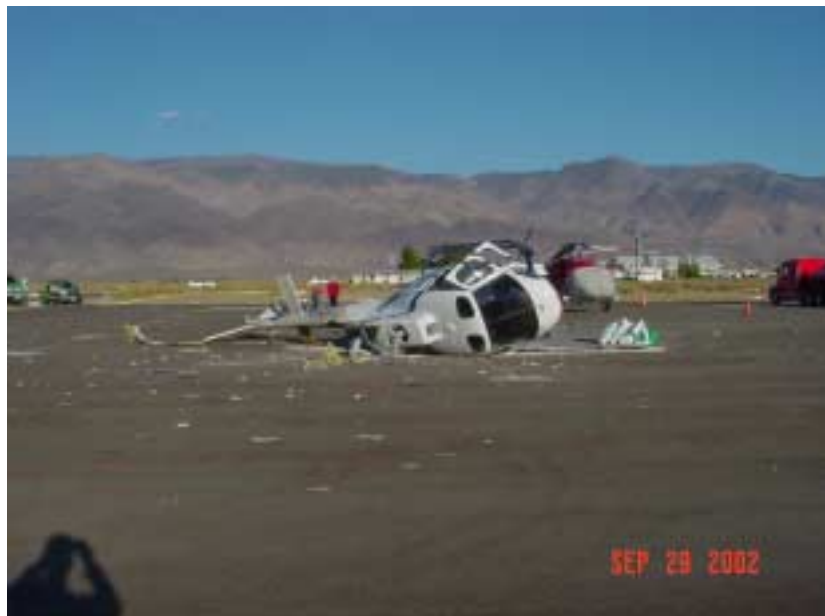
Region 5, Inyo NF, Paiute Fire
Mission: Aircraft Released, Flight was to Home Base

Forest Service officials reported that the helicopter was engaged in a hydraulic actuator check for the first flight of the day. The collective had been placed in the down and locked position and the rotor powered up to 100 percent flight idle. After depressing the hydraulic test switch, the pilot moved the cyclic fore and aft (pumped) to confirm there was remaining pressure for a few control movements. The collective rose uncommanded and the helicopter moved forward in a nose down attitude. The main rotor struck the ground and the helicopter made two revolutions before rolling over onto its side, destroying both the main and tail rotor systems. A small fire ensued in the exhaust area, but was quickly extinguished.

A postcrash examination was conducted, which revealed a deteriorated condition in the collective's locking mechanism. The stud was worn and the collective would come loose during movement of the cyclic. The Forest Service investigators also found this condition on another of their helicopters of the same type.

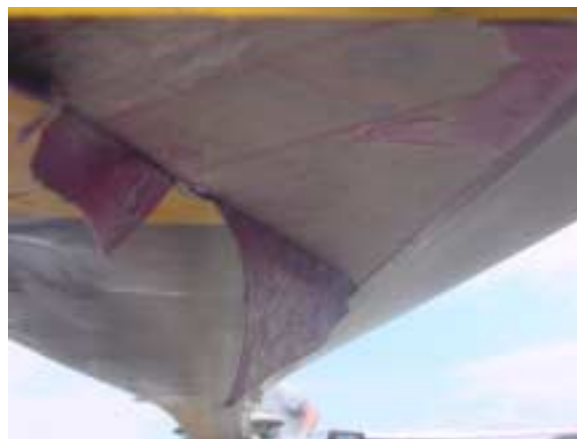
Subject: Bell 407 Main Rotor Blade Airworthiness

Discussion: On July 16, 2002 a Bell 407 helicopter was on short final to a helibase in Arizona when the pilot experienced a slight yaw to the left, shaking of the cyclic, and a vibration in the helicopter. The pilot chose to take the aircraft to an open flat field approximately ¼ of a mile away to avoid possible injury to personnel on the ground at the helibase. After the helicopter was shut down the aircraft was inspected and it was discovered that the skin on the underside of one of the main rotor blades had de-bonded and separated from the blade tip extending inboard approximately 8 ½ inches. The skin tore away from the blade along a line at the aft lower edge of the leading edge abrasion strip and de-bonded aft approximately four inches. The occurrence is currently under investigation to try to determine the cause of the failure.

The USDA Forest Service is asking all contractors to assure airworthiness of all Bell BHT 407 Main Rotor Blades. This assurance is required prior to further flight after receipt of this safety alert. Regional Aviation Maintenance Inspectors in the Forest Service Regions will be notified as to the status of all contracted (exclusive use or all when needed) Bell BHT 407 helicopters.

If any abnormalities are noted or suspected the aircraft is not to be flown and the operator needs to notify a Forest Service Maintenance Inspector immediately.
