Executive Summary

Fiscal Year 2001 Accidents

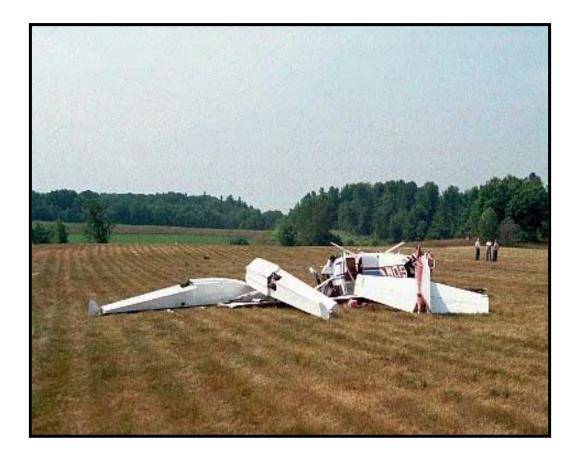
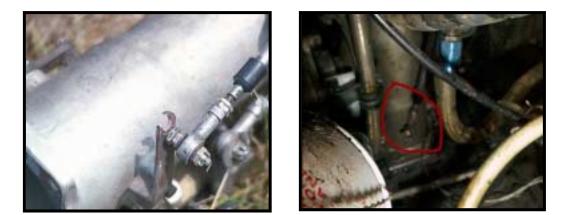
Region 9, Huron-Manistee NF Mission: Reconnaissance

On July 20, 2001, at 1515 eastern daylight time, a Cessna U206G amphibian, N756DM, operated by Scenic Seaplanes, Incorporated and piloted by a commercial pilot, sustained substantial damage when it nosed over in a field 5 miles east of Freemont, Michigan, during an emergency landing. Prior to the accident, the airplane's engine lost partial power during cruise flight. Visual meteorological conditions prevailed at the time of the accident. The aerial observation flight was contracted by the United States Forest Service to perform fire patrol under the provisions of 14 CFR Part 135. A company VFR flight plan was on file. The pilot and passenger, a pilot-rated aerial observer, on board the airplane reported minor injuries. The local flight originated at Cadillac, Michigan, at 1400.

In his written statement, the pilot said they were proceeding east at approximately 2,500 feet mean sea level when he noticed the manifold pressure had dropped to approximately 30 inches of Mercury (Hg). The pilot said he moved the throttle in and out several times but the power did not change. The pilot said he executed a 180-degree turn toward the Freemont Airport. On completion of the turn, the pilot noticed the manifold pressure had dropped to 15 inches Hg. The pilot looked for a place to land. He said there was nothing in front of them but trees. The pilot then noticed a farm field beneath and to the left of him. He said he decided to put the airplane down in the field. The pilot said he left the wheels and the flaps up because he was "low, slow, and short". He said the farm field was a short one. The pilot said he tried to flare. They hit the ground hard. The pilot said he did not recall the airplane going over its nose and coming to rest on its back.

A Federal Aviation Administration inspector examined the airplane at the accident site. The airplane was found resting inverted in a corn stubble field. The left float and legs were bent to the right and resting against the right float. The landing wheels in the floats were in the "up" position. The engine mounts were twisted 35 degrees to the left. The cowling and forward fuselage was crushed aft and twisted left. One of the three propeller blades was bent aft. The other two blades were bent forward. The aft fuselage was bent and buckled. The empennage was broken off. Both wings showed numerous bends and buckles. Flight control continuity was confirmed. An examination of the engine showed the throttle cable broken at the linkage to the throttle box lever arm. No other anomalies were found with the airplane.

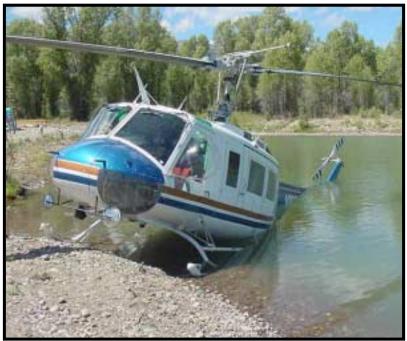
Region 4, Bridger-Teton NF Mission: Water bucket operations

NTSB Identification: : **DEN01TA134A and DEN01TA134B** Accident occurred Tuesday, July 31, 2001 at JACKSON, WY Aircraft: Bell 212, registration: N911VR Aircraft: Bell 205A-1, registration: N205BR Injuries: 2 Uninjured.

On July 31, 2001, at 1347 mountain daylight time, a Bell 205A-1 helicopter, N205BR, sustained substantial damage when the water bucket of a Bell 212 helicopter, N911VR, contacted its main rotor system near Jackson, Wyoming. The Bell 205A-1 helicopter was registered to Idaho Helicopters, Inc., of Boise, Idaho, and the Bell 212 helicopter was registered to Rogers Helicopters, Inc., of Fresno, California. Both helicopters were being operated by the U.S. Forest Service as public use fire fighting flights. The airline transport pilot of the Bell 205A-1 and the airline transport pilot of the Bell 205A-1 and the airline transport pilot of the Bell 205A-1 and a flight plan was not filed for the Bell 212. Both flights originated from Wilson, Wyoming.

According to preliminary information, the Bell 205A-1 helicopter was at an out-of-ground effect hover over a pond near the Snake River using a long line and bucket to pick up water during fire fighting operations. While the Bell 212 helicopter was operating in close proximity, its long line and bucket got tangled in the Bell 205A-1's main rotor system. The pilot of the Bell 205A-1 performed a vertical autorotation to the water, coming to rest with the tail section and part of the fuselage in the pond. The Bell 212 was not damaged.

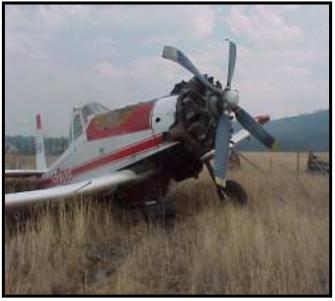
NTSB Identification: **SEA01TA152**. Accident occurred Thursday, August 16, 2001 at Ukiah, OR Aircraft: WSK PZL Mielec M-18 Dromader, registration: N52768 Injuries: 1 Minor.

On August 16, 2001, approximately 1125 Pacific daylight time, a WSK PZL Mielec M-18 Dromader, N52768, registered to Western Pilot Service, and operated by the USDA Forest Service, as a local public use firefighting operation, collided with a fence during landing at a private airstrip located about four miles southeast of Ukiah, Oregon. Visual meteorological conditions prevailed at the time and company visual flight rules flight- following was in effect. The aircraft was substantially damaged and the commercial pilot, the sole occupant, received minor injuries.

The pilot reported that there were no mechanical failures or malfunctions with the aircraft at the time of the accident.

The black top runway is 5,000 feet in length and 100 feet wide with a rise in the center. The pilot reported that the wind was variable at about 5 mph at the time.

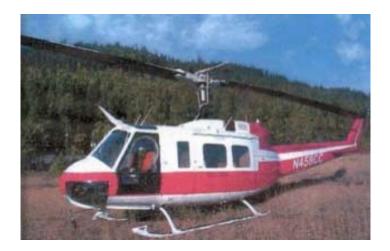
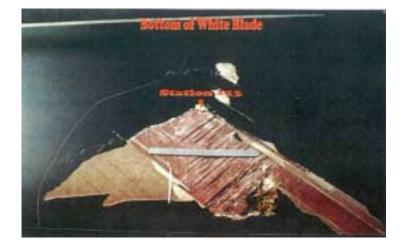
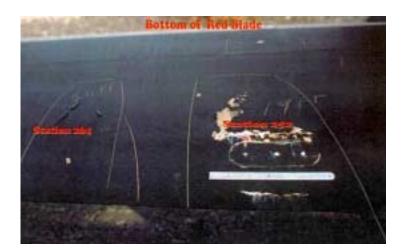
Region 1, Kootenai NF Mission: Water Bucket Operations

NTSB Identification: **SEA01TA172** Accident occurred Monday, September 17, 2001 at Troy, MT Aircraft: Bell 205, registration: N458CC Injuries: 1 Uninjured.

On September 17, 2001, about 1600 mountain daylight time, a Bell 205 helicopter, N458CC, sustained substantial damage following a main rotor blade strike while conducting firefighting operations near Libby, Montana. The helicopter is registered to Billings Flying Service, Billings, Montana, and was being operated by the United States Forest Service (USFS) as a public use aircraft. The commercial pilot, the sole occupant of the helicopter, was not injured. Visual meteorological conditions prevailed, and USFS VFR flight following procedures were in effect.

In a written statement dated September 26, 2001, the pilot reported that he was maneuvering near a shoreline in an effort to get a full bucket of water. "I made 40-50 bucket drops on the fire and flew out my fuel cycle before breaking off from the fire and returned to Troy Airport. On the return flight to Troy airport, I noticed a vertical vibration at approximately 90 knots (forward airspeed)." He continued to Troy airport at a slower speed to avoid the vibration. After landing without incident, the pilot noted damage to the helicopter's main rotor blades. He also noted that pine needles had been ingested into the aircraft's induction system. The pilot did not recall coming into contact with anything during the flight.

Post accident examination of the helicopter, by a certified mechanic, revealed that both main rotor blades sustained substantial damage.

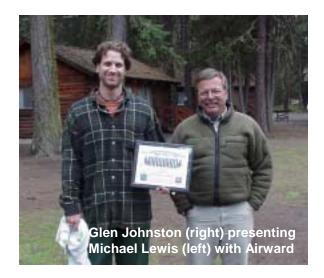
Michael and Steve's Interception Saves the Game

Following a routine flight in their contract Bell 407, vibrations were noted after touchdown, requiring an inspection by the mechanic. The inspection revealed significant damage to the tail rotor gearbox assembly at the attachment point with the Michael Lewis, helicopter manager, tailboom. captured the damage with a prompt SafeCom, notified the Forest Aviation Manager and dispatcher, and initiated procedures to correct the damage. After notification. Steve Tome. Regional HOS, recognized the significance of the defect, particular aircraft since that has had an directive for airworthiness issued tail rotor problems. Here comes the play of the game.

Believing this could be related to other aircraft, Steve and Michael removed the aircraft from service until a more thorough investigation could be made. They completed a report with photographs for review by the Washington office, which had received a report of similar problems with another aircraft recently. This resulted in Bell Helicopters issuing a safety alert for inspections of the Bell 407 tail rotor system. Their thorough follow-up of a "one time" incident may prevent a more serious failure for another crew in the future. Thanks for the play that saved the game Michael and Steve!
