# Guidelines for Detection, Analysis, and Treatment of Materials-Related Distress in Concrete Pavements Volume 3: Case Studies Using the Guidelines

PUBLICATION NO. FHWA-RD-01-165

AUGUST 2002

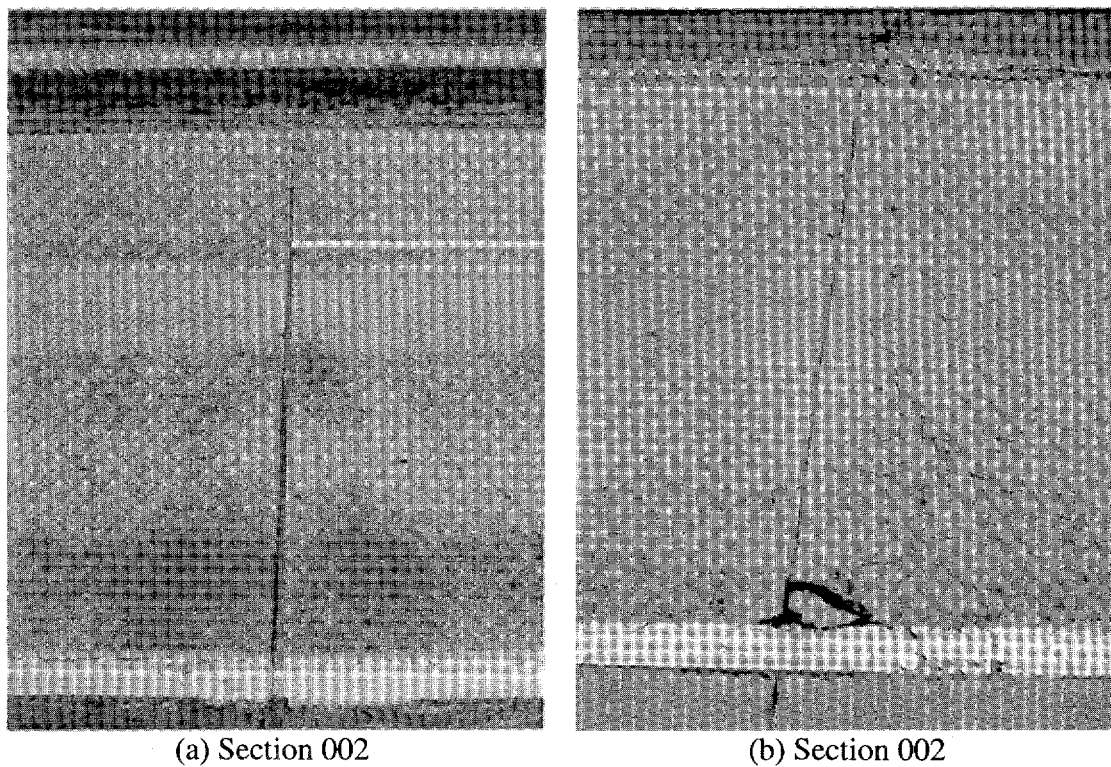
Figure 3-2. Typical distress manifestation observed on SD-090-019-002.

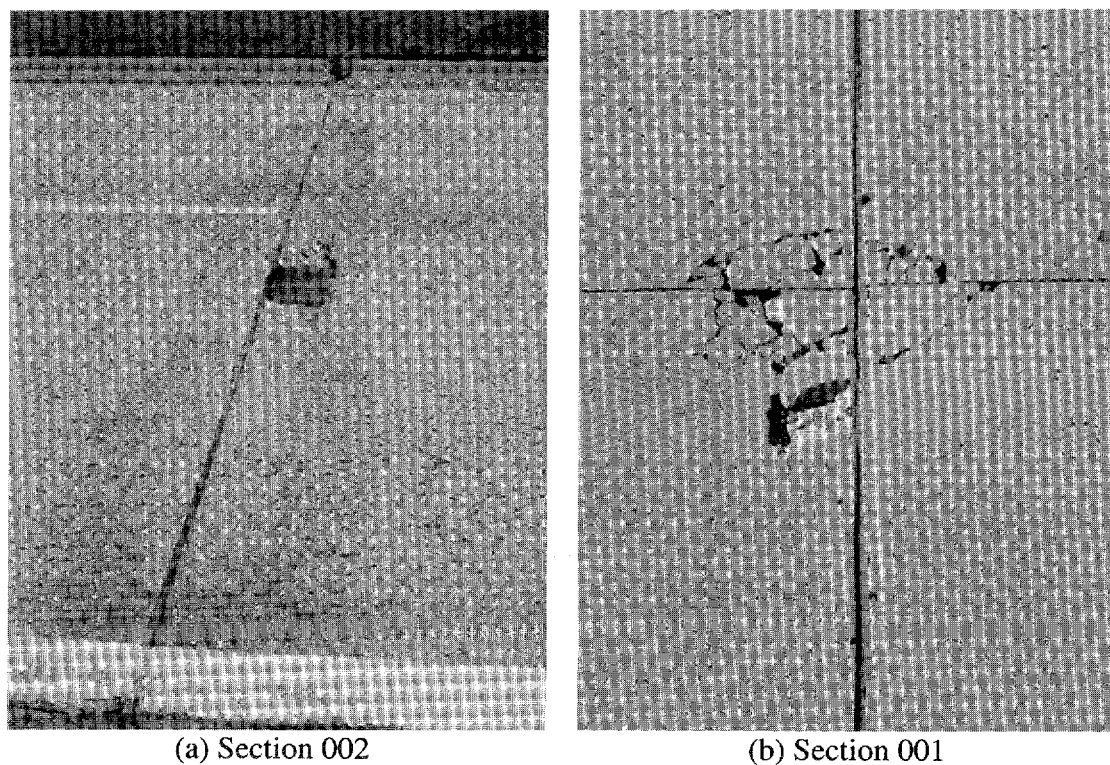
Figure 3-3. Typical distress manifestation observed on SD-090-019, Sections 1 and 2.

On Section 001, the area around the joints is discolored, showing a brownish-gray staining. However, the cracking pattern around the joints is similar to the slab interior. The MRD has progressed at a few of the slab corners and spalling has occurred. There is no exudate from the cracks on this section.

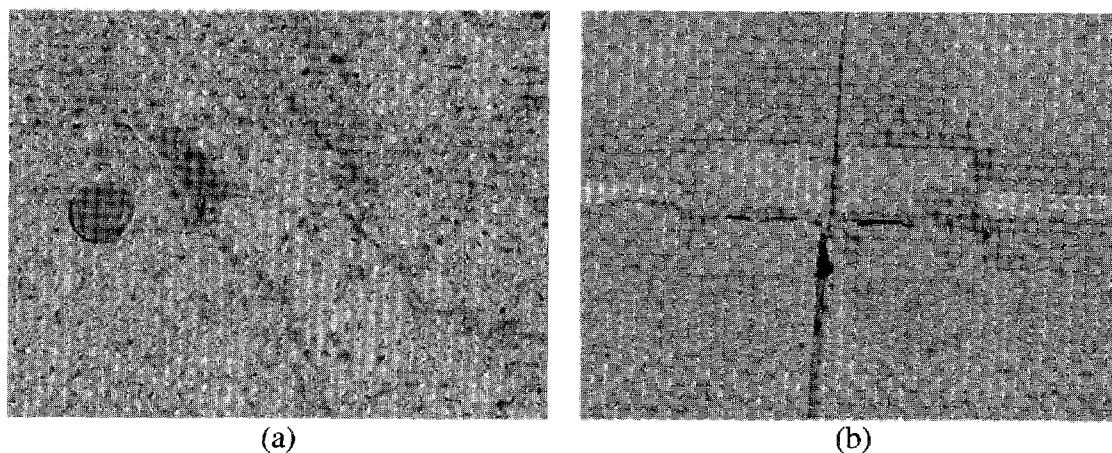
Figure 3-4. Typical distress manifestation observed on SD-090-019-002.

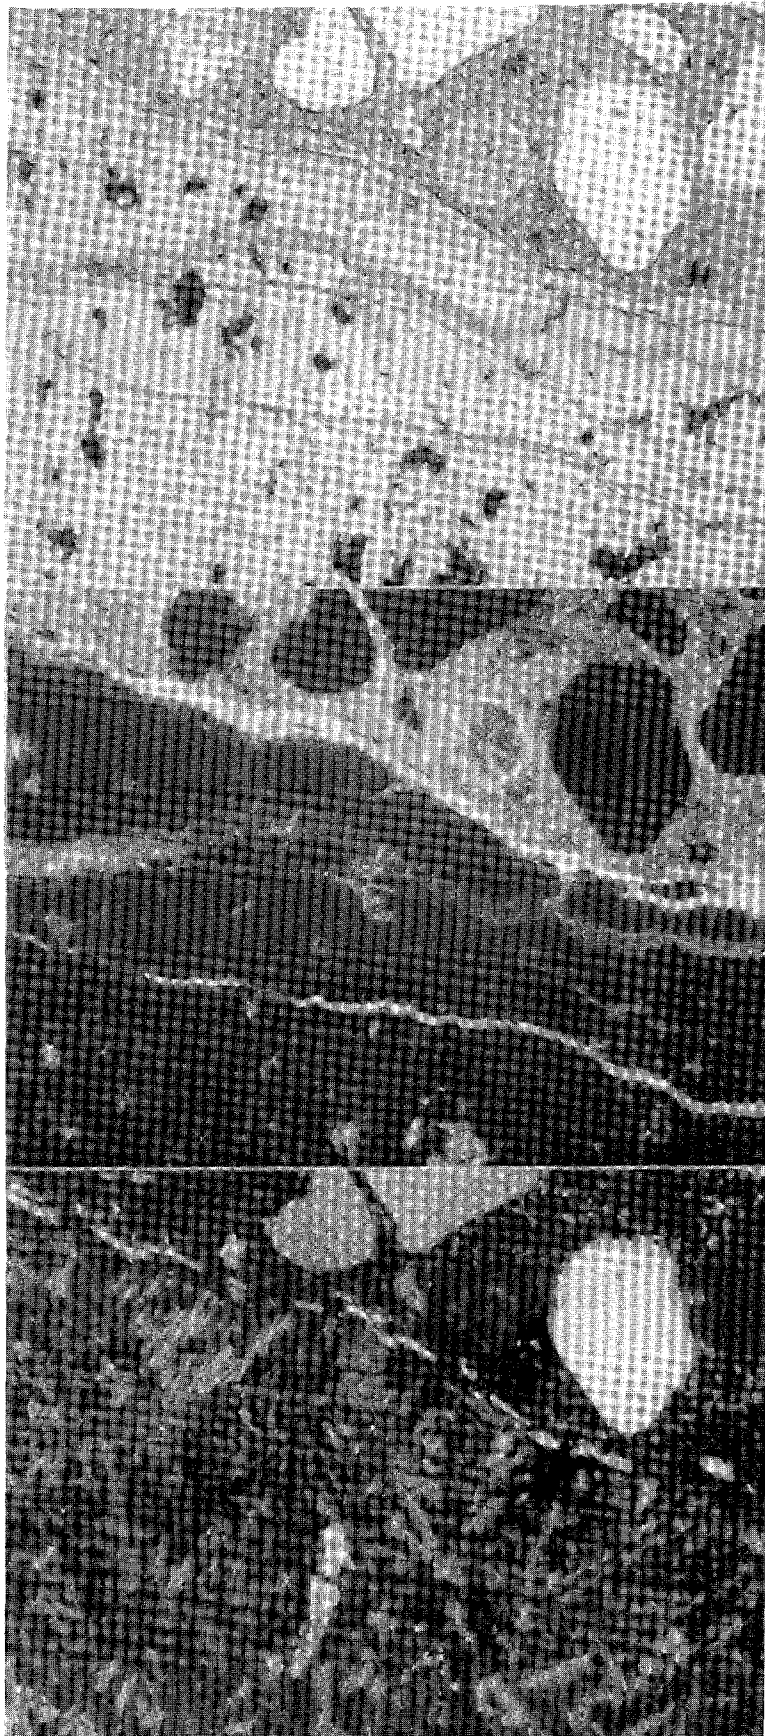
Figure 3-12. Core SD-090-019-001B, thin-section micrographs of same rhyolite aggregate that was stained with sodium cobaltinitrite ASR stain as shown in figure 3-9 (b). From top to bottom: transmitted plane polarized light, epifluorescent mode, and transmitted cross polarized light. Ettringite can be seen filling the entrained air void, ASR gel can be seen in the crack within the aggregate, and hydrocalumite can be seen in the crack along the contact between the aggregate and the cement paste. This same area was analyzed with the SEM to collect quantitative chemical information about the gel, ettringite, and hydrocalumite.

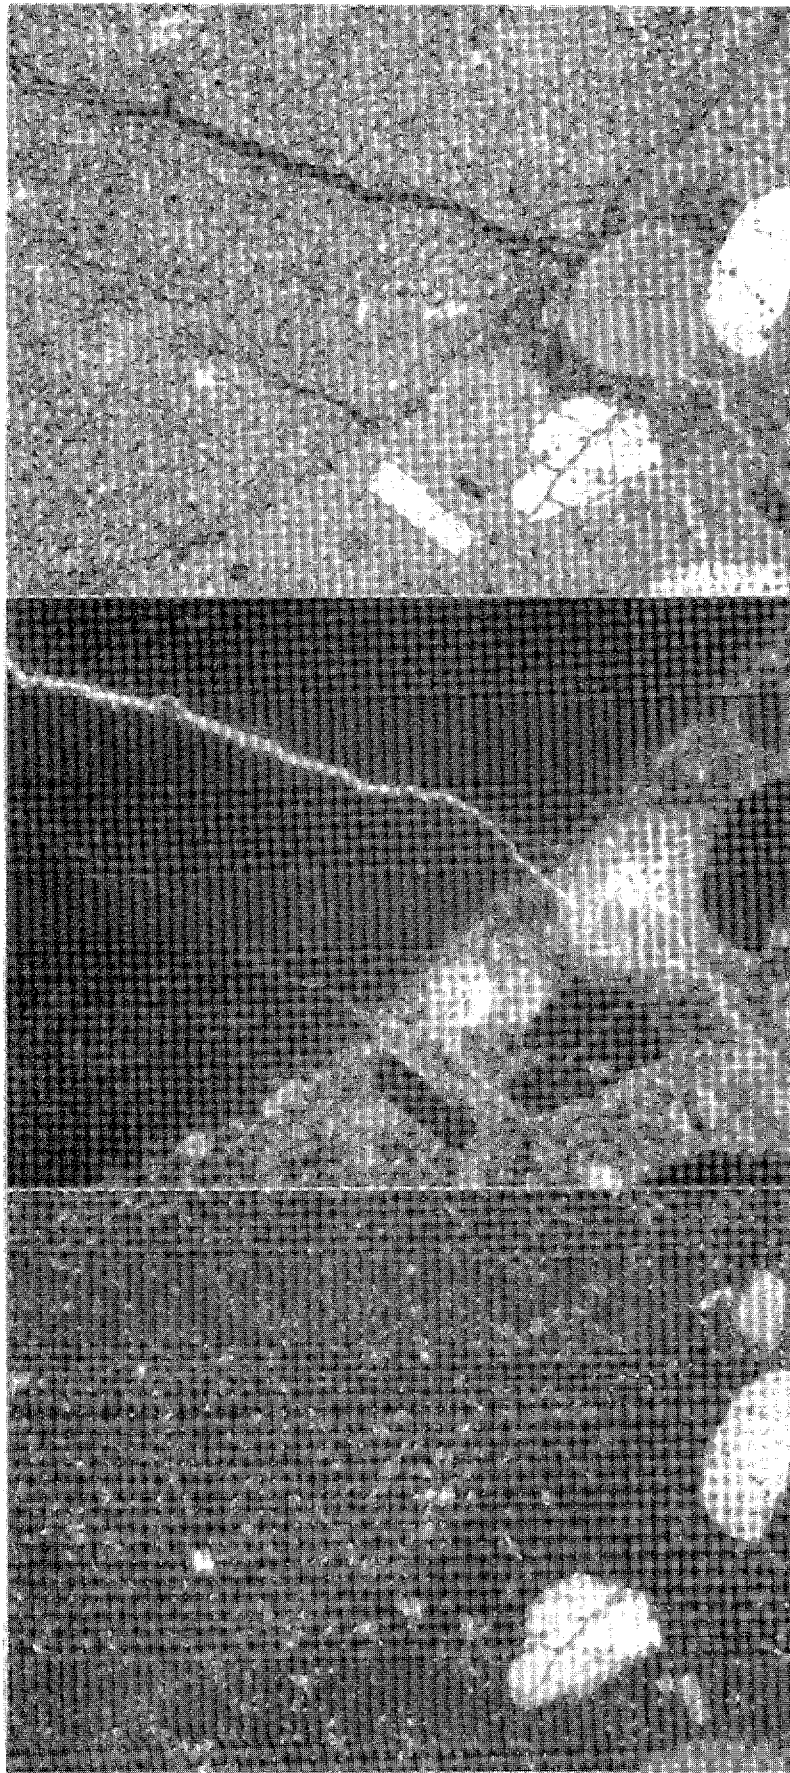
Figure 3-13. Core SD-090-019-001B, thin-section micrographs of same volcanic aggregate that was stained with sodium cobaltinitrite ASR stain as shown in figure 3-8 (c). From top to bottom: transmitted plane polarized light, epifluorescent mode, and transmitted cross polarized light. Ettringite can be seen filling the entrained air void, ASR gel can be seen in the crack within the aggregate, and hydrocalumite can be seen in the small entrained air void in the lower right hand corner. This same area was analyzed with the SEM to collect quantitative chemical information about the gel, ettringite, and hydrocalumite.

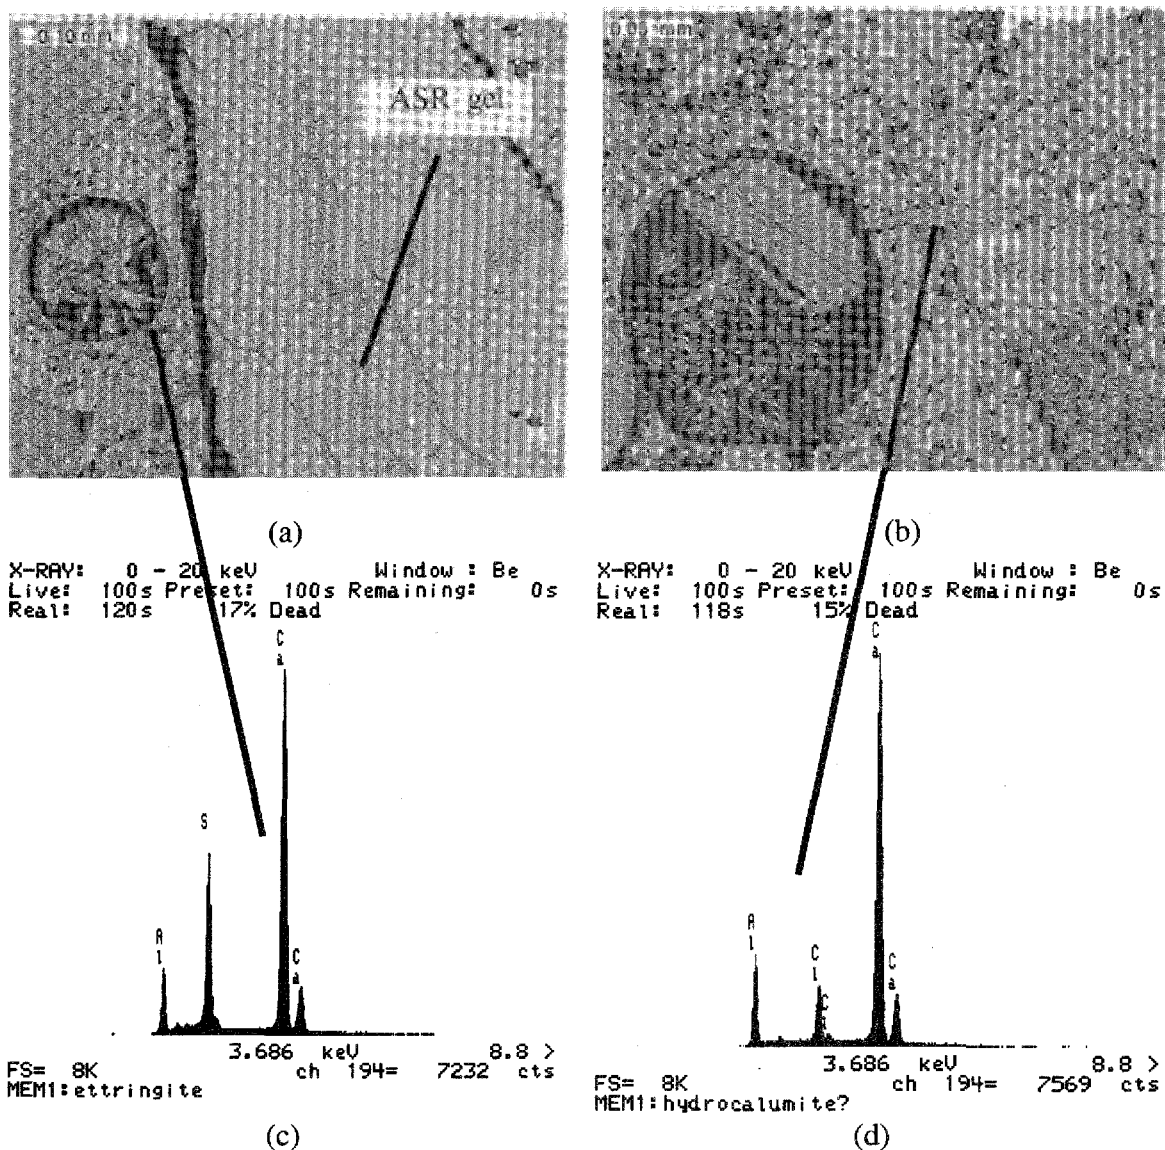
Figure 3-14. Ettringite (a) and hydrocalumite (b) infilling in void and crack, respectively. Example spectra from each phase are shown in (c) and (d), respectively.

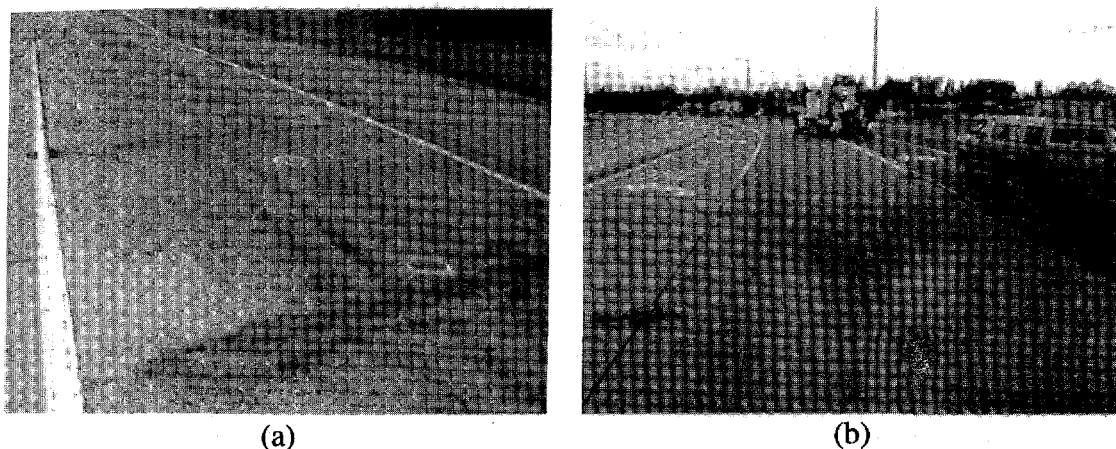
Figure 3-21. Typical distress manifestations observed at MN-065-064.

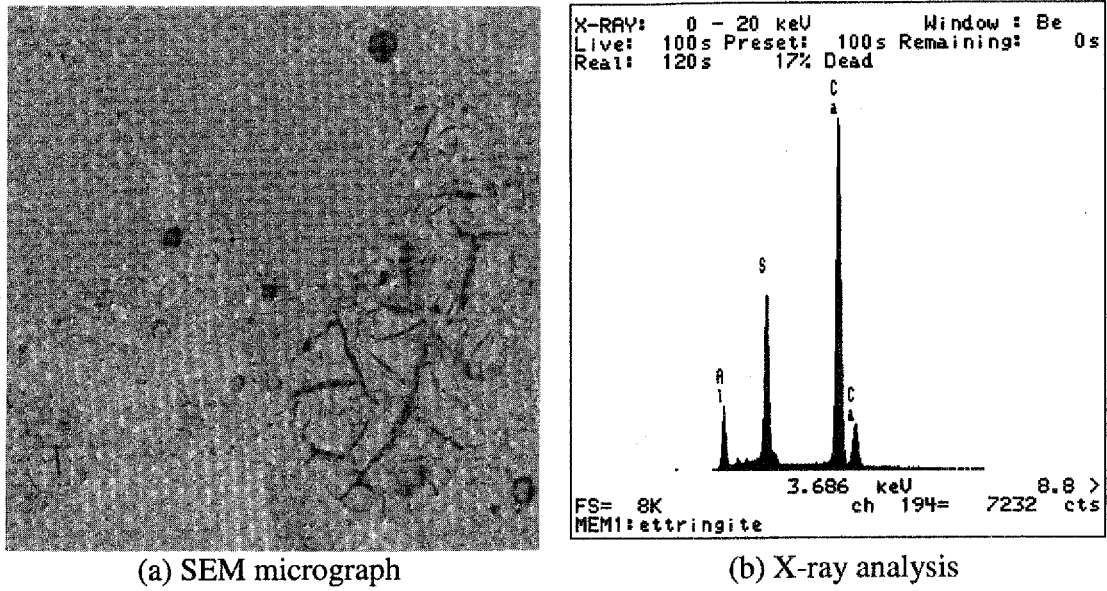
Figure 3-39. Typical SEM micrograph and x-ray analysis for ettringite infilling air void.

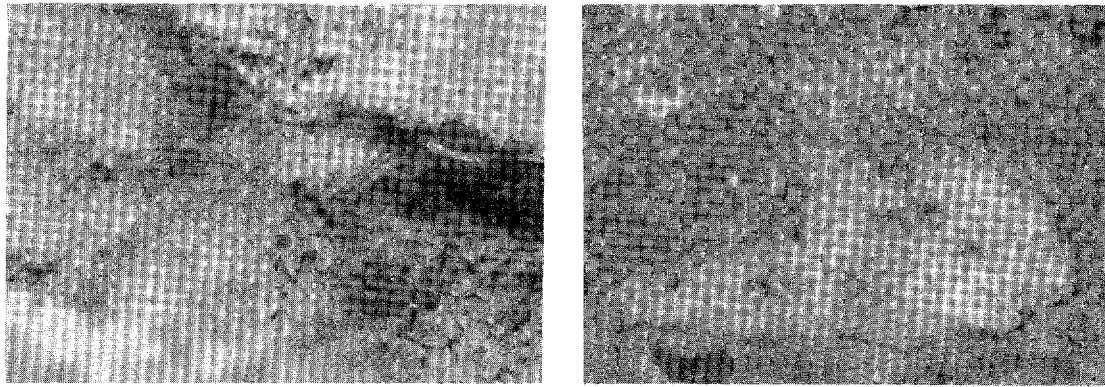
(a) Desiccated ASR gel lining large entrapped air void.

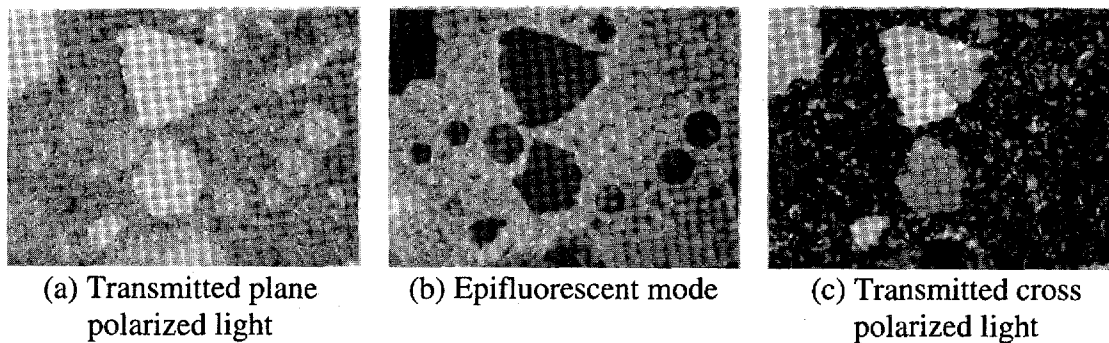
Figure 3-50. Petrographic micrographs from spall obtained from NC-440-015 showing ettringite filled entrained air voids. Ettringite growths are unusually dense.

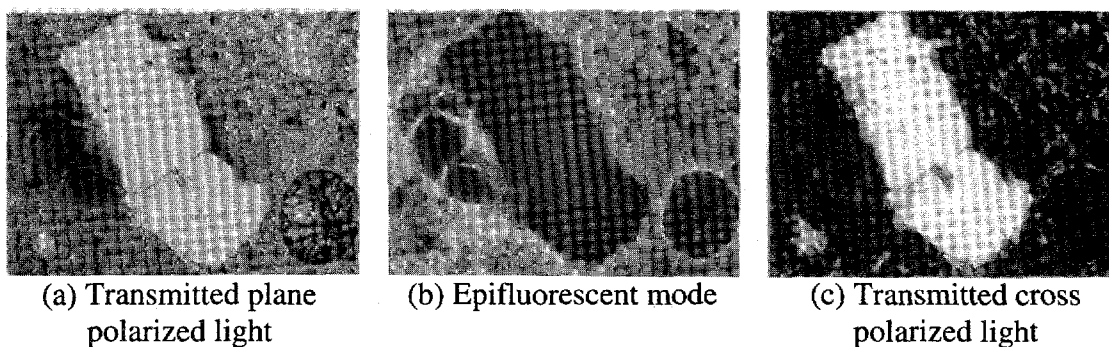
Figure 3-51. Petrographic micrograph of a tan to red coating observed on some of the fine aggregates that appears to undergo ASR from spall obtained from NC-440-015.

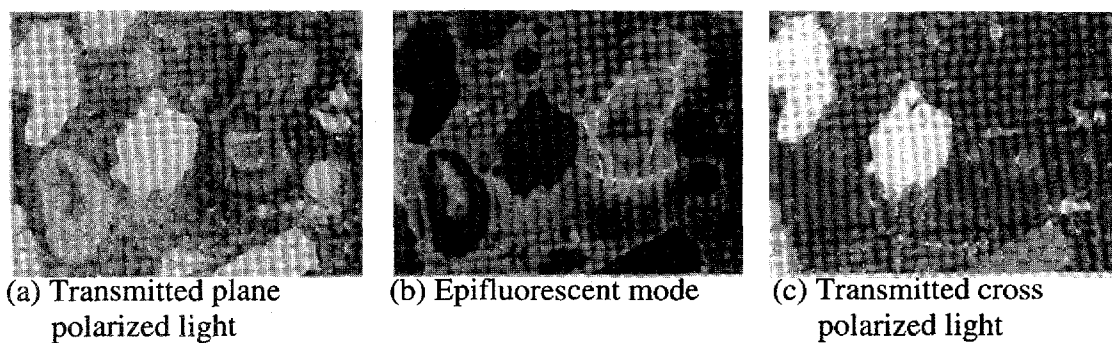
Figure 3-52. Petrographic micrograph of ettringite and “ASR gel blob” from spall obtained from NC-440-015. The term ASR gel is misleading in this example, since the reaction product is slightly birefringent and, therefore, crystalline.

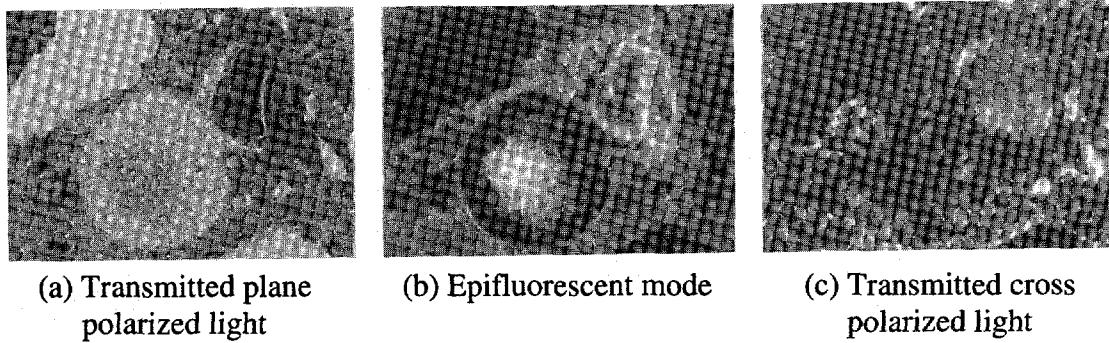
Figure 3-53. Petrographic micrograph of ettringite intermixed with ASR gel. As in figure 3-52, the ASR “gel” in this image is birefringent and crystalline.

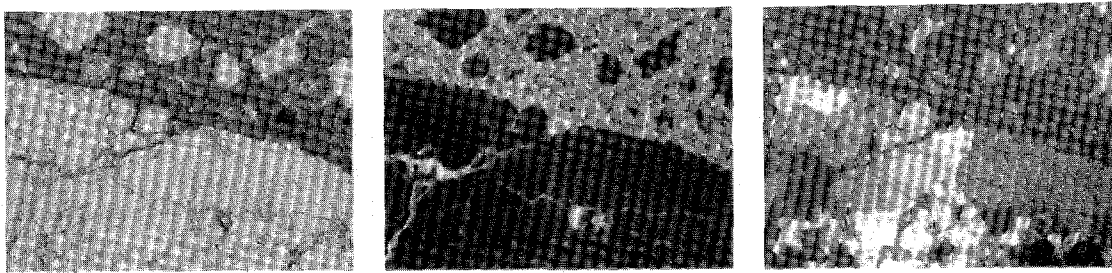
Figure 3-54. Petrographic micrograph of ASR gel in crack within coarse aggregate. The gel deposit in this image was analyzed with the SEM. Again, the ASR “gel” in this image is birefringent and crystalline.

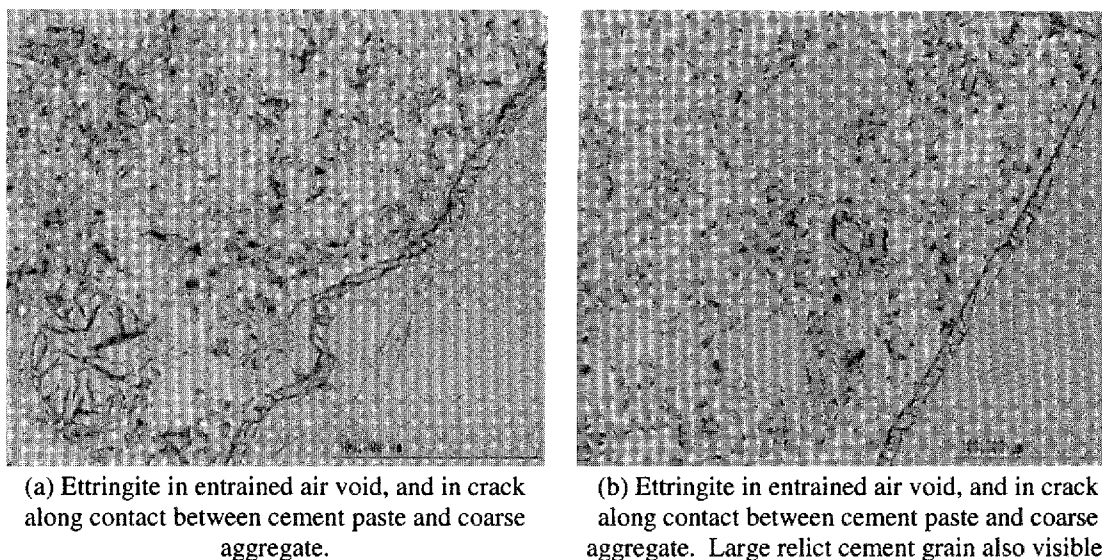
Figure 3-55. SEM micrograph of ettringite filling air voids and crack.

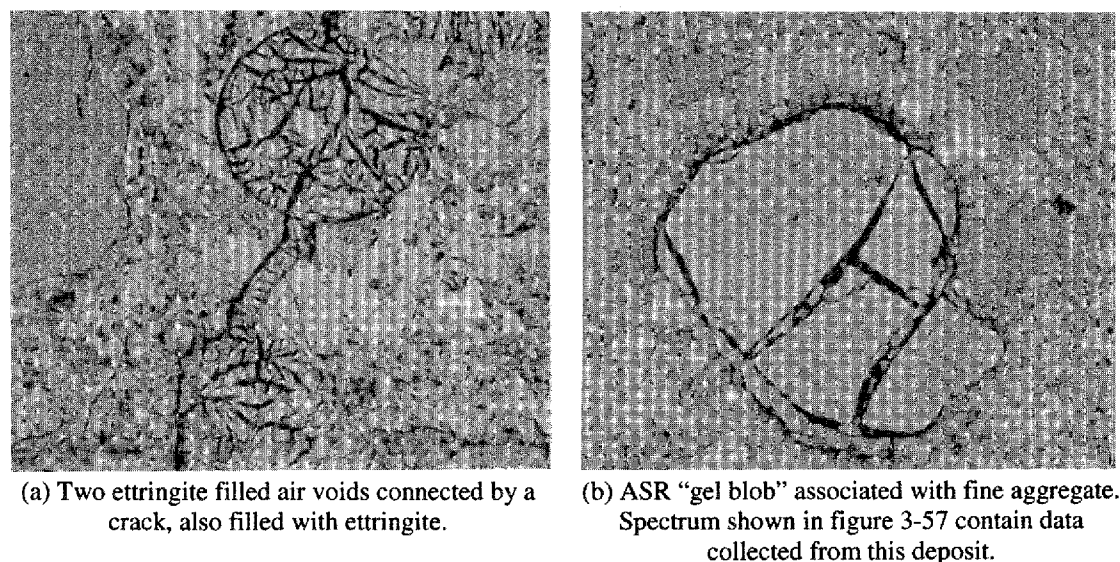
Figure 3-56. SEM micrograph of ettringite and ASR reaction product.

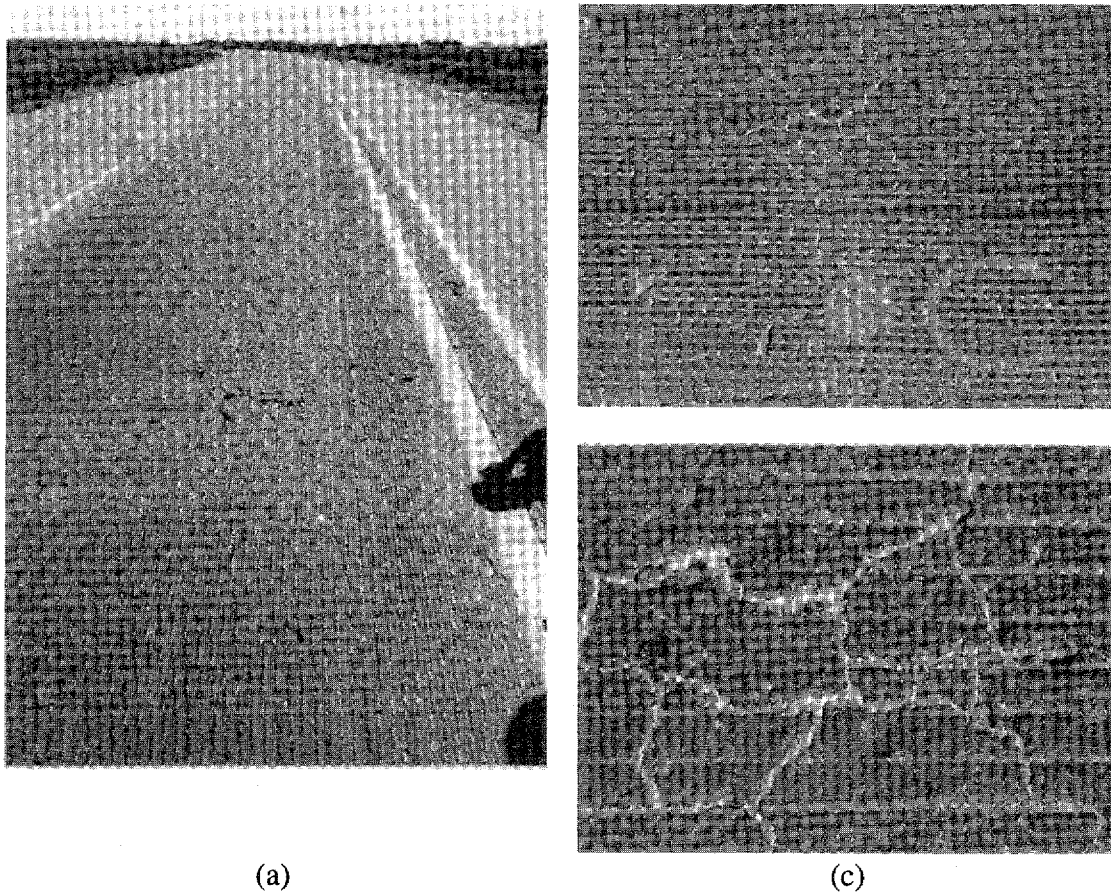
Figure 3-63. Typical conditions at CA-058-141.

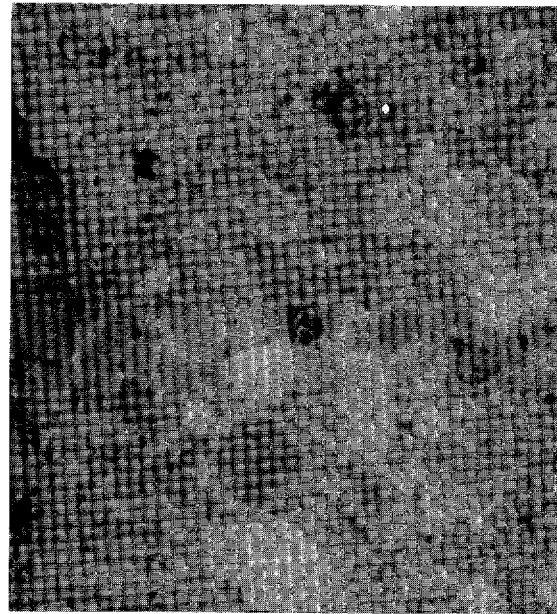
(b) An unpolished cut surface that has been stained to show ettringite filled cracks and voids

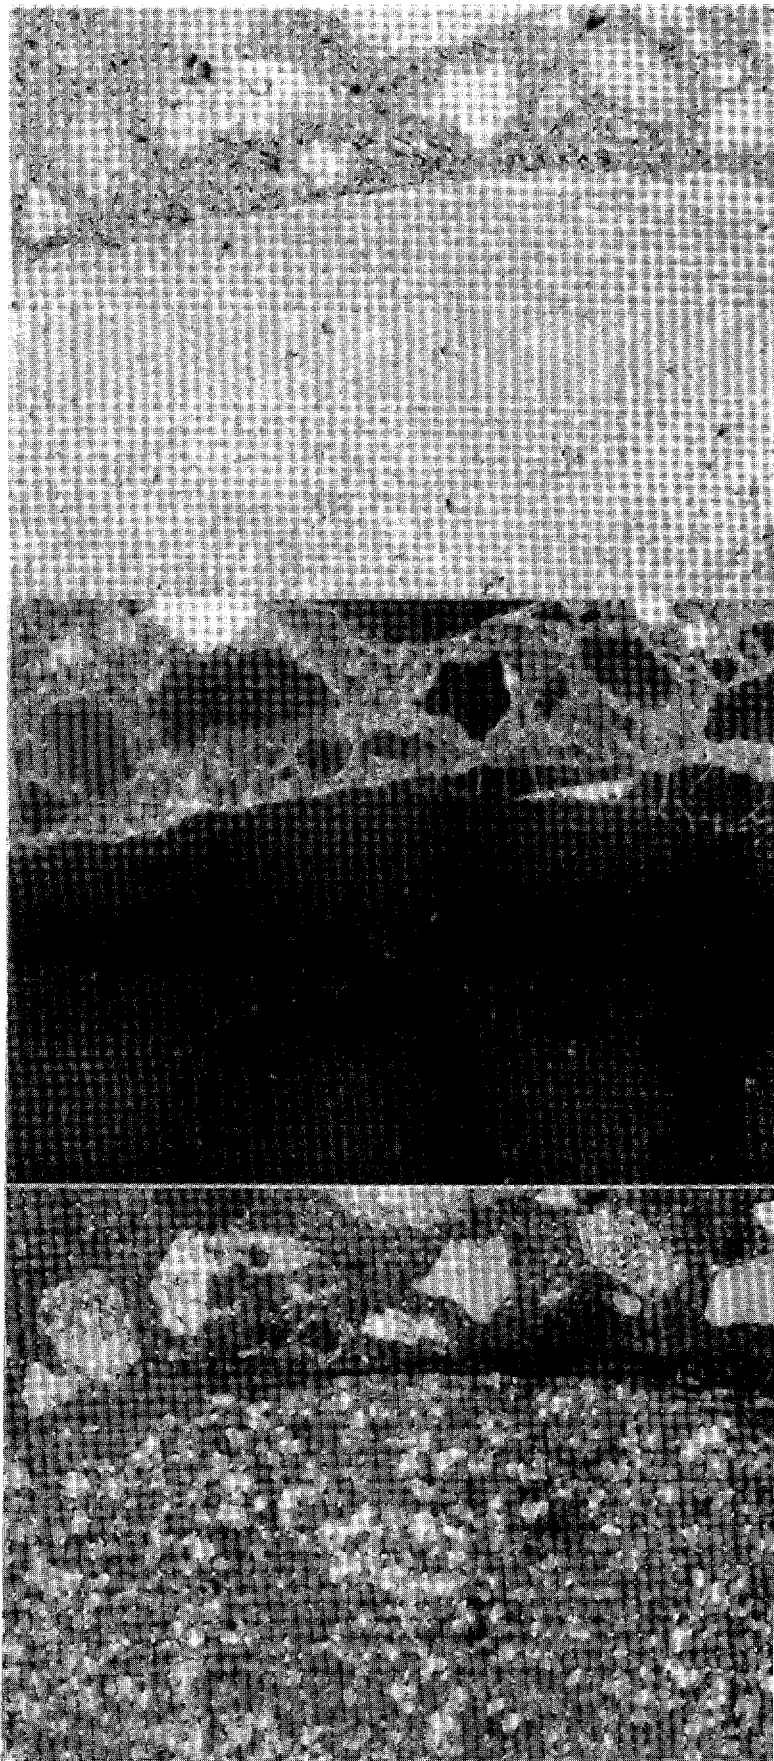
Figure 3-66. Petrographic micrograph of core CA-058-141-001E, thin-section micrographs of ASR gel deposit in crack along felsic volcanic aggregate. The same deposit was analyzed with the SEM to collect quantitative chemical information about the gel. From top to bottom: transmitted plane polarized light, epifluorescent mode, and transmitted cross polarized light (magnified 48x).

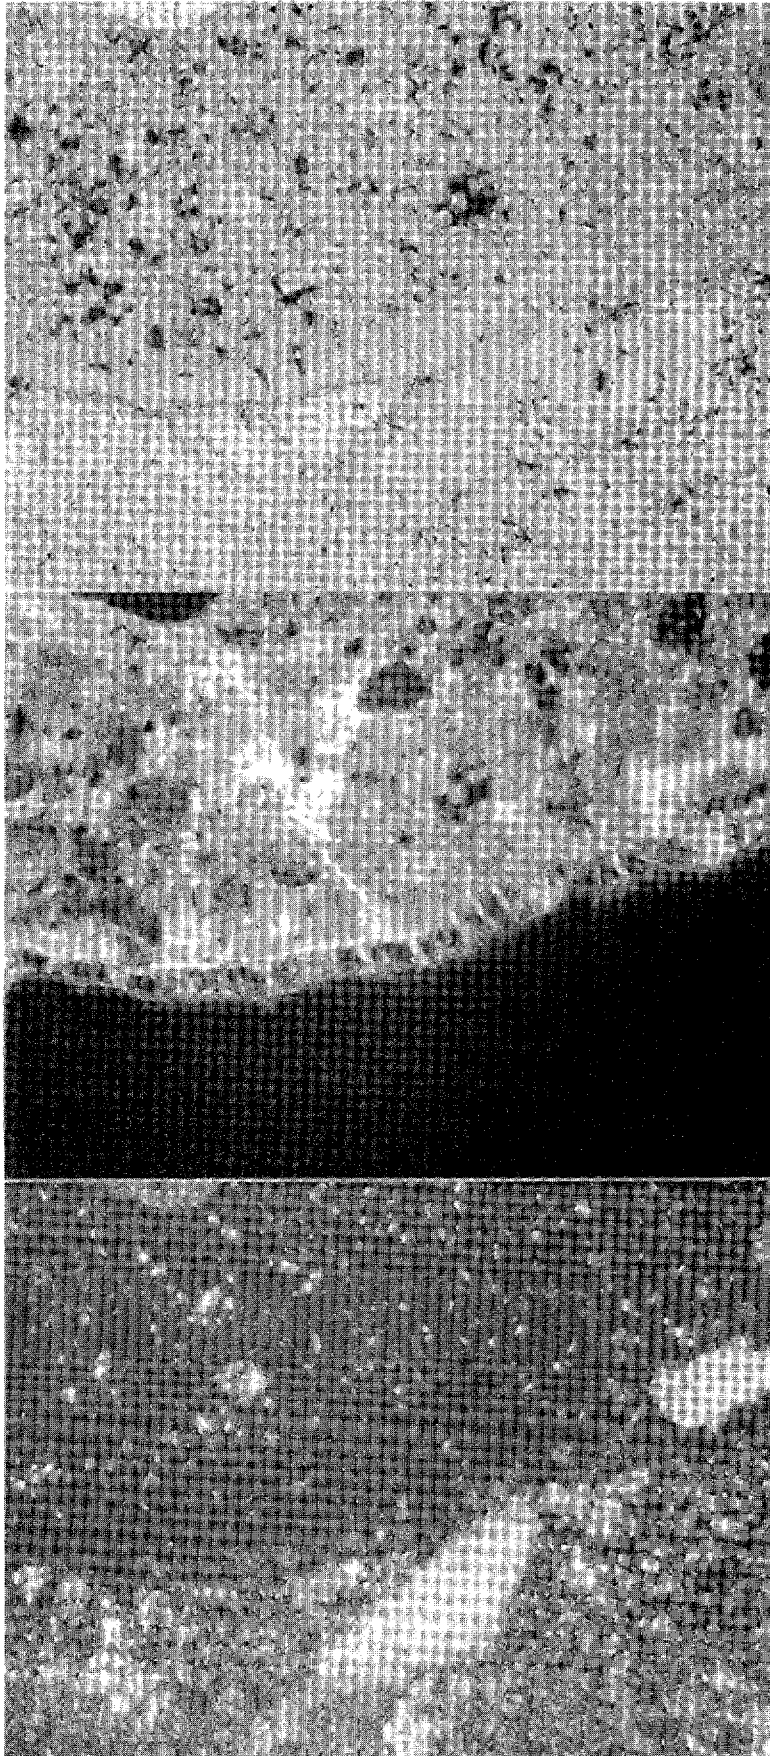
Figure 3-67. Petrographic micrograph of core CA-058-141-001E, thin-section micrographs of ettringite filled crack along contact between coarse aggregate and cement paste. From top to bottom: transmitted plane polarized light, epifluorescent mode, and transmitted cross polarized light (magnified 188x).

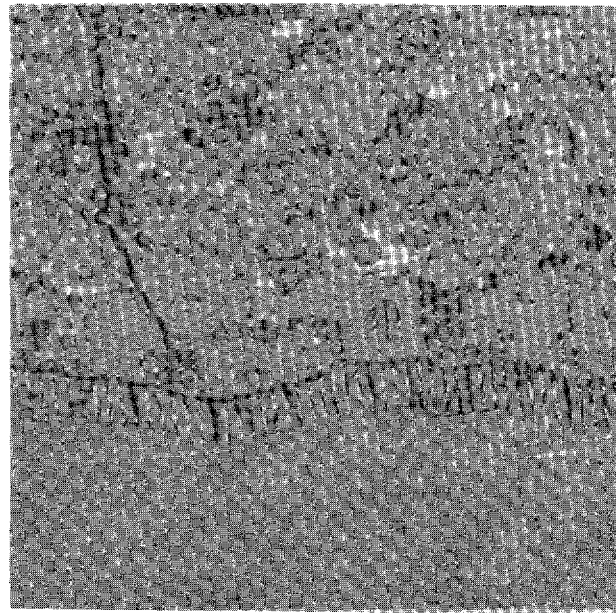
(b) BSE image of ettringite filling a crack along the contact between a coarse aggregate and the cement paste.

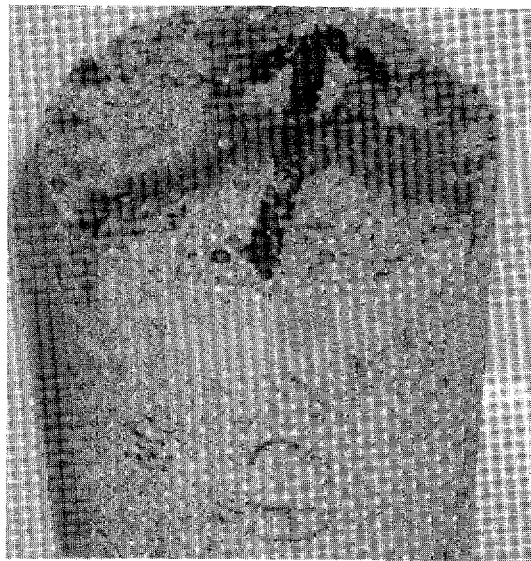
Figure 3-75. Map cracking pattern on core CA-014-011-001E, emphasized by wetting down the surface.

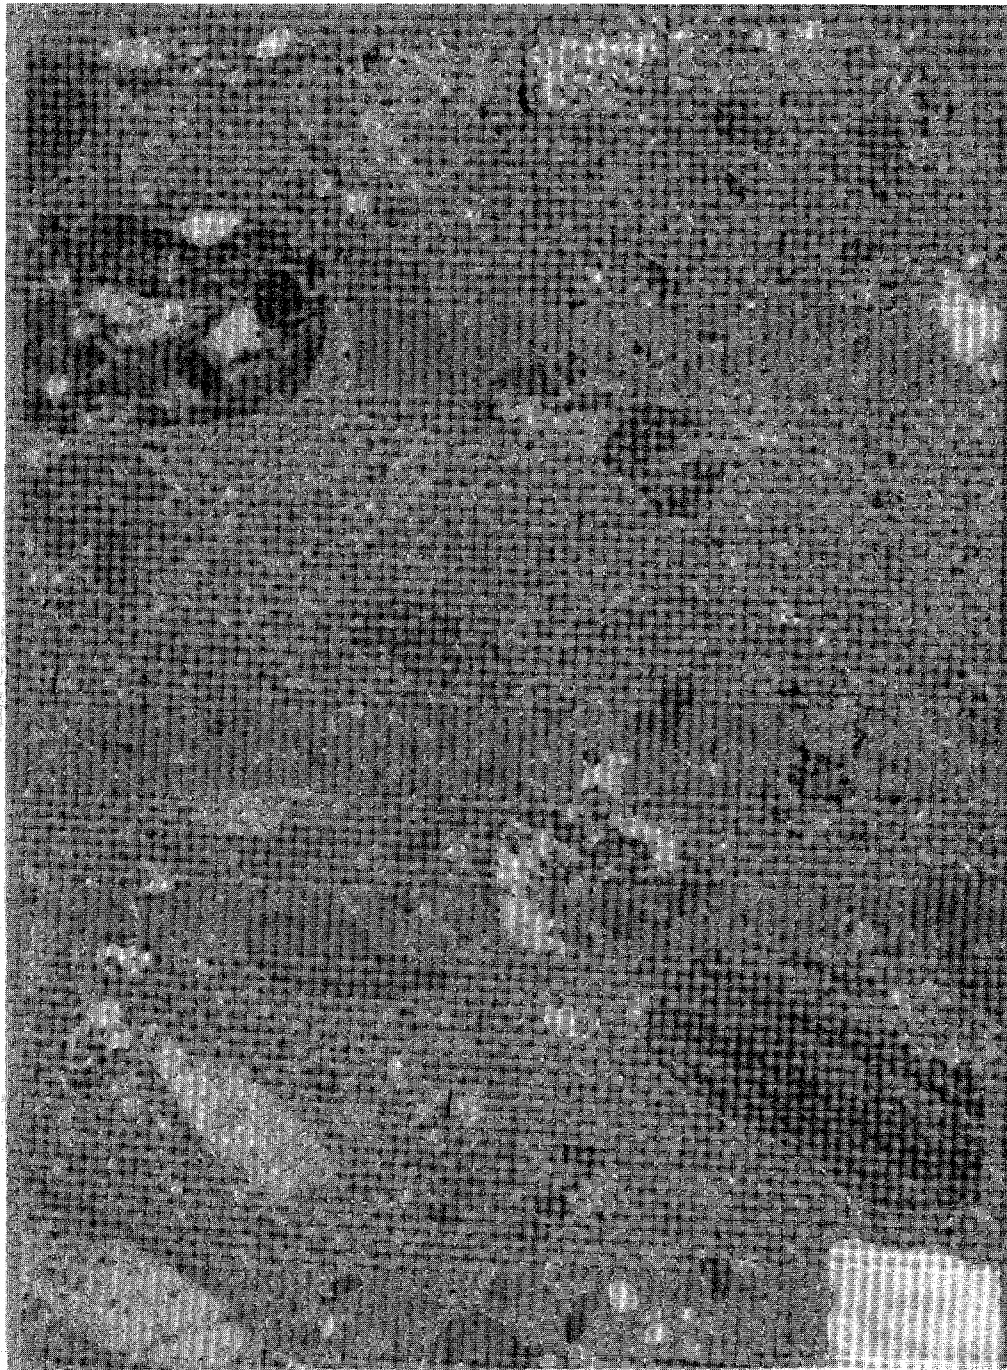
Figure 3-77. Same area of core CA-058-011-001E as shown in figure 3-78, included to show darkened reaction rims on some of the coarse aggregate (magnified 1.5x).

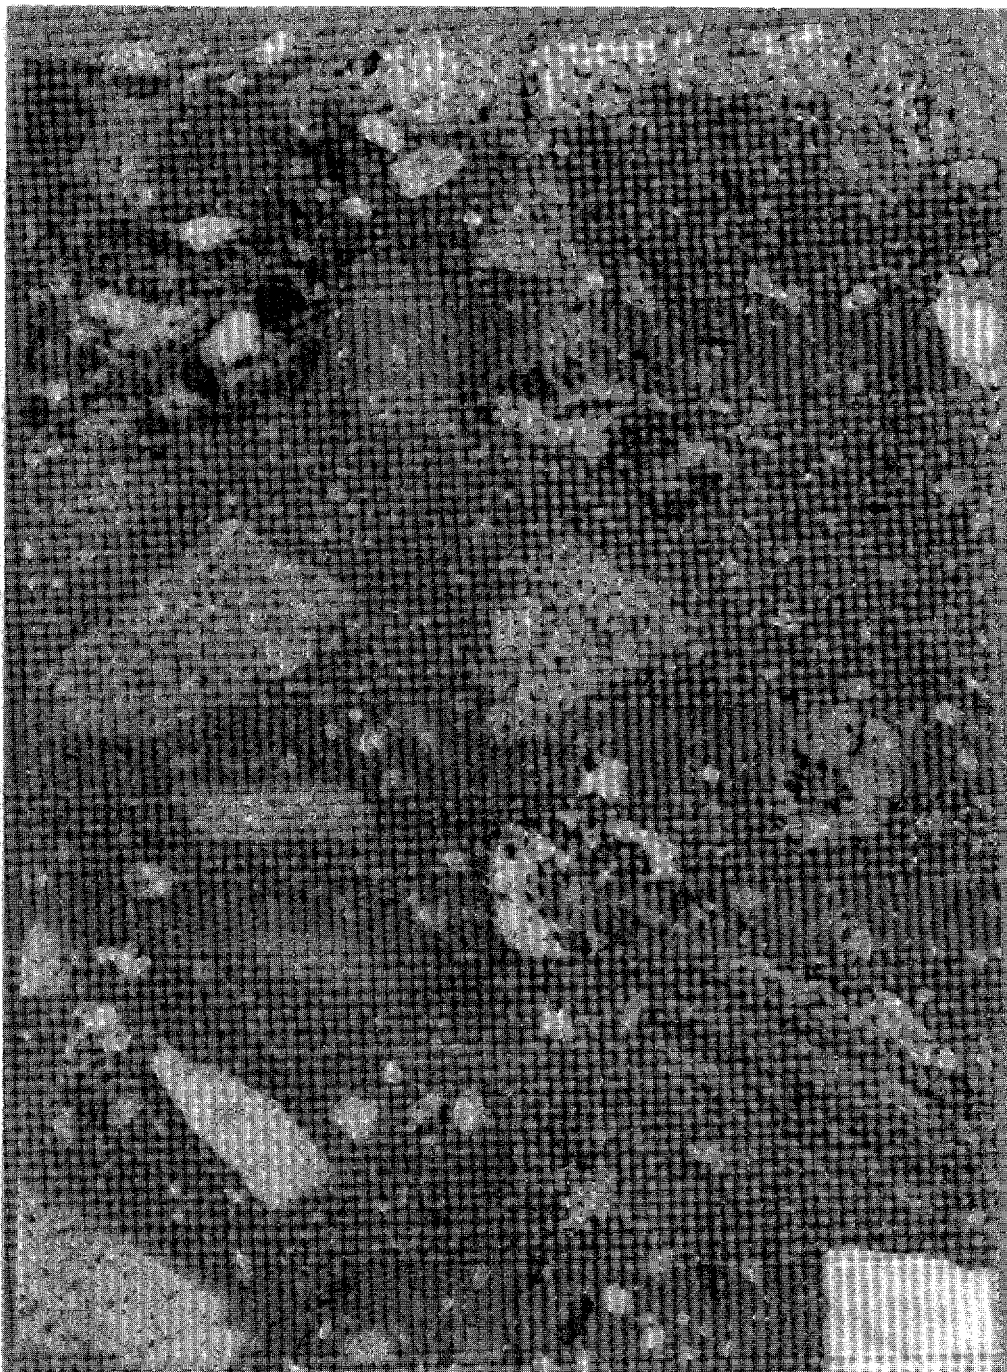
Figure 3-79. Phenolphthalein stained polished slab, showing carbonation along plastic shrinkage crack (magnified 1.5x).

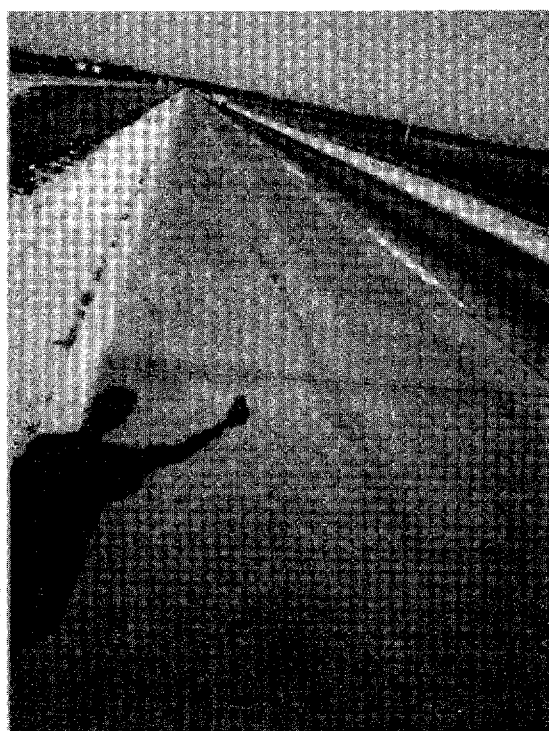
(a) Staining along longitudinal cracks

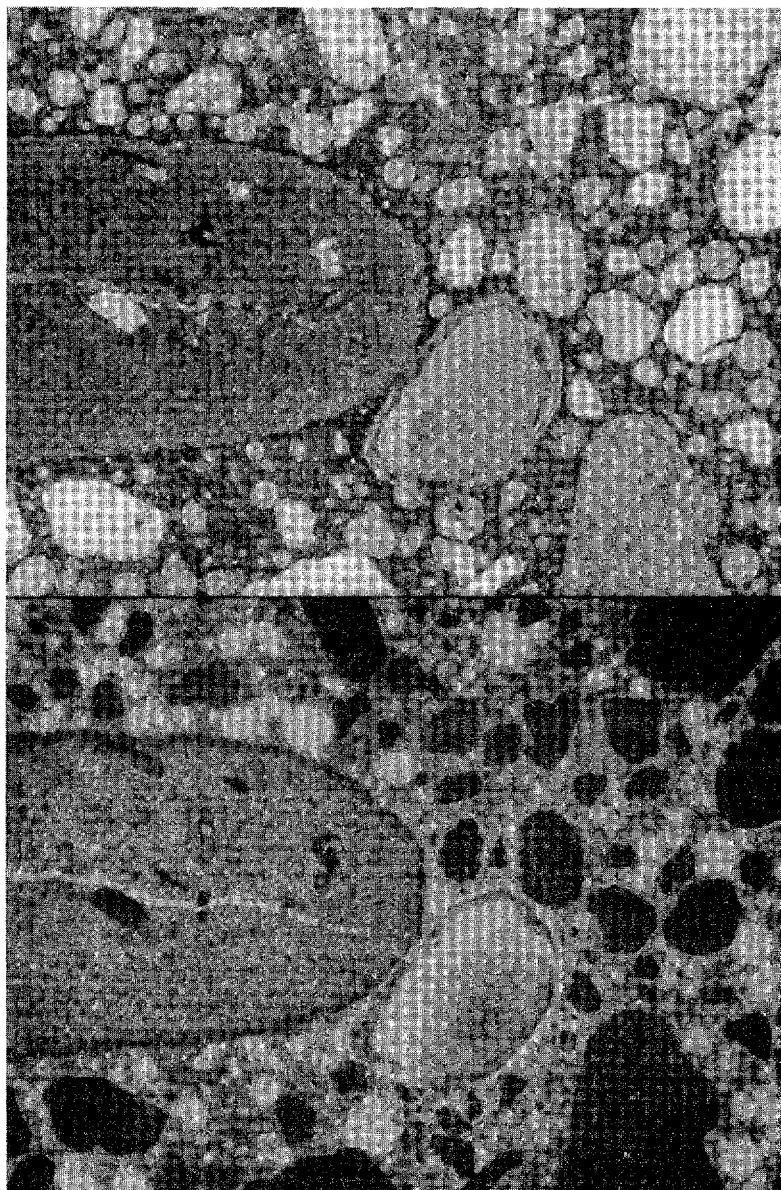
Figure 3-85. Reactive fine aggregate particle with alkali-silica gel filled air voids as viewed in thin section. Top image is transmitted plane polarized light, bottom image is in epifluorescent mode, magnified 20x.
