MEDIUM-RANGE and LONG-RANGE PLANS FOR GEOLOGICAL AND HYDROLOGICAL STUDIES OF THE SNODGRASS MOUNTAIN SKI AREA EXPANSION

By: GEO-HAZ Consulting, Inc. Date: 15 Feb 2007

Report and Photographs of the May 2001 Landslide on Mount Crested Butte, Beneath the Gold Link Lift

Subject: Engineering Consultation Goldlink Slope Failure Crested Butte Ski Area Mt. Crested Butte, Colorado Job No. GS-3252

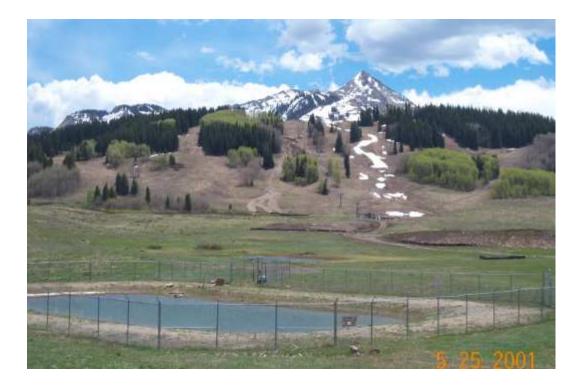
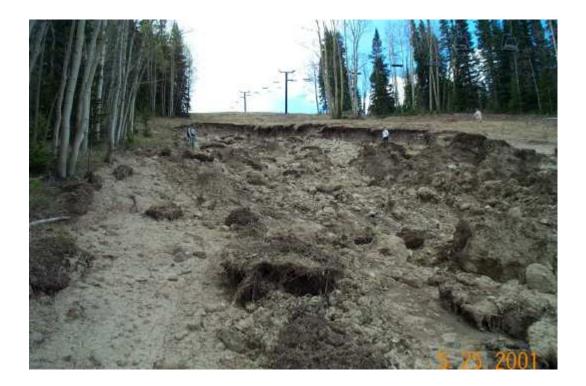
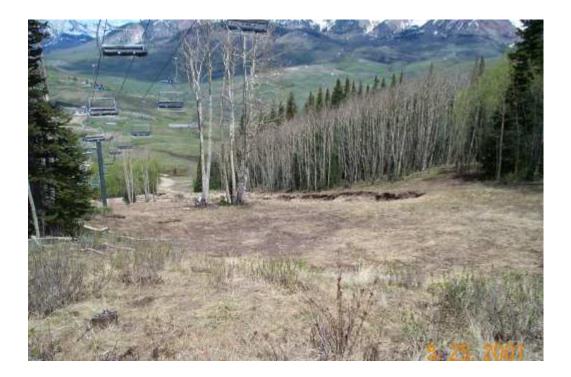
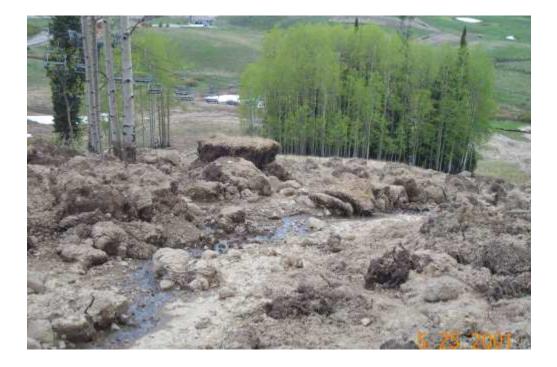
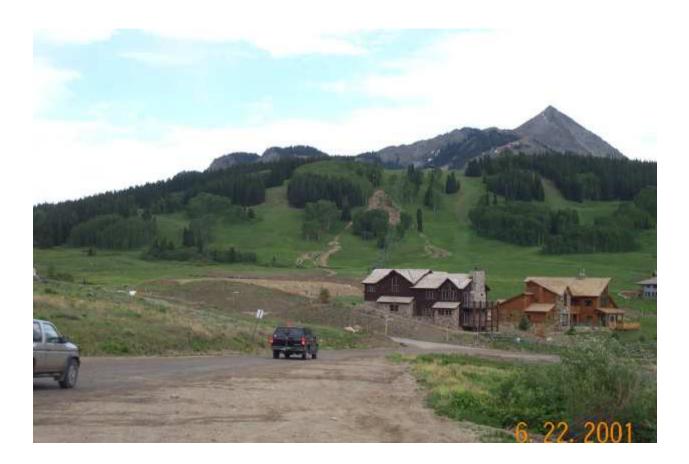
The slump appears to actually be a shallow debris flow, earth flow situation on about a 30% slope. The result of this earth flow has left a scare about 60 Ft. wide, 6-8 Ft. deep, and 200 Ft. long. The amount of material displaced was estimated by Stewart Johnson to be roughly 4,000 Cu. Yd.s. This displaced material flowed, mostly as a fluid, down slope for roughly another 200-250 Ft. The flow split 1/3 of the way down slope and followed 2 small drainage ways to the base of the slope. The western most flow washed up against the base of tower 4 and bent the base of the ladder, and left an accumulation of material, but did not appear to have any other visible impact.

I dug a small excavation pit at the head of the fresh movement area and observed dense gravelly reddish clay layer, which could have acted as a failure plane. Toward the base of the slope, we noticed a small seep or spring like area around lift 3, that Roark had mentioned flows most of the time.

Based on my observations, I feel this slope failure is the result of a rather rapid earlier snow melt situation, which saturated the soil profile, followed by a final wet snow/rain storm event. The landform position is such, that all the depressional areas up slope hold water and contribute to the ground water conditions down slope. The last storm event apparently added water to the already saturated profile, with the landscape position helping to concentrate the water flow. The saturated situation was probably perched above the clay layer. It may have been dammed up at a point about 185 feet down slope, where there is a slight change in grade. This built up to a point where it could no longer support the weights involved, and released as a fluid debris flow situation. I feel that explains current site conditions that lead to the debris flow. However, the action of clearing the stand of trees to create this ski run may have also been one contributing factor, even though this occurred years ago. I contacted Mike Burke, Geo-Technical Engineer on the San Juan National Forest, and he supports my concepts. He mentioned that often times, removal of trees can lead to progressive slope failure situations. As a result of tree removal, the actual physical support that tree roots may supply, deteriorates over time. Also, growing trees pull a considerable amount of water from the soil as they grow and transpire. When they are no longer there, more water is held in the soil profile. These factors singly, may not appear to explain the slope movement, but when considered cumulatively they provide the best logical explanation, especially in light of the fact that I could find no other sources of water concentrations, construction activities or vegetative disturbances up slope or in the near vicinity.

I strongly recommend that the ski area be required to have this evaluated by a Geo-tech Engineer, or an Engineering Geologist. Some of my initial thoughts and concerns are:

- Drainage of the area should be addressed, although most of the material is no longer there, water relationships in the slope should be evaluated and actions taken to prevent any future progressive slope failures.

- The action of filling in the void left in the slope with the material that traveled down slope needs to be <u>carefully engineered and evaluated</u>. Any type of regrading and filling in will have to be firmly anchored below any failure plane (concrete pilings, steel pilings, treated wood pilings), and the area drained, both surface and subsurface.

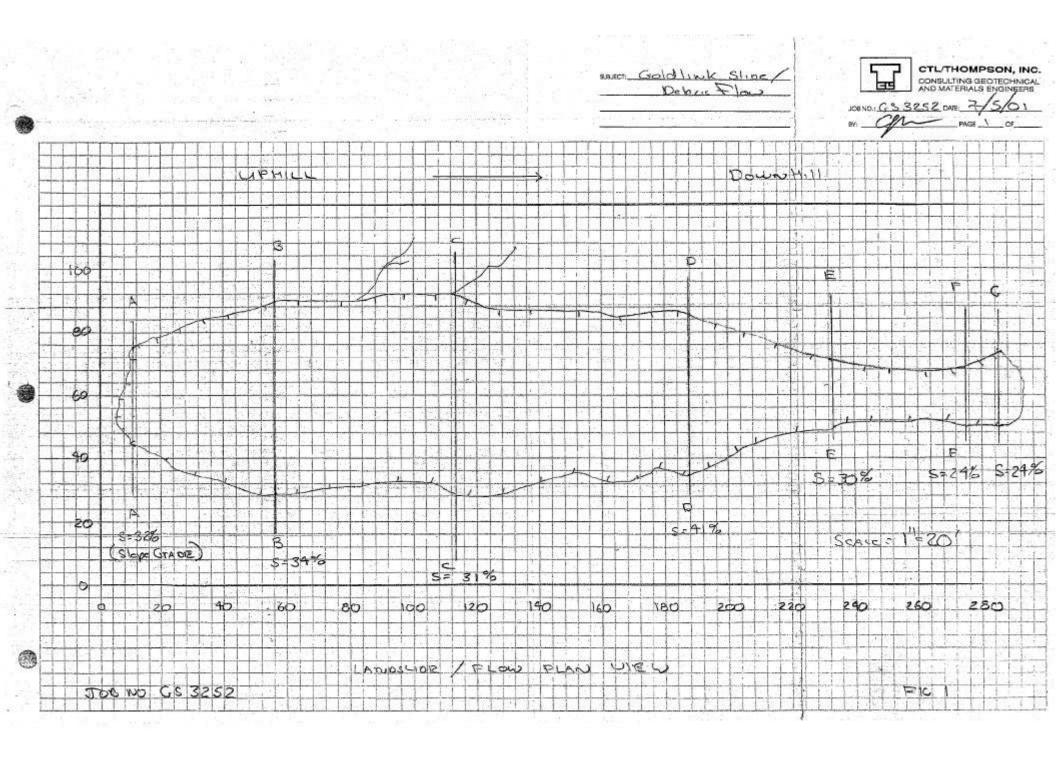
The slide/flow evacuation area was 20 to 65 feet wide, 5 to 8 feet deep and about 280 feet long. Figure 1 shows a plan view of the evacuation area and Figure 2 shows cross-section profiles. We estimate the volume of the evacuation area is 2000 cubic yards. The soils which slid were colluvium consisting predominantly of silty to clayey sand with gravels and silty to clay gravel. At the time of failure, the saturated soils lost shear strength and the soils flowed downhill about 300 feet. The evacuation area was well defined with distinguishable boundaries. Soil movements were also expressed at the ground surface by two large cracks extending from the flank scarp nearest the ski lift. An estimated 5 to 10 gallons per minute (gpm) of clear water was seeping from the evacuation area of the slide during our initial visit.
