Re: Turkey Point Unit 3  
Docket No. 50-250  
Order (EA-03-009) Relaxation Request  
Examination Coverage of Reactor Pressure Vessel Head  
Penetration Nozzles

**TURKEY POINT UNIT 3 RELAXATION REQUEST  
FROM US NRC Order EA-03-009**

**“Hardship or Unusual Difficulty without Compensating Increase in  
Level of Quality or Safety”**

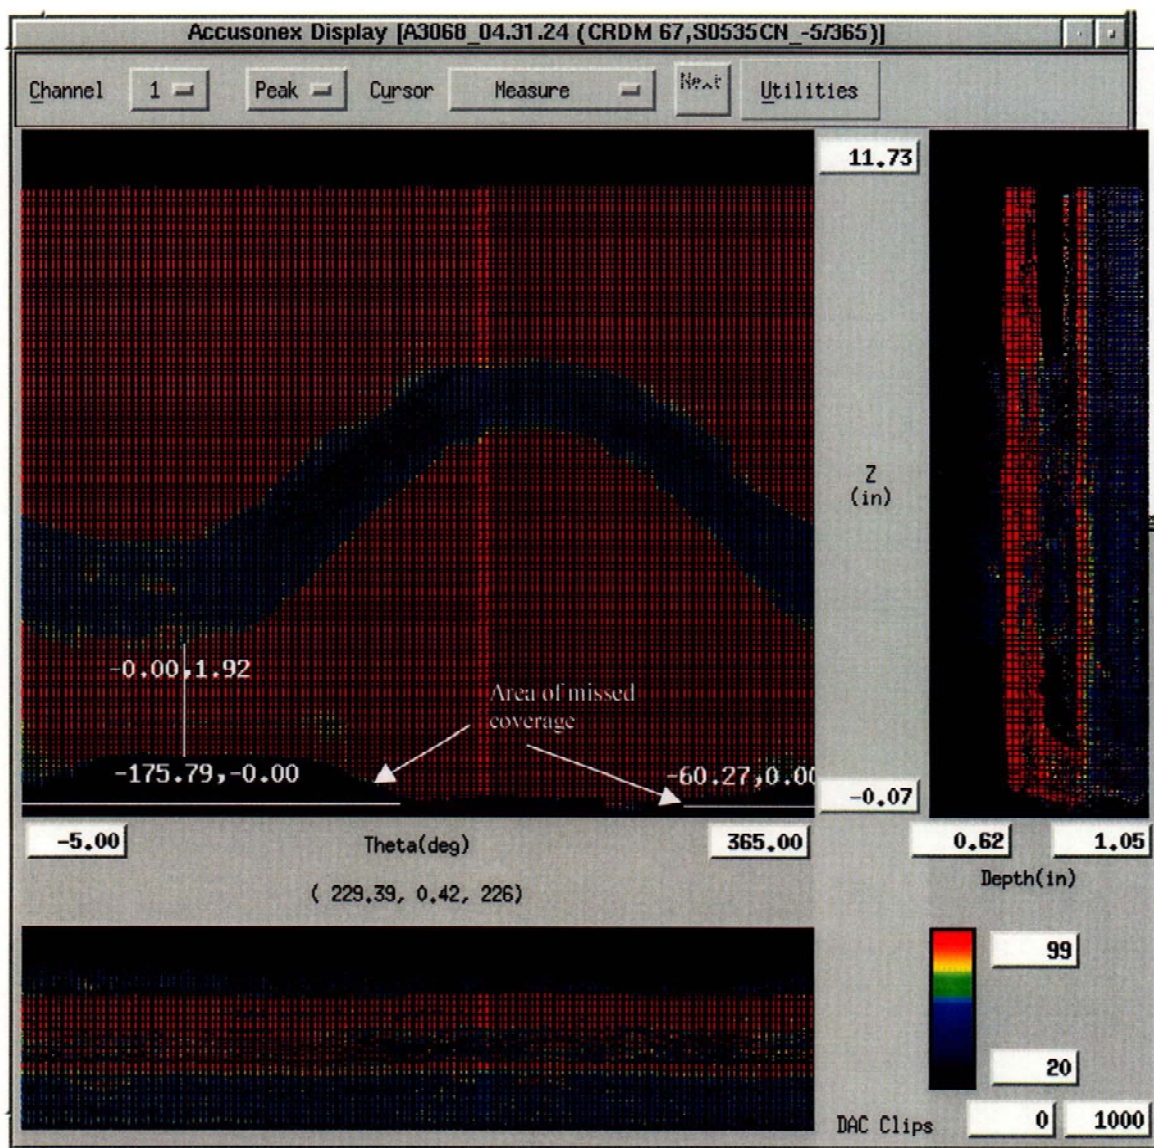
Pursuant to Order Section IV.F.(2) "Compliance with the Order for specific nozzles would result in hardship or unusual difficulty, without a compensating increase in the level of quality and safety", FPL is requesting this relaxation for Turkey Point Unit 3. Currently, with 48 of 66 RPV nozzle penetrations examined, there are 6 RPV head penetrations that contain areas of coverage less than that required by the NRC Order. The Order requires examination from 2 inches above the J-groove weld to the bottom of the RPV head penetration nozzle. The reduced coverage is caused by nozzle configuration, and limitations of the probe design used for the Ultrasonic (UT) examination. Specifically, actual coverage below the weld, in the non-pressure boundary portion of the nozzle, did not in all cases, extend to the "bottom of the nozzle." A typical example of the UT cover area, with the area of missed coverage identified, is shown in Figure 1.

**Figure 1: Typical RPV Nozzle UT Inspection "C" Scan with area of missed coverage identified by arrows and above the white horizontal line.**

The proposed alternative is to perform the UT examination to the extent practical. This is defined as "the examination shall be performed to include 2 inches above the weld to  $\geq$  1 inch below the weld." This relaxation request documents and submits to the NRC, deviations from the NRC Order required inspection coverage area along with a justification as to their acceptability.

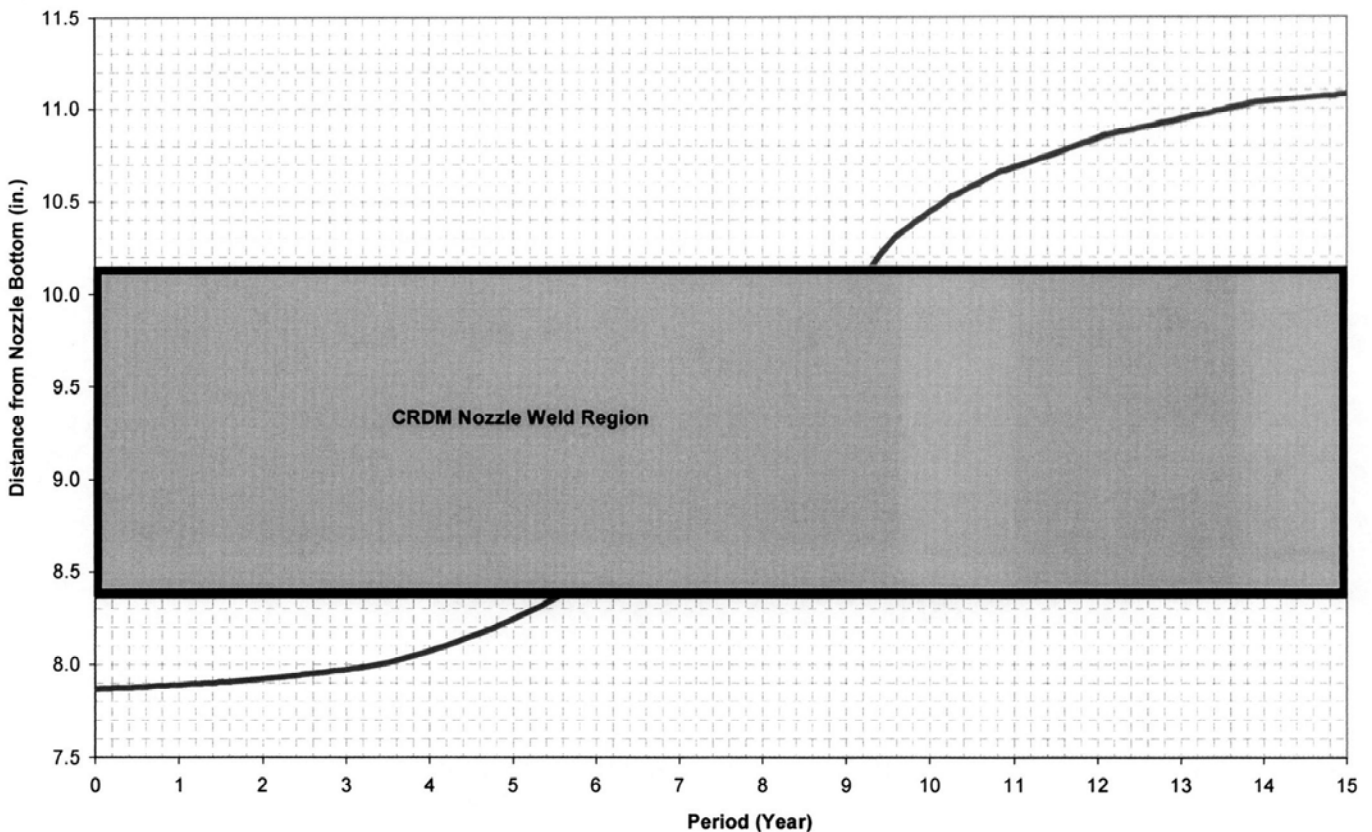
To determine the significance of an axial flaw that is contained in the non-pressure boundary nozzle material in the un-inspected region >1 inch below the weld, a flaw tolerance approach is used. A flaw evaluation was performed postulating an axial flaw in the area of missed coverage below the weld using WCAP-16027-P<sup>3</sup>. A through wall flaw is postulated in the nozzle material from the bottom of the penetration to 1" from the bottom of the weld. The flaw evaluation in WCAP-16027-P is based on Turkey Point Unit 3 and 4 specific stresses in the nozzle penetrations. Since the stresses >1" below the weld are too low to propagate an axial flaw, the WCAP-16027-P flaw evaluations start at ½" below the weld, and evaluate the time to propagate the flaw in the nozzle to the bottom of the weld (start of the pressure boundary portion of the nozzle material or toe of the J-groove weld). Assuming a through wall flaw below the weld, with the flaw end located at ½" below the weld (which is in the area of complete UT examination coverage), an axial flaw would take greater than 5 years of operation (Figures 6-12 through 6-20 in WCAP-16027-P) in any nozzle location to grow to the point of contact with the weld. This time period is significantly greater than the current inspection frequency of every refueling cycle (18 months for Turkey Point Unit 3) identified in NRC Order EA-03-009. As an added conservatism, this evaluation does not attempt to evaluate the time for the axial flaw to grow from the bottom of the weld through the pressure boundary. Figure 2 provides a graphical presentation of the above flaw evaluation discussion for the outer most penetration location.

Figure 2: Through-Wall Axial Flaws Located in the 42.6 Degree Row of Penetrations, Uphill Side - Crack Growth Predictions (From Figure 6-19, WCAP-16027-P)

Therefore, there are no concerns with the structural integrity of the RPV penetration nozzles that could be caused by axial cracking in the missed coverage areas in the non-pressure boundary portion of the nozzle material  $> 1"$  below the weld for a period of  $> 5$  years of operation.
