Re: Turkey Point Unit 3
Docket No. 50-250
Order (EA-03-009) Relaxation Request
Examination Coverage of Reactor Pressure Vessel Head
Penetration Nozzles - Supplemental Data

**TURKEY POINT UNIT 3 RELAXATION REQUEST
FROM US NRC Order EA-03-009**

**“Hardship or Unusual Difficulty without Compensating Increase in
Level of Quality or Safety”**

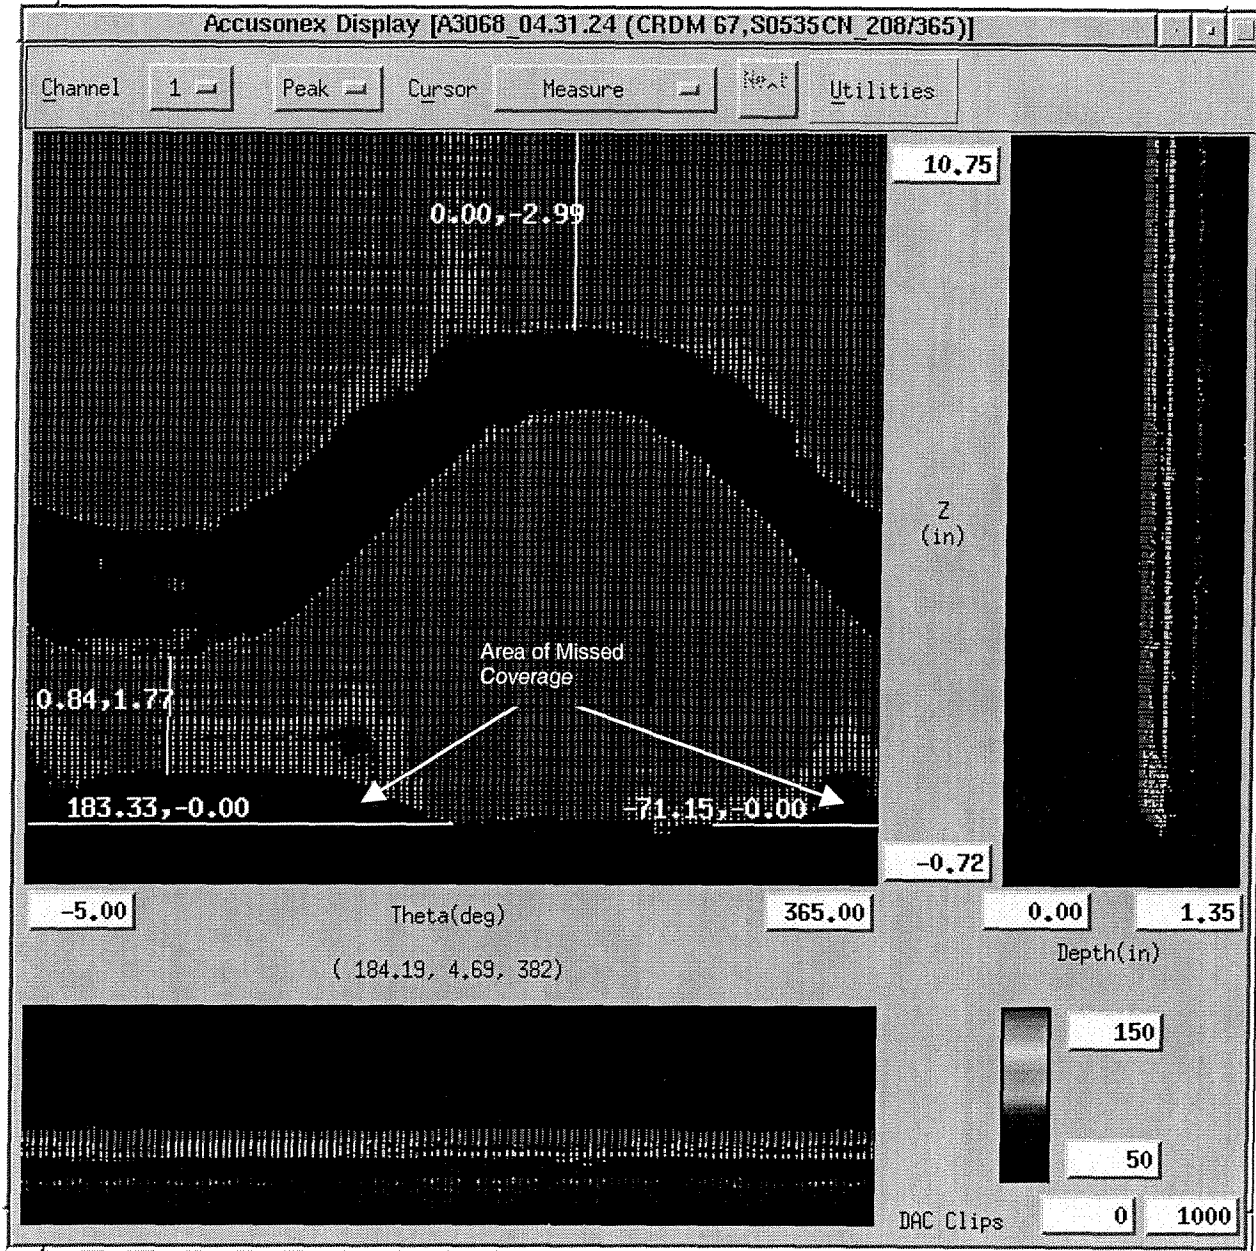
Pursuant to Order Section IV.F.(2) "Compliance with the Order for specific nozzles would result in hardship or unusual difficulty, without a compensating increase in the level of quality and safety", FPL is requesting this relaxation for Turkey Point Unit 3. There are 9 RPV head penetrations that contain areas of coverage less than that required by the NRC Order. The Order requires examination from 2 inches above the J-groove weld to the bottom of the RPV head penetration nozzle. The reduced coverage is caused by nozzle configuration, and limitations of the probe design used for the Ultrasonic (UT) examination. Specifically, actual coverage below the weld, in the non-pressure boundary portion of the nozzle, did not in all cases, extend to the "bottom of the nozzle." A typical example of the UT coverage area, with the area of missed coverage identified, is shown in Figure 1.

Figure 1: Typical RPV Nozzle UT Inspection "C" Scan with area of missed coverage identified by arrows and above the white horizontal line.

Previously, Figure 1 was included to depict a “typical” example for nozzle #67. The figure 1 that is included in the supplemented request is the actual C-scan for nozzle #67 that illustrates the circumferential extent of missed coverage. The extent of missed coverage at the bottom of the nozzle is determined by, in this case, adding the two numbers. Additionally, the total circumferential extent of missed coverage, in degrees, is now shown in Table 2 for every nozzle where coverage was less than 100%.

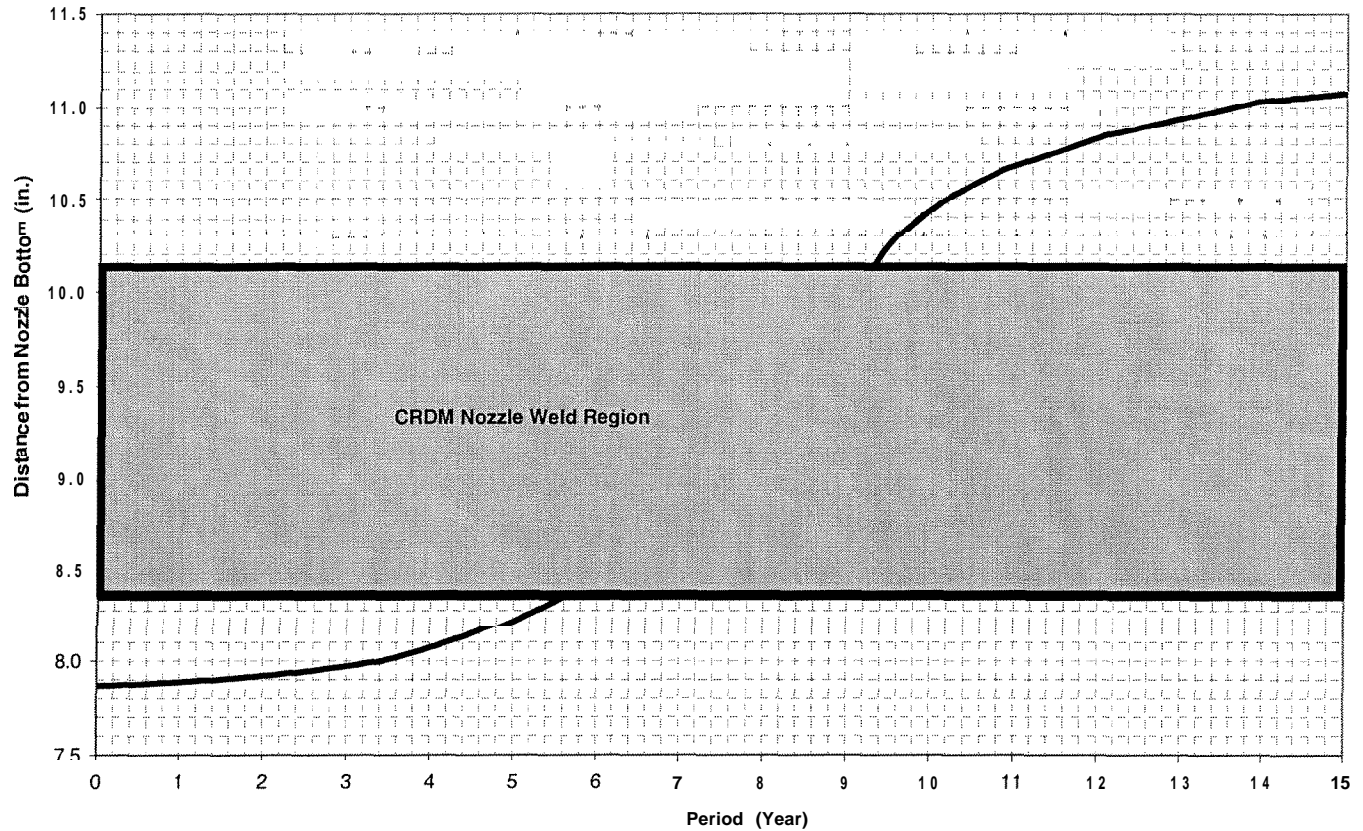
To determine the significance of an axial flaw that is contained in the non-pressure boundary nozzle material in the un-inspected region >1 inch below the weld, a flaw tolerance approach is used. A flaw evaluation was performed postulating an axial flaw in the area of missed coverage below the weld using WCAP-16027-P³. A through wall flaw is postulated in the nozzle material from the bottom of the penetration to 1" from the bottom of the weld. The flaw evaluation in WCAP-16027-P is based on Turkey Point Unit 3 and 4 specific stresses in the nozzle penetrations. Since the stresses >1" below the weld are too low to propagate an axial flaw, the WCAP-16027-P flaw evaluations start at ½" below the weld, and evaluate the time to propagate the flaw in the nozzle to the bottom of the weld (start of the pressure boundary portion of the nozzle material or toe of the J-groove weld). Assuming a through wall flaw below the weld, with the flaw end located at ½" below the weld (which is in the area of complete UT examination coverage), an axial flaw would take greater than 5 years of operation (Figures 6-12 through 6-20 in WCAP-16027-P) in any nozzle location to grow to the point of contact with the weld. This time period is significantly greater than the current inspection frequency of every refueling cycle (18 months for Turkey Point Unit 3) identified in NRC Order EA-03-009. As an added conservatism, this evaluation does not attempt to evaluate the time for the axial flaw to grow from the bottom of the weld through the pressure boundary.

Figure 2: Through-Wall Axial Flaws Located in the 42.6 Degree Row of Penetrations, Uphill Side - Crack Growth Predictions (From Figure 6-19, WCAP-16027-P)

Therefore, there are no concerns with the structural integrity of the RPV penetration nozzles that could be caused by axial cracking in the missed coverage areas in the non-pressure boundary portion of the nozzle material > 1" below the weld for a period of > 5 years of operation.
