**DAVIS-BESSE REACTOR VESSEL HEAD DEGRADATION  
LESSONS-LEARNED TASK FORCE REPORT**

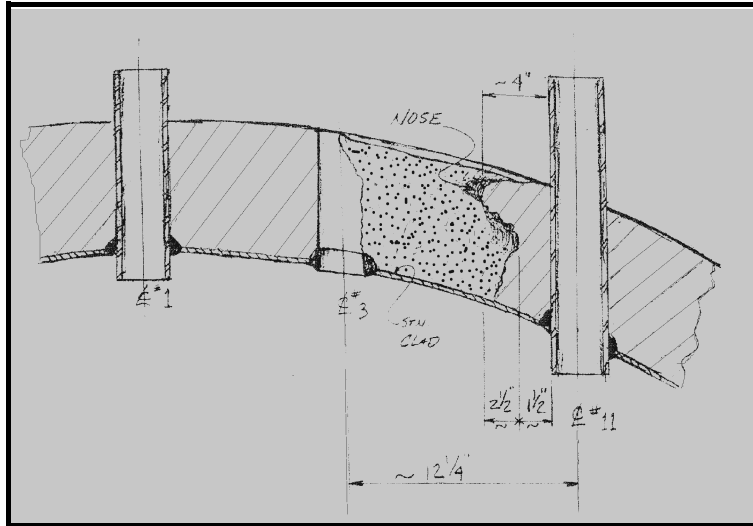
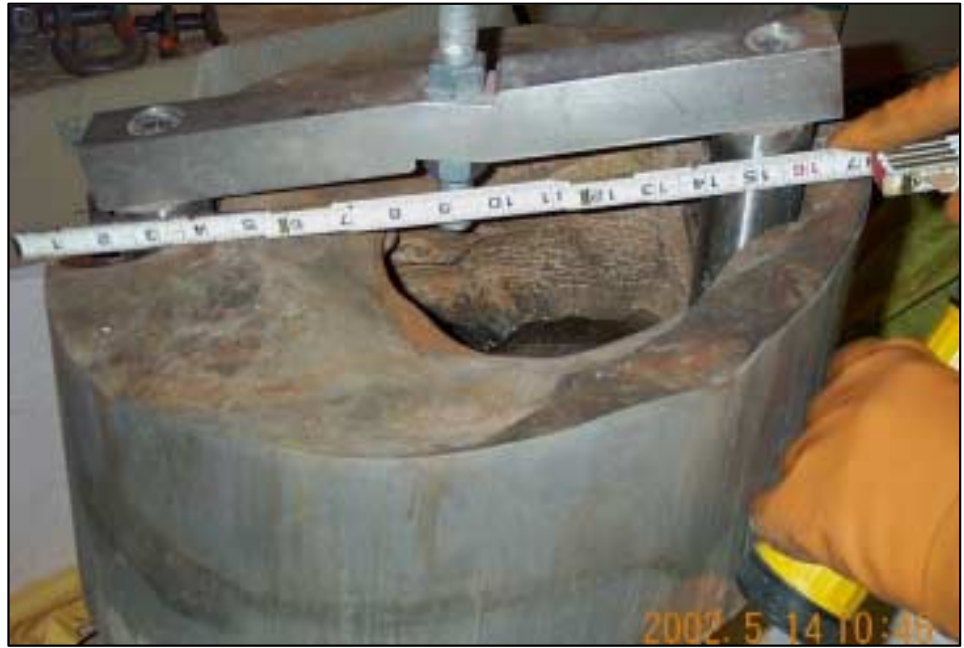
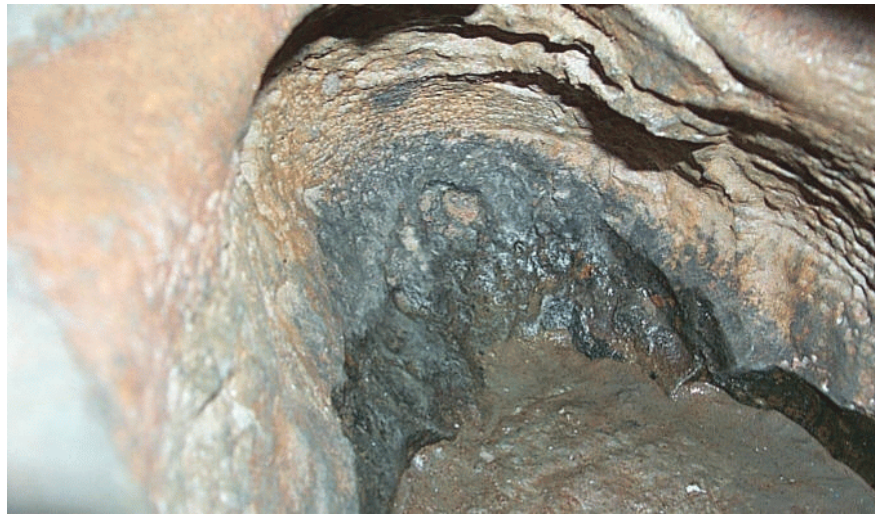
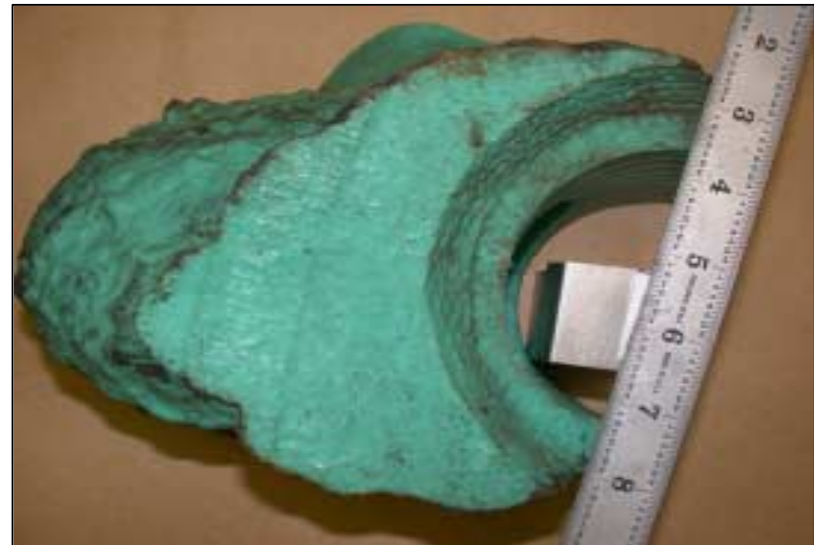
**Figure 2-4**  
**DBNPS VHP NOZZLE NO.3 DEGRADATION CAVITY**

On March 5, 2002, the licensee for DBNPS in Oak Harbor, Ohio, discovered a cavity in the RPV head, adjacent to VHP Nozzle 3. Davis-Besse Nuclear Power Station is a pressurized water reactor (PWR) plant. A schematic of a typical PWR reactor is shown in Figure 2-1. The DBNPS Nuclear Steam Supply System (NSSS) was fabricated by the Babcock & Wilcox (B&W) Company. Typical B&W RPV head and VHP nozzle design and fabrication details are depicted in Figures 2-2 and 2-3. Details of the degradation cavity in the DBNPS RPV head are shown in Figure 2-4.

In a May 7, 2002, meeting between the NRC and FENOC, the licensee presented its technical root cause of the RPV head degradation. Boric acid corrosion of the carbon steel RPV head was clearly the primary contributor to the degradation. The primary corrosive attack of the RPV head was likely caused by leakage from a long through-wall axial crack in VHP Nozzle 3, but may also have been assisted by control rod drive mechanism (CRDM) flange leakage onto the RPV head from above. The potential for boric acid degradation of the carbon steel of an RPV head, as a result of leakage through a cracked VHP nozzle, was recognized and analyzed in industry safety evaluations submitted to the NRC in 1993 (refer to Section 3.2.3). However, at

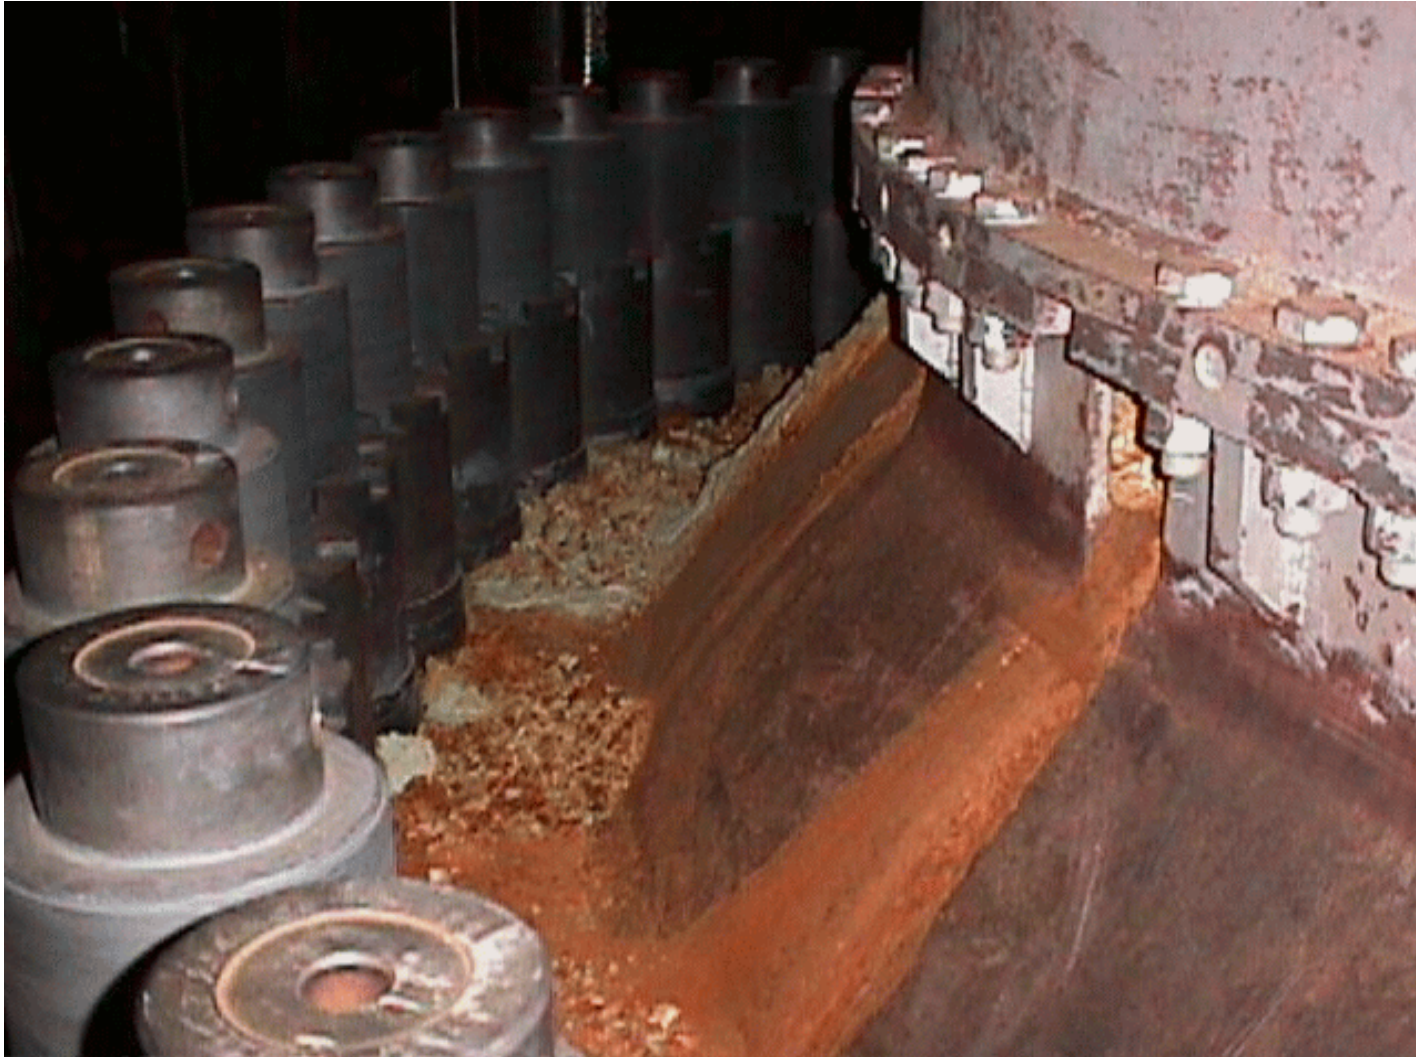
**Figure 2-5 BORIC ACID DEPOSITS ON RPV HEAD FLANGE**

Prior to the DBNPS VHP nozzle leakage and RPV head degradation event, there were two other significant boric acid degradation events previously at DBNPS. One of these involved the head vent flange to Steam Generator No. 2 (1993), while the other involved the pressurizer spray valve (1998). In addition to these events, the plant experienced CRDM flange leakage throughout its operating life, which resulted in the accumulation of boric acid deposits on the RPV head. At some point in the latter half of the 1990s, the combination of flange leakage and leakage through VHP Nozzle 3 caused the formation of the wastage cavity that was discovered in March 2002. As previously discussed, the mechanism for the cavity formation clearly involved corrosion due to the presence of boric acid. It is also likely that the degradation leading to the cavity formation had progressed over several years. As described elsewhere in this report, there were also indications that significant boric acid degradation was present in the DBNPS containment, most notably red/brown deposits on the containment radiation monitor filter elements and other components. As subsequently observed in videotapes documenting the condition of the RPV head from 1996 onward, the accumulation of boric acid deposits and corrosion products on the top of the RPV head (particularly in the region of VHP Nozzle 3), precluded effective visual examination for leakage from cracked VHP nozzles. Figure 2-5 shows a picture of boric acid deposits on the DBNPS RPV head flange region from Refueling Outage (RFO) 12 (2000). Figure 2-6 depicts boric acid deposits on the RPV head found during

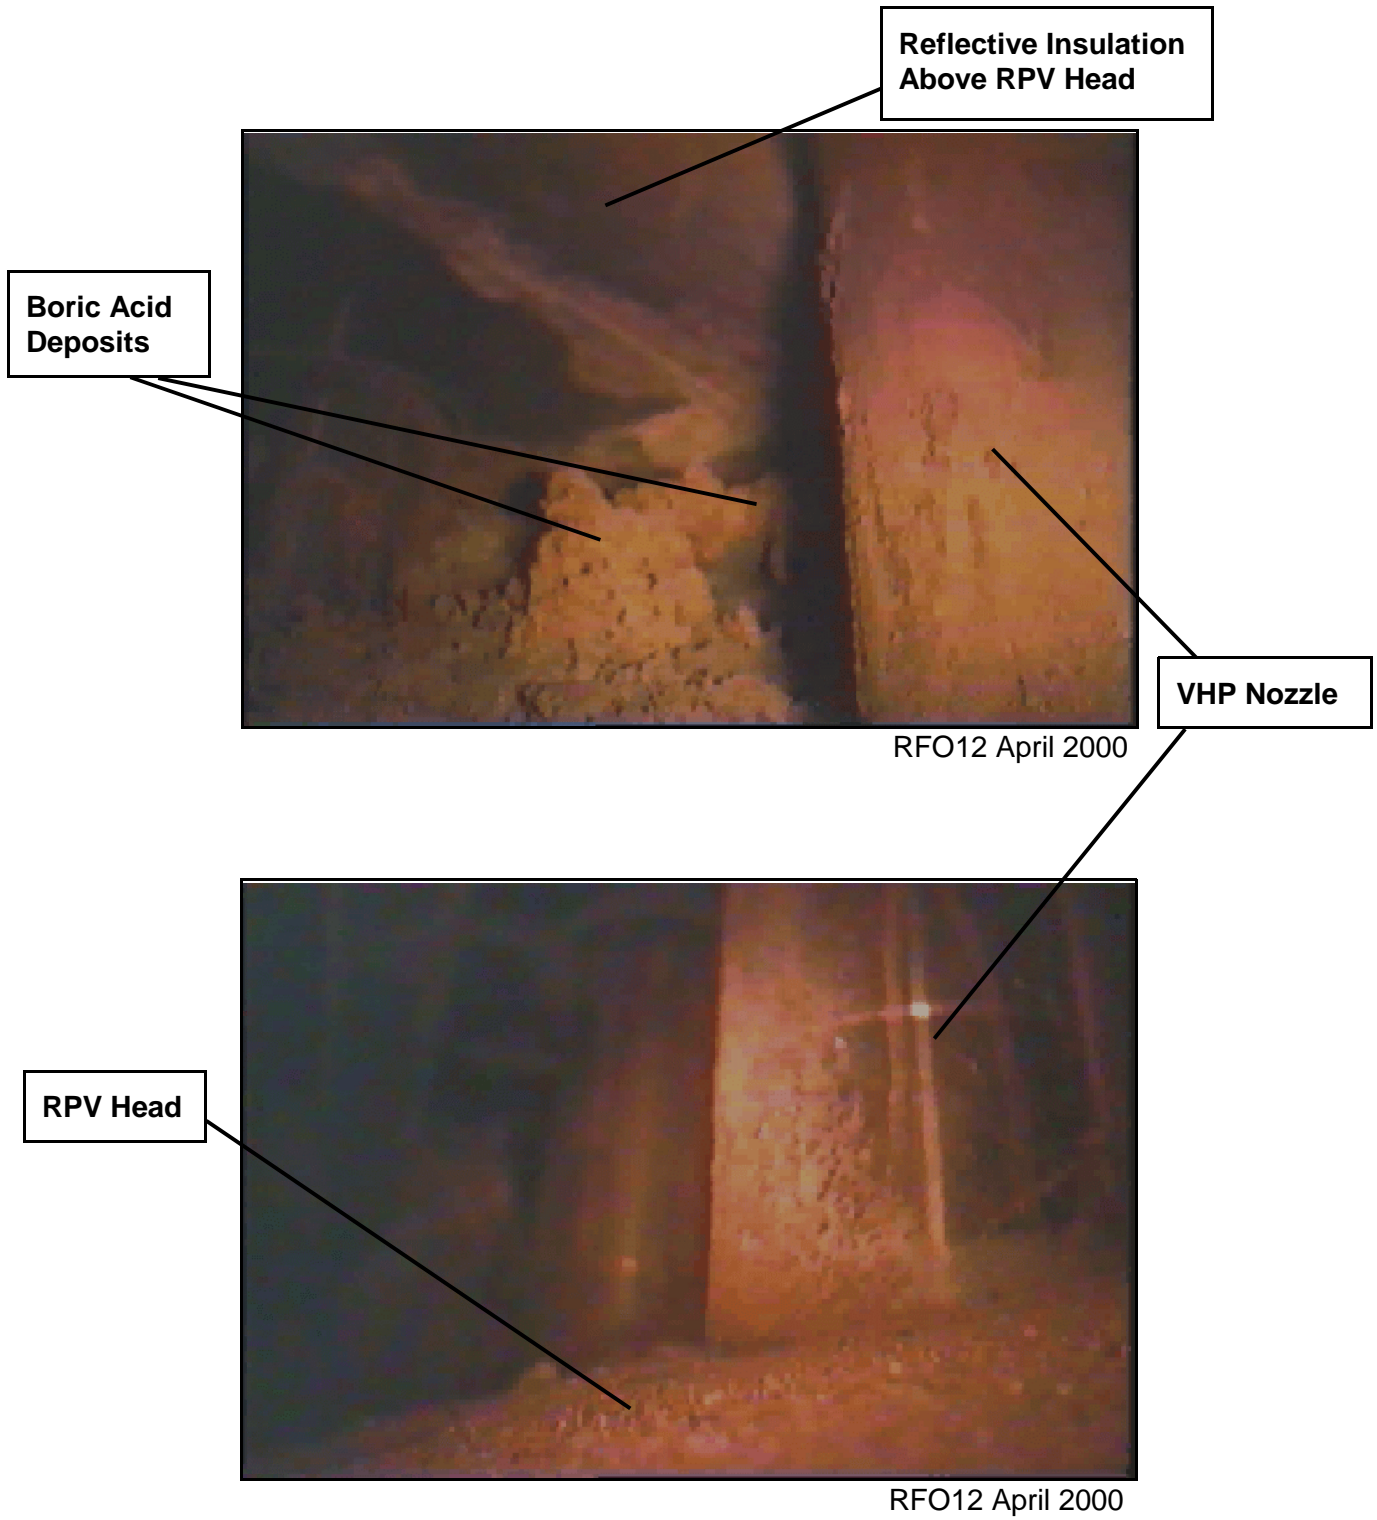
Figure 2-6

**BORIC ACID DEPOSITS ON THE RPV HEAD (top) AND AREA RELATIVELY FREE OF DEPOSITS (bottom)**
