MISCELLANEOUS ELECTRICAL VOLUMES II

FIST VOLUMES 3-18 THROUGH 3-28

UNITED STATES DEPARTMENT OF THE INTERIOR

BUREAU OF RECLAMATION

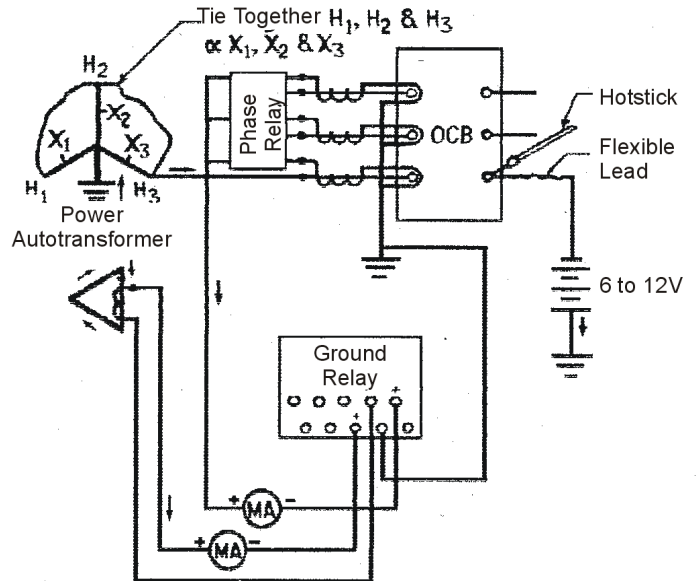
Connections required in the test are shown in the illustration. From the manufacturer's instruction book and prior testing, the relative polarity of the relay coil terminals will be known. With the milliammeters connected as shown with respect to the known polarity of the relays, closing of the circuit will cause both milliammeters to deflect in the same direction; when the circuit is opened they will deflect in the opposite direction. In the case of relays protecting large transformers, several seconds must be allowed for the iron to magnetize before the circuit is opened to get a deflection.

SIMPLE METHOD requires one or two dc milliammeters, plus a dc supply source to prove connections to relays

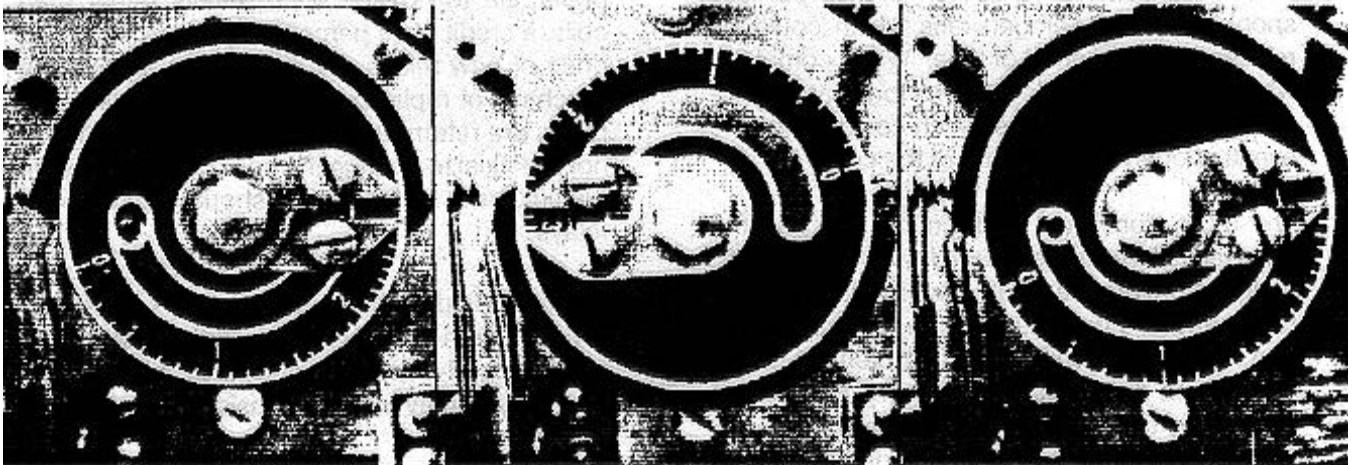
Figure 1

At one of our facilities, false tripping has been attributed to overtravel in a General Electric Type RPM timer relay. The cam assembly overtraveled while resetting, and this allowed the TU2 contact to close. This happened just as the fault was reestablished and allowed the backup distance relay to trip without delay.

Some newer RPM relays are provided with a cam to maintain the TU2 contacts closed, after its time delay, until the RPM is deenergized. When a long-time delay is required, the back edge of the cam is near the TU2 contacts at the reset position; and any overtravel during resetting can cause the cam to bump the TU2 contacts closed.

At locations where this is found to be a problem, a small portion of the cam's surface can be removed from the back edge. Only that portion of the cam that is causing the problem should be removed, since a shorter time delay setting may be required in the future.

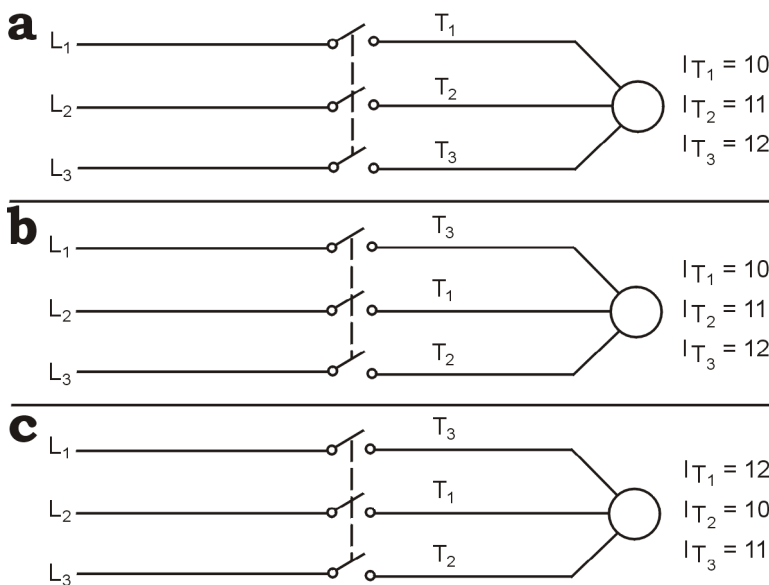
A simple test will determine whether current unbalance is the result of voltage unbalance, or caused by problems in the motor itself, Fig. 1. Line leads and motor terminal leads are identified, and a current check is taken of each line lead. Motor terminals are then rotated in such a manner that direction of motor rotation is preserved. Another, current reading is taken of each line. if the high-reading line remains the same as on the first check, then the problem is one of voltage unbalance. If the high-reading is observed on another line, then the problem is internal to the motor or is in its connections.

Simple test determine whether current unbalance or motor problem is cause of voltage unbalance. In (a), line current-readings are taken of each phase. In (b) and (c) motor terminal connections have been rotated in a manner that motor direction of rotation remains unchanged. In (b), the same readings prevail as were read for the test connection in (a), indicating that the problem is caused by unbalanced line voltages. In (c), the highest-reading phase has shifted, indicating that the problem is in the motor connections or the motor.

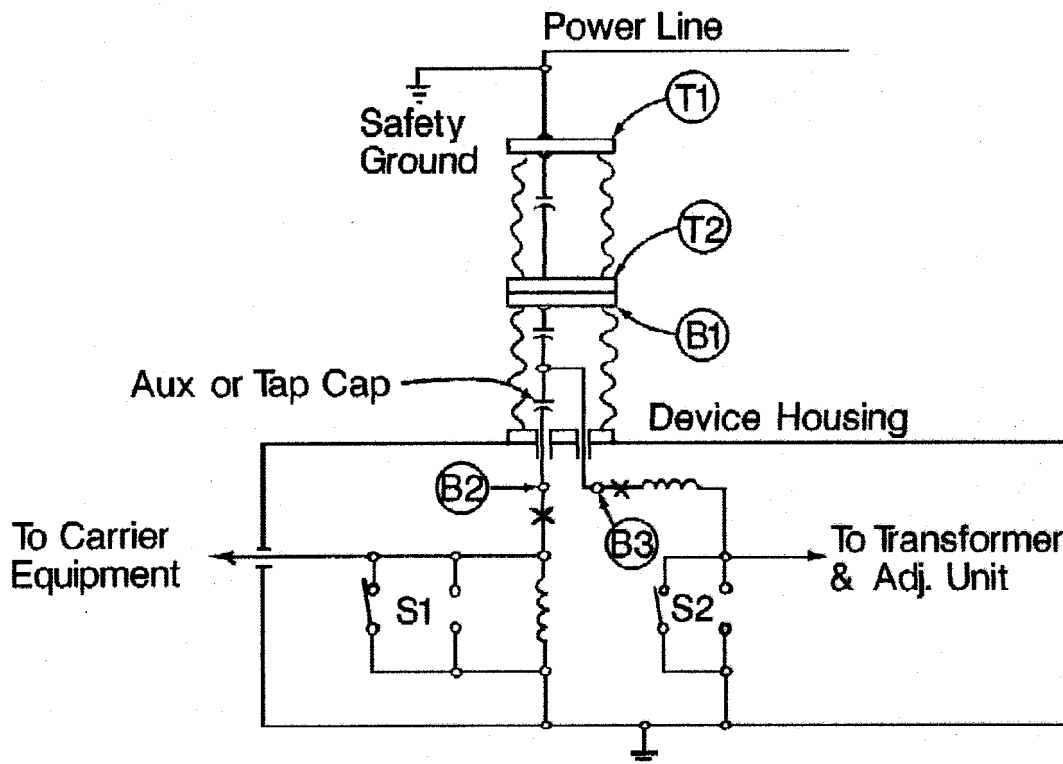
Figure 1

The test procedure outlined under [Figure 1](#) is designed to produce the data required for individual units with a minimum of disconnection, while enhancing safety and reducing the effects of electrostatic interference.
