## Update – Battery Booster Explosions

DOE/EH-0697

2005-15 (Update)

January 2006

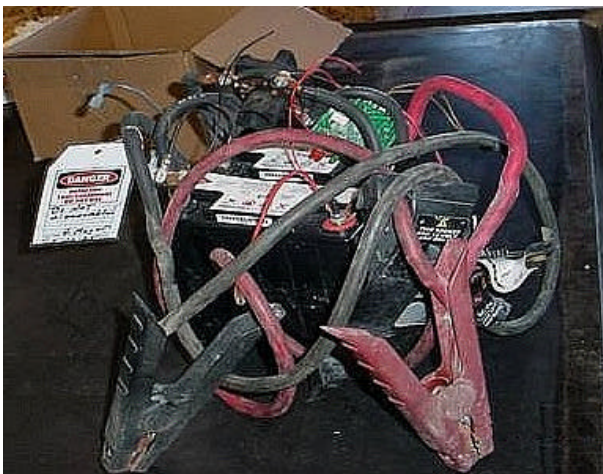
**Figure 1. The damaged battery booster after the explosion**

On August 30, 2005, at the River Protection Waste Treatment Plant construction project, a maintenance mechanic connected the battery booster unit to a crane and attempted to jump-start it. When he turned the selector switch from 24v to OFF, the booster exploded, propelling pieces of the plastic case as far as 25 feet. No one was injured, but three workers, including the maintenance mechanic, reported to the project medical facility with hearing impairments. [ORPS Report EM-RP--BNRP-RPPWTP-2005-0021]

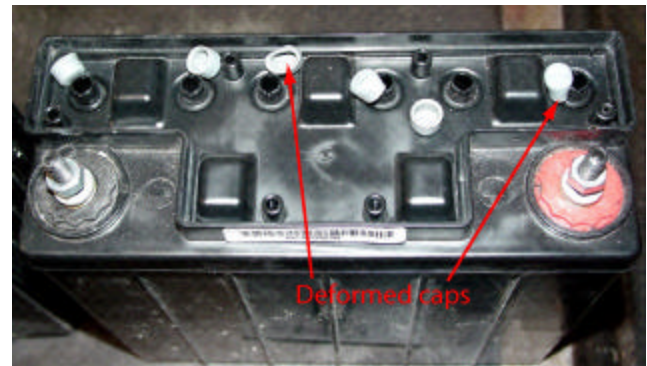
The mechanic and his superintendent examined the remains of the battery booster unit and found that the rubber caps that covered the battery cells had not been properly seated on the cells, and two of the caps were visibly deformed (see Figure 2 below). Also, the case itself did not appear to have been adequately ventilated, and the switch contacts were exposed. Investigators believe that built-up hydrogen gas inside the case was ignited by a spark generated by the exposed contacts.

**Figure 2. The uncapped battery cells**

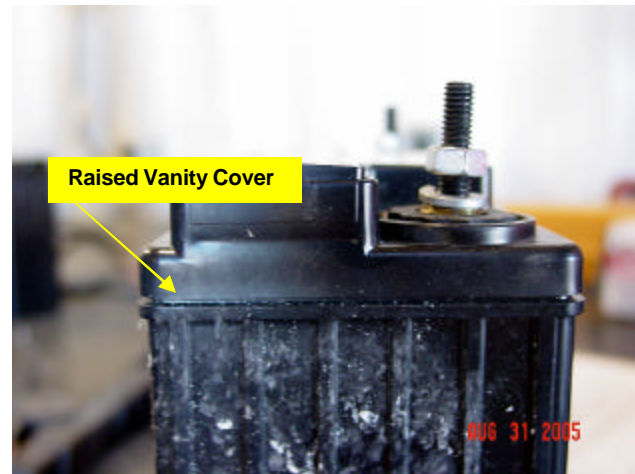
**Figure 3. Battery with raised vanity cover**

The Office of Environment, Safety and Health recommends that sites examine their inventory of battery

charging equipment, removing any Solar Truck Pac model ES1224 units from service to check for any indication that the battery seal has been lost. The actual cell caps are covered with a vanity cover; any displacement or distortion in this vanity cover may indicate loss of battery cell seal (Figure 3). Removal and replacement of the vanity cover is not recommended as careful alignment is needed to avoid damaging the battery cell seals. If these indications are found, contact the manufacturer and report this finding in the Occurrence Reporting and Processing System (ORPS).
