UNITED STATES  
NUCLEAR REGULATORY COMMISSION  
OFFICE OF NUCLEAR REACTOR REGULATION  
WASHINGTON, D.C. 20555-0001

January 17, 1995

NRC INFORMATION NOTICE 95-02: PROBLEMS WITH GENERAL ELECTRIC CR2940 CONTACT  
BLOCKS IN MEDIUM-VOLTAGE CIRCUIT BREAKERS

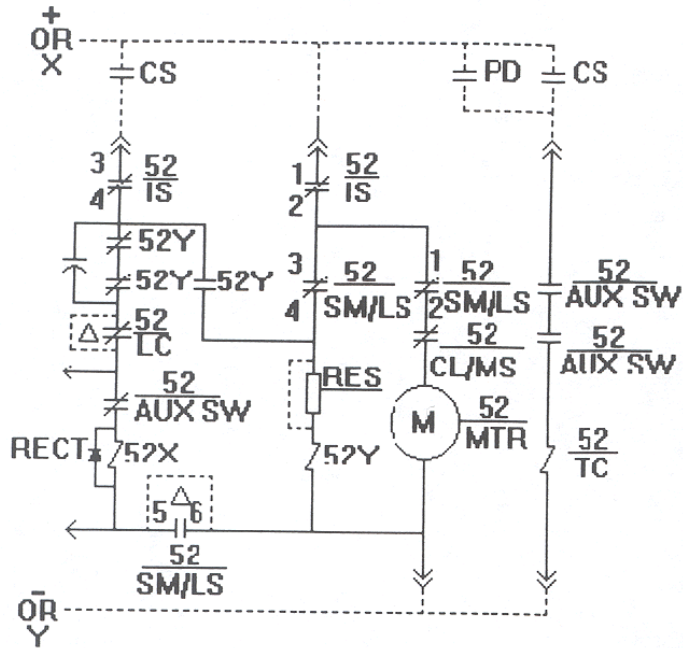
FIG. 1 MAGNE-BLAST CONTROL CIRCUIT SCHEMATIC  
 (ADAPTED FROM INSTRUCTION BOOK GEI-88761)

The stuck open power switch contacts are shown on the breaker connection diagram as contacts 5 and 6 of "power switch" assembly 52-SM/LS, which consists of three CR2940 contact blocks or switches ganged together. Depending on the breaker configuration with the various control options available, contacts 5 and 6 of 52-SM/LS are known as the "close permissive switch," the "control power available/closing spring charged switch," or most commonly, the "white light switch." The breaker electrical connection diagram (also shown in Attachment 2) shows the three CR2940 contact blocks that comprise power switch 52-SM/LS as normally open contacts 1, 2, 3, and 4, and normally closed contacts 5 and 6. Note that at some plants, plant diagrams may designate these as switches S-1 (5 and 6), S-2 (3 and 4), and S-3 (1 and 2). The three contact blocks are opened or closed simultaneously by the interaction of their plungers and moving contact carriers, according to the state of the breaker closing spring. A striker and cam mechanism, which operates by the action of the breaker closing spring and its charging and release mechanism, actuates the first contact block plunger. Its moving contact carrier in turn operates the plunger of the next (middle) tandem contact block, the moving contact carrier of which then operates the plunger of the third contact block. Contacts 3 and 4 are in the anti-pump (52Y relay) circuit and contacts 1 and 2 control the closing spring charging motor. The switch with contacts 3 and 4 and the switch with contacts 1 and 2 are both of the normally open (or "momentary contact") configuration with catalog number CR2940U310. Contacts 5 and 6 are in series with the breaker closing circuit. The switch with contacts 5 and 6 is a normally closed or "maintain contact" configuration; catalog number CR2940U301.

In operation, immediately after the breaker closing spring discharges to close the breaker, contacts 1, 2, 3 and 4 of power switch assembly 52-SM/LS are held closed during the charging cycle of the closing spring and are allowed to reopen (by means of their individual internal contact return springs) when the breaker closing spring is fully charged. There were no reported instances of mechanical interference and failure to return to the normally open state. Contacts 5 and 6, held open during closing spring charging, are supposed to reclose by means of their internal contact return springs when released upon completion of the breaker closing spring charging cycle. However, the CR2940U301 contact block containing contacts 5 and 6 in two of the Magne-Blast breakers being tested failed to reclose when required, thus disabling the closing control circuits of the breakers. The moving contact bar of the normally-open configuration contact block (CR2940U310) was a relatively straight piece; whereas, the moving contact bar of the failed normally-closed configuration contact block (CR2940U301) was a complex curved piece, which appeared to make it more susceptible to interference, apparently from excess plastic mould flashing.

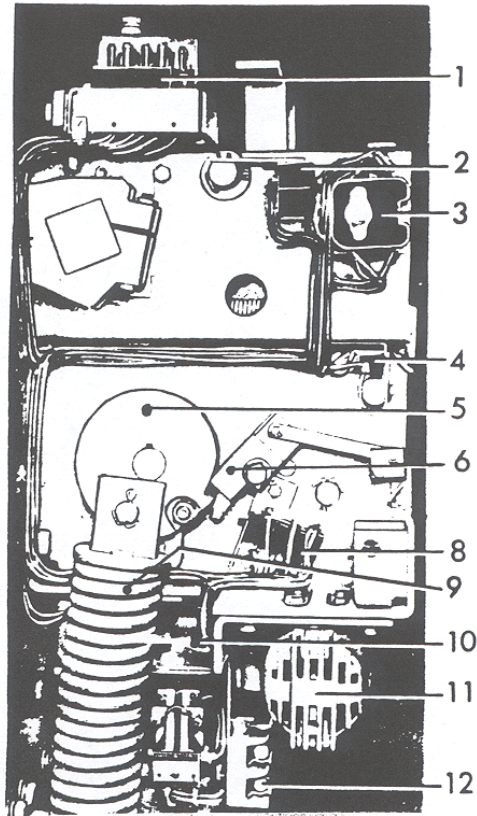
FIG. 2 - LEFT SIDE VIEW  
 ML-13 OPERATING MECHANISM

(they can also be closed in the test position). The contact block or switch containing 52IS contacts 1 and 2 (in series with the breaker closing spring charging motor circuit) is mounted on the bottom of a small bracket at the top of the left side of the operating mechanism frame by means of two special machine screws. The heads of these screws are to be drilled and tapped with female threads to accept the male threads of the mounting screws of the other 52IS contact block (containing contacts 3 and 4 in the breaker closing circuit) that is designed to be mounted onto the bottom of the first contact block. A lever of the breaker cubicle interlock mechanism operates the plunger of the upper (charging motor interlock) contact block. Simultaneously, the moving contact carrier assembly inside the upper switch operates the plunger of the lower (closing interlock) contact block that protrudes into the case of the upper contact block. The lack of female threads being cut into the hole drilled in the head of one of the two special mounting screws in the upper contact block prevented the use of one screw in mounting the lower contact block properly. As a result, during subsequent operations of the breaker, the lower block became loose such that its plunger could not be depressed to close it by the moving contact carrier of the upper contact block. The breaker closing circuit therefore did not function.
