UNITED STATES
NUCLEAR REGULATORY COMMISSION
OFFICE OF NUCLEAR REACTOR REGULATION
WASHINGTON, D.C. 20555

December 2, 1994

NRC INFORMATION NOTICE 94-84: AIR ENTRAINMENT IN TERRY TURBINE
LUBRICATING OIL SYSTEM

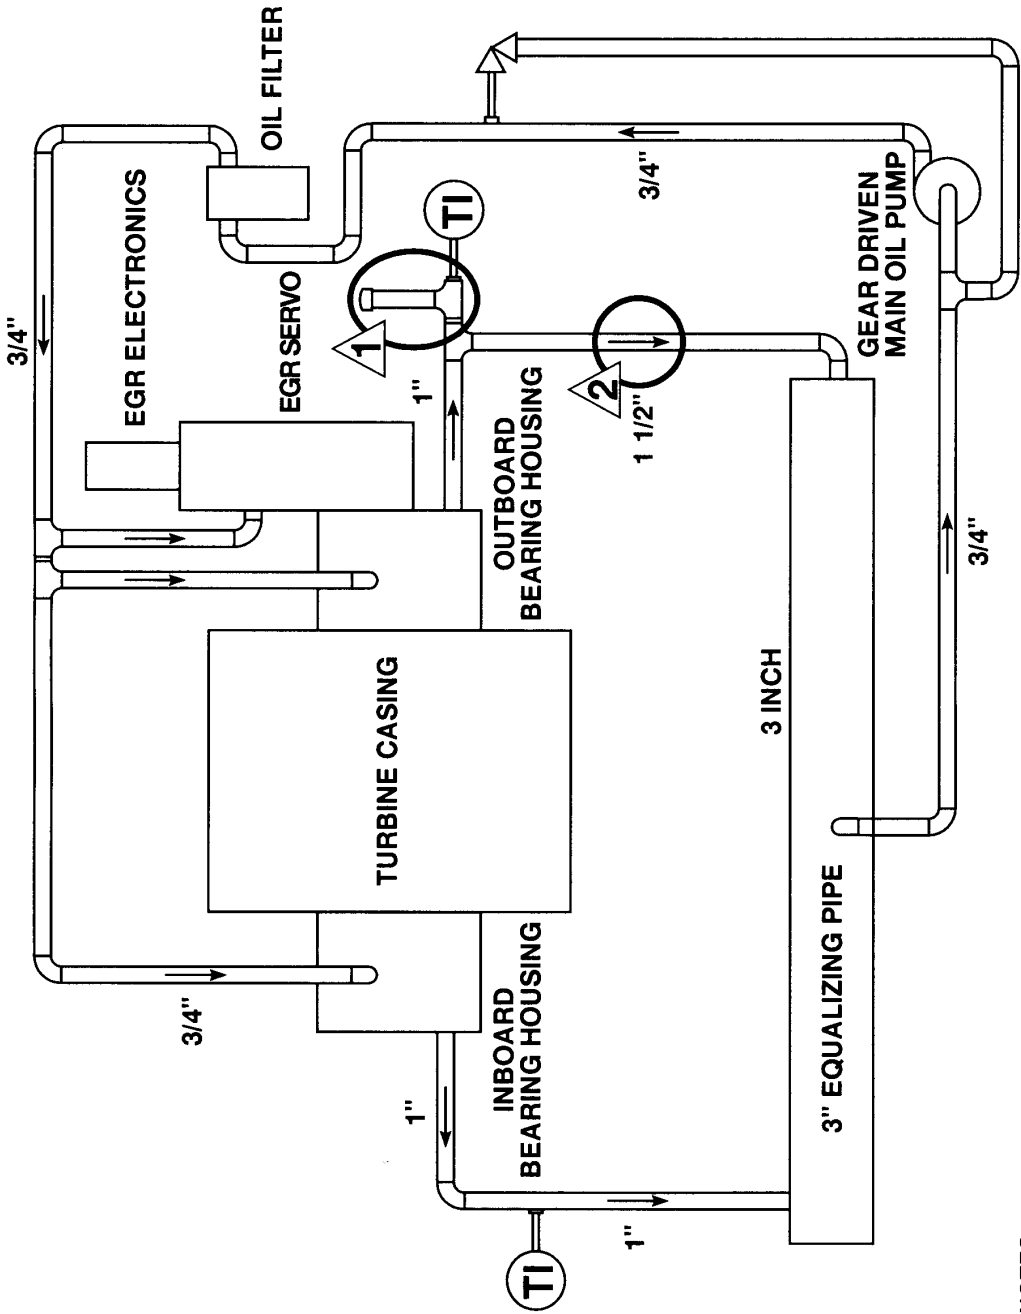
MODIFIED TERRY TURBINE OIL LUBRICATION SYSTEM AT SEQUOYAH NUCLEAR PLANT

On November 6, 1994, the licensee for Sequoyah experienced a similar lube oil leak on the turbine-driven auxiliary feedwater (TDAFW) pump during a surveillance test run. Troubleshooting efforts, including ultrasonic testing, determined that air voids were forming in the outboard drain line, preventing adequate oil return from the outboard bearing housing, and resulting in oil level fluctuations between the two bearing housings.

The problem begins when entrained air causes foaming of the oil that prevents proper drainage from the outboard bearing housing and its oil level begins to increase. When the level rises to the point where the overspeed trip disk is rotating in oil, more aeration and foaming occur, exacerbating the problem.

Investigation determined that the air voiding phenomenon was time dependent, which raised questions about the adequacy of the duration of previous TDAFW pump test runs. Factors such as pump speed, oil system configuration, and oil system pressure, could affect when this phenomenon would occur. The licensee corrective actions included installation of an atmospheric vent at the top of the outboard bearing drain line and replacement of a portion of the 1-inch drain line with a 1.5-inch drain line (see Figure 1). An extended test run following the modifications verified that the problem was corrected.

- 1 ADDITION OF ATMOSPHERIC VENT AT THE TOP OF THE OUTBOARD BEARING DRAIN LINE.
- 2 OUTBOARD BEARING HOUSING DRAIN LINE ENLARGED FROM 1" TO 1 1/2".
