SAFETY & HEALTH BULLETIN

Removable Beryllium Contamination Found on Radiation Monitoring Instruments

DOE/EH-0673

Issue No. 2005-03

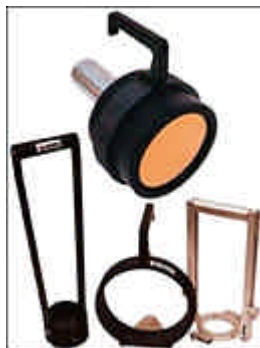
A technician was determining whether the laboratory's old, non-functioning sodium iodide scintillation detector probes could be repaired or should be packaged for disposal. The probes had been stored in the laboratory's calibration facility for a long period of time, likely over 10 years. The technician requested precautionary swipes of probes to determine if there was any surface contamination, after being told that some of the probes might have beryllium windows.

The preliminary results of the beryllium swipes showed elevated levels of surface contamination. The source of the beryllium contamination was believed to be oxidation of unprotected beryllium windows on the old probes.

- All areas where the probes were stored or handled were isolated.
- Swipes were taken in adjacent areas.
- Air monitoring was initiated to determine if there was any airborne contamination.
- Occupational medical personnel spoke with the workers who may have handled the probes to assure they are informed of the hazards of their potential beryllium exposure.
- All of these types of sodium iodide scintillation detector probes at the laboratory were located and swiped.
