Refinery Operator Fatality Caused by Improper Manlift Use

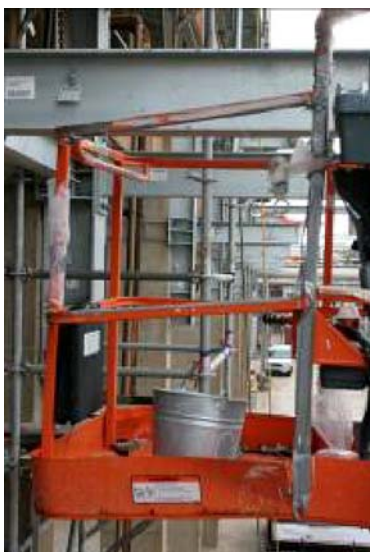
The injured pipefitter was part of a crew engaged in installing and welding structural steel piping for new flares. The work area was about 33 feet from the ground and was very congested with numerous obstacles. As Figure 1 shows, there were only a few inches of clearance between the top of the manlift basket (orange) and the 10-inch I-beam above. Because the I-beam was directly above the area where the manlift basket was positioned, the pipefitter was forced to lean over as he worked.

Figure 1. Manlift proximity to upper I-beam

Investigators discovered that the pipefitter was aware that he had chosen the least accessible path to get to the work area. They also determined that the manner in which the pipefitter was using the manlift violated OSHA requirements, manufacturer recommendations, and company policy. Section [453](#), *Aerial lifts*, of the OSHA Standard for Construction, 29 CFR 1926, requires employers to ensure that only authorized, trained employees operate aerial lifts and that manufacturer limits on boom and basket loads are not

exceeded. In this case, investigators uncovered evidence that the pipefitter had been operating the manlift improperly that day by setting the speed control to the highest level, circumventing the joystick's safety interlock, and applying a vertical force to the basket. None of these actions is permitted by the manufacturer.

In response to this unfortunate accident, BP Texas City revised its manlift operating procedure, hazard assessment form, and pre-use inspection record.

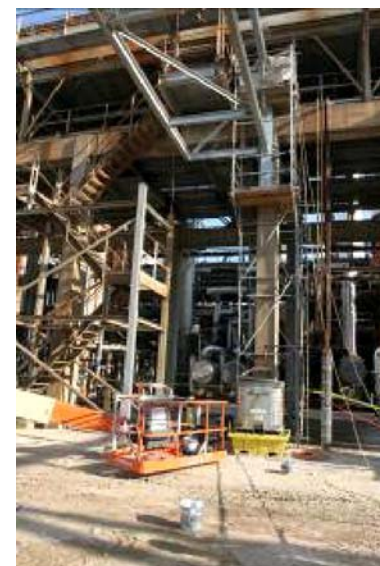
Figure 2. Another view of the work area

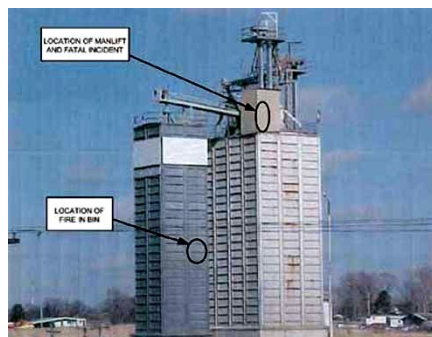
Figure 3. Location of the fire and adjoining silo

breathing apparatus (SCBA), was instructed to search for fire-spread in an adjacent silo (see Figure 3). The firefighter had received only oral instructions on operating the manlift from a plant employee.

further. Another firefighter climbed a fixed ladder to the fourth level, where he discovered that the victim's SCBA had become wedged between the frame of the manlift and the fourth-floor opening, which was smaller than that of the other floors. Resuscitation attempts were unsuccessful. The ensuing investigation identified concerns in work planning, hazards identification, training, communication, and written procedures. The investigators recommended that the manufacturing plant clearly label any potentially hazardous areas.

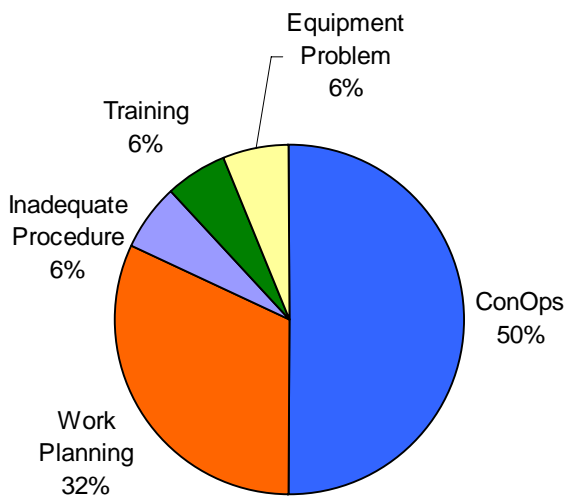
The Office of Health, Safety and Security analyzed 50 events involving manlifts at DOE sites that bear some similarity to the two fatalities. As Figure 4 illustrates, the root cause of half of the events involved conduct of operations failures (i.e., inadequate understanding of hazards, errors in equipment selection, procedure violations, and errors in judgment). Nearly a third of the events involved poor work planning.

Figure 4. Root causes of selected DOE manlift events

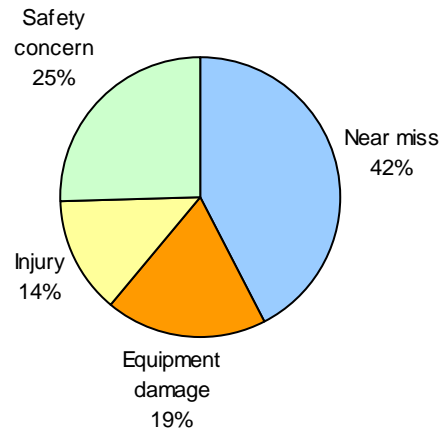
Figure 5 demonstrates that of the 50 events analyzed, nearly half were near misses and 14 percent resulted in injuries. The most recent of these events occurred on June 26, 2006, at Los Alamos National Laboratory (LANL). A subcontractor mechanic and a teamster were unloading an electric manlift from a tilt trailer when the trailer suddenly toppled over. The mechanic, who was sitting in the manlift basket, bruised his

Figure 5. Outcome of analyzed events
