COMPLETION REPORT LOWER STOKES FISH PASSAGE IMPROVEMENT PROJECT BEAVER CREEK, METHOW SUBBASIN, WASHINGTON MARCH 2004

Lower Stokes Fish Passage Improvment Project

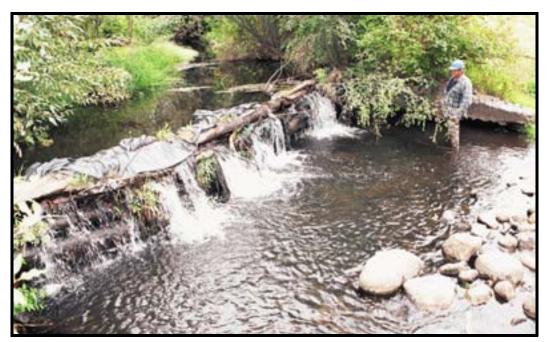
The 3½-foot-high diversion dam, made of stacked logs and lined with plastic (photo A-1), was removed entirely. To replace it, a so-called "Rosgen" rock vortex weir (Weir No. 1) was installed at the site of the new point of diversion (photo A-13). The weir formed a small pool at a higher elevation, and this allows sufficient water to be diverted into the irrigation ditch to meet the water right. The water drop over the new weir is 0.8 feet, which meets State standards for fish passage. Because the large rocks establish a hardened point, Weir No. 1 provides "grade control" which means the stream is unable to downcut its bed over time.

Photo A-1. Original Lower Stokes Diversion Dam just prior to removal; the dam height is about 3½ feet. Compare the concrete wing wall behind worker and the water elevations to that shown in Photo A-20.

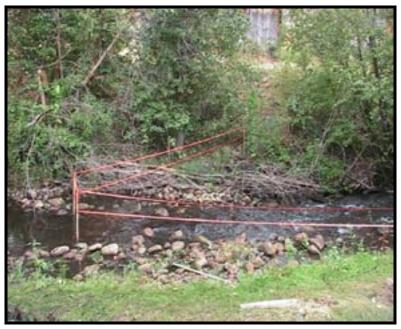
Photo A-2. Preliminary layout of upper weir (Weir No. 1); flow is from left to right.

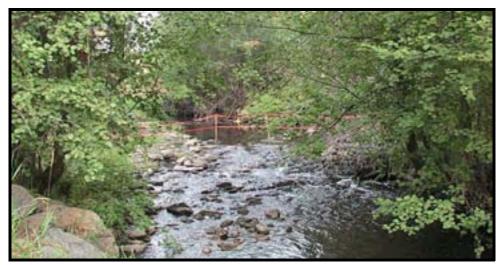
Photo A-3. Looking upstream at Weir No. 1 showing the drop to pool. The height of the riffle (\pm 10 inches) equals the amount of headloss available to deliver the irrigation water.

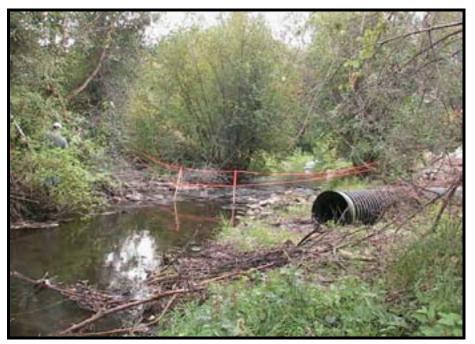
Photo A-4. Looking downstream at entrance to dewatering pipe and the Weir No. 1 layout. The cofferdam will be located between the pipe and the layout.

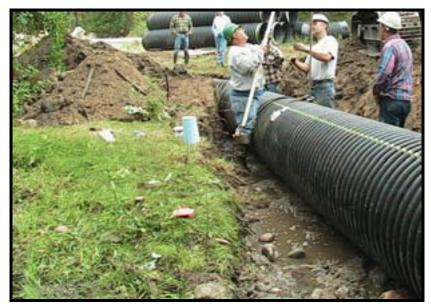
Photo A-5. Excavation crew checking for proper slope of dewatering pipe.

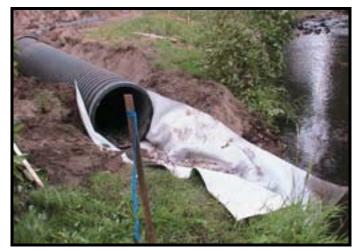
Photo A-6. Downstream end of dewatering pipe with fabric for erosion control.

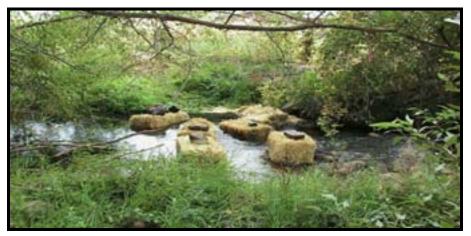
Photo A-7. Straw bales below Weir No. 1 construction area prior to dewatering. The straw bales help filter silt during and after construction.

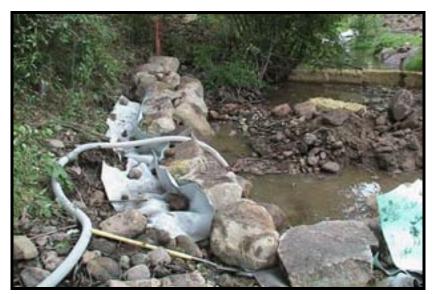
Photo A-8. Installation of geotextile fabric behind first arm of Weir No. 1. Attached to the hose is a trash pump, sending the muddy water up onto the shore so the silt can settle out while the water returns. Note the downstream straw bales.

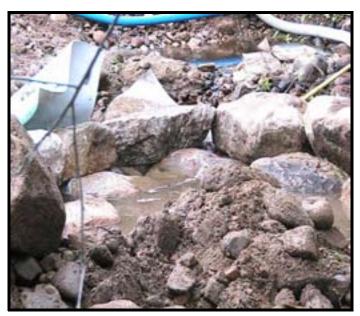
Photo A-9. Looking upstream at base rocks of Weir No. 1. To prevent downstream movement, the rocks on the top layers are behind the base rocks.

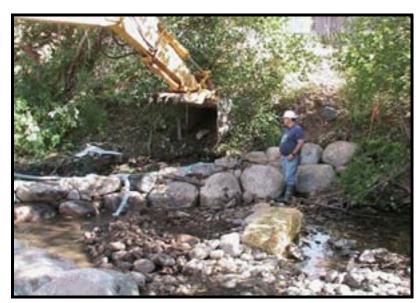
Photo A-10. Backfilling the left-bank weir arm. Note the even slope of the weir arm toward the center of the structure and the lack of spaces between rocks.

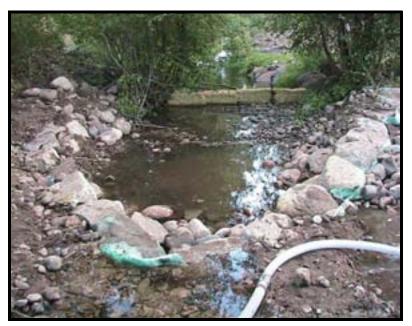
Photo A-11. Looking downstream at completed Weir No. 1 (trash pump hose in foreground).

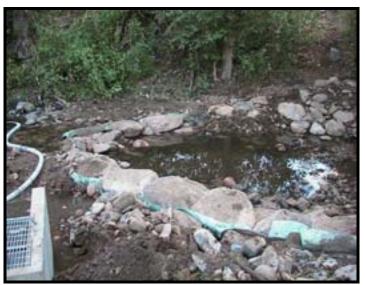
Photo A-12. Completed Weir No. 1. The new diversion box (at lower left) was placed so that it will draw water at low flows but not block water from the right-side weir arm area (foreground).

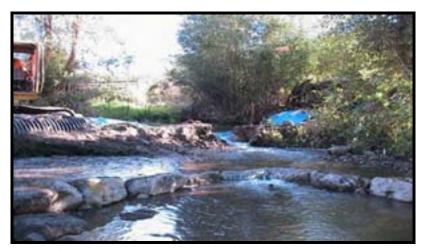
Photo A-13. Looking upstream at newly completed Weir No. 1 and the partially breached cofferdam A. To avoid releasing the backed-up water all at once, the cofferdam is breached in small sections.

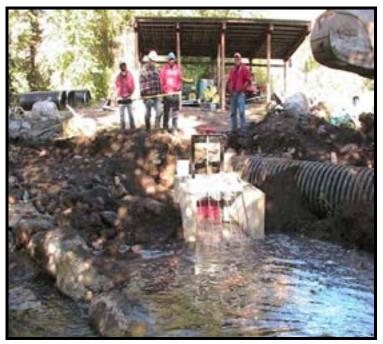
Photo A-14. The newly installed diversion box was tested and satisfied the flow requirement for the landowner's water right.

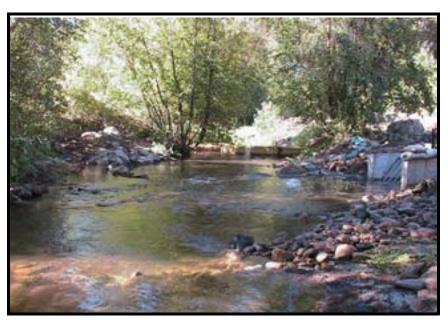
Photo A-15. Looking downstream at Weir No. 1 (center) from the remains of Cofferdam A. The new diversion box is at center right.

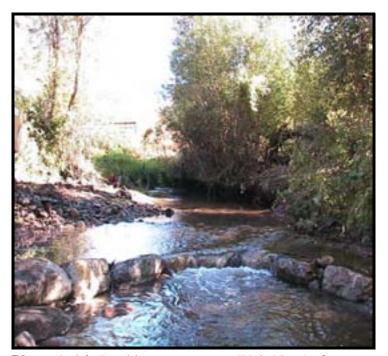
Photo A-16. Looking upstream at Weir No. 1 after Cofferdam A has been removed.

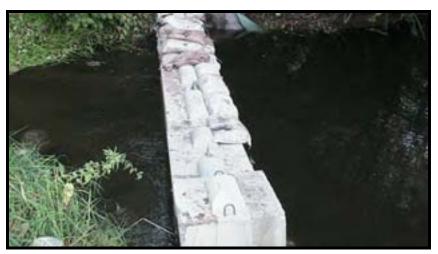
Photo A-17. Concrete "ecology blocks" were used as the core of Cofferdam B, which dewatered the construction sites for Weirs No. 2 and 3. They are cast from leftover concrete batches, reducing waste; note the rebar "lifting eyes" for placement and removal.

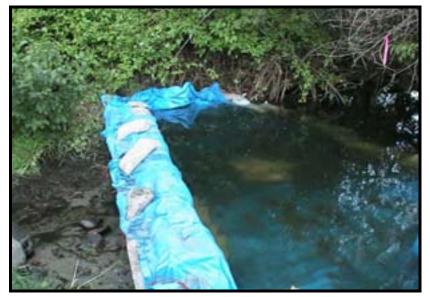
Photo A-18. Cofferdam B with sandbags holding down geotextile tarp, which holds back water.

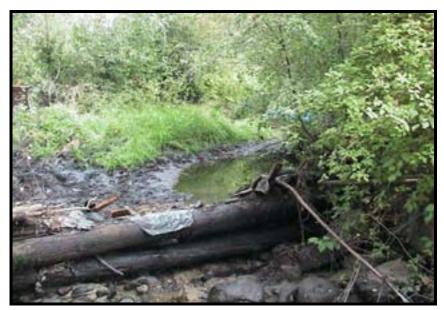
Photo No. 19. The Lower Stokes Diversion Dam was deconstructed in stages to facilitate electro-shocking and removal of fish from project area.

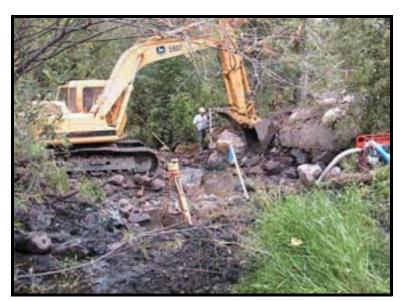
Photo A-20. Looking downstream at initial excavation of Weir No. 3. The concrete at right of photo is the upstream wall of the former diversion dam. The wall and the dam were about the same height (as shown in Photo A-1).

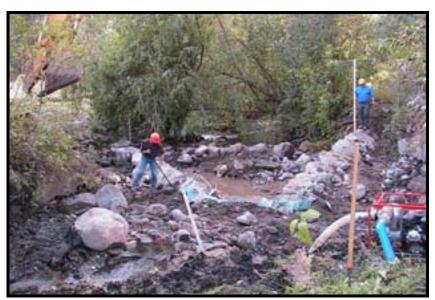
Photo A-21. Looking downstream at Weir No. 3 just prior to completion. The worker at center-left is filling the spaces between the large rocks with cobble-size material and fines.

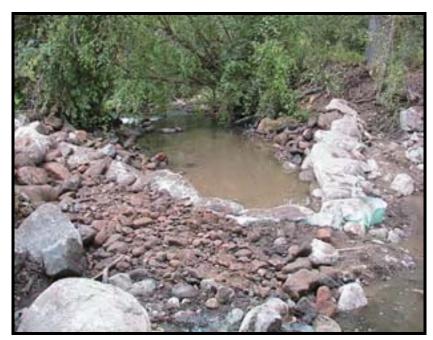
Photo A-22. Looking downstream at Weir No. 3 about 3 hours after Photo A-21 above was taken. The weir has been backfilled and the scour hole excavated.

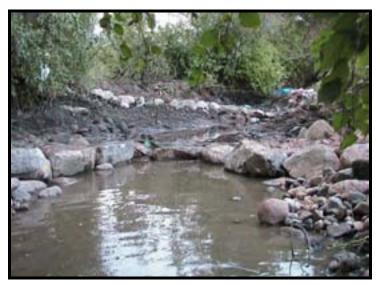
Photo A-23. Looking upstream at the lower weirs (Nos. 3 and 2).

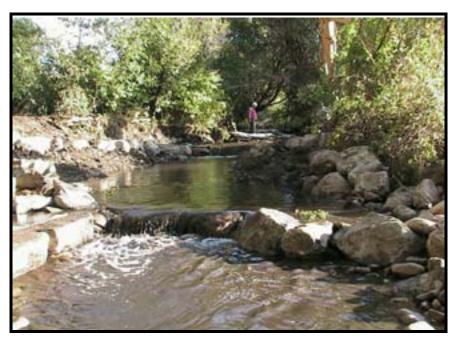
Downstream, near the location of the former diversion dam, two more vortex rock weirs, No. 2 and No. 3, were constructed; these stabilized the slope and energy of stream in this reach. These structures were designed to provide grade control and eliminate "headcutting" (the large, downward movement of a streambed that results when a stream is steepened). See Photo A-24.

Photo A-24. Looking upstream at Weirs No. 3 and No. 2 as water muddy from the removal of Cofferdam B flows past.

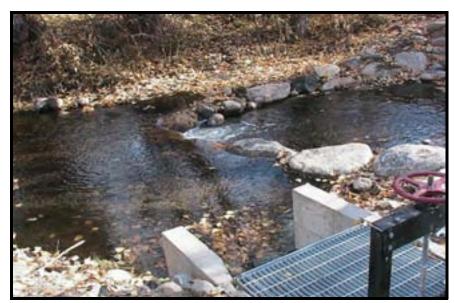
Photo A-25. This picture of Weir No. 1 was taken about mid-November 2003, about 2 months after completion. The weir was designed to pass a "bankfull" flow of 170 cfs and was tested with one minor event of about 30 cfs. The flow shown is about 6 cfs.
