Re: Inaccurate SJM 3219 Safety Alerts & Skyjack Service Bulletins 60 and 77

Service Bulletin #60 SJM3219 Scissor Ends Inspection And Repair

Service Bulletin #77
SJM3219 Scissor Ends Inspection and Repair
*******SAFETY RELATED*******

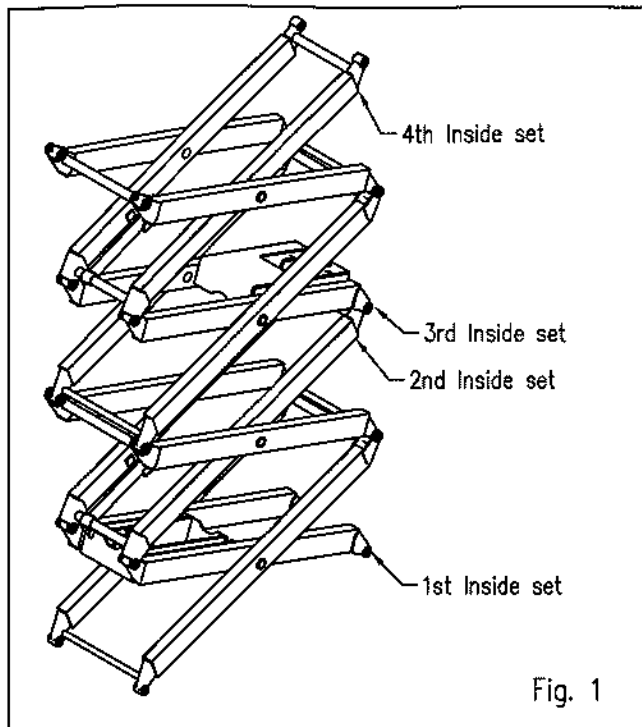
Fig. 1

1. Raise the machine to approximately a platform height of six feet.
2. Set safety bar in place
3. Visually inspect for cracks on all male and female scissor end weldments. Special attention should be focused on the second and third inner level scissor end weldments, both ends and the tubes up to approximately one-inch from the weld. (Note: Level #1 is the bottom level)

Note:
From Machines inspected, cracks
have shown in 2nd and 3rd inner
scissor arm sets.

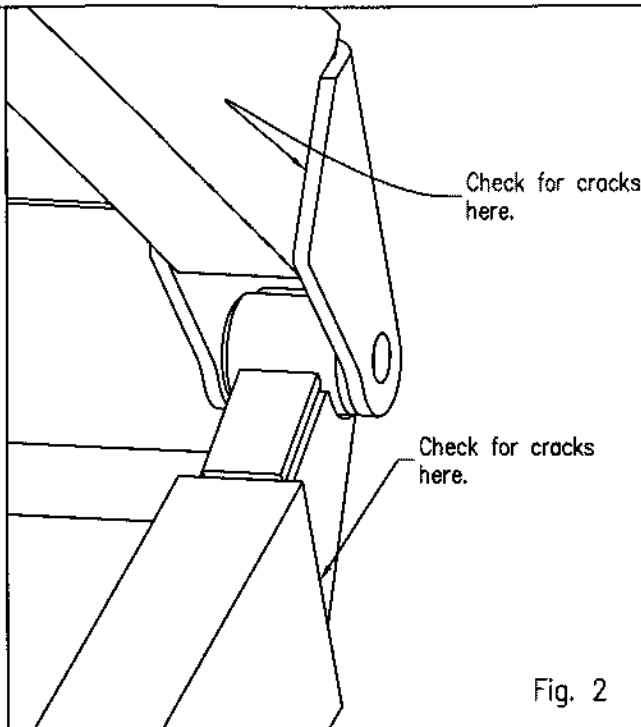
Fig. 2

1. Completely lower the machine.
2. Connect pressure gauge to the lift hose and set lift pressure to the pressure stated on the unit's identification plate.
3. Ensure unit lifts 500 lbs. And no more.
4. Cycle the unit to ensure smooth operation and re-inspect scissor ends for any cracking.
(See Figures #1 & #2)

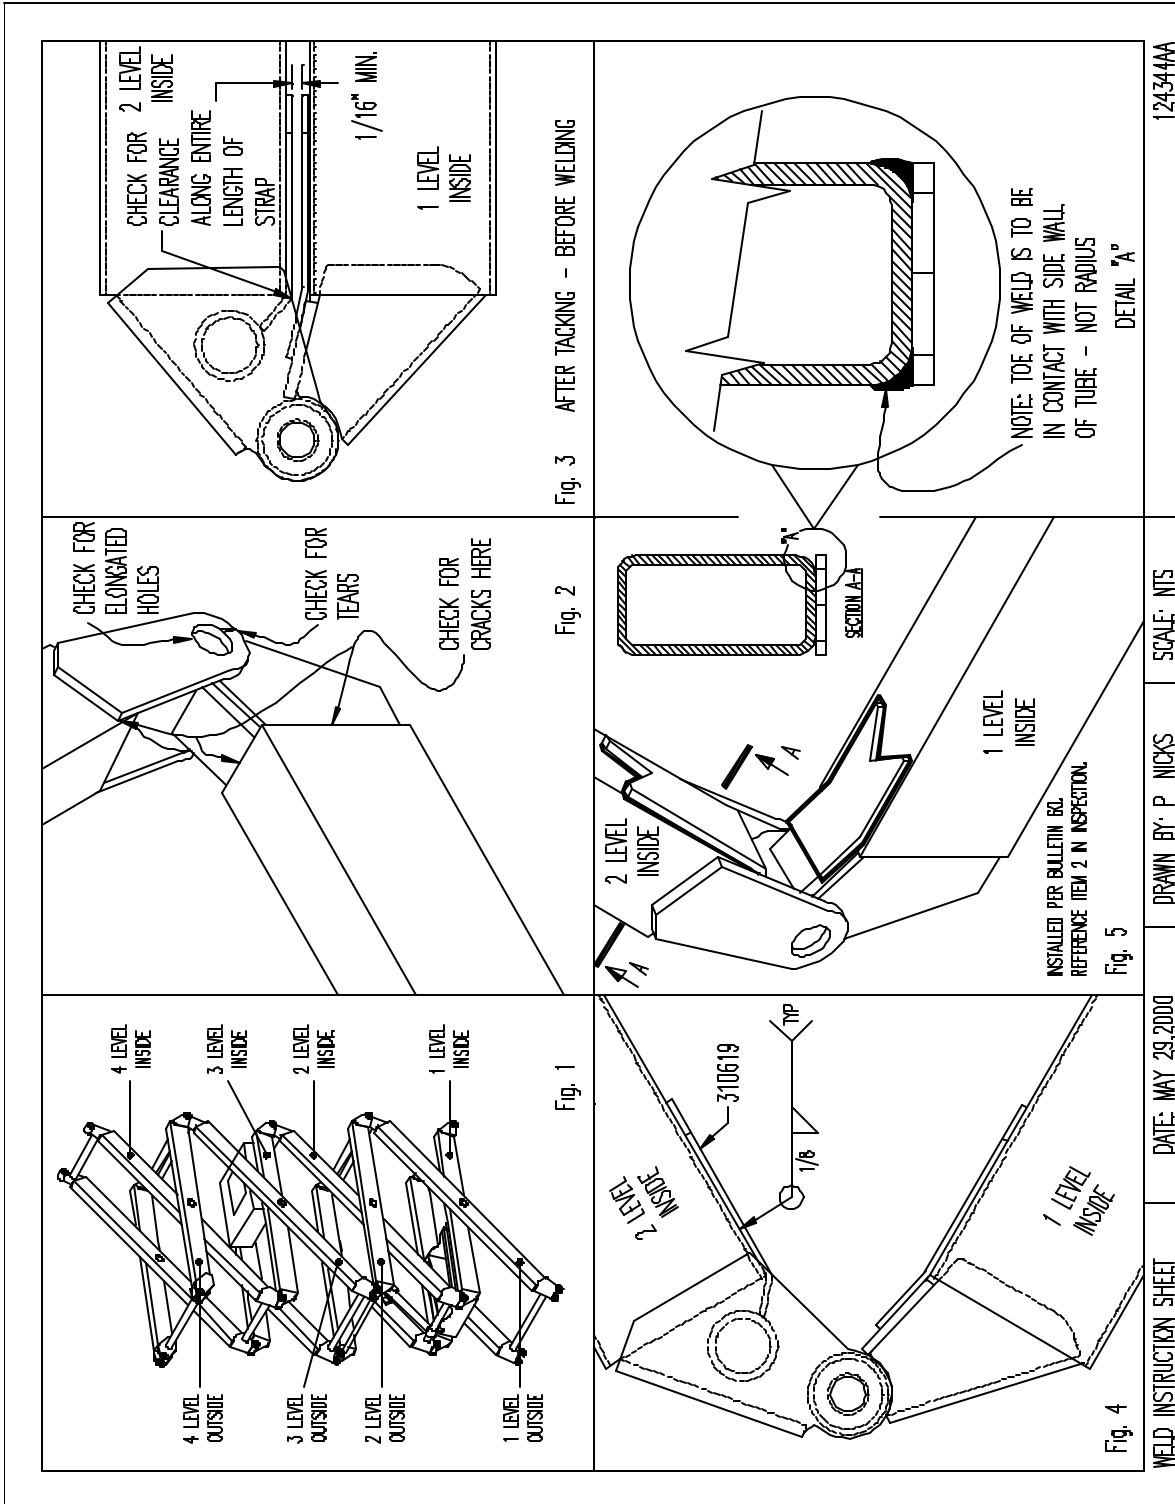
WELD INSTRUCTION SHEET

3. After paint removal, visually inspect for cracks and faulty welds on all male and female scissor end weldments. Special attention shall be focused on the bottom corners of the scissor tube at the toe of the welds joining the female scissor ends to the tube. See Fig. #2.

4. Remove paint from the area of cracks to be welded and weld the cracks.
5. Remove paint from the areas where the provided reinforcing straps, part #310619, are to be welded (see figures #3 and 4). Note: All female ends are to be reinforced with strap #310619, except the four female ends at the base (bottom of level 1) and the two female ends under the platform (the top of level 4). (Note: Only level 2 inside is shown in figures # 4 and 5).

6. At each location in turn, clamp the provided strap to the scissor tube at the female scissor end making sure that the end of the strap is in contact with the boss inside the female end and the length of the strap is in complete contact along the tube. See figures #3 and 4.

9. Check that there is clearance between each male and female scissor end as shown in figure # 3. Use a feeler strap 1/16" thick. If there is interference or contact between the boss in the female end and the adjacent male end or the strap and the adjacent scissor tube, adjust the strap location. If this is not possible, report to SKYJACK service at 800-275-9522 or 630-262-0005.

10. If there is clearance, raise the platform back to the position required for welding.
11. Weld all straps all around with 1/8" fillet welds using 3/32" or 1/8" type E7018 rods. The welds must be continuous from the tube to the inside of the female end and across the boss inside the female end. See figures #4 and 5.
