2006-02

**Snapped Lifting Sling Causes Fatalities**

November 2006

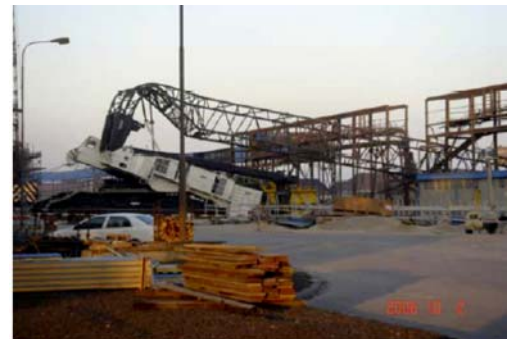
On October 2, 2006, two people were killed and several others seriously injured when a crane boom flipped over its cab and dropped onto a pipe rack (see photo) and an office building. The crane had been lifting a load when the lifting sling snapped, dropping its load and causing the crane boom to flip.

Important Point:	<ul style="list-style-type: none"> <li>The crew was experienced, judged to be one of the “most professional and safety-conscious contractors in Saudi Arabia” performing a “routine simple lift.”</li> <li>The sling inspection was inadequate.</li> </ul>
Contributor:	<ul style="list-style-type: none"> <li>The crew stated that the sling “looked OK.”</li> </ul>
