**Red Bluff Diversion Dam
Fishway Attraction Study**

Spillway Operation Test

Conducted for
Red Bluff Field Office

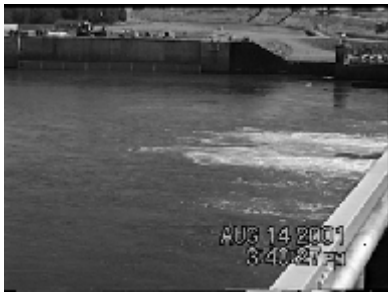
Figure 5 - Photographs of surface flow conditions during test 1.

Hydraulic Jump Stability - Releases from gates 5,6, and 7 produced a bubble plume that extended to approximately the spillway endsill (figure 5). The hydraulic jump downstream of gates 5, 6, and 7 appeared very stable. The gate openings tested provided a ratio of tailwater depth to hydraulic jump conjugate depth greater than one for all gates (table 1). Reclamation Engineering Monograph 25 recommends a ratio greater than 1 for good jump stability.

View of white water turbulence downstream of gates 5, 6 and 7.

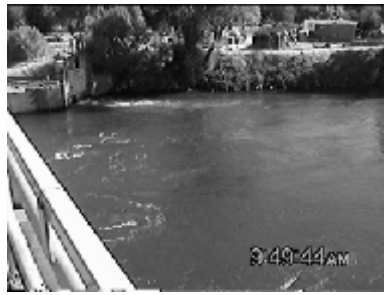
View of surface flow conditions downstream of the left bank fishway.

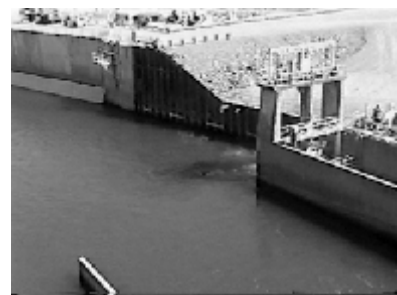
View of surface flow conditions downstream of the right bank fishway.

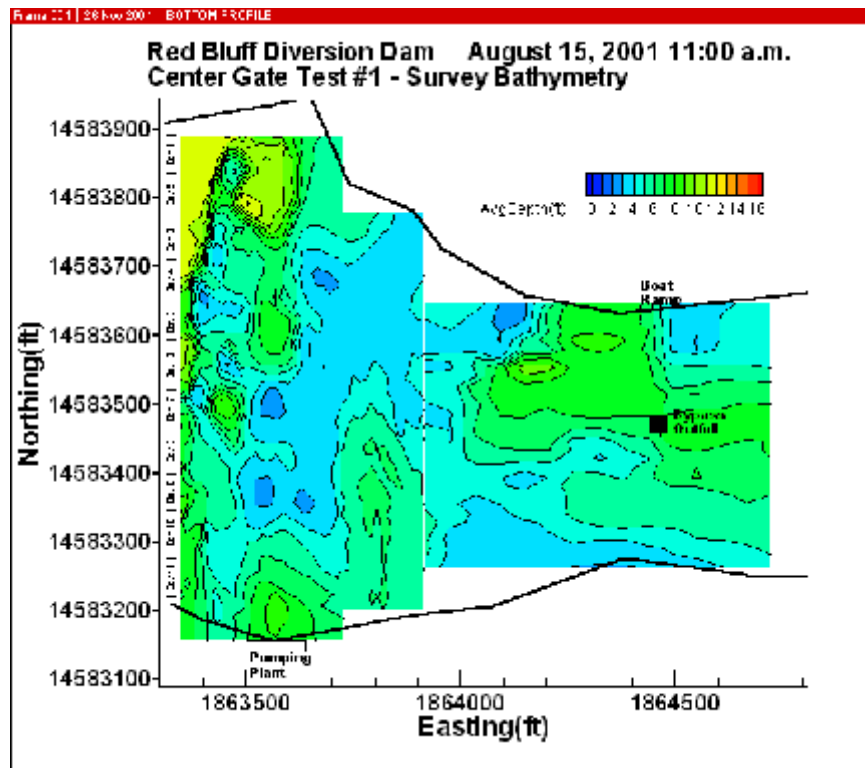
Figure 6 - River bathymetry downstream of Red Bluff Diversion Dam after test 1.

River Bathymetry and Flow Conditions Downstream of the Spillway - Figure 6 gives the post test river bathymetry. Figure 7 shows the change in depth between pre and post test 1 conditions. Scouring in the center of the river was accompanied by deposition near each bank downstream of the fishway entrances. The large river center flows scoured material downstream of gates 5,6, and 7 exposing the spillway apron endsill and downstream riprap. Deposition of 6 ft to 8 ft occurred in front of the pumping plant downstream of bays 10 and 11 and downstream of bays 1 and 2. The rapid movement of material toward the river banks was driven by the lateral spread of spillway releases as the flow impacted the extensive alluvial deposit immediately downstream of the center gates. The dive inspection indicated the riprap was not affected by the test flow. River velocities measured during the test using an ADCP are given in figure 8. The flow field for a distance of nearly 600 ft downstream of the dam is poorly defined due to sediment deposits and the wide channel. Strong flows were measured about 300 ft downstream of the spillway apron along both river banks. The flow likely resulted from the movement of spillway flow around the river centered deposits rather than fishway flows. The ADCP data shows fishway flow rapidly mixed with spillway flows. Fishway flow velocities were not discernable from other spillway driven flow velocities beyond 50 to 75 ft downstream of the fishway entrance.

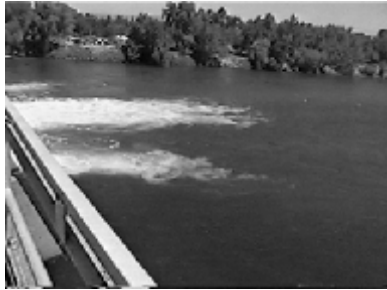
Figure 9 - Photographs of surface flow conditions during test 2.

Hydraulic Jump Stability - Releases from gates 5, 6, and 7 produced a bubble plume that extended well beyond the spillway endsill, as shown in figure 9. The hydraulic jump downstream of gates 5, 6, and 7 remained stable with the increased flow of test 2. The gate openings tested provided a ratio of tailwater depth to hydraulic jump conjugate depth greater than one for all gates, (table 2).

View of white water turbulence downstream of gates 5, 6 and 7.

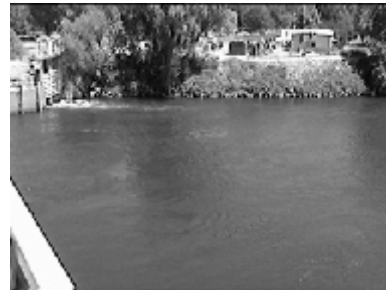
View of surface turbulence downstream of the left bank ladder.

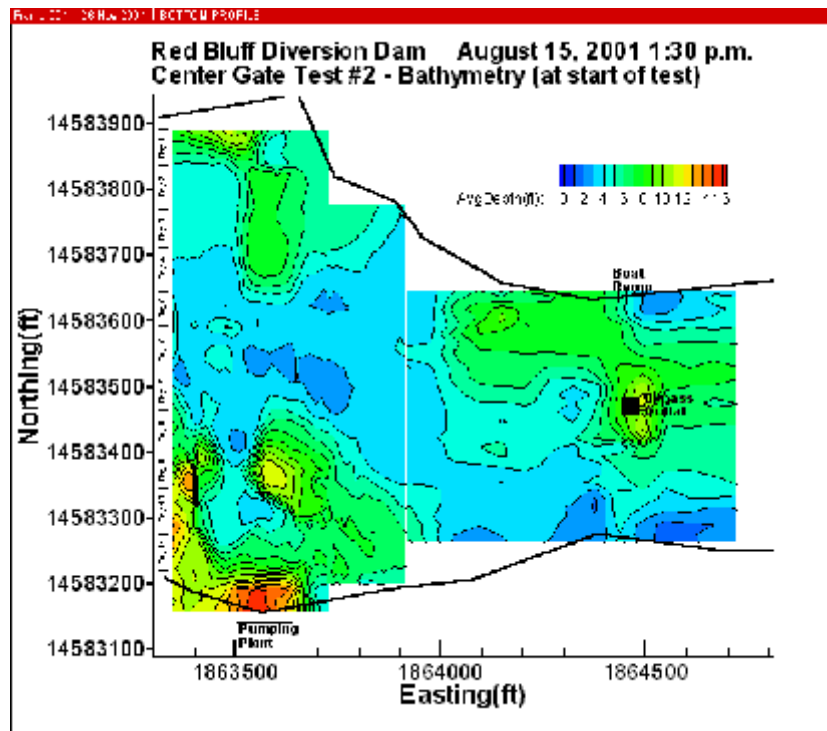
Figure 10 - River bathymetry following test 2.

River Bathymetry and Flow Conditions Downstream of the Spillway - The high river centered releases continued to move alluvial material downstream and toward both banks. The dive inspection found no indication that the riprap apron was affected by the test flow. Figure 10 gives the post test 2 river bathymetry and figure 11 shows the change in depth between test 1 and post test 2 conditions. By the end of test 2, the flow releases had cut channels toward each bank through the remaining alluvial deposit in the center of the river. The flow resulted in 4 to 6 ft of material deposition in the river downstream of bays 1, 2, 3, 4, and 11. River velocities measured during the test are given in figure 12. The large river center alluvial deposit continued to control flow patterns upstream of the fish screen bypass outfall. Similar to test 1, fishway flows were not distinguishable in the velocity measurements taken 100 ft downstream of the spillway endsill.

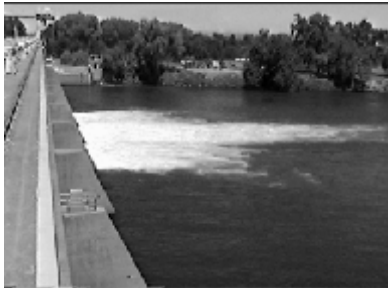
Figure 13 - Photographs of surface flow conditions during test 3.

Hydraulic Jump Stability - Releases from gates 5, 6, and 7 produced a bubble plume that extended well downstream of the spillway endsill, as shown in figure 13. The hydraulic jump downstream of gates 5, 6, and 7 remained stable. The flow through gate 6 yielded a ratio of tailwater depth to hydraulic jump conjugate depth of just under 1.0, (table 3).

View of white water turbulence downstream of gates 5, 6 and 7. Surface turbulence extended well downstream of the stilling basin endsill.

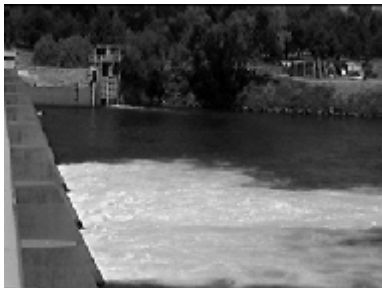
View of surface flow conditions exiting the left bank fishway.

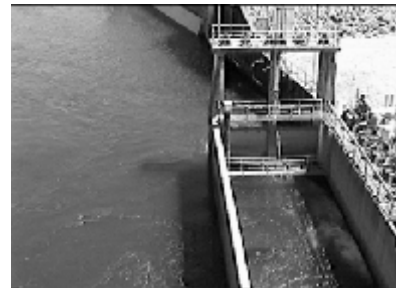
View of surface flow conditions exiting the right bank fishway.

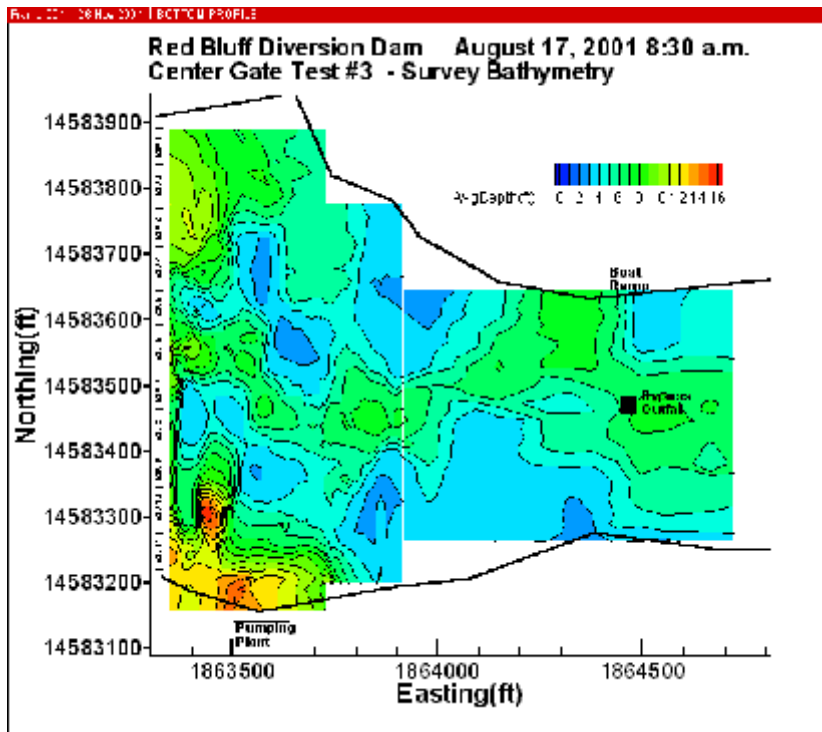
Figure 14 - River bathymetry following test 3.

River Bathymetry and Flow Conditions Downstream of the Spillway - The high river centered releases continued to move alluvial material downstream and toward both banks. Test 3 flows scoured a channel that extended about 800 ft downstream of the spillway (figure 14). Material removed during test 3 deposited downstream of bays 1 through 4 and 8 through 11 (figure 15). The dive inspection found no indication the riprap apron was affected by the test flow. River velocities measured during the test are given in figure 16. Similar to tests 1 and 2, fishway flows were not distinguishable in velocity measurements taken 100 ft downstream of the spillway endsill.
