Lunar Roving Vehicle (LRV) Missing Fender Extension Saga

Retractable Fender Extensions Required For Folding of LRV Wheels

Extracts From Apollo Mission Flight Evaluation Reports

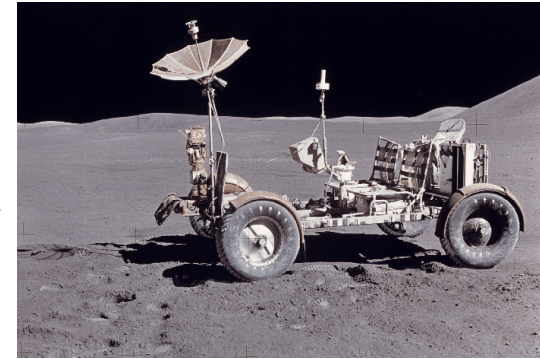
Loss of LRV Left Front Fender Extension on Apollo 15

No structural damage to the LRV was noticed by the crew, although a close inspection was not performed. A preliminary review of LRV photos reveals no wheel wire mesh breakage. These photos, however, do show that the forward portion of the left front fender was missing after EVA-1. Cause of this is unknown.

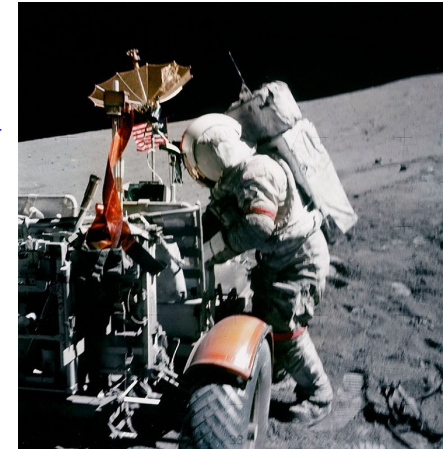
Loss of LRV Right Rear Fender Extension on Apollo 16

The crew reported that the right rear fender extension was bumped and knocked off while working around the aft end of the LRV. This created a significant problem in that excessive dust was thrown forward onto the crew and LRV by the rear wheel. A redesign of the fender extension stop is being incorporated to eliminate this problem.

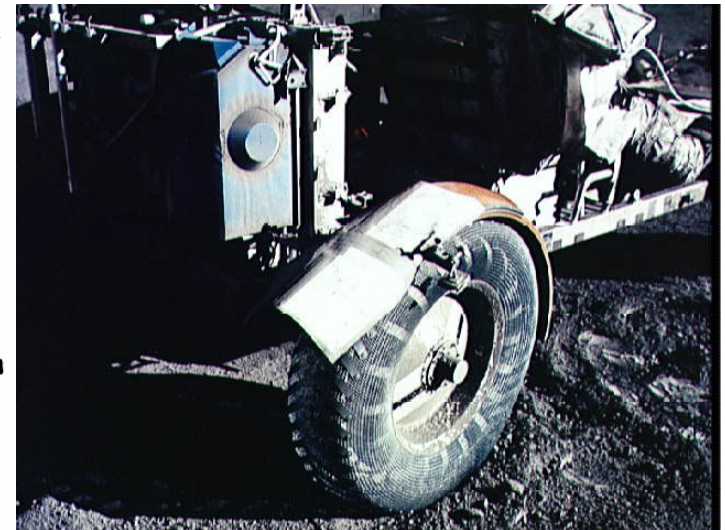
Loss of LRV Right Rear Fender Extension on Apollo 17

During Extravehicular Activity (EVA-1) at the LM prior to driving to ALSEP, the CDR inadvertently pulled off the right rear fender extension by catching it with the hammer carried in the right leg pocket of the Extravehicular Mobility Unit (EMU).

While still at the LM site, the CDR spent approximately 12 minutes taping the extension onto the fender. Because of the dusty surfaces, the tape did not adhere and the extension fell off returning from Station 1. In the moon's low gravity and hard vacuum, loss of the fender extension allowed dust to be thrown forward by the revolving rear wheel onto the LRV and crew. Per real time procedures established by MSC and MSFC, the crew taped together four Lunar Module (LM) maps and fastened them to the fender with two clamps from the LM (refer to Figure 20-3). Installation of this fix required approximately 7 minutes of CDR and Lunar Module Pilot (LMP) surface time at the beginning of EVA-2. This fix was adequate for the remainder of the mission.

A fender extension was also lost on Apollo 15 and 16. A fender modification was incorporated for Apollo 17 to prevent the fender extension from being dislodged from its guides. The fix would have been effective except that the force applied was so great that it fractured the guide material.

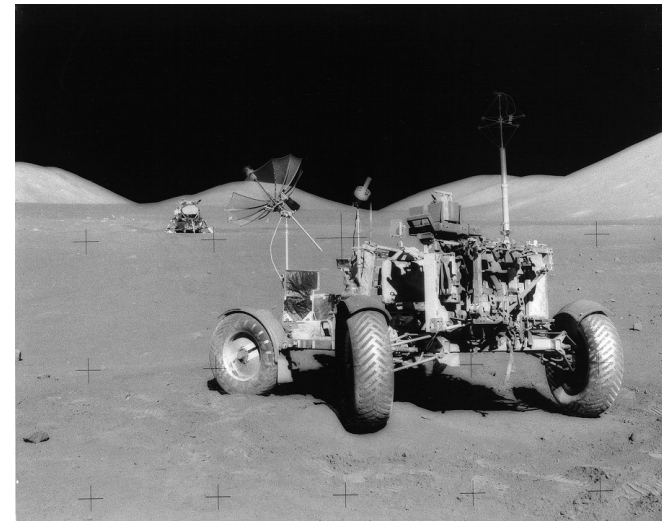
LRV Parked For Lunar Module Ascent Observation

In the process of preparing “Back to the Future” retrospective LRV thermal control experiences presentation, discovered picture of Apollo 17 in it’s last parked position that shows missing left front and left rear fender extensions, and missing right rear fender extension and fender map fix

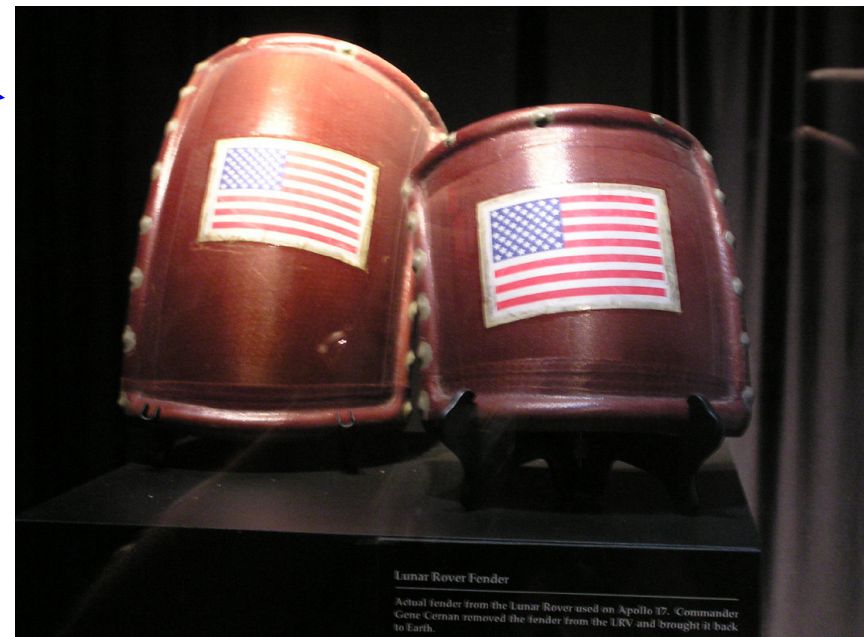
Picture of Apollo 17 Extensions Taken by Ben Nault

Fender extensions claimed to be: “Actual fender from the Lunar Rover used on Apollo 17” discovered on display at Kansas Cosmosphere museum.

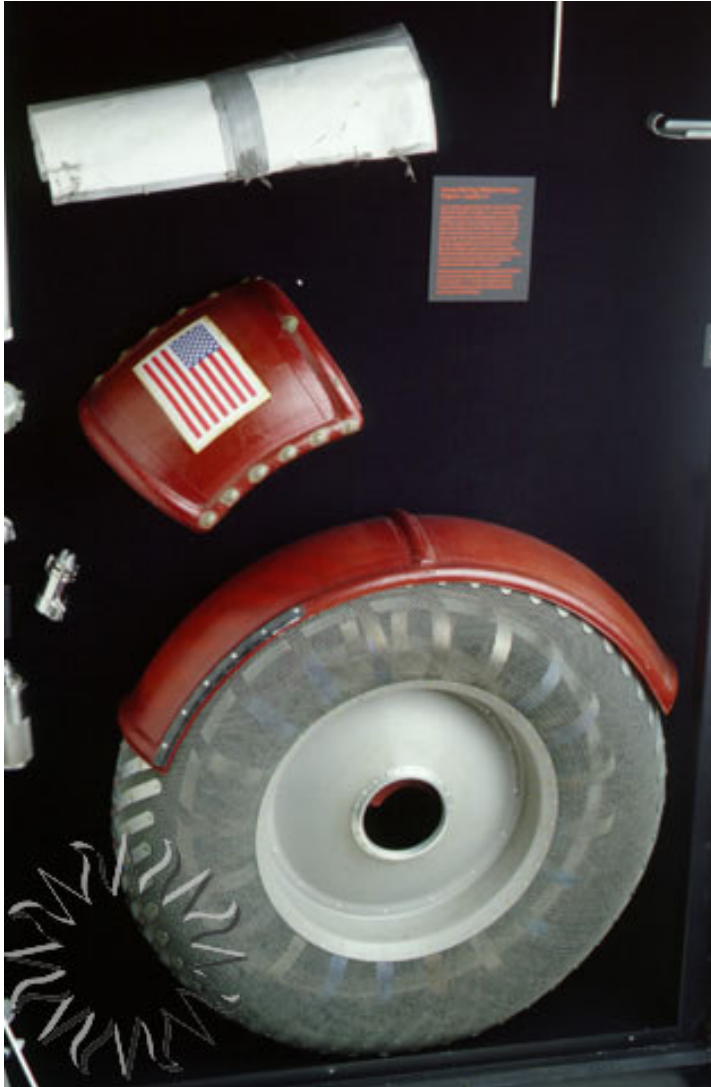
Apollo 17 Fender Extension and “Map Fix” Located at Smithsonian National Air and Space Museum (NASM)

- The saga about the missing LRV fender extensions is important because, had we known about them being returned to Earth, we could have inspected them and gained knowledge about exposure of materials to the lunar environment, and the nature and extent of the damage which had resulted in their being removed – accidentally or on purpose
- Perhaps we can now extract them from their resting places in the museum in Kansas and at the NASM and take a new look at them
- It would also be useful to ask whether similar LRV parts were returned from Apollo 15 and/or Apollo 16
