Board of Inquiry Report

Event No: BN05040181 (SIR:35/05 / IER:SE 9924)	Date of Event: 20/04/2005
Report Title: Fractured Pipe With Loss of Primary Containment in the THORP Feed Clarification Cell	
Report Authorised by Convening Authority: B Snelson – Managing Director, British Nuclear Group Sellafield	
Signed:	Date: 26 May 2005

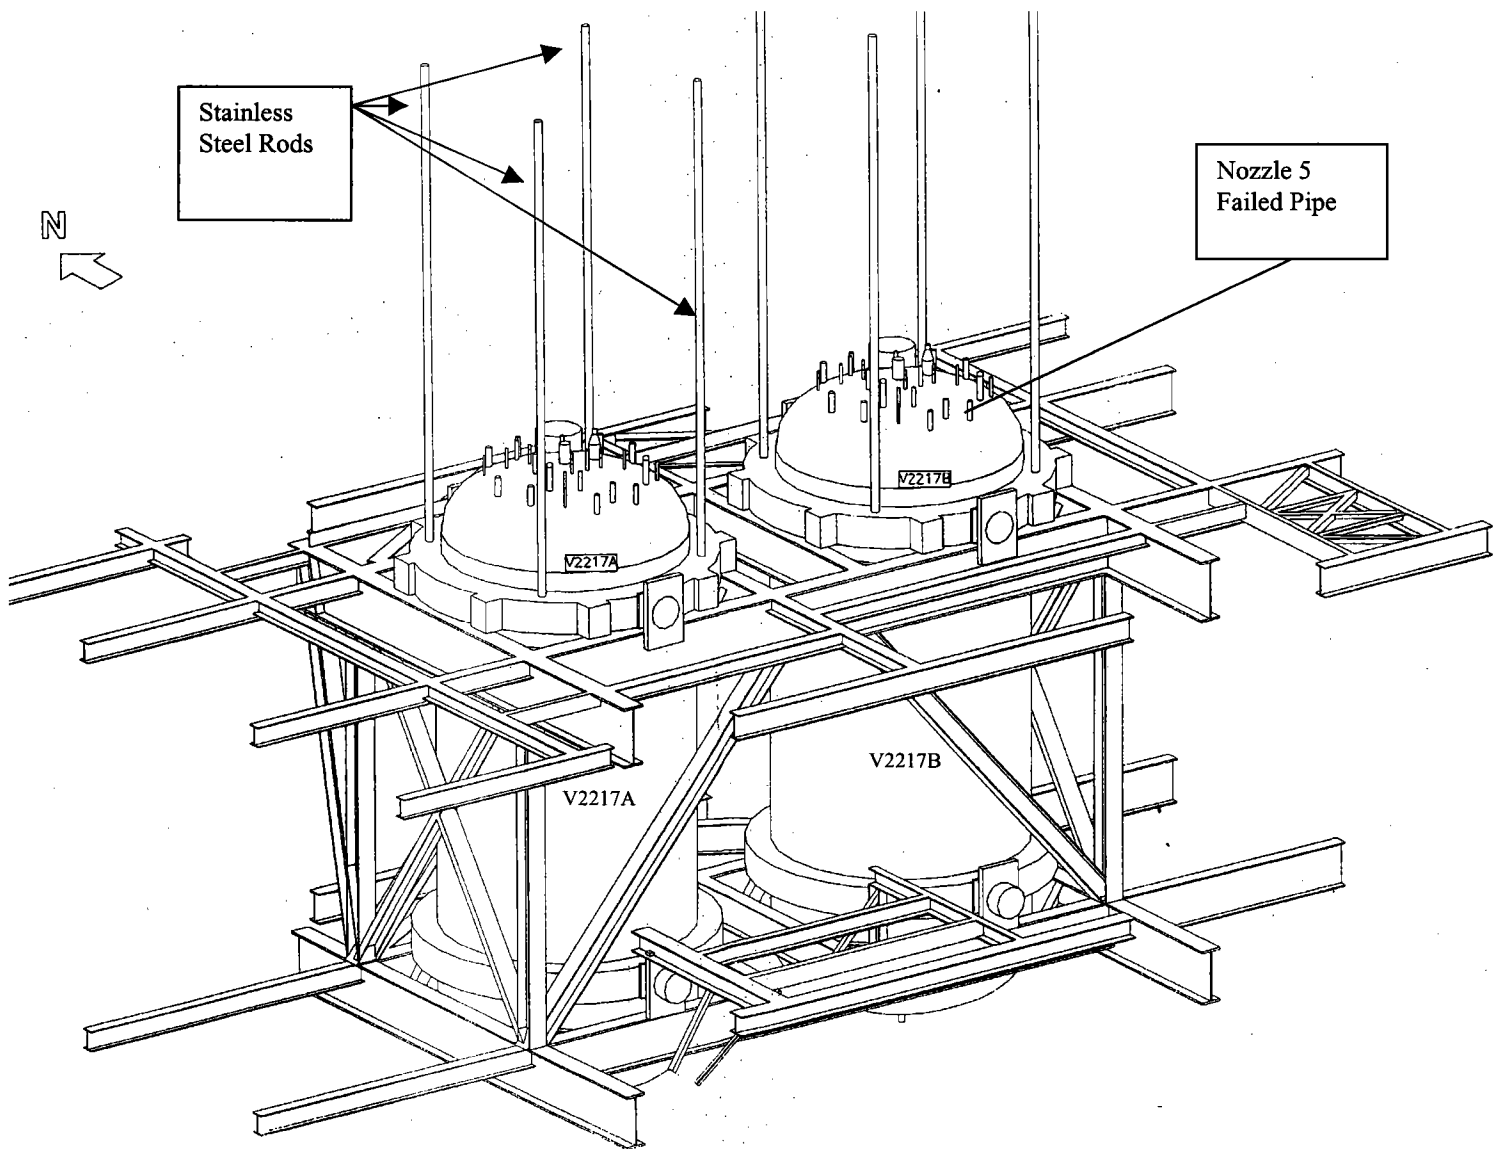
Fig 1 View from the southeast showing carbon steel structure and both accountancy tanks.

The steel structure below the tanks is fabricated in carbon steel and protected with a painted covering. It is in the form of two levels, at 5.75m and 1.75m, with extensive vertical bracing between the two levels. This steelwork is supported by plates cast into the concrete walls of the cell. None of the steel structure is located below the level of the 0.3M stainless steel cell bund. See fig 1.
