**U. S. Department of Energy
Oak Ridge Operations Office**

Type B Accident Investigation

**Bechtel Jacobs
Company LLC
Subcontractor Employee
Injuries from a
November 15, 2000,
Fall Accident at the
Oak Ridge National
Laboratory**

December 2000

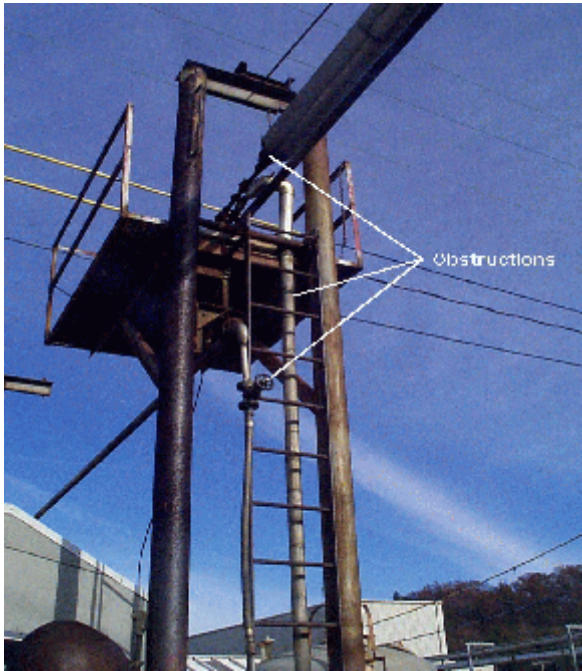
Exhibit 2-9. View of Fixed Ladder with Obstructions

As shown in Exhibit 2-9, a condensate drain line runs down the back of the rungs, with the distance behind the top rung to the line being 5 3/8 inches. The drain line angles into the back of the ladder, and at the bottom

rung, the clearance distance was diminished to 1 1/8 inches. The clearance at the fourth rung was approximately 4 inches. Also, a steel angle created an obstruction (3 3/4 inches) behind one rung. Title 29 CFR 1910.27(c)(4) requires at least a minimum clearance of 7 inches in back of a fixed ladder. UT-Battelle tagged the ladder out as “rejected” due to obstructions, rust, and corrosion. However, at the time of the accident, no tag was in place on the ladder.

serious deficiencies was the noncompliant clearance at the rungs from the back of the ladder. A condensate drain line runs down the back of the rungs, with the distance behind the top rung to the line being 5 3/8 inches. The drain line angles into the back of the ladder, and at the bottom rung, the clearance distance was diminished to 1 1/8 inches. The clearance at the fourth rung was approximately 4 inches. This could seriously impede a worker's climb or descent from the ladder. It was noted that the drain line runs down the right side of the ladder (refer back to Exhibits 2-9 and 2-10), and AW-1 was reported to have lost his footing with his right foot. It is possible that this obstruction helped cause the worker to lose his footing. A steel angle created an obstruction (3 3/4 inches) behind one rung. Title 29 CFR 1910.27(c)(4) requires at least a minimum clearance of 7 inches in back of a fixed ladder. Also, the overhead obstructions (steam line and other piping) at the top of the ladder and a protruding valve adjacent to the fifth rung created an unsafe condition.

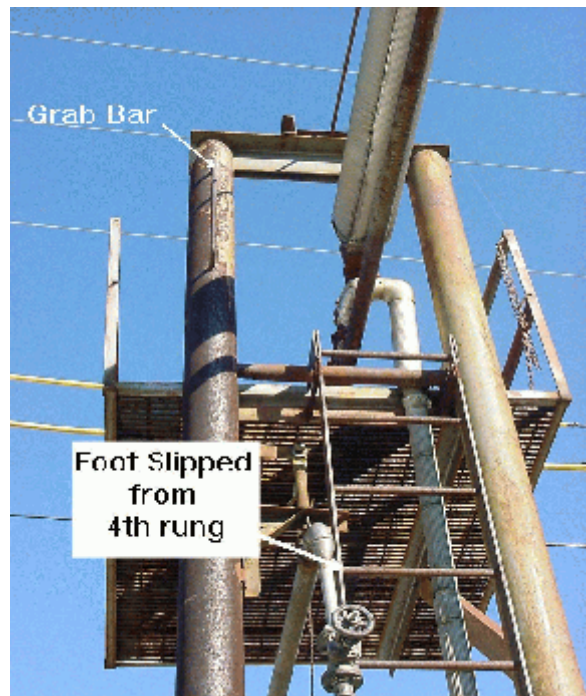
Exhibit 2-10. Closeup View of Top of Ladder

After work on the platform was completed, AW-1 began to descend from the platform via the fixed ladder. As AW-1 descended from the platform, his right foot slipped off of the fourth rung of the ladder. He then lost his grip with his right hand, causing him to swing around 180 degrees while still hanging on with his left hand from the platform support grab bar. (See Exhibit 2-10, Closeup View of Top of Ladder.) The injured employee and two eyewitnesses informed the Board that AW-1 tried to regain his footing, but he could not do so and fell approximately 13 feet. At some point during his fall, AW-1 was somehow turned so that he landed on the back side of his head. Two other eyewitnesses observed the fall but did not see what caused AW-1 to turn as he fell. (See Exhibit 2-11 for the general location of AW-1 after he fell.)

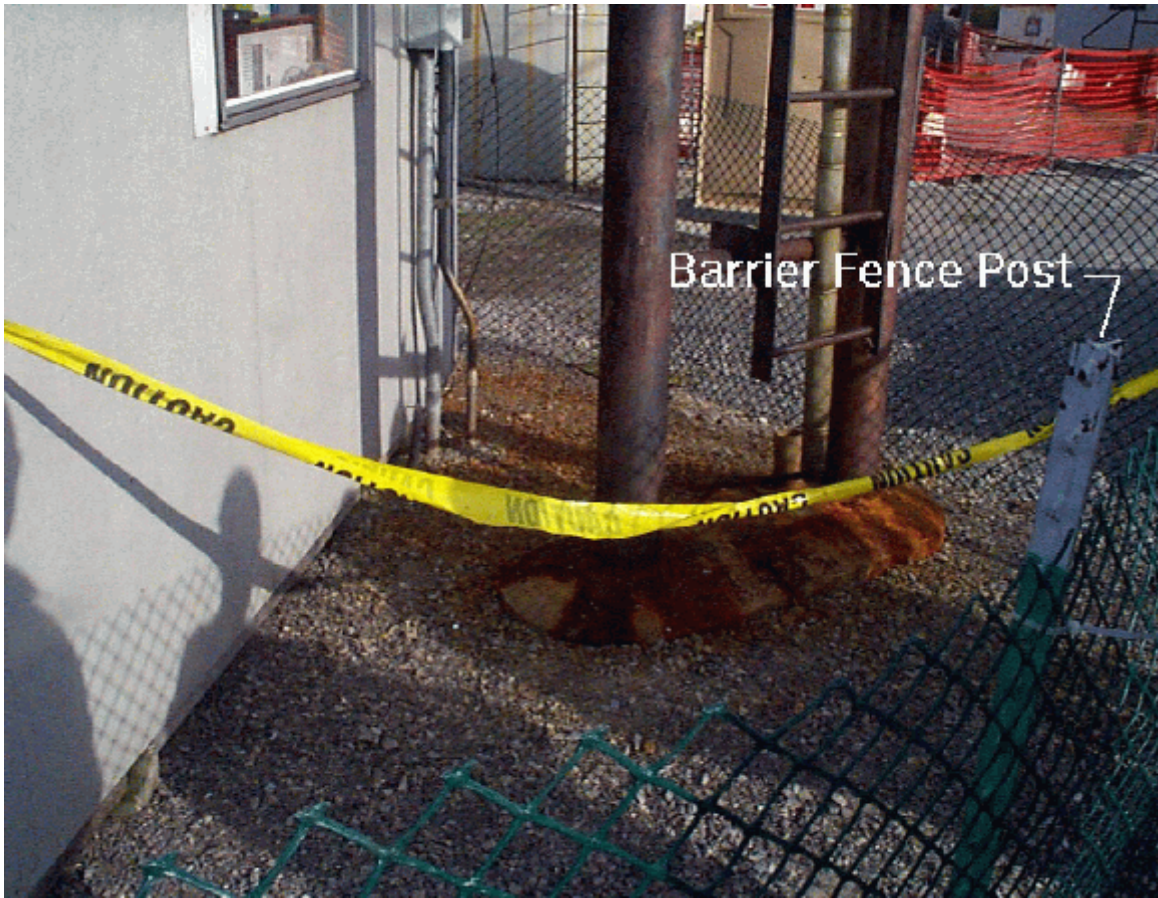
Exhibit 3-1. Construction Barrier

During a visit to the accident scene, the Board identified the existence of an impalement hazard from the plastic mesh construction barrier with metal supports that had been erected around the west end of the platform (see Exhibit 3-1, Construction Barrier). Had the employee not fallen to the north side of the ladder, he might well have been impaled on one of the metal supports to the south or the west of the ladder. The impalement hazard had not been identified, analyzed, nor abated.

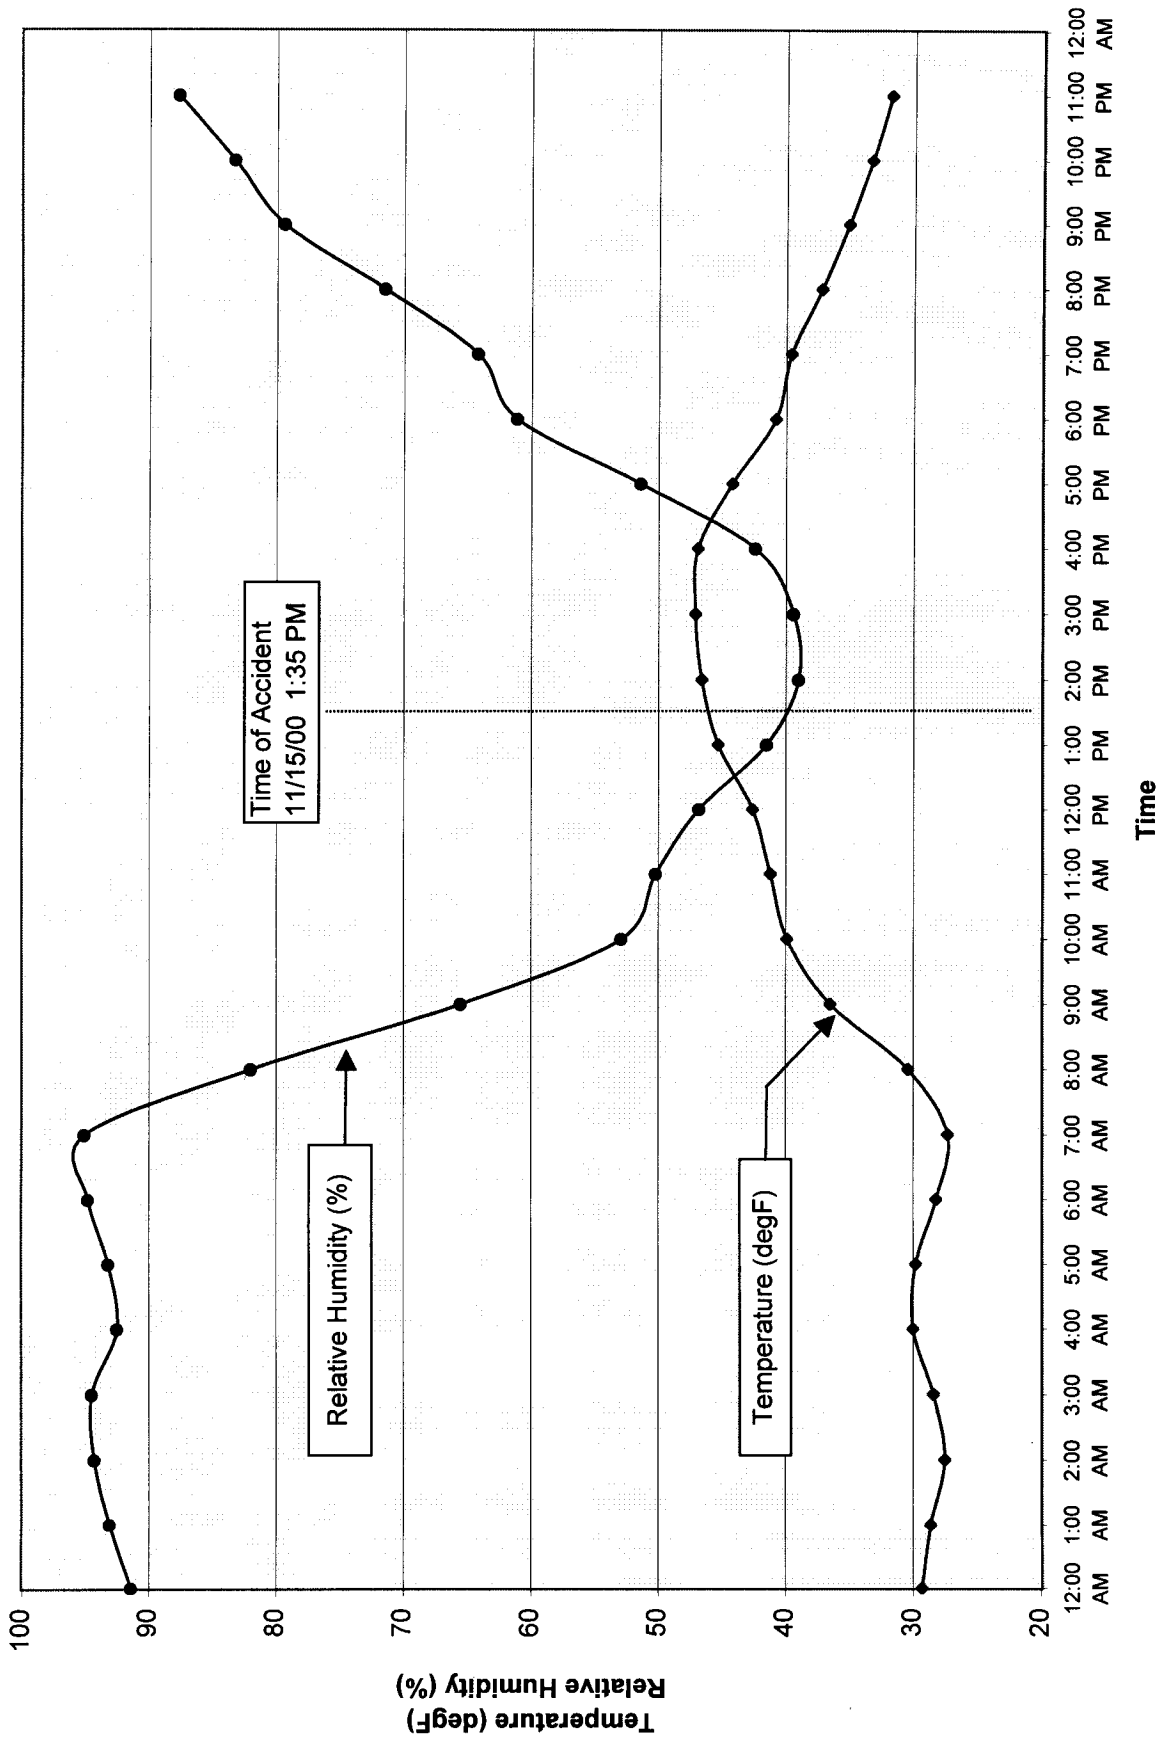
Figure B-1. Meteorological Data on 11/15/00 at 10 Meters - ORNL Met Tower 2

There was also a possibility that the overnight low temperatures (28°F) and the high relative humidity (96%) followed by daytime warming could have contributed to some moisture on the ladder. See the meteorological data in Appendix B. The Board could not determine
