**Type B Accident Investigation
of the Mineral Oil Leak Resulting in
Property Damage at the Atlas Facility
Los Alamos National Laboratory
New Mexico**

March 2001

**Office of Defense Programs
National Nuclear Security Administration
U.S. Department of Energy
Washington, DC 20585**

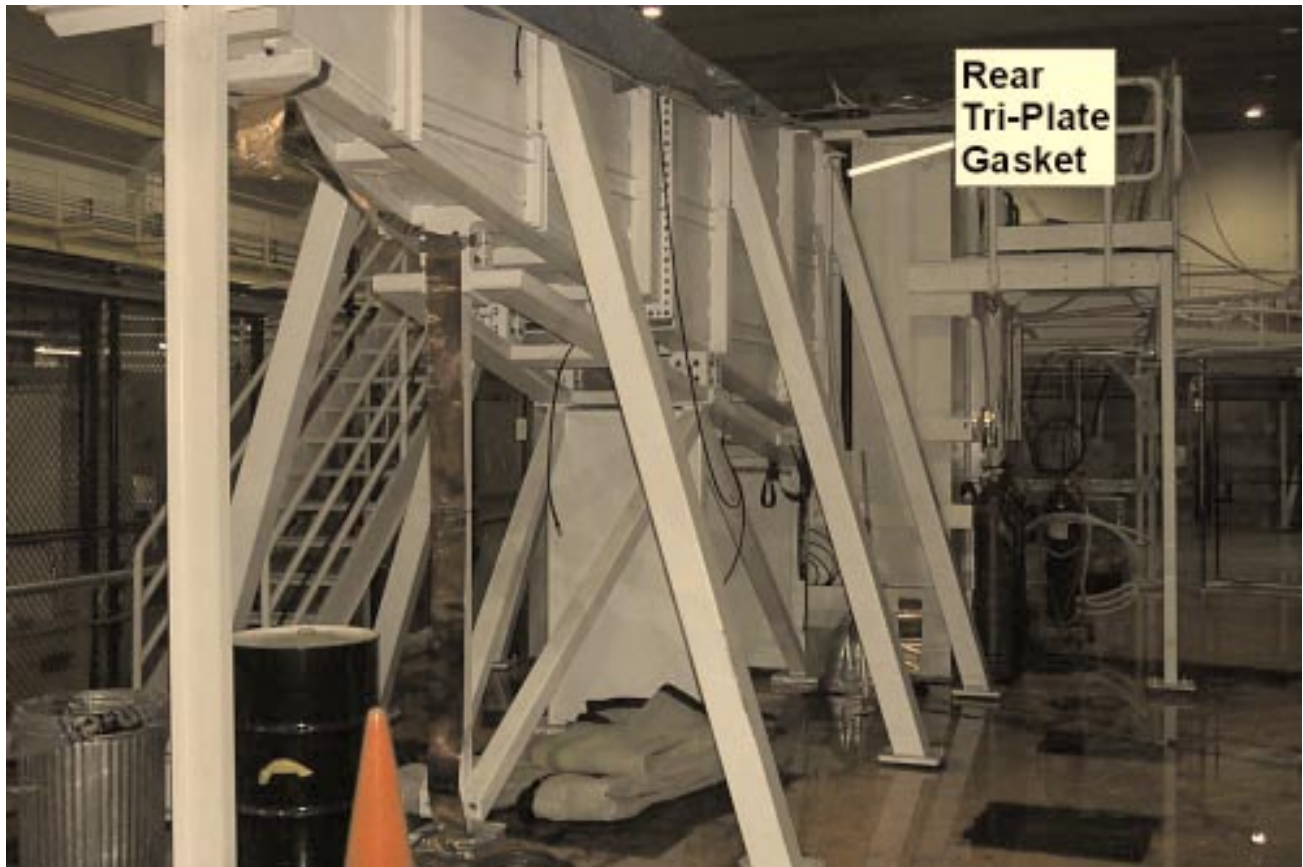
Figure 3. The First Article Assembly, where the leak occurred, is composed of the Maintenance Unit Tank and the Vertical Transmission Line Tank (note oil on floor).

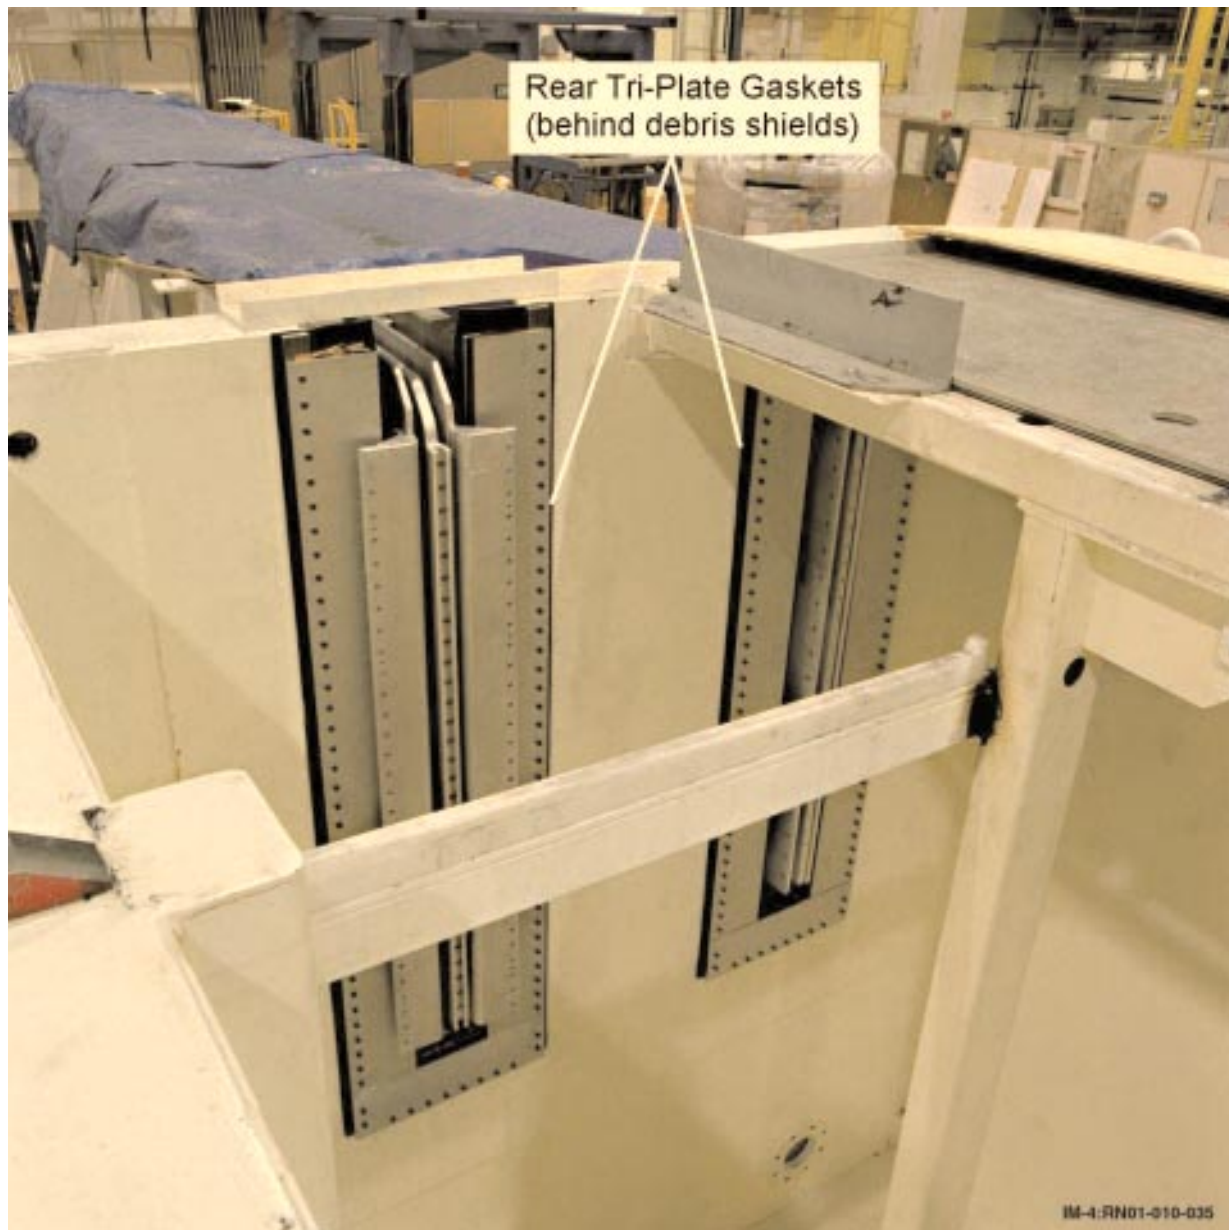
Figure 4. The interior of the Maintenance Unit Tank, showing the location of the Rear Tri-Plate Gaskets as installed.

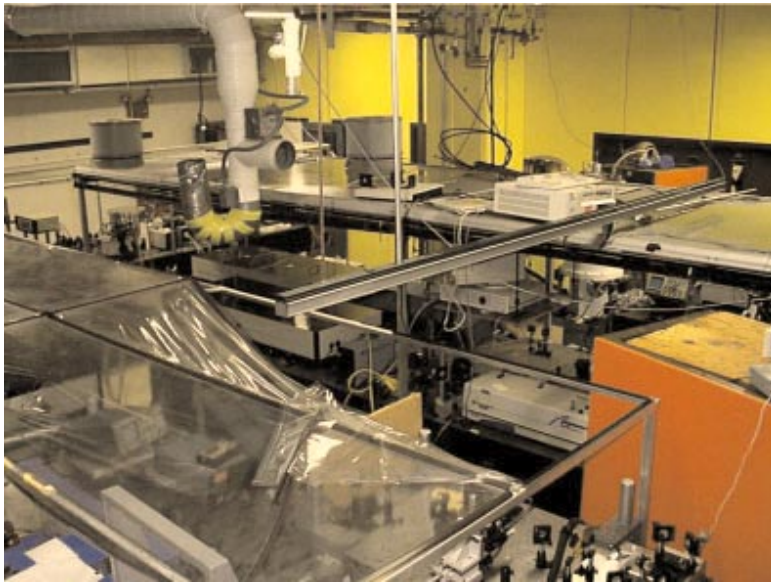
Figure 5. Overview of the MST-10 Optics Laser Laboratory in the basement of Building 125, where much of the damage occurred.

had already been exposed to the oil. Personnel from the Optic Laser Laboratory arrived and made an inspection of the laboratory equipment. They determined that the equipment in the laboratory had sustained significant damage. An inventory of the equipment and an initial damage estimate of \$3,250,000, based on 100% loss were prepared by the MST-10 staff. This estimate was later refined to the current estimate of \$1,800,000.

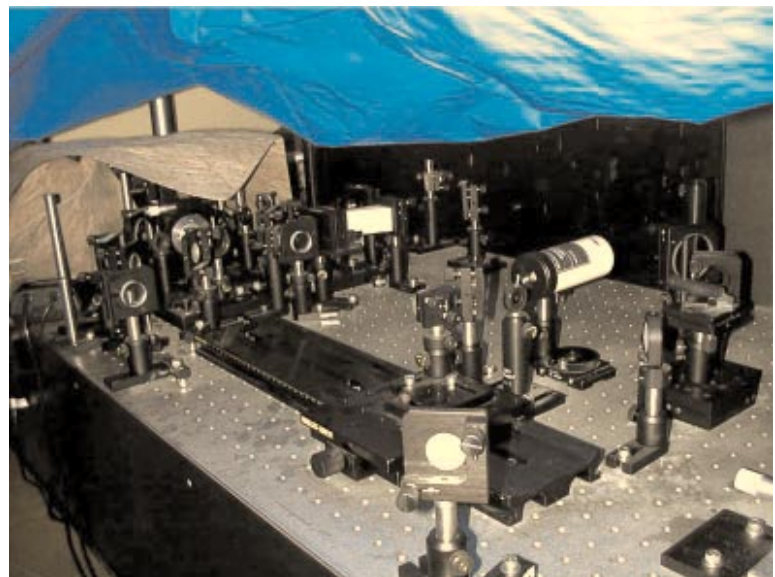
Figure 6. Laser optics table in the MST-10 Optics Laser Laboratory with mineral oil damage.

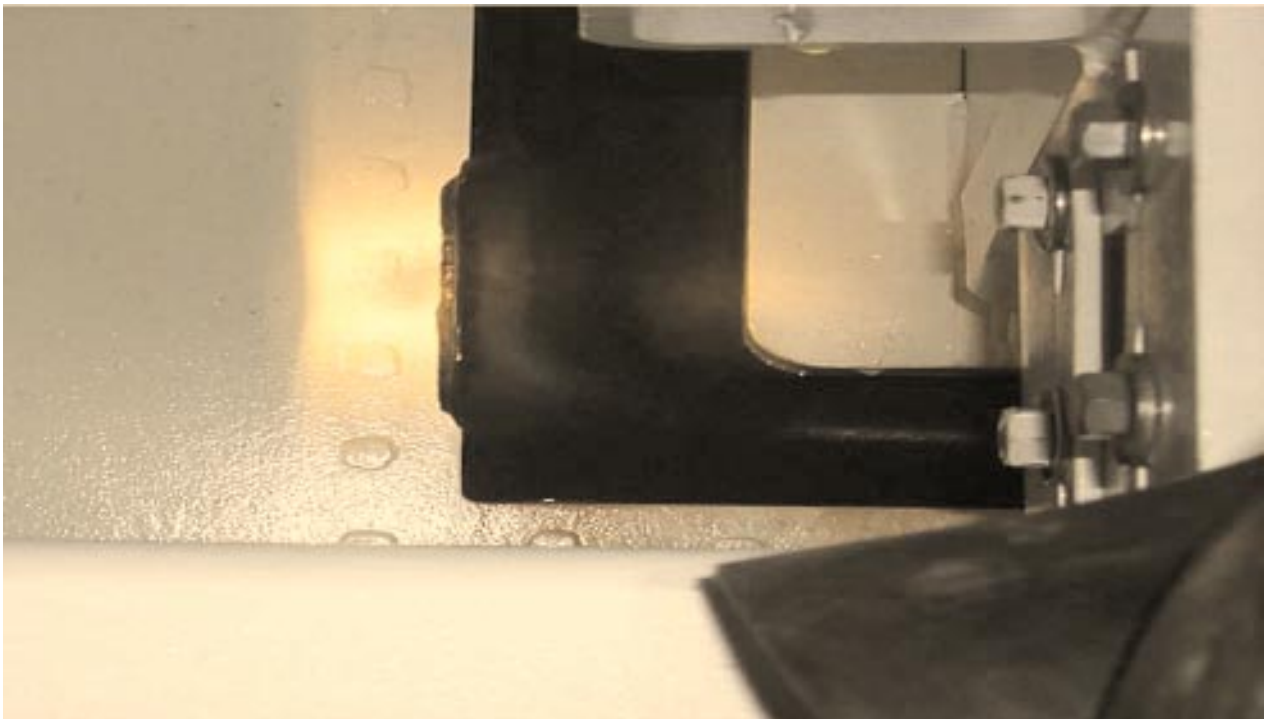
Figure 8. This tear in the right Rear Tri-Plate Gasket of the First Article Assembly created a 2.7 in² providing the leak path for the mineraloil.

The Board closely examined the condition of these Rear Tri-Plate Gaskets. A six-inch tear in the right gasket along the First Article tank edge was observed. The tear created an opening of approximately 2.7 in.² and was identified as the source of the mineral oil leak (see Figure 8). Numerous cracks, 6- to 12-inches long and approximately 0.25 inches deep, were identified along the metal/gasket interfaces (see Figure 9). The outside surface of the left Rear Tri-Plate Gasket had a large number of surface cracks and one major tear. The Board also noted that the Rear Tri-Plate

Gaskets bulged outward because of the hydrostatic pressure of the mineral oil.

The exact time and date of the leak could not be confirmed; however, based on the 2.7 in.² opening in the gasket, Atlas personnel estimated that it could take as little as two to three hours for the tank to drain to the bottom of the tear. An Atlas Project Mechanical Technician discovered the leak on Monday at 6:00 a.m. on January 8, 2001. P-22 Atlas personnel observed the oil still flowing shortly after the discovery, so the rupture may have occurred earlier on Monday morning.

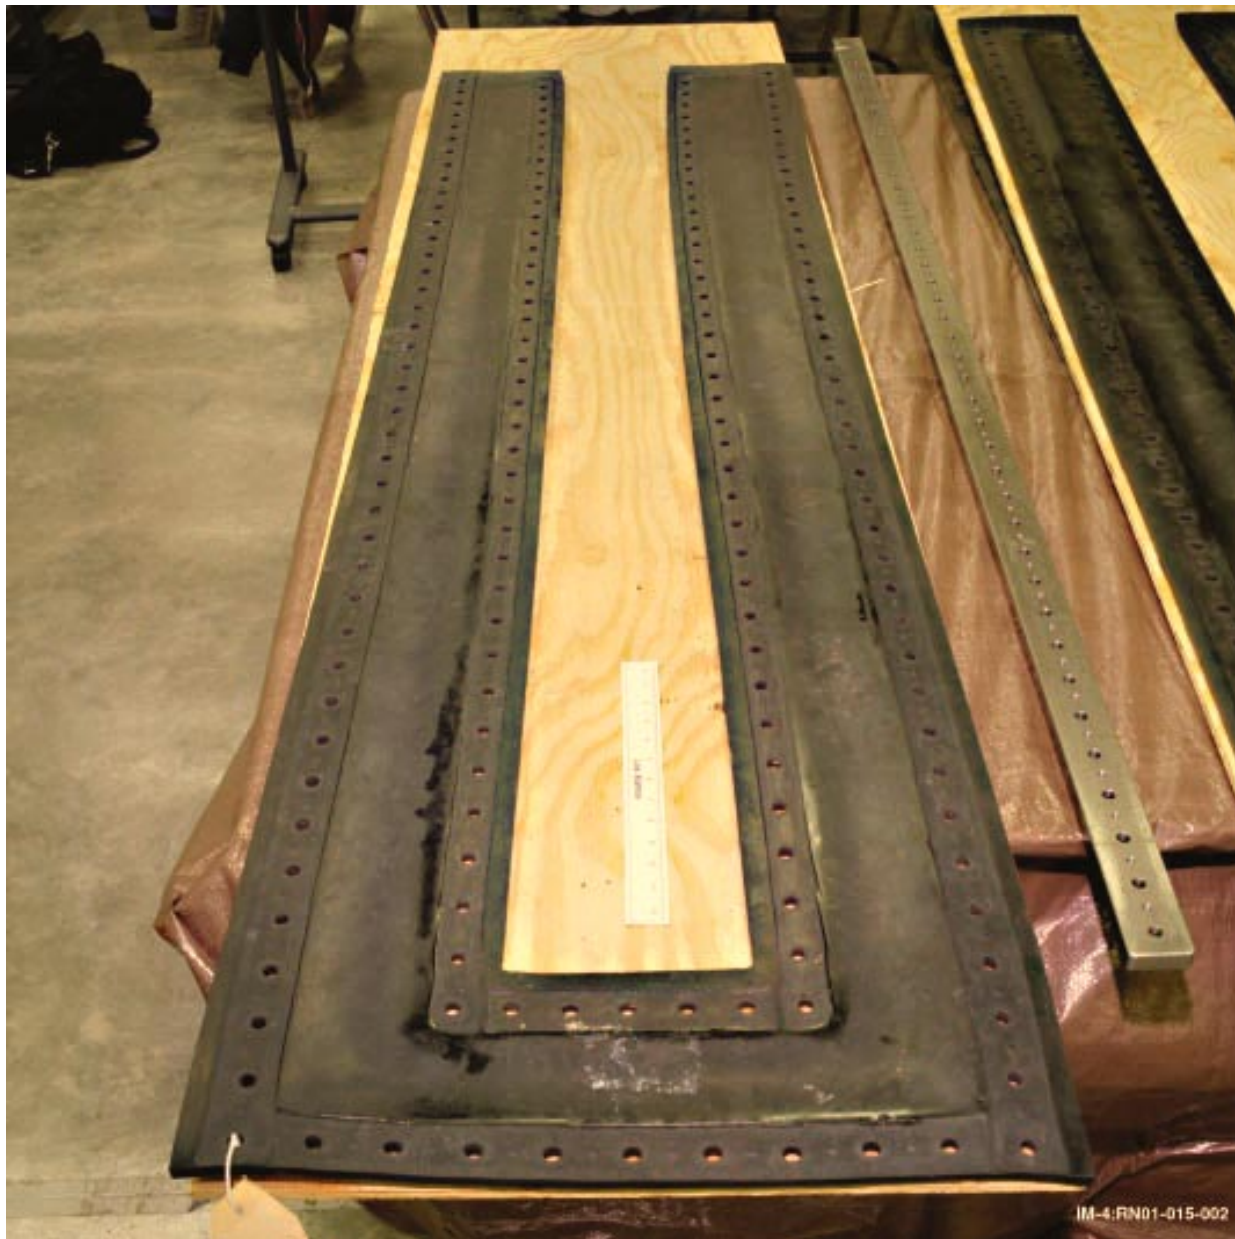
Figure 9. The right Rear Tri-Plate Gasket and one of the backing bars after removal. The gasket displayed significant deterioration along borders where the backing bars were attached

1. There was no nylon fabric reinforcement in the First Article Assembly Rear Tri-Plate Gaskets. The Board noted that there was a difference in characteristics between the gaskets taken from the Prototype Assembly and the First Article Assembly. There was evidence of fiber in the Prototype Gasket, but there was no evidence of fibers in the First Article Assembly Gasket. The P-22 personnel made similar observations on the day of the leak discovery.
