**U. S. Department of Energy
Oak Ridge Operations Office**

**Type B
Accident Investigation Board Report
of the
UT-Battelle, LLC,
Contractor Employee Injuries
from a September 7, 2001,
Burn Accident
at the
Oak Ridge National Laboratory,
Building 9210**

October 2001

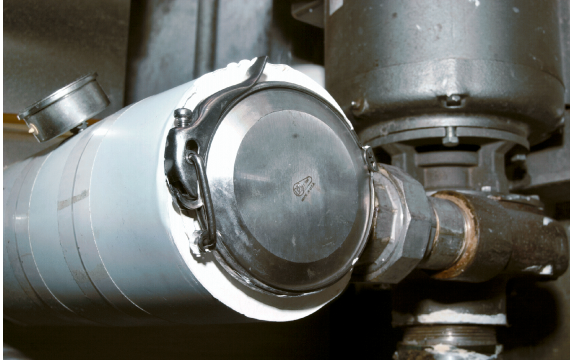
The end cap on the filter assembly came off during contact with the worker or the cart the worker was using. The injured worker was

unclear as to exact action which released the filter assembly latch. Water that was normally

Exhibit 2-2. Latch and Filter Assembly

heated above 180°F degrees and under approximately 30 pounds of pressure was immediately released onto the worker. The filter assembly clamp could be opened with as little as ten pounds of pressure. It was an original piece of equipment. The equipment was an optional component that, as installed, protruded slightly into the work area. The normal setup had the assembly perpendicular to the washer. According to the schematics, it could have been installed parallel to the washer.

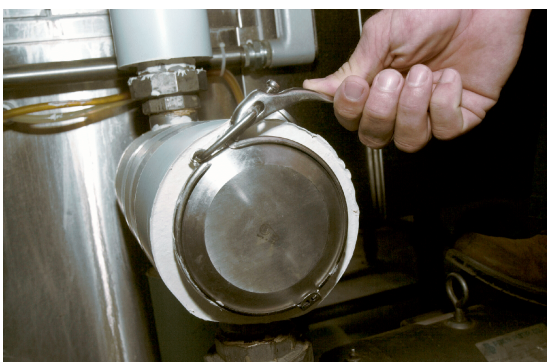
Exhibit 2-3. Filter Assembly Clamp

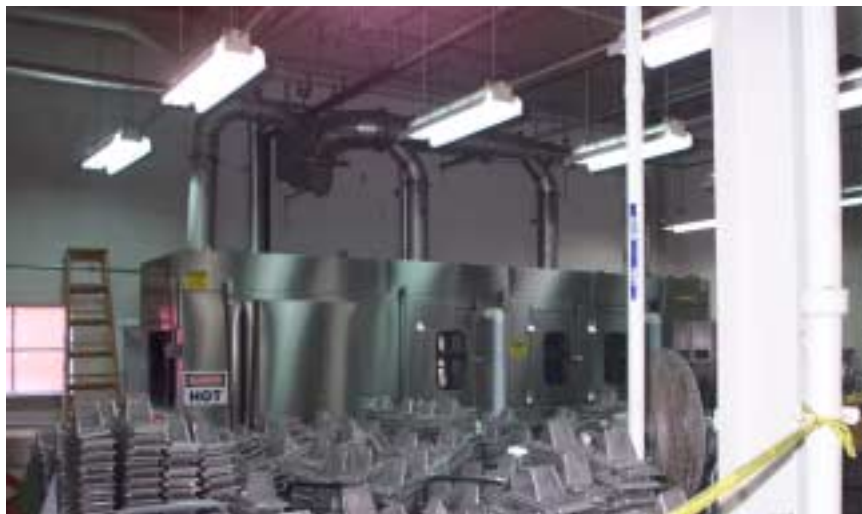
During installation of the tunnel washer, the exhaust fan and motor were located above the washer, which created a noise hazard to the equipment operators.

The fan and motor should have been located outside of the room/building, which would only have required an additional 10 feet or less of duct work. Placing the fan over the tunnel washer created a high noise area, and the employees were required to wear hearing protection. The high noise level also made it difficult for people outside the room to hear the injured worker call for help. After the worker sustained severe burns, she had to travel approximately 50 feet to exit the room to obtain help.

Exhibit 3-1. Exhaust Fan and Motor above the Tunnel Washer

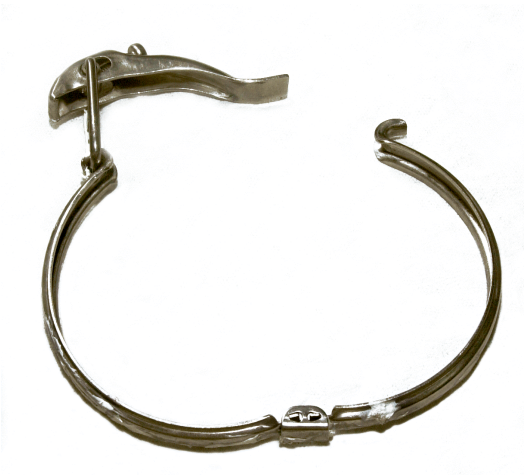
The less-than-adequate design of the latch assembly for the automatic self-cleaning debris filter was a primary factor in the accident. The access assembly consisted of three parts (i.e., an outer plate, a rubber seal, and a hinged clamp with a levered latch that secured the outer plate and seal). When the levered latch was in a relaxed state (open), the outer plate and seal immediately fell to the floor.

The tip of the levered latch protruded approximately 1/8 inch beyond the end of the filter access assembly.

Exhibit 3-2. Filter Latch Assembly
