**TYPE B ACCIDENT INVESTIGATION BOARD  
REPORT**

**GROUT INJECTION OPERATOR INJURY AT  
THE COLD TEST PIT SOUTH,  
IDAHO NATIONAL ENGINEERING AND  
ENVIRONMENTAL LABORATORY,  
OCTOBER 15, 2001**

**IDAHO OPERATIONS OFFICE**

November 2001

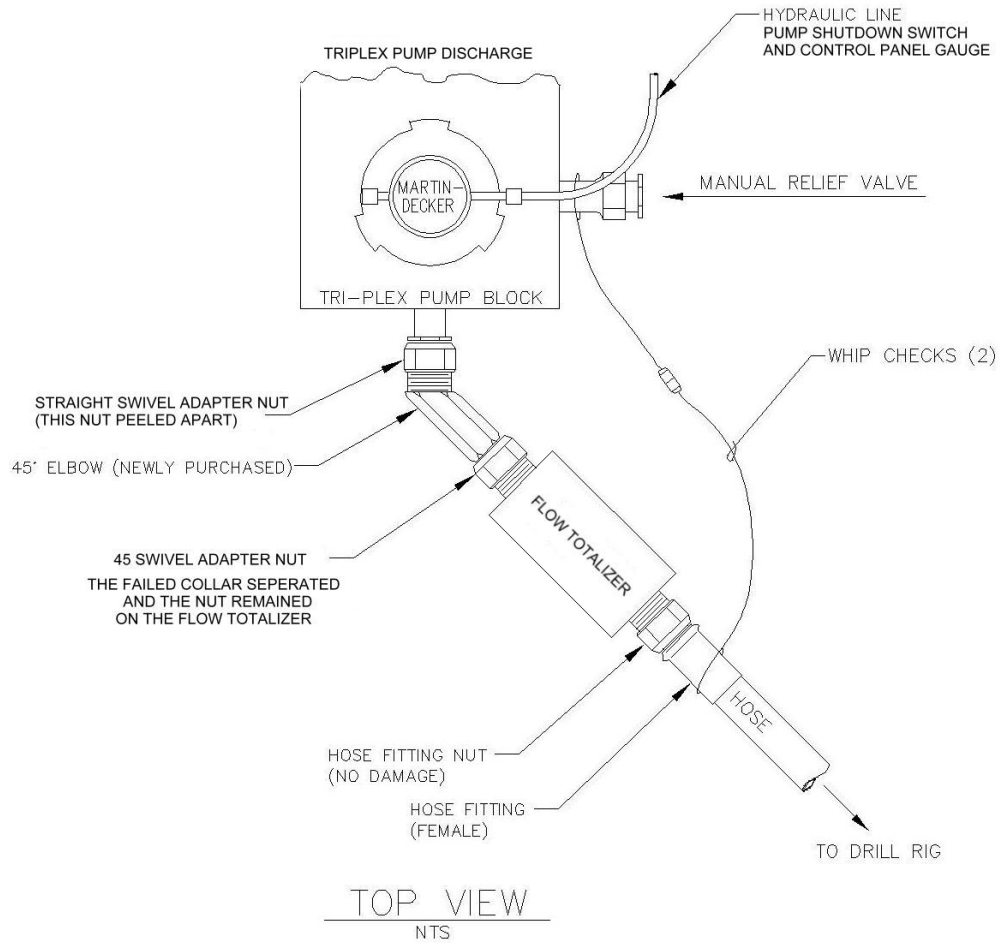
### Triplex Pump Discharge With Fittings, Flow Totalizer and Hose

The accident occurred when a 45° swivel elbow with a rated working pressure of 3,000 psi (normal working pressure during high pressure grout injection was 6,000 psi) broke under pressure and set into course a chain of events that led to the injury of a subcontractor operator. The equipment involved in the accident, shown in the equipment drawing, included the straight swivel adapter on the triplex pump high pressure outlet, a 45° swivel elbow, a flow totalizer and two whip check restraining devices. (See Triplex Pump Discharge With Fittings, Flow Totalizer and Hose.)

The Board determined that the most likely chain of events for the accident started with the failure of the collar on the 45° swivel elbow nut by ductile rupture. This allowed the remainder of the 45° swivel elbow nut and flow totalizer to separate from the grout flow path. The flow totalizer was restrained to the block of the triplex pump by the use of two whip checks on its outlet connecting hose. The whip checks restrained the flow totalizer until the applied forces and momentum broke the whip checks.

While the flow totalizer was being thrown from the system, the applied force from the 45° swivel elbow was transmitted onto the straight swivel adapter nut on the high pressure outlet of the triplex pump. The straight swivel adapter nut then ruptured in a brittle cleavage fracture causing the 45° swivel elbow and the straight swivel adapter nut to be thrown from the grouting system. The straight swivel adapter nut struck the operator on his safety glasses on the right side of the head in the vicinity of the right eye socket causing the safety glasses to break and striking the operator.

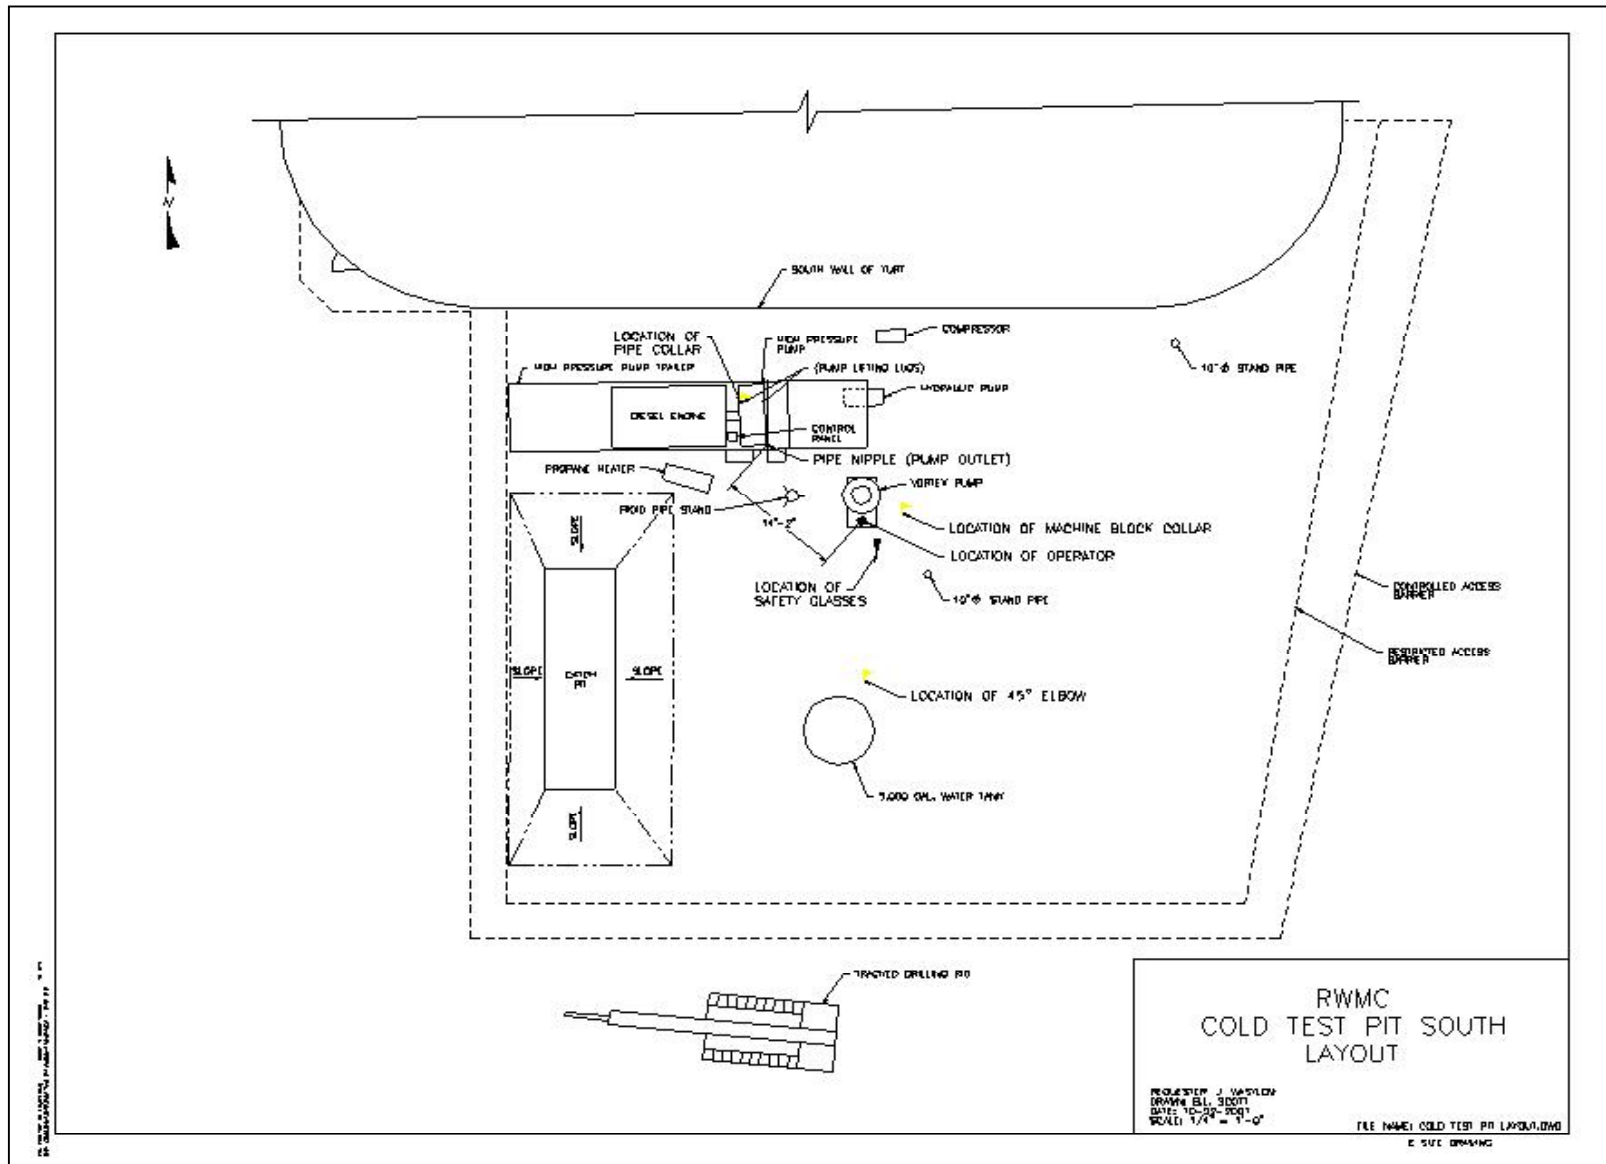
Cold Test Pit South – Evidence Locations

Evidence collection continued and flags placed into the ground at approximate locations where the items were found. The accident scene was then ribboned off for access

On October 18, 2001, a DOE Accident Investigation Board member found the separated collar of the 45° swivel elbow nut and placed the item into evidence. This 45° swivel nut collar was found on top of the triplex pump, which had been covered for weather protection since the clean out process after the accident.

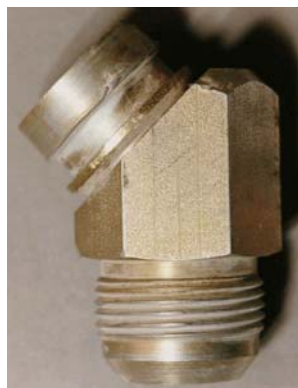
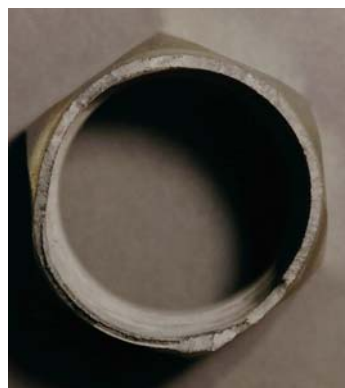
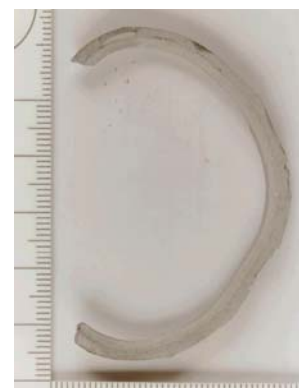
### 45° Swivel Adapter

The fitting nut collar was entirely separated from the main body of the nut by a circumferential fracture. The fracture surface was very uniform, with no sign of an initiation site. It was concluded that the nut failed by ductile rupture corresponding to a tensile overload (i.e. high pressure).

The damage patterns exhibited by the fittings and their post-accident resting places, suggest a failure sequence. The 45° swivel elbow nut failed by tensile over-load in a plane perpendicular to its centerline as noted by the uniform fracture surface. By comparison, the straight swivel adapter fitting exhibited a failure pattern that was dominated by a loading unsymmetrical to the fitting centerline. Such a failure pattern is consistent with a loading resulting from a blow down through the downstream end of the 45° swivel elbow fitting, since the exiting flow would be in a direction well off of the centerline of the straight swivel adapter. Failure of the whip checks that spanned the failed fittings indicates a dynamic unloading of the system fluid through the failure locations, confirming that a system blow down did occur.

Thus, it is most likely that the 45° swivel elbow nut preceded and contributed to the failure of the straight swivel adapter rather than a failure sequence in the opposite order.

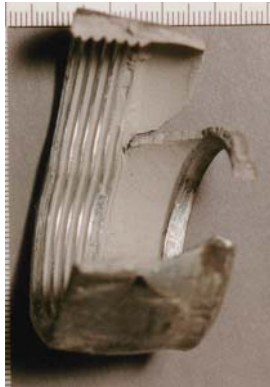
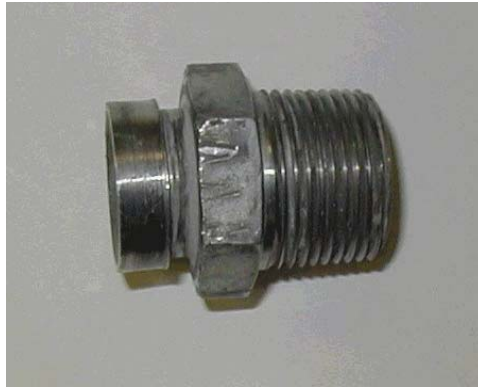
#### **Straight Swivel Adapter**

The fitting nut failed by a brittle cleavage fracture process, not uncommon for low-carbon steels. Fracture by cleavage is promoted by low temperature, high loading rates, or a combination of both.

The straight swivel adapter had been in service for some time and was not replaced just prior to the accident on the morning of October 15, 2001. There were no manufacturing trademarks on the fitting and no information about the fitting was available. However, the 45° swivel elbow had been recently purchased from a local vendor and installed by the subcontractor on the morning of the accident. The manufacturer's catalog rated working pressure for this fitting was 3,000 psi. It should be noted that the vendor
