FINAL REPORT

OCTOBER 2002

**TYPE B ACCIDENT INVESTIGATION
BOARD REPORT OF THE JUNE 2002
HIGH RADIATION DOSE TO EXTREMITIES
IN BUILDING 151
LAWRENCE LIVERMORE NATIONAL LABORATORY,
LIVERMORE, CALIFORNIA**

**OAKLAND OPERATIONS OFFICE
DOE/OAK—505**

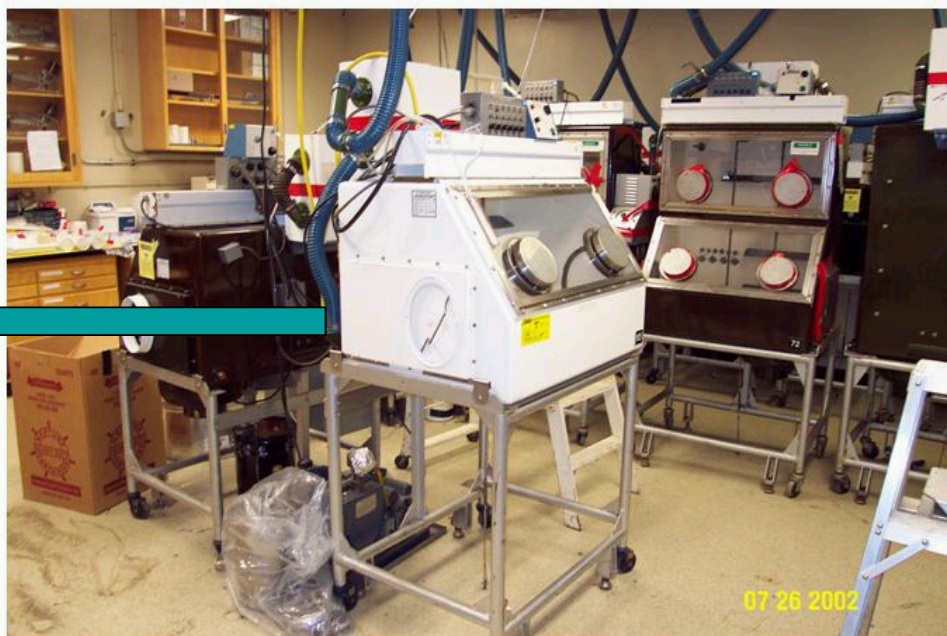
Figure 5. Glovebox 65 in Room “B”.

June 10, 2002—Prior to 0800 hours, the Researcher moved the two Flint-glass bottles into Glovebox 65 in Room “B” (see Figure 4). It was during this time that the Researcher put on his ring dosimeters. His ring dosimeters are normally stored on the workbench in the room, away from the radioactive materials or storage areas. He took the ORNL quartz bottles (L1197 and 1244) out of the Flint bottle and surveyed each tube individually, placing each tube one at a time, as close to the inside edge of the glovebox (box) as possible and taking a box-contact reading from outside of the box. The dose rate from L1197 was 13.5 mR/hr while L1244 was 44 mR/hr. The dose rate for the 40-ml centrifuge cone (L5) was not indicated.

The Researcher proceeded to remove the glass stopper (lid) from L1197 but the stopper broke off. Additional efforts to pull out the stuck or bottom portion of the stopper were unsuccessful. The Researcher set L1197 aside and turned to the L1244 stopper, which was successfully removed.

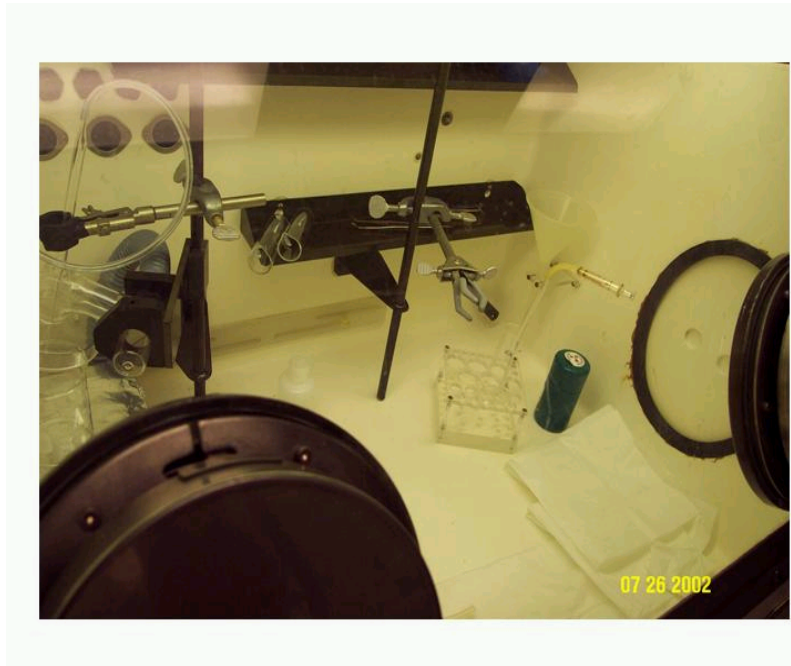
Figure 6. Tools used in Glovebox 65.

Figure 6 shows the lead pig containing the 11-mg Cf-249 still situated on the workbench while the rest of the materials were in storage in Glovebox 3, behind Glovebox 65.

Administrative controls such as the IWS and the OSPs were in existence at the time the accident occurred but in general these are general purpose documents. The Researcher did not familiarize himself with the IWS and OSP requirements for a hazard assessment by the ES&H team HP. Consequently, engineered and administrative controls present for the work activity were inadequate. ALARA controls were not sufficiently implemented. If a hazard assessment was performed by the HP, in all probability, the HP would have identified additional administrative controls or other engineered controls to prevent this event. The administrative controls might have included additional personnel to help with the work, increased survey frequency, increasing the frequent exchange of dosimeters rather than the monthly frequency. Additional engineered controls might have included the use of additional shielding blocks and leaded gloves.

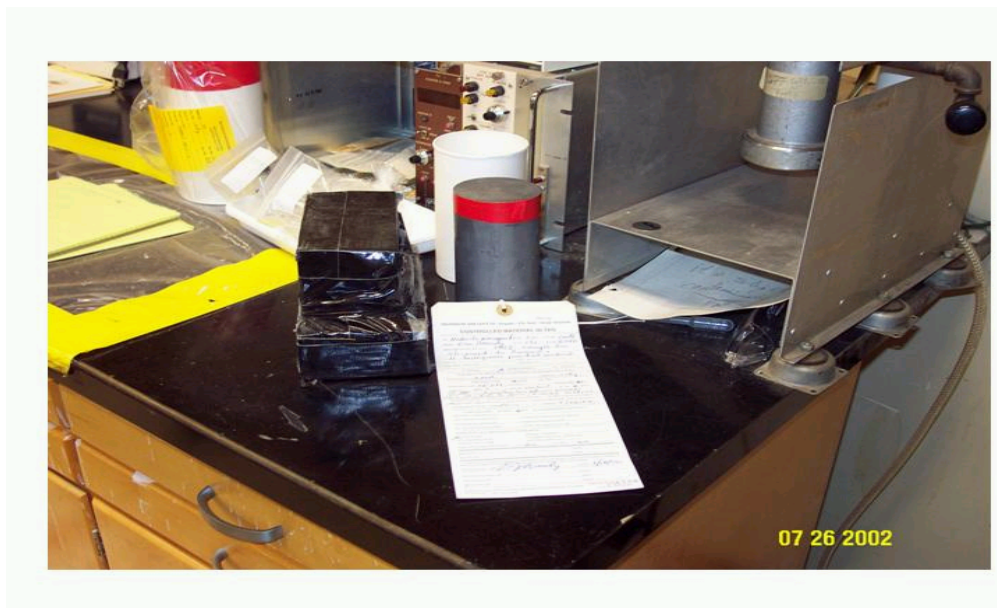
Figure 7. Lead pig containing 11 mg Cf-249 source.

On July 31, 2002, LLNL established a Dose Reconstruction Committee to determine the official dose of record. The Dose Reconstruction Committee performed radiation surveys of Room "B" on August 1, 2002 to determine if dose rates from the materials were consistent with calculations. Although three other experiments had been conducted in Room "B" since the Researcher completed the June work, the radioactive materials (11 mg of Cf-249, the curium-245 component, the left-over Cf-249, and wastes) were still in the room. The tools used in the work activity were still in Glovebox 65 (see Figure 5).

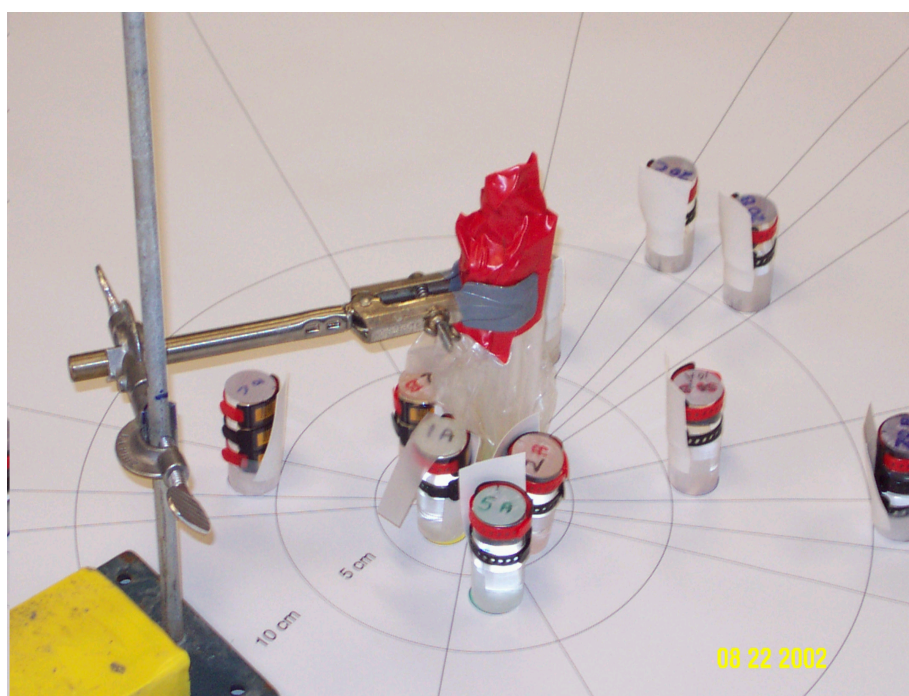
Figure 8. Dose reconstruction with ring dosimeters.

Tests were also conducted with several Harshaw 740 ring dosimeters (see Figure 7), including the ones worn by the Researcher in June 2002, to try and simulate the doses at various distances from the source. Ring dosimeters were positioned at various distances around the bare 11 mg Cf-249 (in its centrifuge cone only) and exposed for 2 hours. Four dosimeters placed at 2 cm from the source gave doses ranging from 17.2 rem to 33.5 rem for the 2-hour exposure. Two dosimeters at 1 cm gave 28.6 and 44.4 rem, respectively. One Researcher ring received a dose of 7.03 rem at 5 cm and the other received 1.9 rem at 10 cm. Since the exact mass configuration of the Cf-249 in the cones prior to the purification was not known, the results from these tests were not particularly helpful for evaluating exposures at close contact with the source. This is especially true when one takes into consideration the fact that as one approaches within 5 cm of the source, the inverse square law becomes less valid.

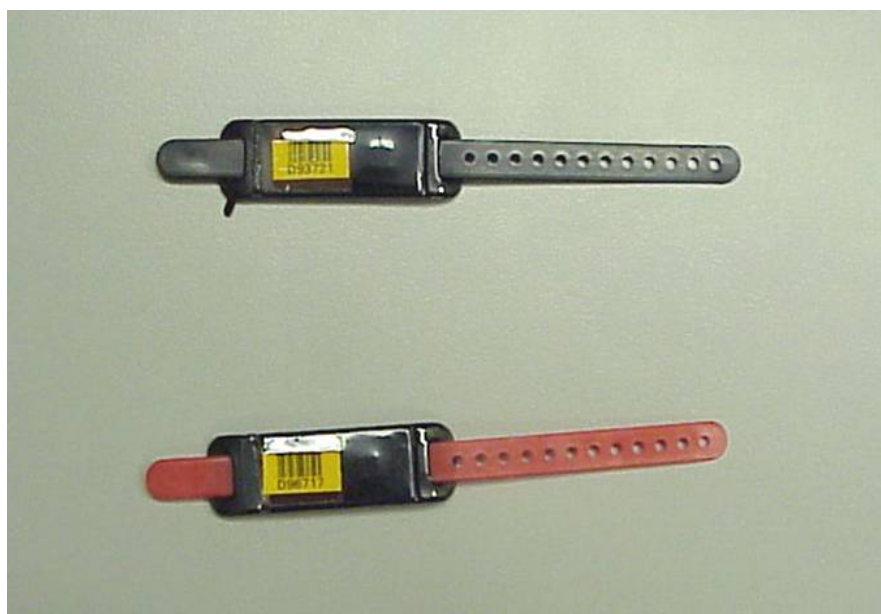
Figure 9. Ring Dosimeters.

July 22, 2002—The ring dosimeters were read. The ring dosimeter with the red strap (Dosimeter #92783) gave a dose of 120 rem while the dosimeter with black strap (Dosimeter #97258) showed a dose of 54 rem. (The red strapped dosimeter is normally worn on the right hand; the black strap is worn on the left hand.) Following the discovery of the high doses, the Researcher was verbally informed by the HP not to perform further radiological work.

The dosimeters, normally calibrated to 500 mrem, were recalibrated on July 23, 2002, using Cs-137 to doses in the range of the actual measurements (98 and 49 rem). Based on the recalibration, the extremity doses were revised to 111 rem and 62 rem, respectively. The Researcher was notified, Hazards Control (HC) notified CMS, and LLNL filed an Unusual Occurrence Report to report the overexposure.

The Board reviewed the history of the two ring dosimeters (serial #92783 and #97258) worn on June 2002, dating back to August 1999 and found no anomalies. The Board also reviewed doses assigned to other ring dosimeters processed in the batch (Batch No. 6020722, July 22, 2002) as the two worn by the Researcher; and again found no anomalies.

The Board found no evidence of a defect in, or contamination of, any of the two ring dosimeters. The reading of the dosimeters followed the chip and automatic reader manufacturer's instructions.

Although the Researcher could not remember whether he wore the red ring on the right or left hand, he was sure he never interchanged them during the work. And since the Researcher is right-handed, the Board assumed that the left hand received the higher of the doses. Therefore, the Board recommends the assignment of the higher of the doses to the left hand.
