# **Type B Accident Investigation Board Report**

**BNFL Inc. Employee Foot Injury  
on December 17, 2003, at the  
East Tennessee Technology Park,  
Building K-31**

**February 2004**

**Oak Ridge Operations Office  
U.S. Department of Energy**

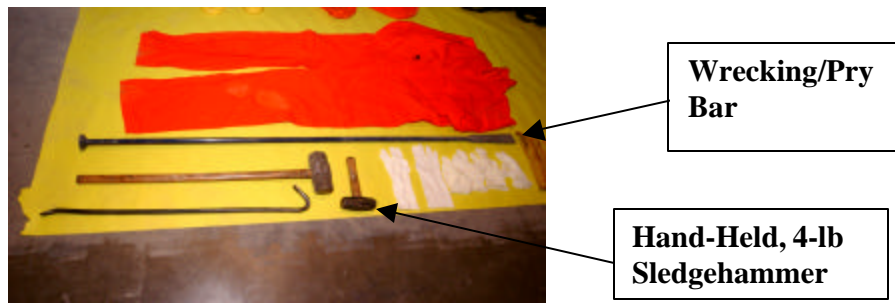
**Exhibit 2-1. Tools Used for Hand Removal of Concrete Blocks from Wide-Flange Column**

On the morning of December 17, 2003, at approximately 7:15 a.m., a Pipefitter sustained a foot injury due to a falling concrete block (cinder block filled with concrete) striking his left foot. The Pipefitter had been in the process of removing concrete blocks from inside the web of the wide-flange, steel Column N25, during the K-31 Control Room demolition, using a wrecking/pry bar at chest height and a hand-held, 4-pound sledgehammer. The wrecking/pry bar and hand-held sledgehammer are shown in Exhibit 2-1.

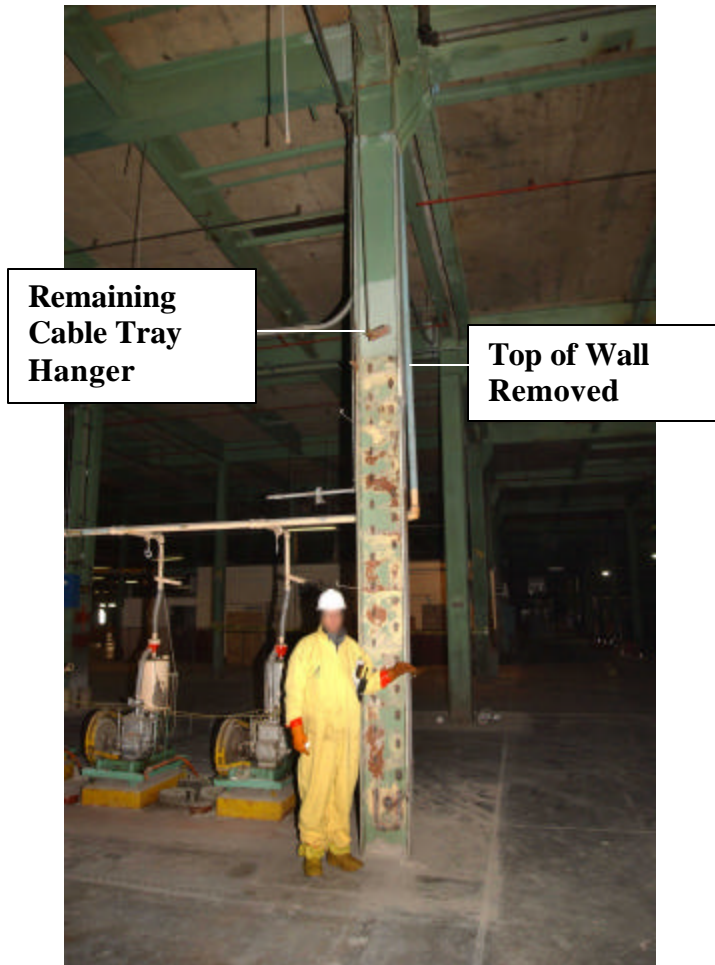
**Exhibit 2-2. Column N25 (Looking North)**

Column N25, shown in Exhibit 2-2 as it currently appears with all block removed, had been full of concrete blocks to a height of approximately 12 feet. An example of a column filled with concrete blocks is shown in Exhibit 2-3.

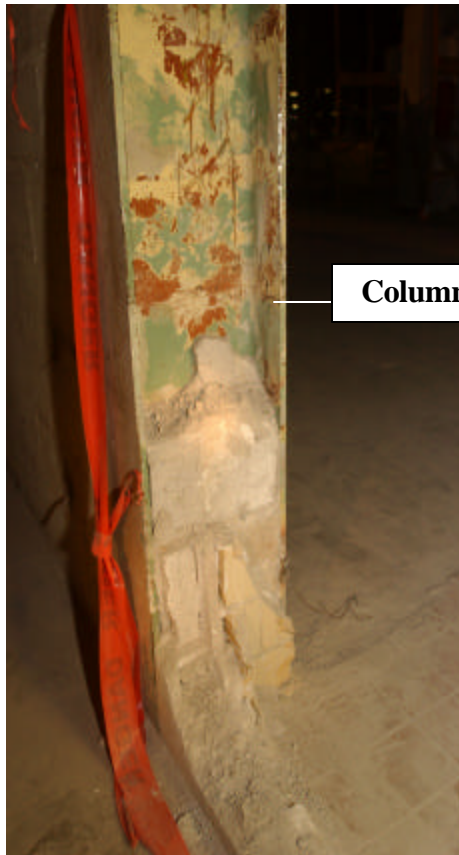
**Exhibit 2-4. View of Column P25 with Lower Block in Column (Looking South)**

Exhibits 2-4, 2-5, and 2-6 show a view of a column with block remaining in the lower portion of the column, a view of a column with block remaining in the column after wall demolition, and a view of the remaining east wall of the Control Room, respectively. The schematic shown in Figure 2-1 provides a plan view of the K-31 Control Room demolition area on the day of the accident. Under the hot work Radiological Work Permit (RWP), the workers were intermittently cutting steel along with performing block removal.

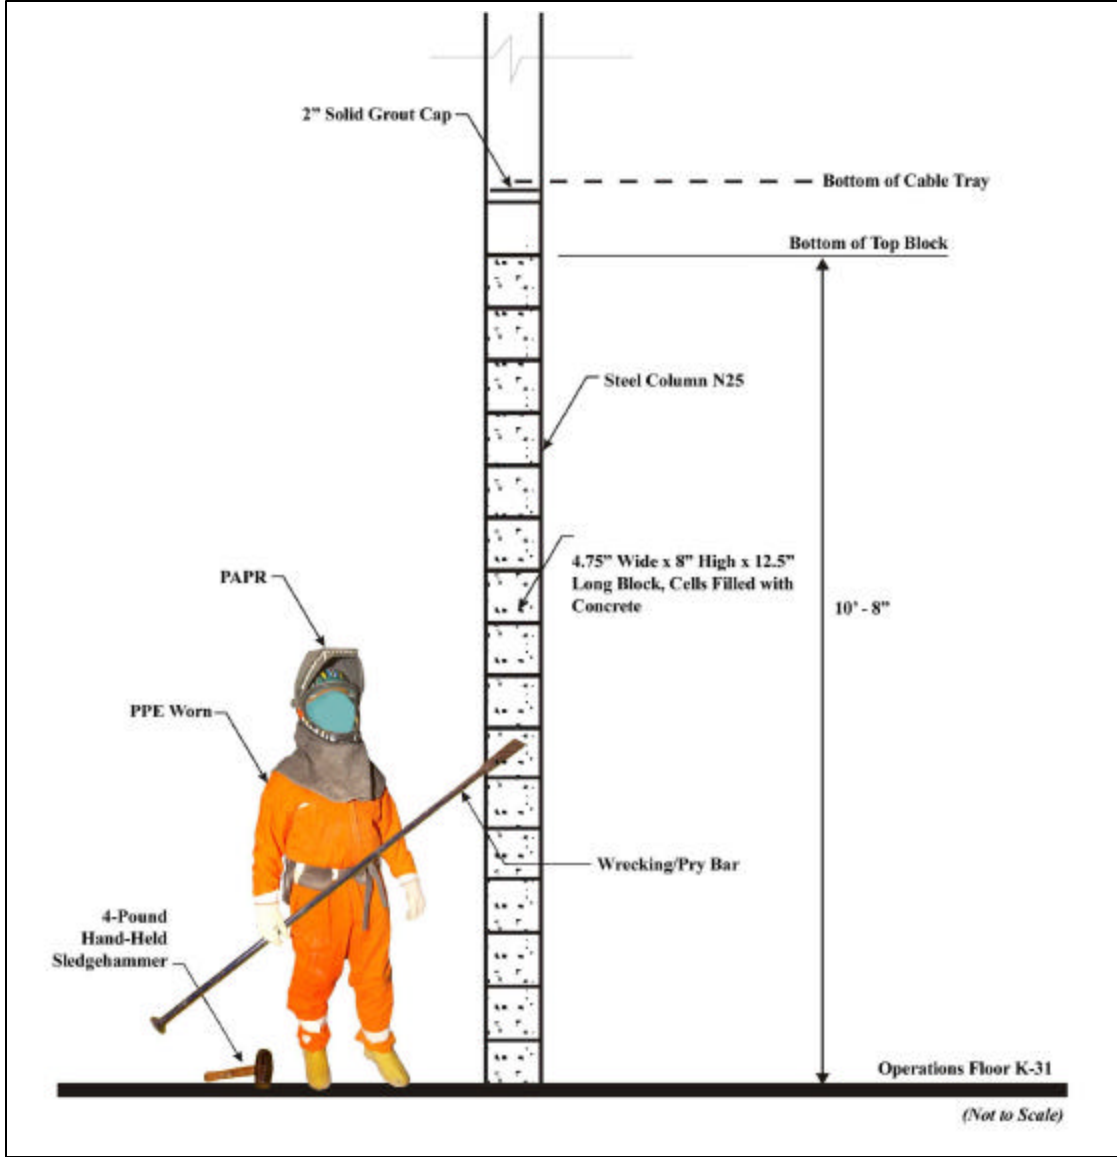
**Figure 2-2. Elevation Schematic of Column N25 Depicting Where Pipefitter was Working**

The Type B Accident Investigation Board concluded that the direct cause of the accident was a loosened concrete block, weighing approximately 49 pounds, falling 10 feet 8 inches, and striking the Pipefitter on his left foot. Based on the distance of the fall and the weight of the concrete block, the impact would release approximately 500 foot-pounds of kinetic energy. The work boot worn by the Pipefitter was an American National Standards Institute rated, 75-pound, steel-toe, work boot (which would equate to protection of approximately 110 foot-pounds of kinetic energy). Neither this work boot nor the use of a metatarsal guard (rated 75, 50, and 30 foot-pounds) would have supported the 500 foot-pounds of energy generated by the falling concrete block.

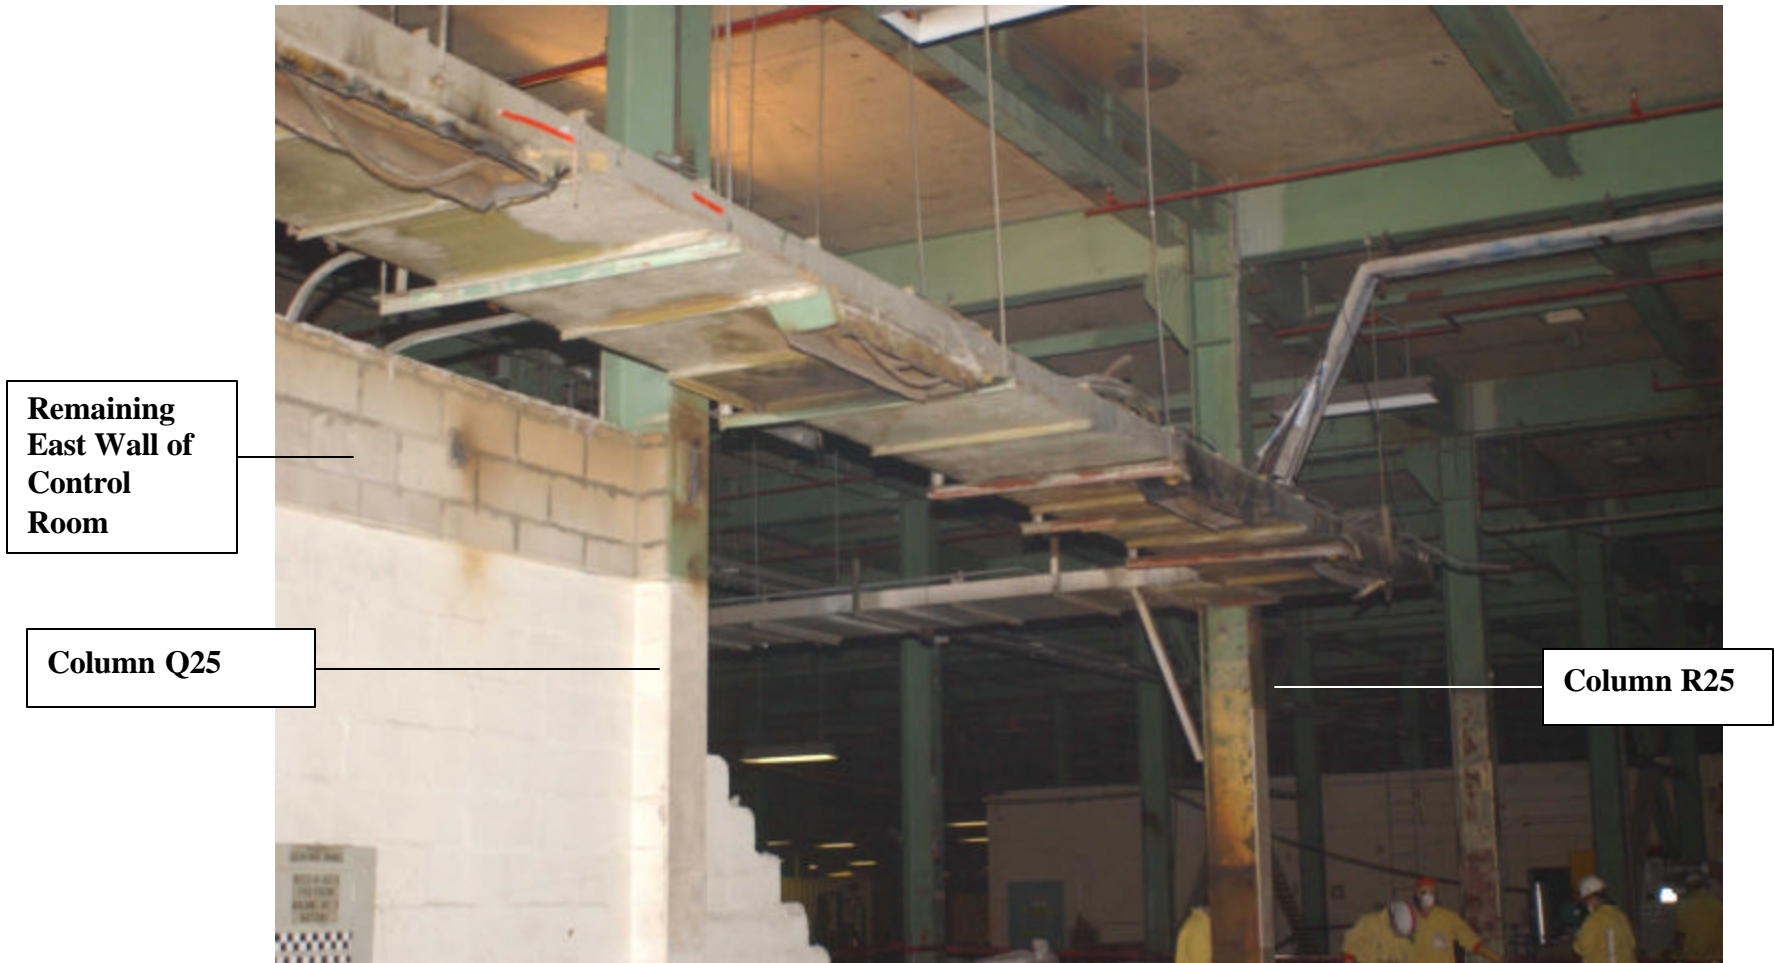
**Exhibit 2-9. Standing Inside Control Room Footprint  
(Looking Southeast at Remaining East Wall and Overhead Cable Tray)**

The EWP Hazard Assessment (HA) identifies inadequate lighting as a hazard and specifies a minimum of 5 footcandles for construction activities. No documented illumination surveys were performed for the K-31 Operations floor demolition until January 13, 2004. When this survey was performed, it was determined that the light levels immediately surrounding Column N25 where the injury occurred were approximately 1 to 2 footcandles. This survey was conducted after the demolition work was completed (with the exception of remaining blocks in columns) and after removal of overhead obstacles (cable trays). Refer to Exhibit 2-9 for an example of Control Room cable trays and columns.

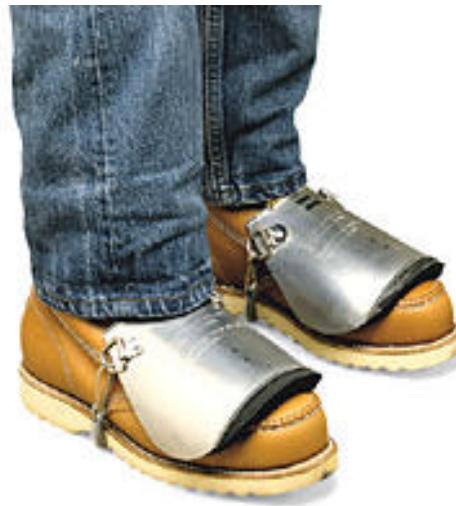
**Exhibit 2-11. Example of a Metatarsal Guard (Not Part of Required PPE)**

Metatarsal guards, which were identified for use in the draft critique planned by the Building Manager, are sometimes worn for hand demolition work. The guards were not part of the crew's PPE. Metatarsal guards (see an example of a metatarsal guard in Exhibit 2-11) are tested in the same manner as a steel-toe, work boot and classed accordingly (75, 50, and 30 pounds) (ANSI Standard Z41-1991, Personal Protective Footwear). A metatarsal guard would also equate to protection of approximately 110 foot-pounds of kinetic energy. Based on the class ratings of work boots and metatarsal guards, neither of these types of PPE would have supported the 500 foot-pounds of energy released by the impact of the free-falling concrete block.

The Building Manager’s draft critique stated that metatarsal guards be used for any future work removing concrete block. (This recommendation did not actually get implemented.)
		DOE Project Manager visits site (sees column with all blocks removed).
12/18/2003- 12/31/2003		Another crew removes overhead cable tray in front of N25 column.
12/18/2003- 1/01/2004		DOE Project Manager informed by BNFL management that informal stop work is in place.
12/19/2003		DOE Project Manager decides and recommends to AMEM that no briefing is needed by BNFL until after holidays.
		AMEM concurs with waiting on briefing.
		Building Manager stops critique process due to management decision (Deputy General Manager) to elevate investigation to Type C.
12/21/2003		Pipefitter discharged from hospital.
12/22/2003		AMEM issues letter to BNFL General Manager stressing safety expectations as the project comes to closure and expressing concern over the recent occurrences in December.

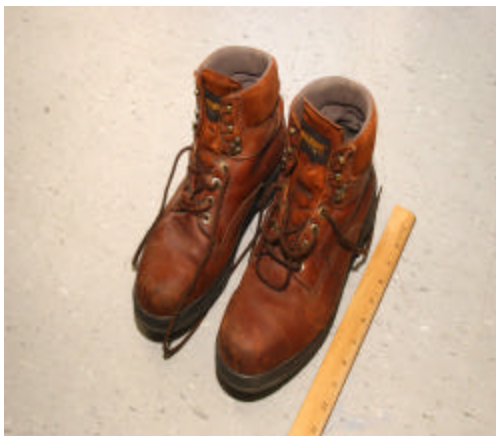
**Exhibit 2-12. Work Boots Worn by Pipefitter**

The Pipefitter had an approximate 49-pound concrete block fall onto his left, steel-toe work boot. The Pipefitter noted immediate pain and swelling. Exhibit 2-12 is a photograph of the actual work boots worn by the Pipefitter at the time of the accident. Exhibit 2-13 is a cutaway view of the Pipefitter's left work boot. The Pipefitter was admitted to the hospital for compartment syndrome to the left foot; dislocation of the joint on the left, fourth toe; and open dislocation of the left, fifth toe with fracture.

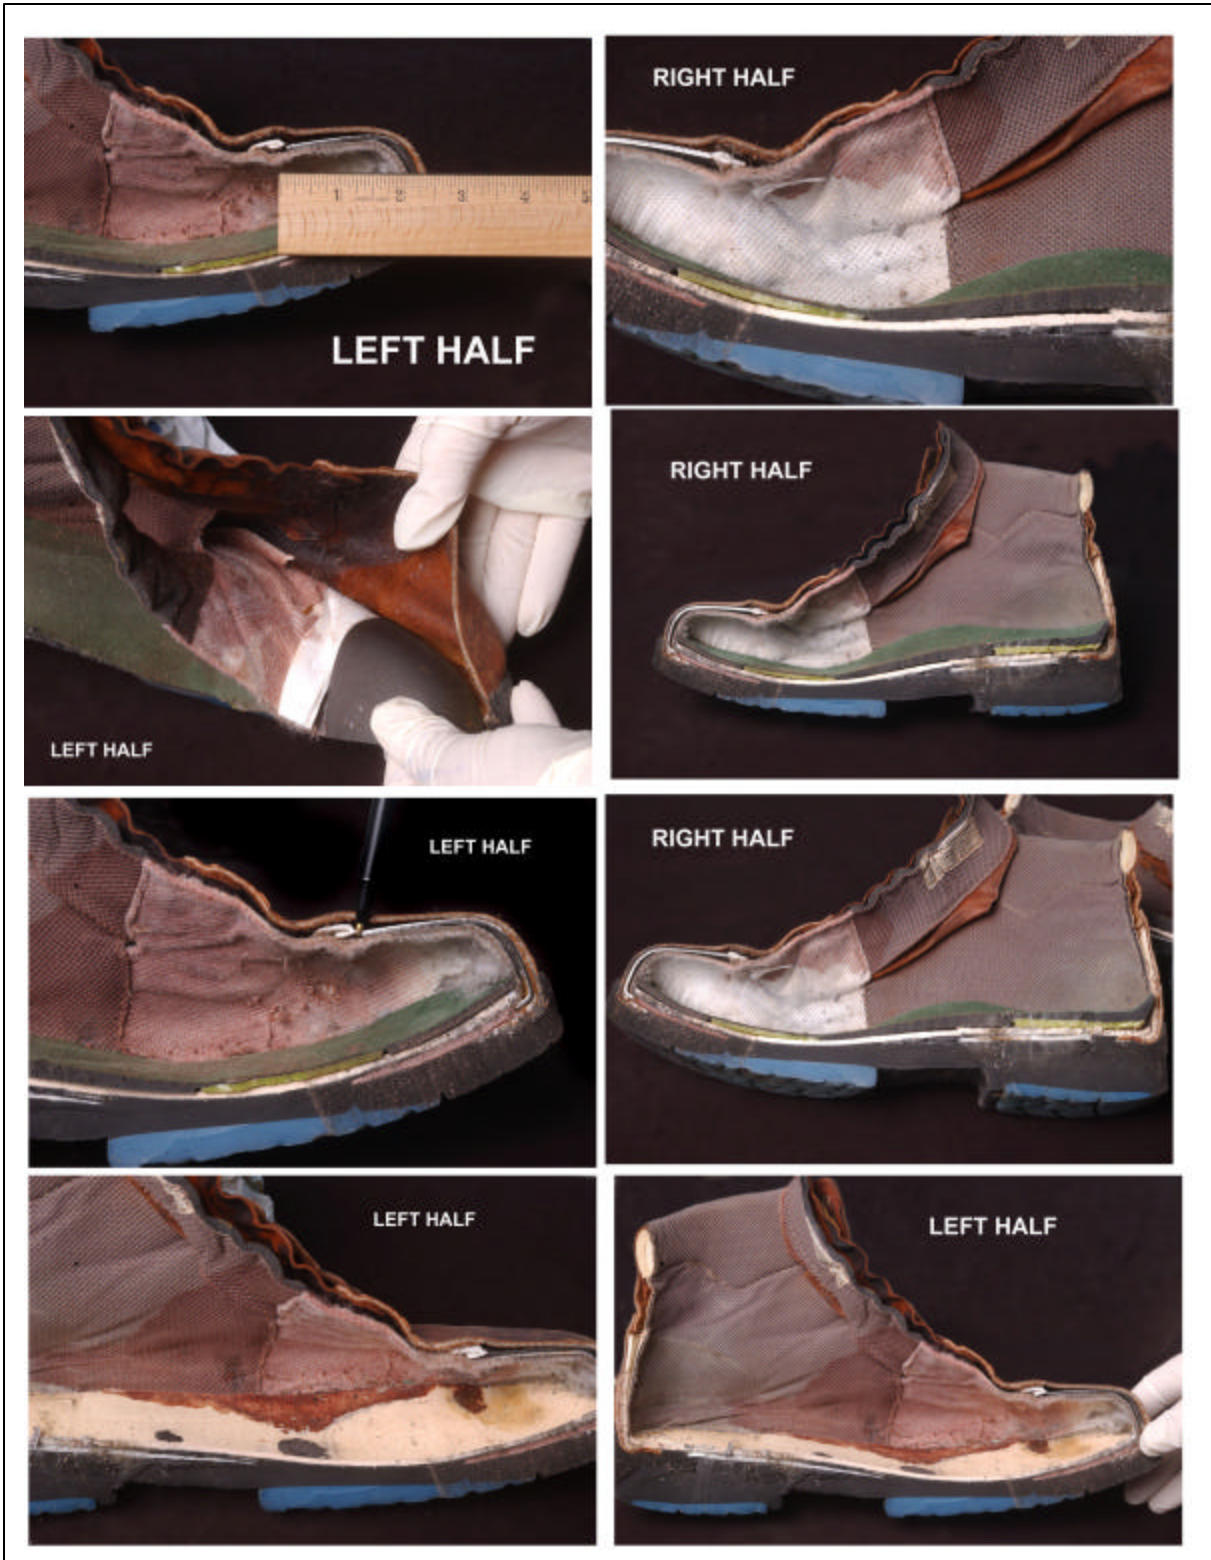
**Exhibit 2-13. Cutaway View of Pipefitter's Left Work Boot**

Based on the distance of the fall (10 feet 8 inches) and the weight of the concrete block (approximately 49 pounds), the block struck the worker's foot with approximately 500 foot-pounds of kinetic energy. The work boot worn by the Pipefitter was an American National Standards Institute (ANSI)-rated, 75-pound, steel-toe, work boot (which would equate to protection of approximately 110 foot-pounds of kinetic energy).
