**Type B Accident Investigation of the
August 5, 2003 Plutonium-238 Multiple
Uptake Event at the Plutonium Facility,
Los Alamos National Laboratory
New Mexico**

December 2003

**National Nuclear Security Administration
United States Department of Energy
Washington, DC 20585**

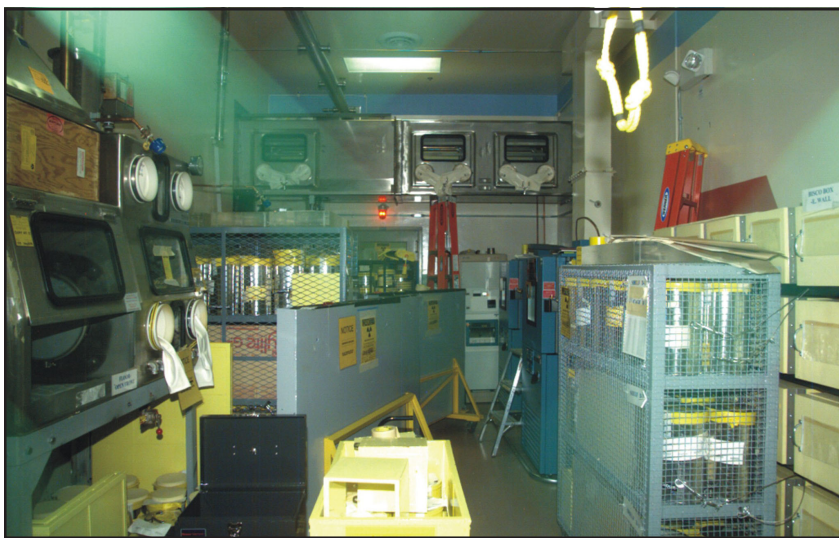
Exhibit 2-1 Photo of room 201B from the doorway to room 201A.

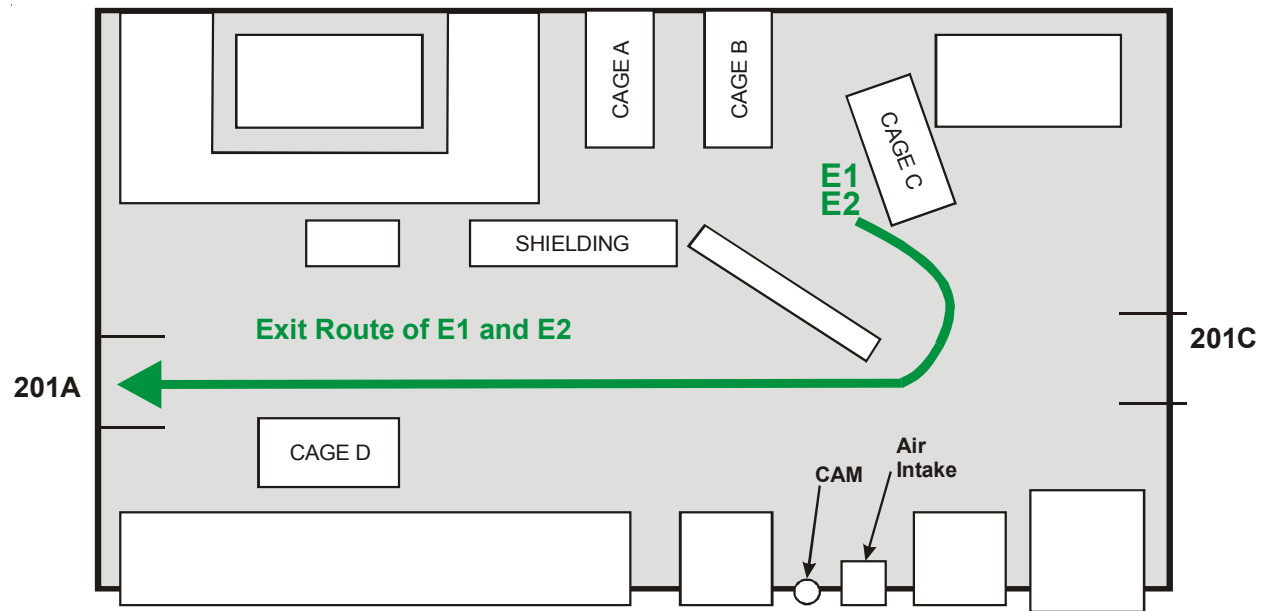
Figure 2-1 Locations and Exit Paths of Workers.

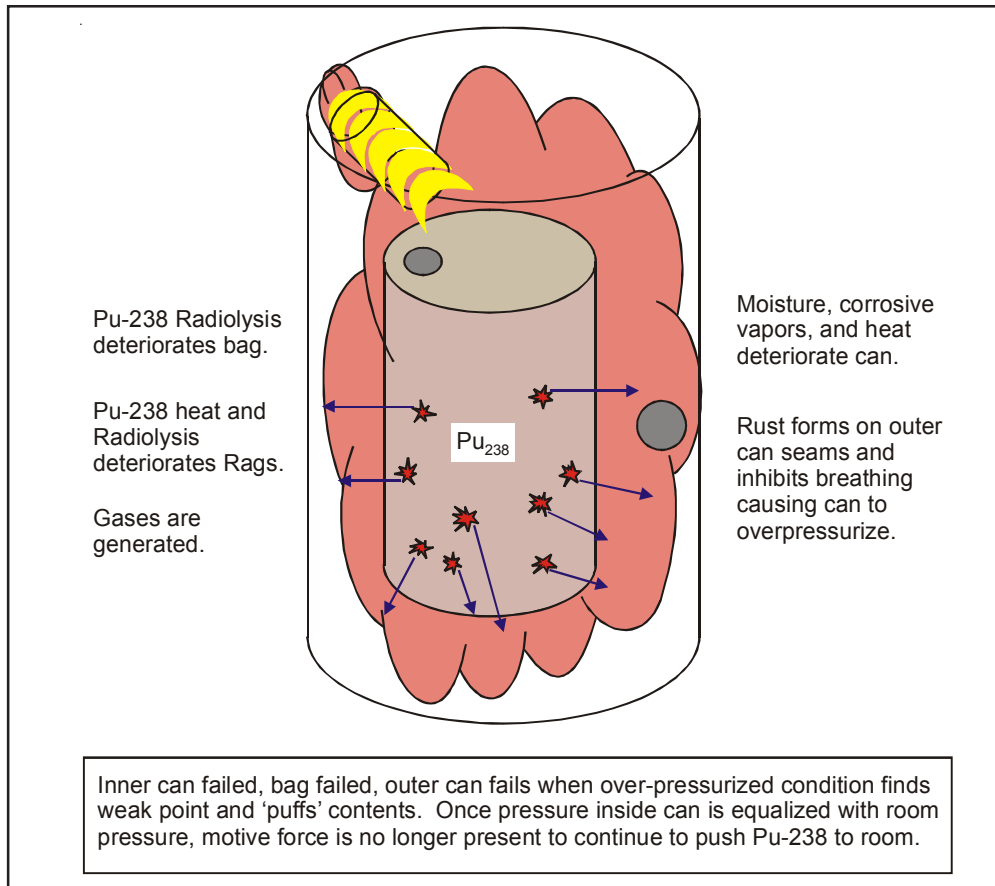
Figure 2-2 Package Failure Scenario

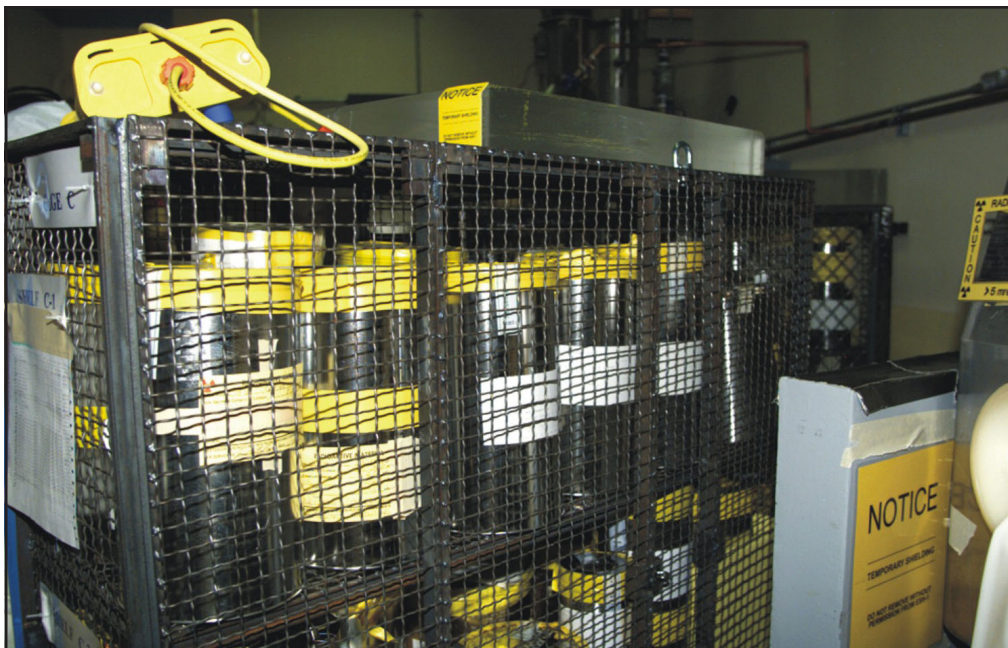
Exhibit 2-2 shows the storage of packages in the cage.

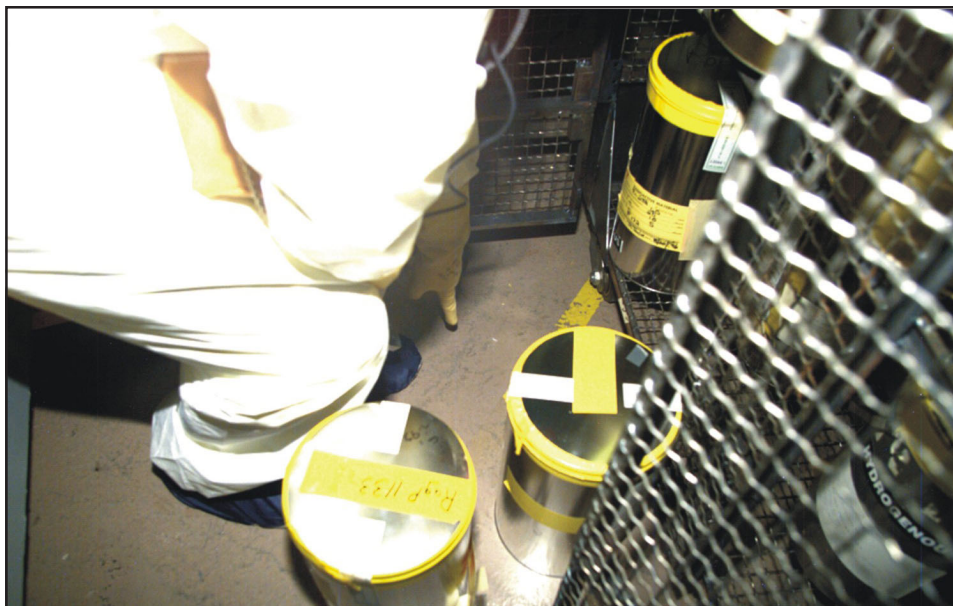
As shown in Figure 2-3, package P3 on the lower left shelf of cage C had the highest contamination reading of the packages in cage C (200,000 dpm/100 cm²). This spot was located where the seam connected to the bottom of the outer can. The seam was oriented towards the front of cage C, pointing towards the 600,000 dpm/100 cm² area on the floor. From the interviews, it was determined that E1 had placed two packages on the floor and was handling another package from the third shelf when the CAM alarm sounded. (The inventory checklist was inadvertently disposed of during post-event cleanup and neither E1 nor E2 were sure of which packages they had already handled; consequently the Board could not determine exactly which packages had been handled before the CAM alarmed, other than the two on the floor.) Based on its proximity, the Board believed that E1 had worked with package P3 prior to the evacuation.

Exhibit 2-3 shows reentry team member pointing out the hot spot location.

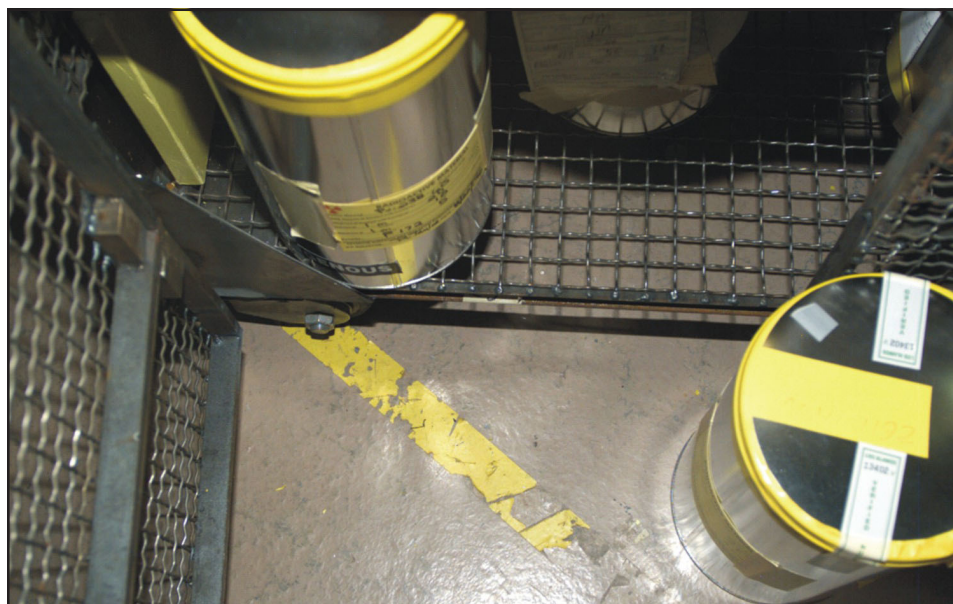
Exhibit 2-4 shows a package on the floor and a suspect package in the cage directly in front of the hot spot location. Note the position of the sidewall seam on the suspect can.

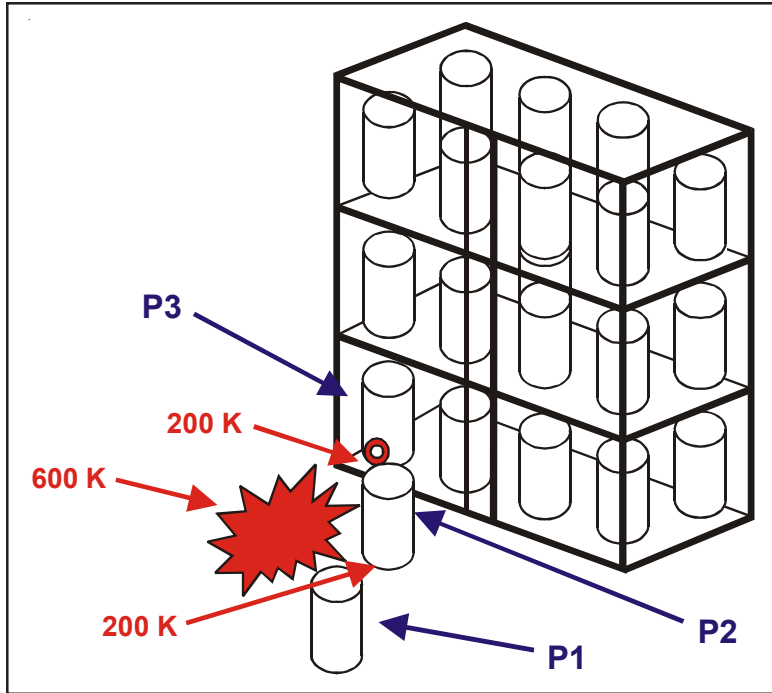
Figure 2-3 Schematic of high contamination readings around cage C.

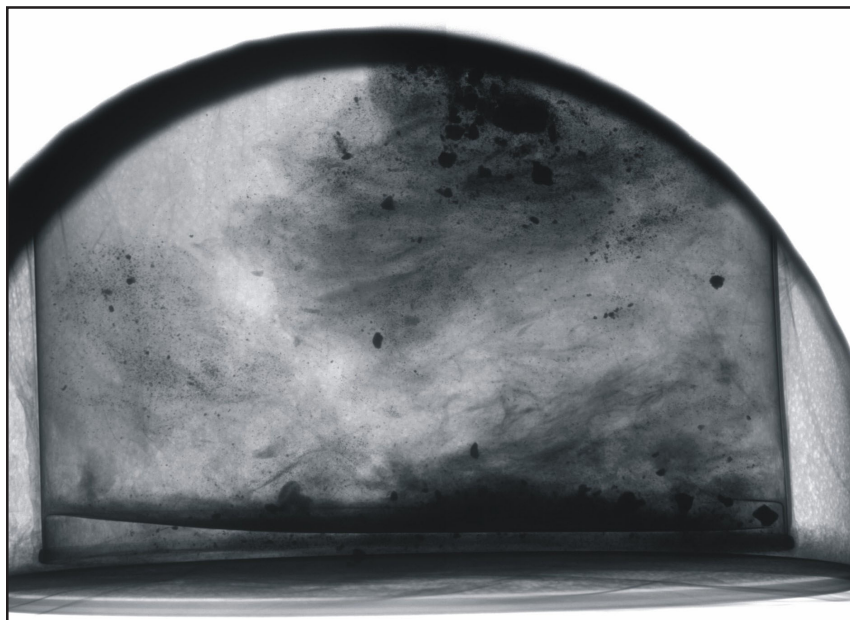
Exhibit 2-5 shows the Digital Radiograph of P3. Note the angle of the bottom of the inner can.

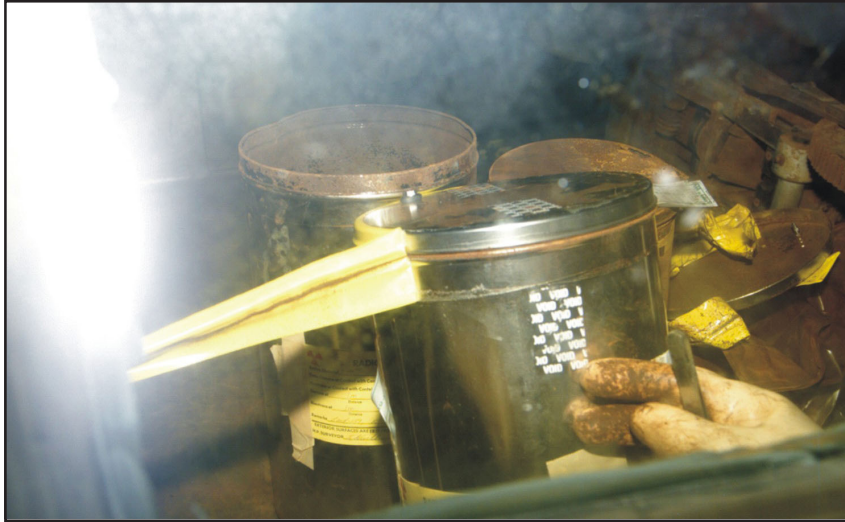
The packages were disassembled in an inert-atmosphere glovebox to evaluate their contents. When the tape was removed from the lid of the outer cans, rust deposits were observed on the tape where the tape was in contact with the lid seal (see Exhibit 2-7). In all three packages, the buildup of rust in the gap between the outer can lid and the lip of the can was extensive. In fact, for one of the packages (P1) it was necessary to pry the outer can lid off because

of this rust buildup. Samples of the outer can rust were analyzed with a scanning electron microscope to determine their content. As expected, iron oxide was the major component, however there was a notable amount of chlorine present in the samples, which was likely due to the degradation of the PVC bags. The hydrogen chloride generated from the bag would combine with the water vapor and form hydrochloric acid, which would then attack the outer can. This would accelerate the corrosion process.

Exhibit 2-7 shows the rust on the tape and under the lid of the outer can.

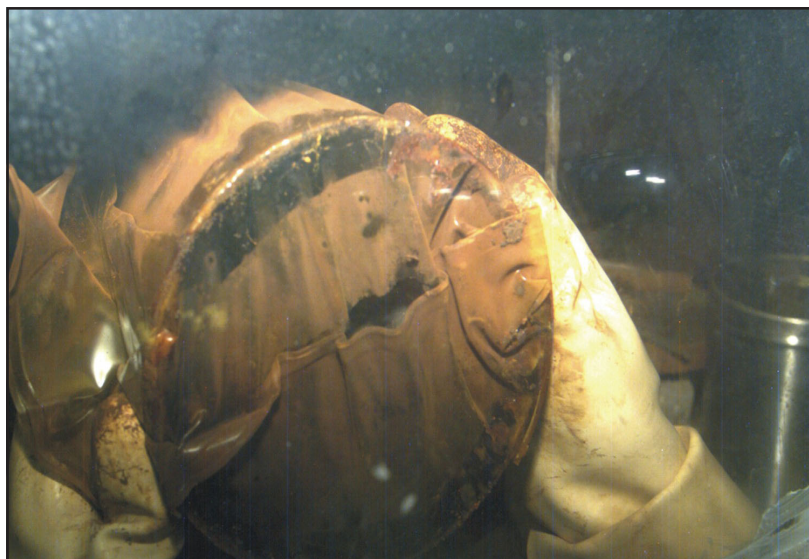
Exhibit 2-8 shows the bag failure of P3.

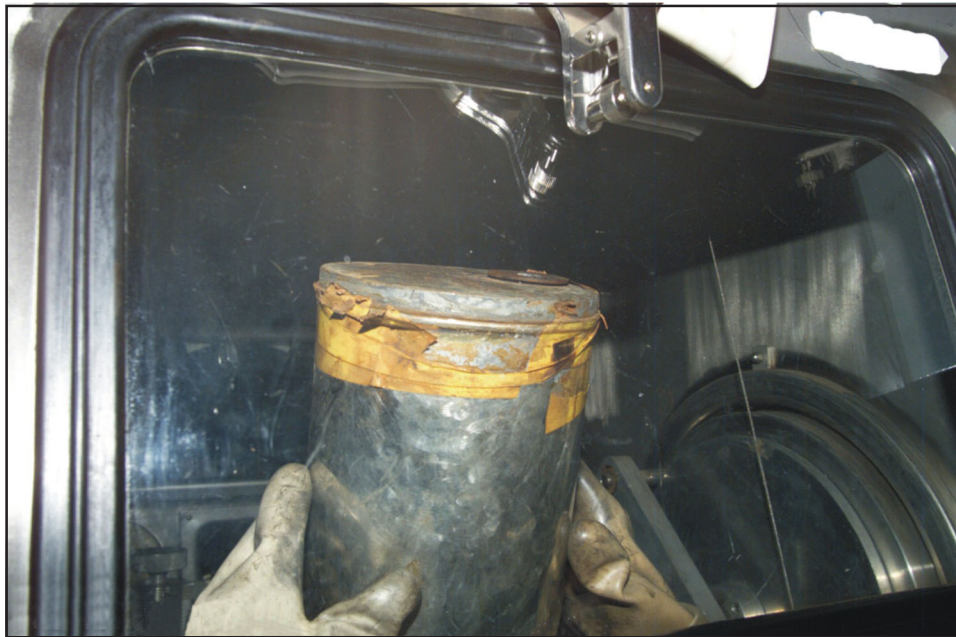
good condition, as shown in Exhibit 2-9. Contrary to the condition of the P2 inner can, both P1 and P3 inner cans showed significant corrosion resulting in failures. A sizeable hole was also identified on the lid of the inner can of P1 (Exhibit 2-10). When the bag was removed from P3, the bottom of the inner can of P3 was found to be separated from the sides of the can, consistent with the radiographs. Further visual observation of P3 showed that the lower section of the inner can sidewall had completely corroded through in multiple points (Exhibit 2-11).

Exhibit 2-9 showing condition of P2 inner can.

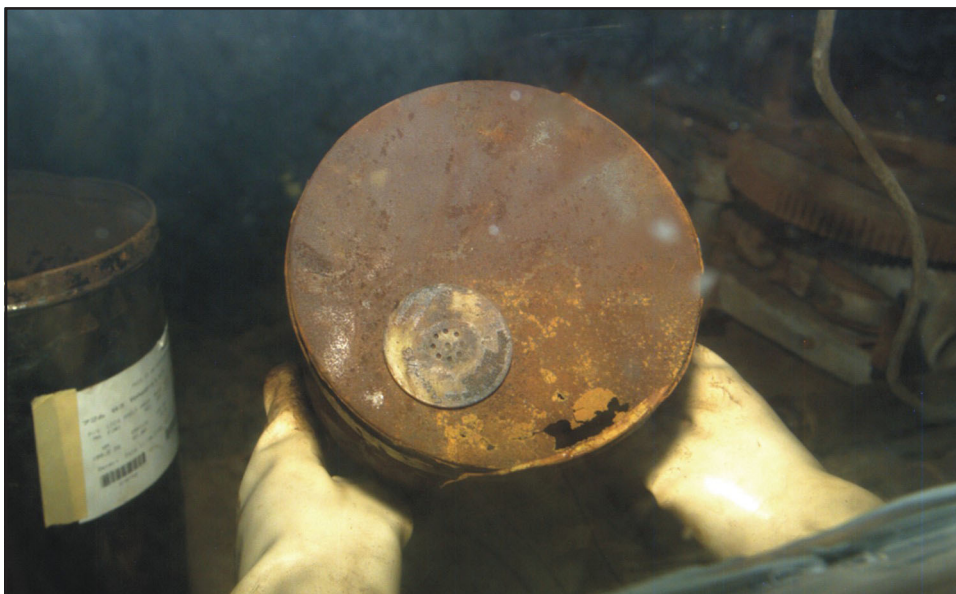
Exhibit 2-10 shows the inner can lid failure of P1.

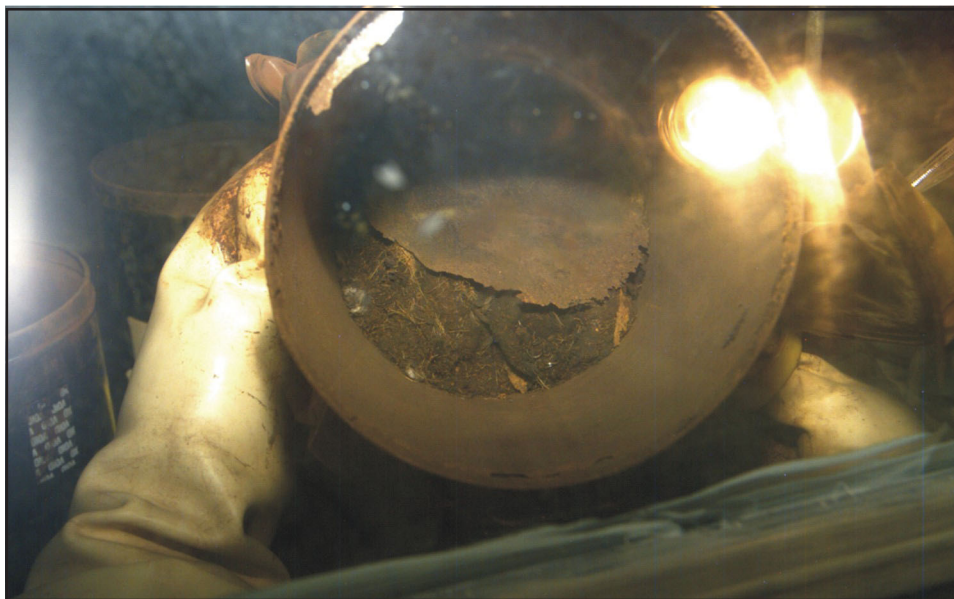
Exhibit 2-11 shows the inner can failure of P3. Note that this view is from the bottom of the can

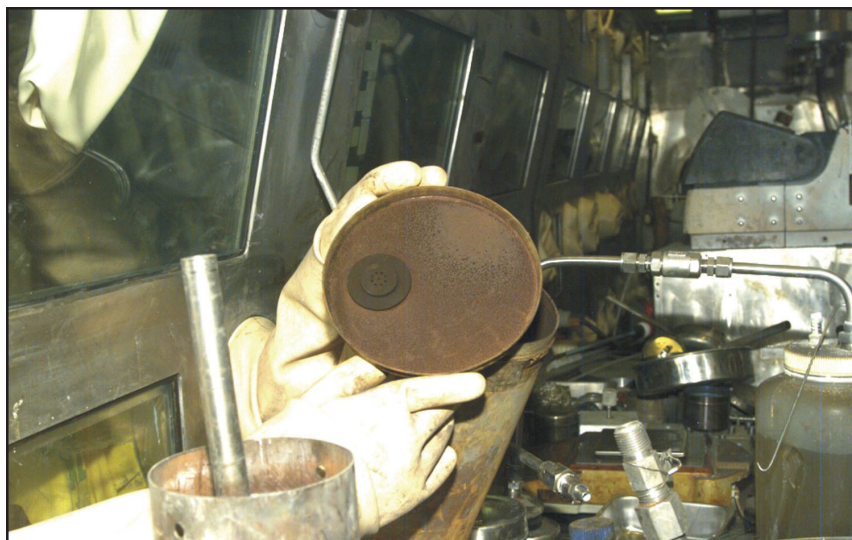
Prior to entering room 201B, the reentry team observed a slip-lid can that showed signs of degradation in a glovebox in room 201. NMT-9 staff stated that the activities in this glovebox used nitric acid, resulting in a caustic environment within the glovebox. The slip-lid can was introduced into this glovebox in June 2003 and had significantly corroded since then, as shown in Exhibit 3-1. In addition, cheesecloth contained in the glovebox appeared to be discolored and was beginning to decompose (Exhibit 3-2).

Exhibit 3-1 Acorroding can in a nitric acid glovebox in room 201.

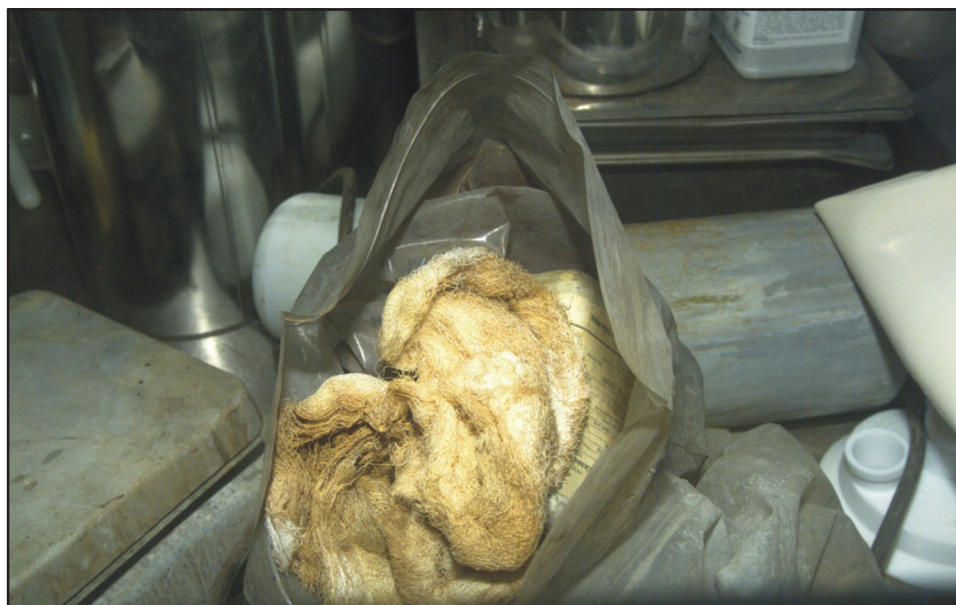
Exhibit 3-2 Cheese cloth used in the nitric acid glovebox in room 201.

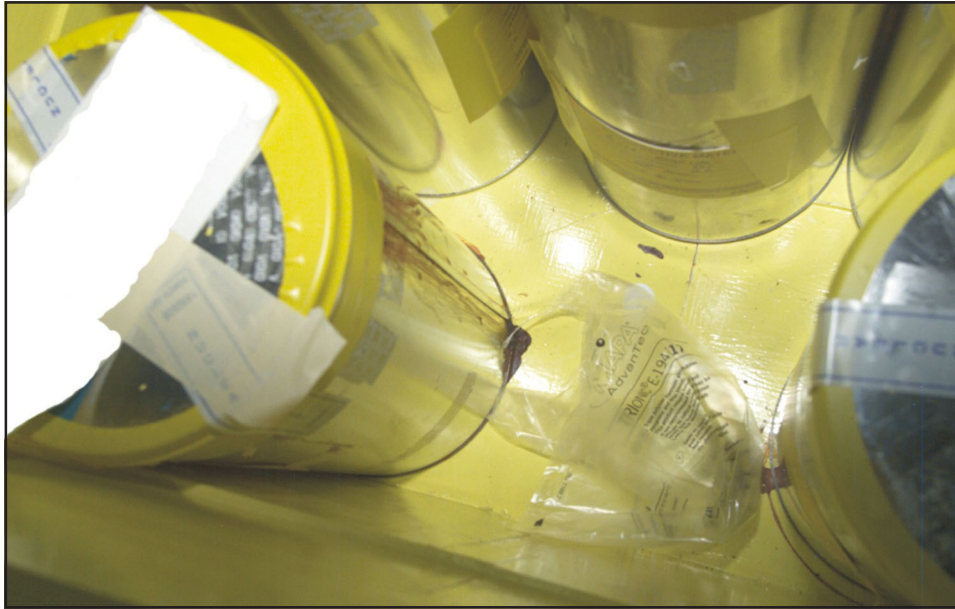
In room 201B, the reentry team found packages sitting in a small cart that had corrosion products flowing down the exterior surfaces of the outer cans (Exhibit 3-3). Several other packages were identified that showed similar indications of corrosion products seeping out around the tape seam (Exhibits 3-4 and 3-5). One package appeared to have corroded all the way through the outer can wall (Exhibit 3-6). A sample was taken of the corrosion products collecting in the cart, as shown in Exhibit 3-3, and it was found to be composed of mainly iron oxide (rust) with some

Exhibit 3-3 shows the corrosion products seeping down a package and onto the cart.

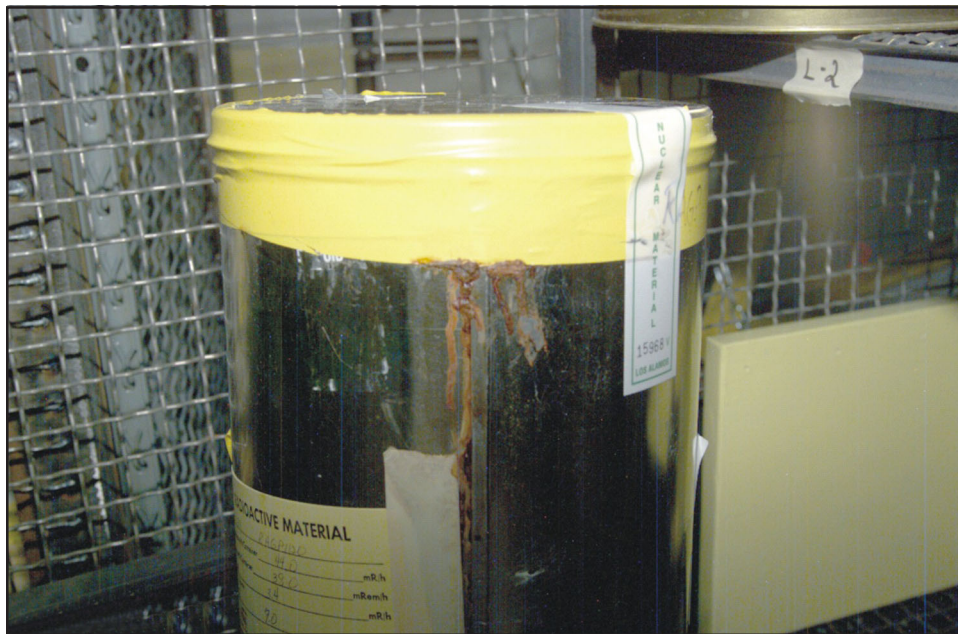
Exhibit 3-4 shows a package with apparent corrosion products seeping under the taped lid.

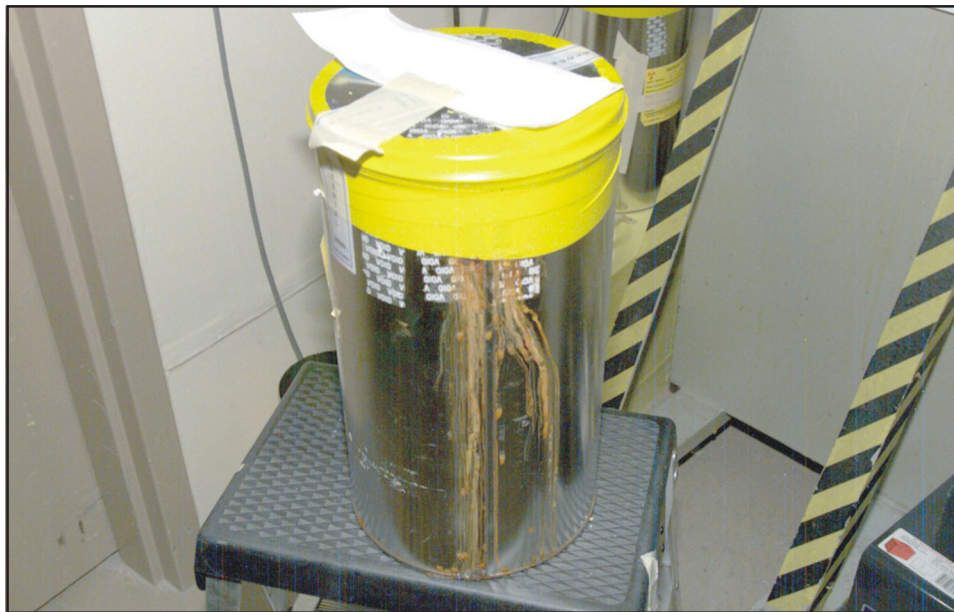
Exhibit 3-5 shows a package with apparent corrosion products seeping down the side of the package.

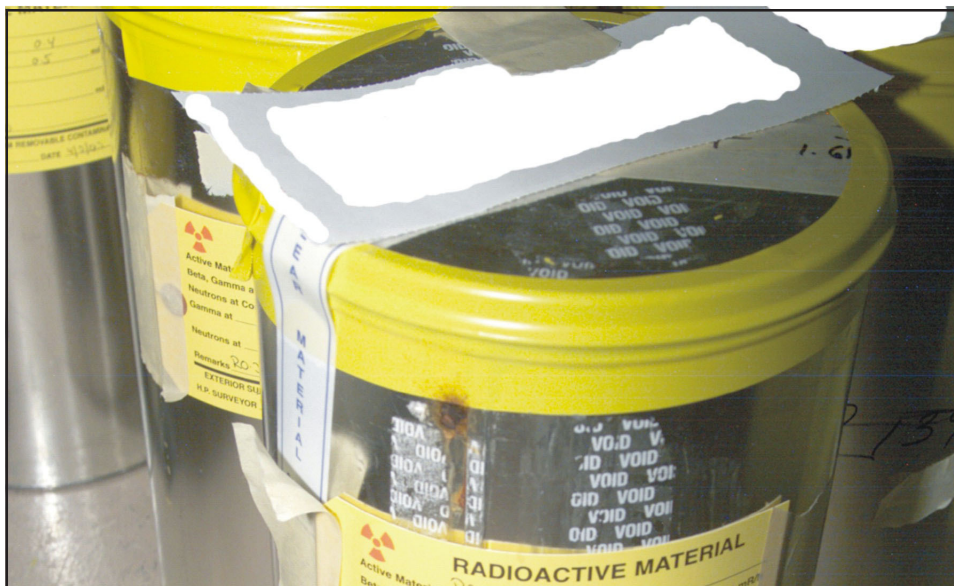
Exhibit 3-6 shows a package with apparent corrosion induced failure. This package had been created less than two months before this picture was taken.

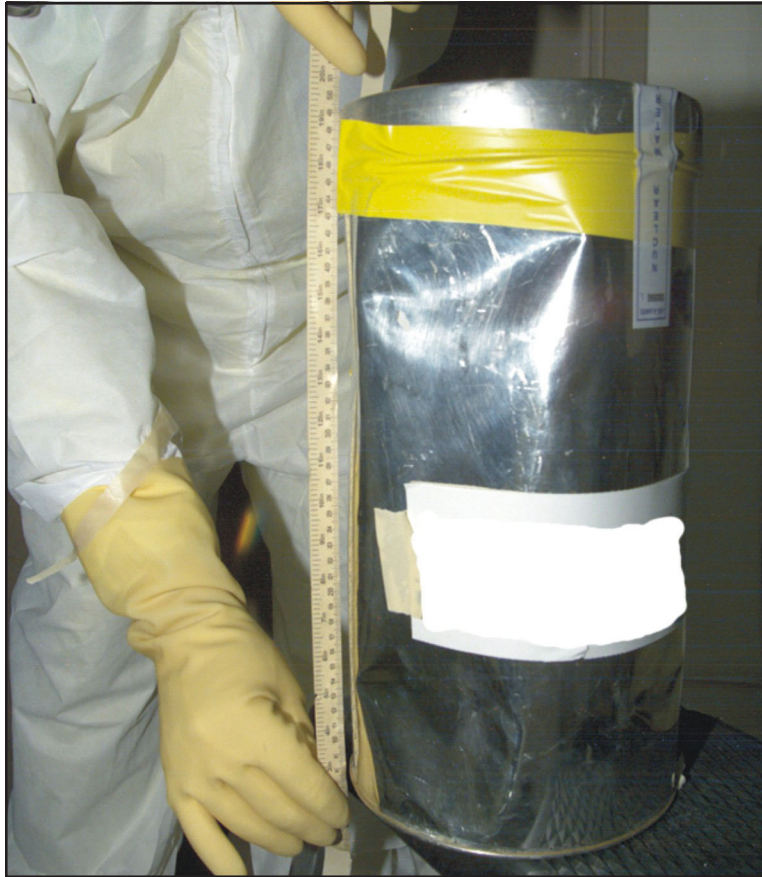
Additionally, three packages showed signs of physical damage (depressions) on the sides and the lid, as shown in Exhibits 3-7 and 3-8. The Board suspected that the packages might be showing signs of “paneling,” a condition where the pressure inside the package was decreasing causing a vacuum (see Section 3.4). The pressure decrease could be formed by the consumption of oxygen and nitrogen in the package’s internal atmosphere by chemical reactions. Several DOE published reports identify these reactions. An alternate explanation could be physical damage caused by handling.

Exhibit 3-7 shows the side of a suspect “paneled” package.

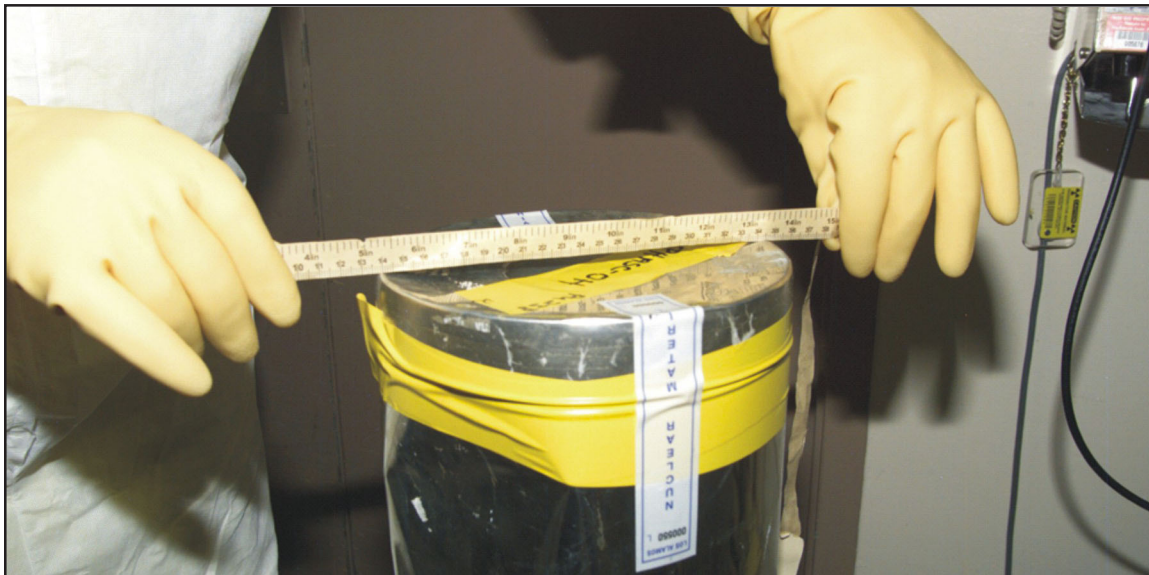
Exhibit 3-8 shows the lid of a suspect “paneled” package.
