**Type B Accident Investigation
Board Report**

**Subcontractor Radioactive Release During the
May 14, 2004, Transportation Activities
Bechtel Jacobs Company LLC
Oak Ridge, Tennessee**

June 2004

**U.S. Department of Energy
Oak Ridge Operations Office**

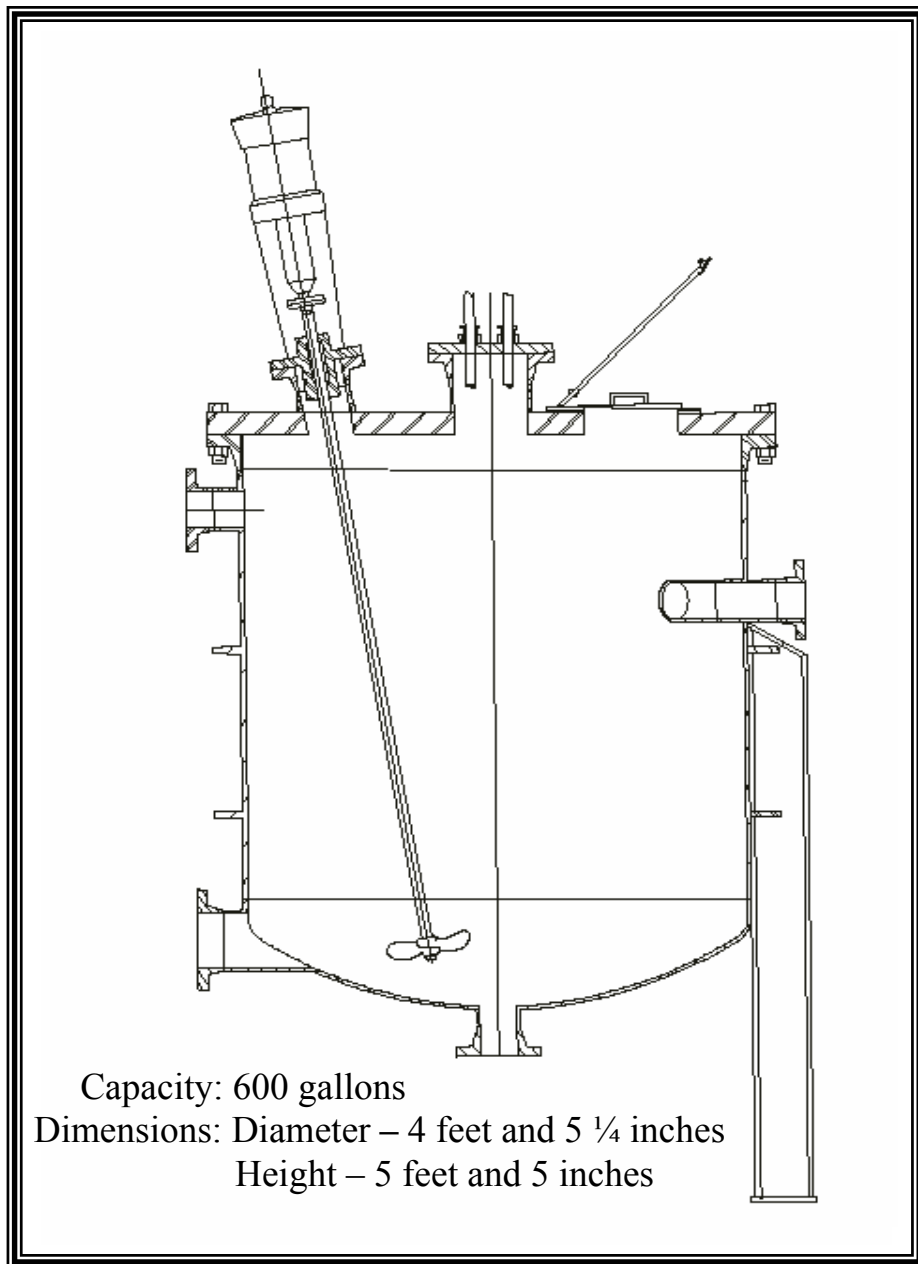
Figure 1-1. Drawing of Tank T-12

with a 90-gallon capacity, and the 600-gallon Tank T-12 that mixed grout and waste prior to underground injection. Tank T-12 was made of stainless steel, was approximately 4.5 feet in diameter, and was 5.5 feet high with a semispherical bottom (see Figure 1-1). It stood on legs that added another 6 inches to its height and had a mixer that protruded several feet above the top. It had multiple nozzles and a port with an observation window on the top. The tank weighed 3,500 pounds empty (without the mixer), and the total live load was estimated at 10,650 pounds. The waste pit contained Tank T-13, which was a below grade tank. The *SEC D&D Work Plan* called for Tank T-13 to be grouted and left in place. All solid waste from the D&D of the NHF would be sent to the EMWMF for disposal and all liquid would be treated through the Low-Level Liquid Waste (LLLW) System.

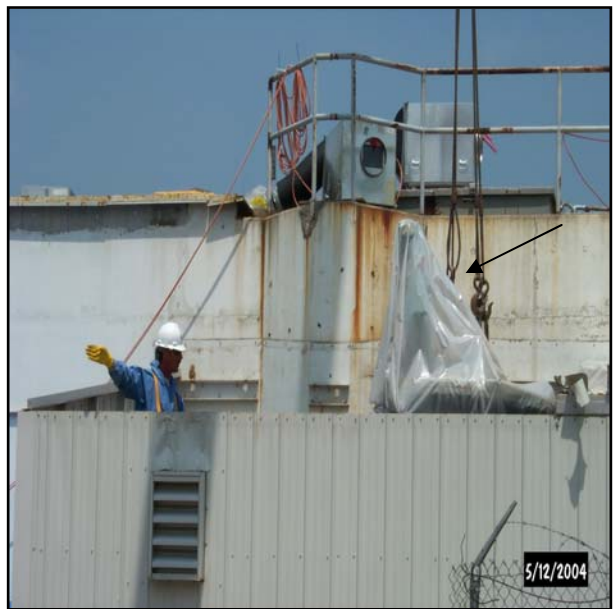
Figure 2-3. Mixer for Tank T-12 Extends Beyond the Roof of the T-13 Annex

The Tank T-12 mixer extended beyond the top of the roof (see Figure 2-3), which made it necessary for a hole to be cut in the roof of the T-13 Annex in order to allow for storage of Tank T-12. Additional plastic and a tarp were placed over Tank T-12 to protect it from rainwater. While in storage, a total of two to three inches of rain was measured at a nearby ORNL meteorological station. The variance requests were approved on May 10, 2004.

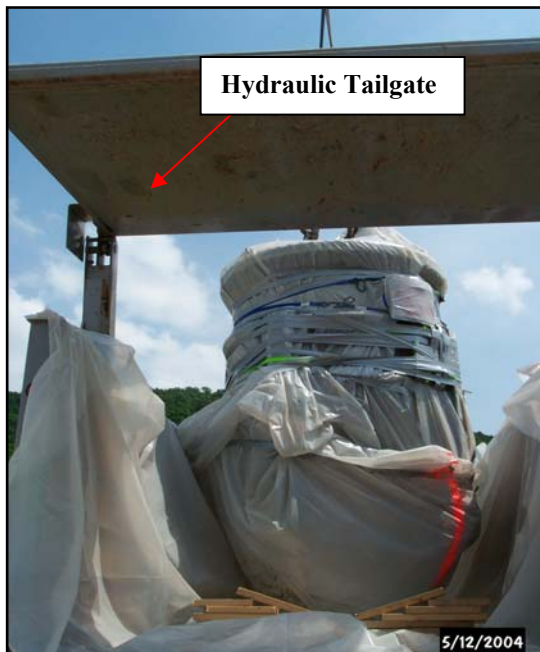
Figure 2-4. Tank T-12 Being Placed into a Truck Bed Lined with Plastic

Two sheets of plastic were placed in the bed of the dump truck (see Figure 2-4). As Tank T-12 was lifted off the ground for the purpose of loading, workers noticed liquid within the plastic wrap that was located at the base. The plastic was punctured to allow for the drainage of approximately 2.5 gallons of liquid (assumed by some personnel to be rainwater) into a bucket. While attempting to transfer Tank T-12 to the dump truck from the T-13 Annex, several drops of liquid fell to the ground. In addition, moisture was noted on the tailgate of the dump truck.

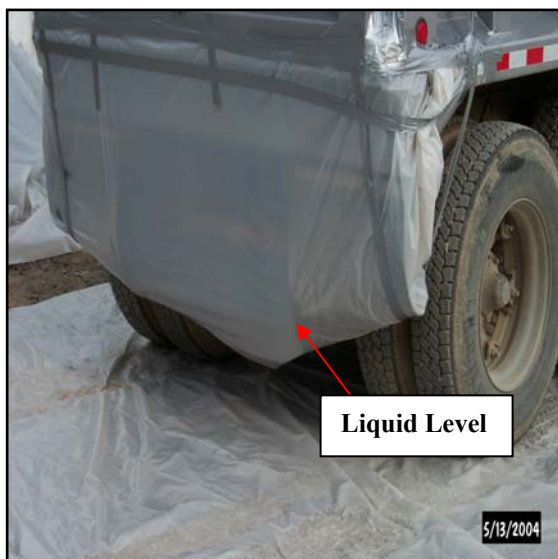
Figure 2-5. Liquid Collected in the Diaper

all readings are beta/gamma results. Due to these findings, the dump truck was moved to a permanent CA and an “Initial Event Report” form was completed. As a precautionary measure, a “diaper” was affixed to the tailgate of the truck to collect any additional liquid (see Figure 2-5).

On the morning of May 13, 2004, the diaper had accumulated 1 to 2 quarts of liquid. At the POD meeting, a path forward for the shipment was discussed. One course of action discussed in the POD meeting was to tilt the truck bed. A static test for liquid was performed prior to Tank T-12 being shipped. BJC and SEC D&D tilted the truck bed for 1 to 4 hours in an effort to collect any additional liquid. (See Figure 2-6 on the following page.) No additional liquid was noted in the diaper. On the morning of May 14, 2004, the unobstructed portion of the truck bed was inspected by an SEC D&D employee, and no liquid was noted.

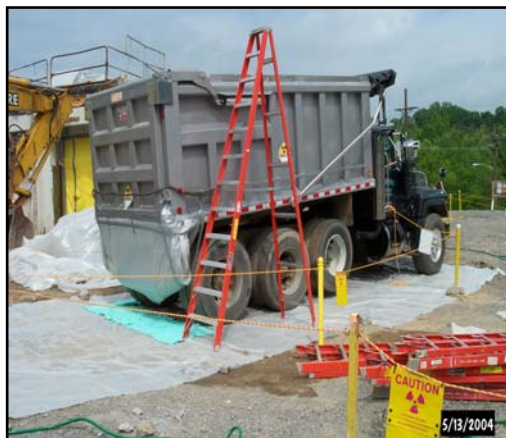
Figure 2-6. Tilting the Truck Bed to Collect Any Additional Liquid

Concerned that rain could spread the contamination, the BJC EMWMF STR directed the positioning of the dump truck that contained Tank T-12 within the CA of the disposal cell where any runoff could be collected in the cell's water containment system. Due to the dose rates (ALARA) associated with Tank T-12 and the possibility of rain, the BJC EMWMF STR directed the disposal of Tank T-12 at approximately 3:30 p.m. It was noted that between 1 quart and 5 gallons of liquid exited the bed of the truck prior to Tank T-12 sliding into the cell (see Figure 2-7).

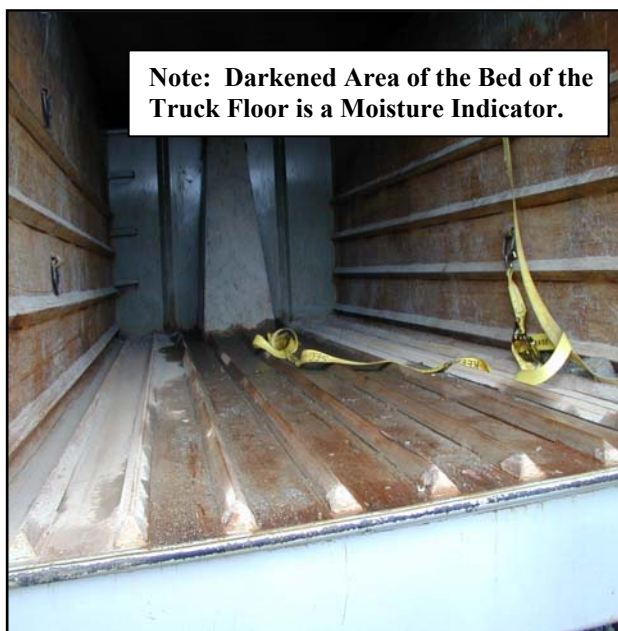
Figure 2-7. Moisture Indicated in the Back of the Truck Bed After Disposal

Note: Darkened Area of the Bed of the Truck Floor is a Moisture Indicator.

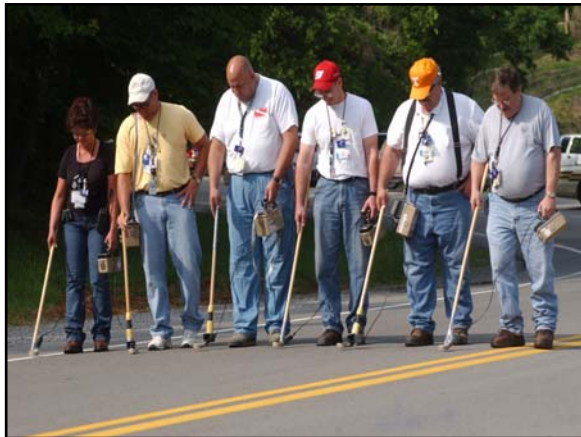
Figure 2-8. RAP Team Conducting Surveys on Hwy-95

The RAP Team arrived on scene at Hwy-95 at approximately 5:45 pm that evening. The RAP Team (augmented by resources from BJC, ORNL, and Y-12) completed surveying Hwy-95 at approximately 3:30 a.m. on May 15, 2004, and left the scene shortly afterwards (see Figure 2-8). The surveys found a maximum of 370,000 dpm/100 cm² on the on-site roads and a maximum of 85,000 dpm/100 cm² on Hwy-95. See Appendix F for a map with an overview of the spill.
