**TYPE B ACCIDENT
INVESTIGATION BOARD REPORT
OF THE JULY 2, 1997
CURIUM INTAKE BY SHREDDER OPERATOR
AT BUILDING 513
LAWRENCE LIVERMORE NATIONAL LABORATORY,
LIVERMORE, CALIFORNIA**

This report is an independent product of the Type B Accident Investigation Board appointed by James M. Turner, Ph.D., Manager of the U.S. Department of Energy, Oakland Operations Office.

The Board was appointed to perform a Type B Investigation of this accident and to prepare an investigation report in accordance with the DOE Order 225.1, *Accident Investigations*.

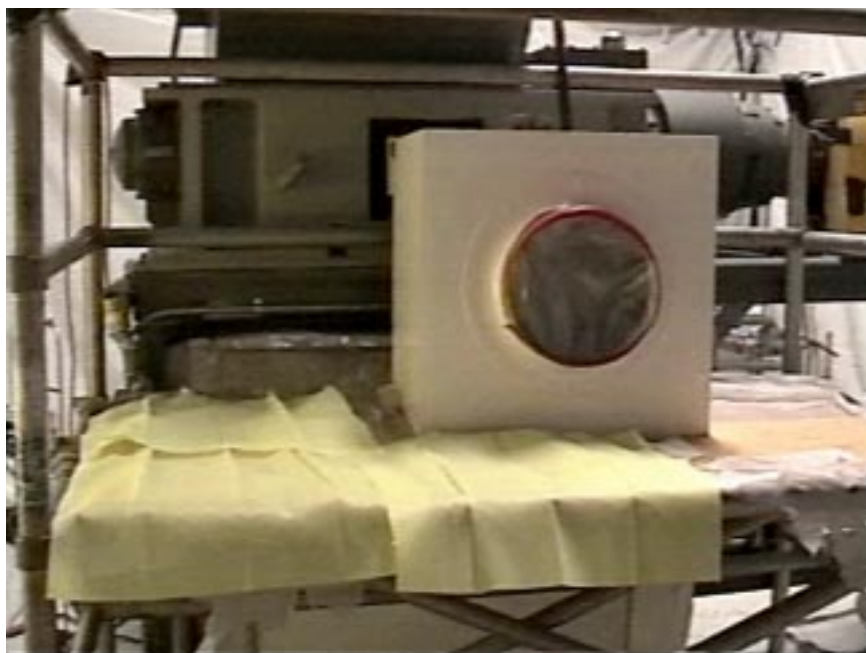
Exhibit 2-2: HEPA filter discovered on the scaffolding platform

(adjacent to shredder) after the accident. Masslin cloth was placed on the scaffolding during post-accident re-entry procedures to prevent spread of contamination.

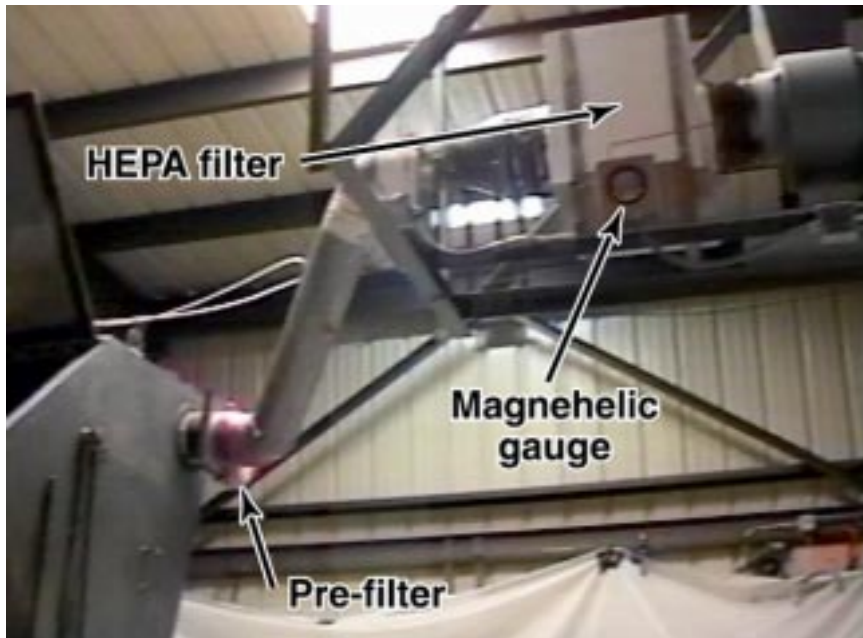
Exhibit 2-3: View of the Shredder's Ventilation System (following modifications and after the accident).

Smoke tests conducted by the re-entry team indicated that little air was flowing through the shredder's ventilation system due to a clogged pre-filter. The pre-filter was changed and found to be very dirty and extremely contaminated. Within minutes of being changed, the new pre-filter clogged up and the air-flow again returned to near zero. A second pre-filter change was made to restore adequate ventilation to the room.

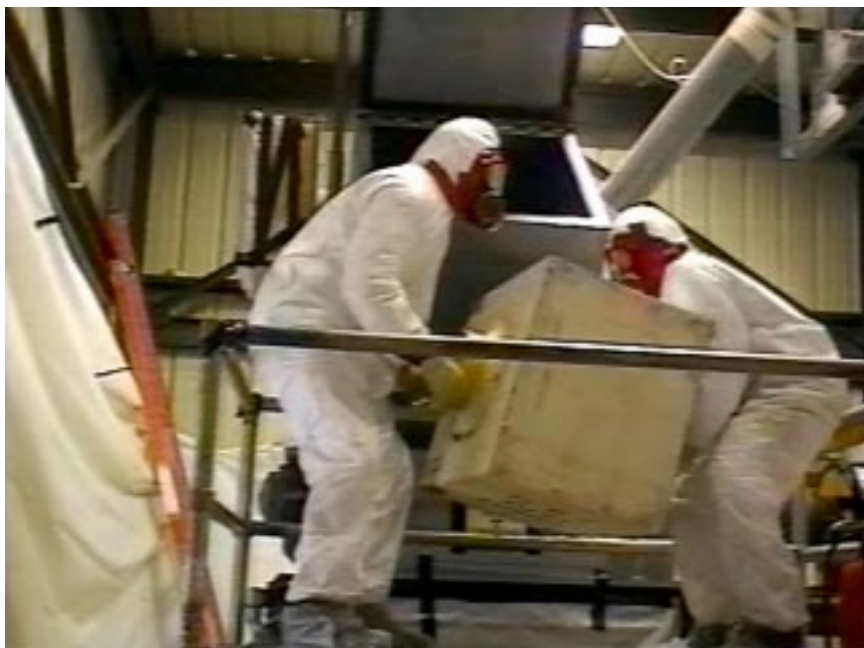
Exhibit 2-4: Shredder workers lifting HEPA filter into shredder hopper (during dry run).

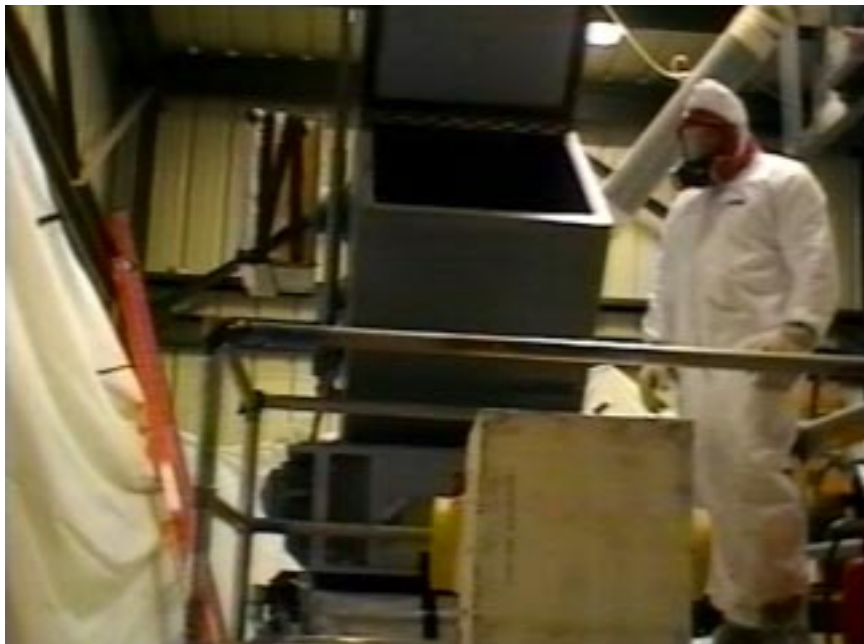
Exhibit 2-5: Shredder worker with shredder hopper door open (during dry run).

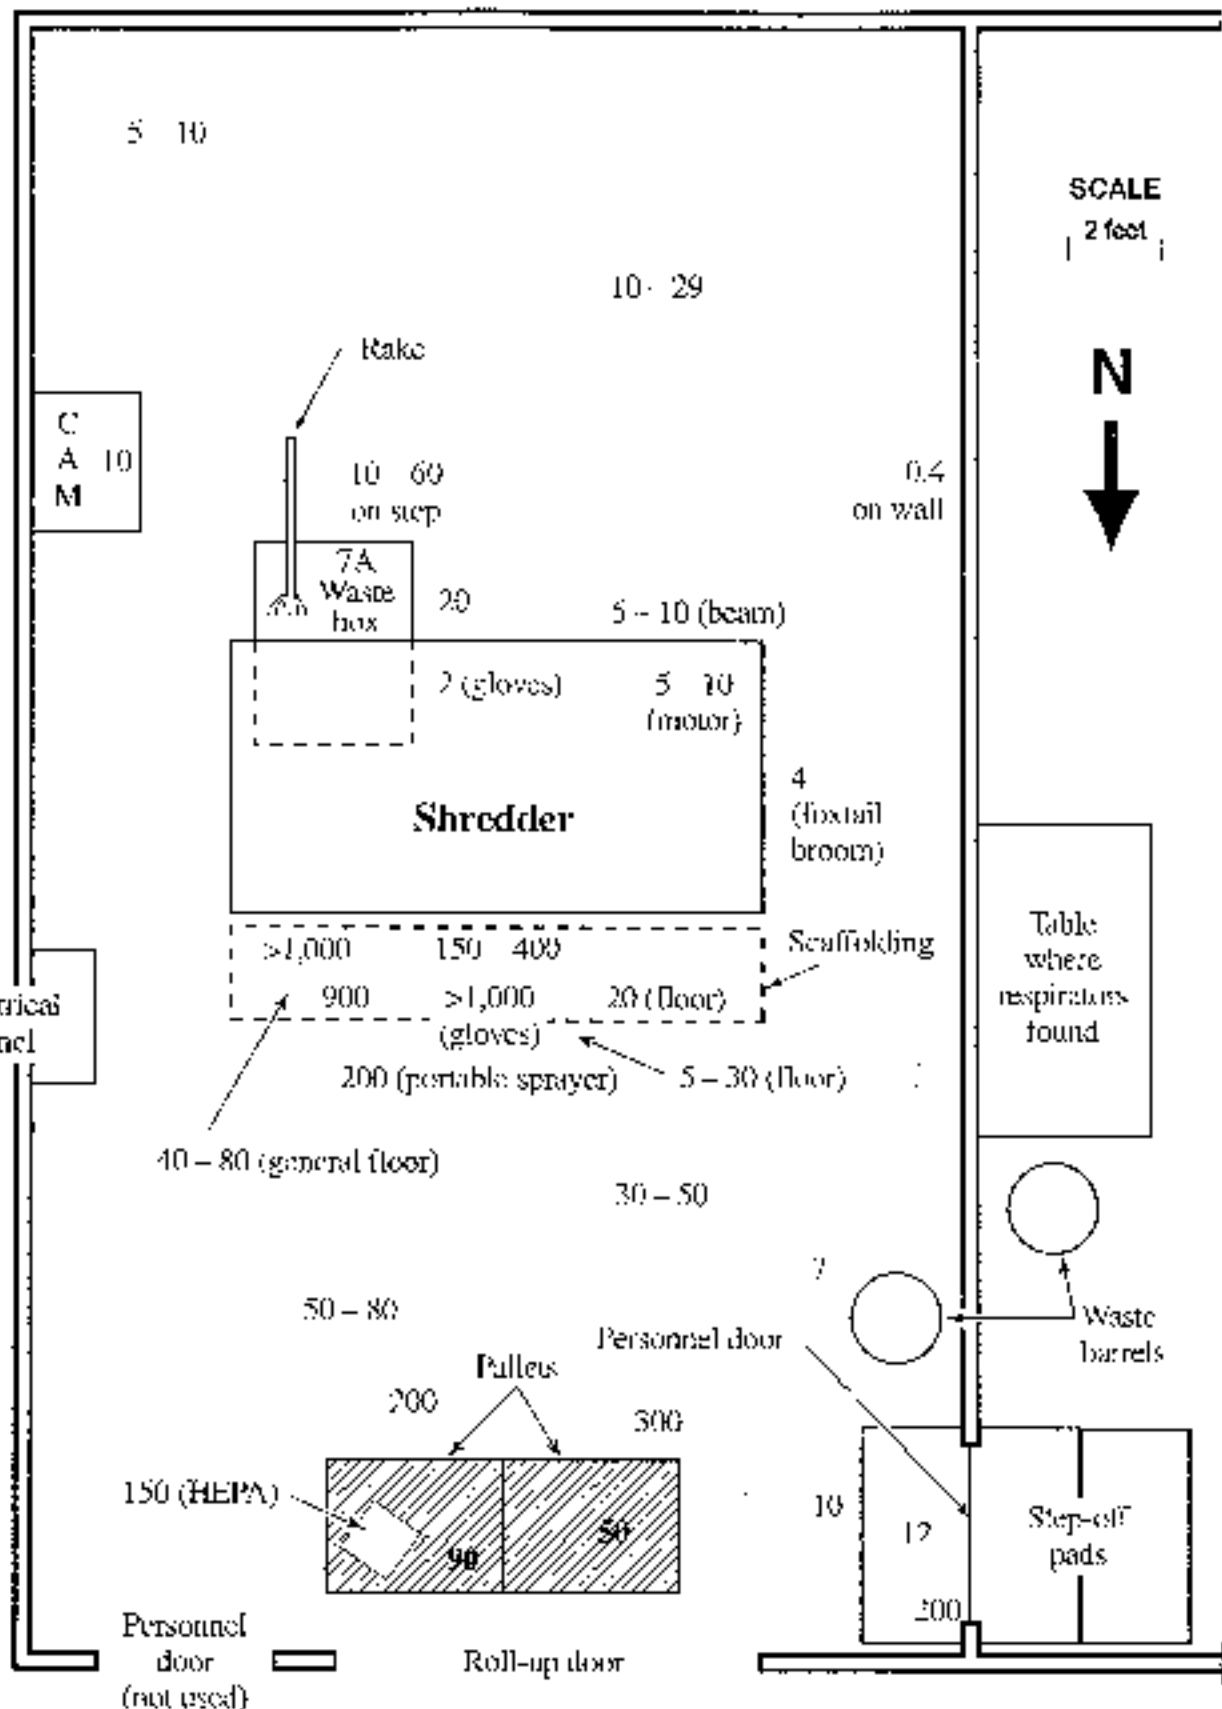
The interior of the personnel door into the shredder room was found to have contamination as high as 10,000 cpm. The plastic curtain draped just beyond the door opening had contamination of up to 12,000 cpm. A survey of the shredder room found widespread, high levels of contamination (see Figure 2-2, Direct alpha meter readings taken in the Shredder Room). The majority of readings on the floor and other flat surfaces read from 10,000 to 80,000 cpm.

The area in front of the roll-up door where the HEPA filters had been unwrapped had direct readings of 200,000 to 300,000 cpm. The scaffolding platform directly in front of the shredder hopper had areas

Figure 2-2: Direct alpha meter readings taken in the Shredder Room following the accident. Direct readings are $\times 10^4$ cpm.

that were off-scale for the portable alpha meter being used, indicating readings over 1,000,000 cpm. A pair of outer leather work gloves found on the scaffolding platform also read off-scale. The Sawzall was found on the platform in front of the shredder hopper. The saw had readings on its motor housing that were off-scale, as did a used blade that was found. Based upon the contamination level found on the Sawzall, it seems probable that the Sawzall was used to cut into the suspect filter (see Exhibit 2-6).

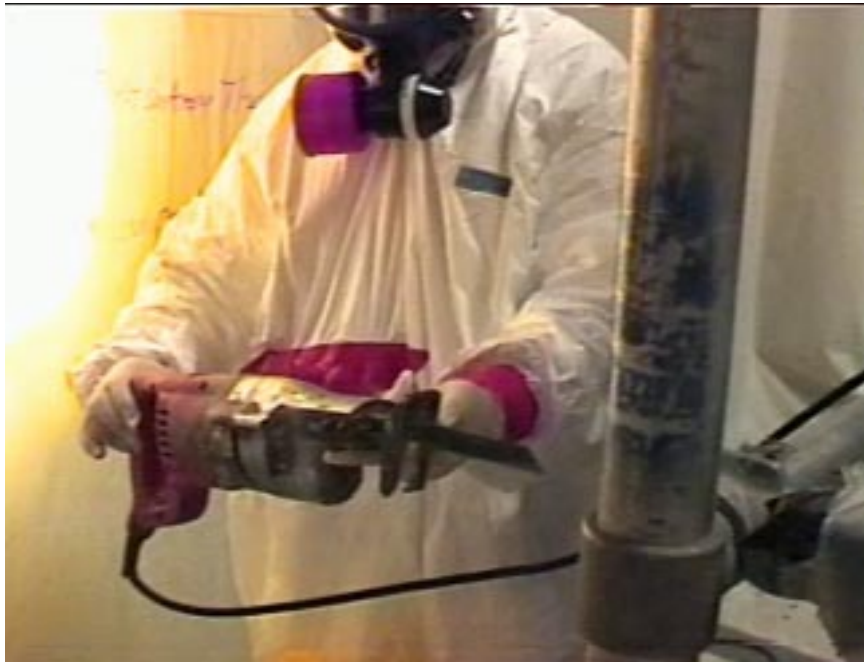
Exhibit 2-6: Re-entry technician holding the Sawzall (following

the accident).

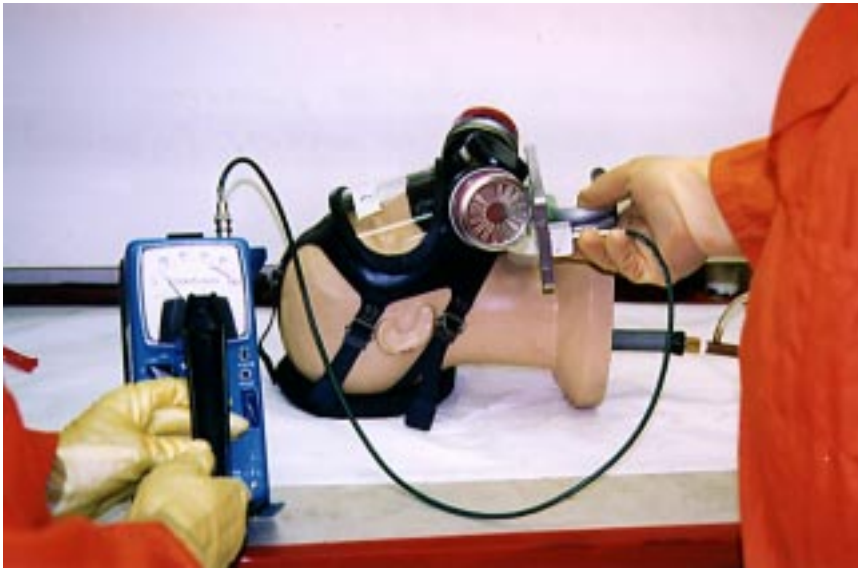
Exhibit 2-7: Photograph of Worker 1's Respirator during testing.

The contamination level on the plastic exhalation valve cover of Worker 1's respirator was found to be 30,000 cpm. The grooved area around the diaphragm indicated 10,000 to 12,000 cpm. The exterior side of the exhalation flapper valve indicated less than 1,000 cpm, while the interior surface indicated no contamination. An examination under a magnifying glass showed no evidence of cracks or objects that could have prevented the flapper valve from closing. The inside of the exhalation tunnel was swiped and no contamination was found.
