**Type-B Accident Investigation Report  
of the January 20, 1998, Electrical Accident  
at Casa Grande Substation, South of Phoenix, Arizona**

**Western Area Power Administration  
U.S. Department of Energy**

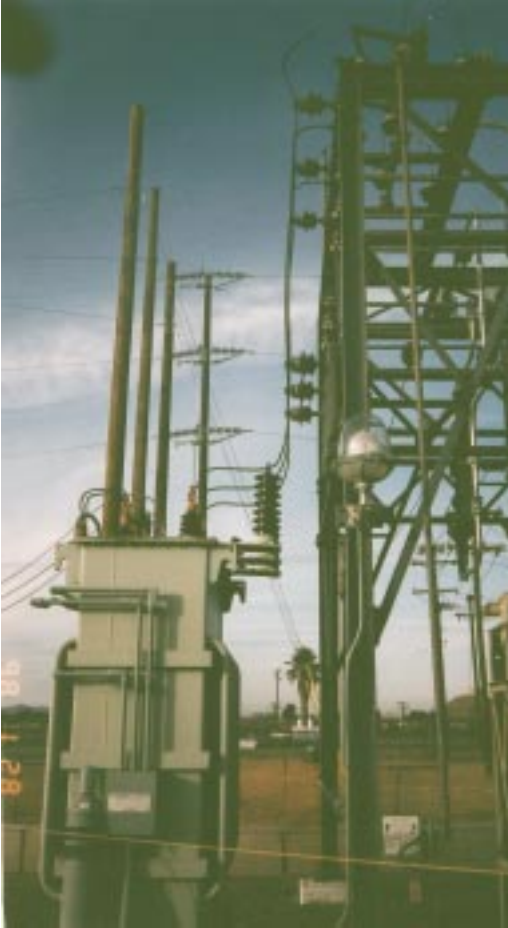
## **NORTH VIEW**

The grounding transformer KZ3A and jumpers scheduled to be removed to place an isolation barrier on the west-end. The picture also shows Disc. SW. 1421 open, locked and tagged

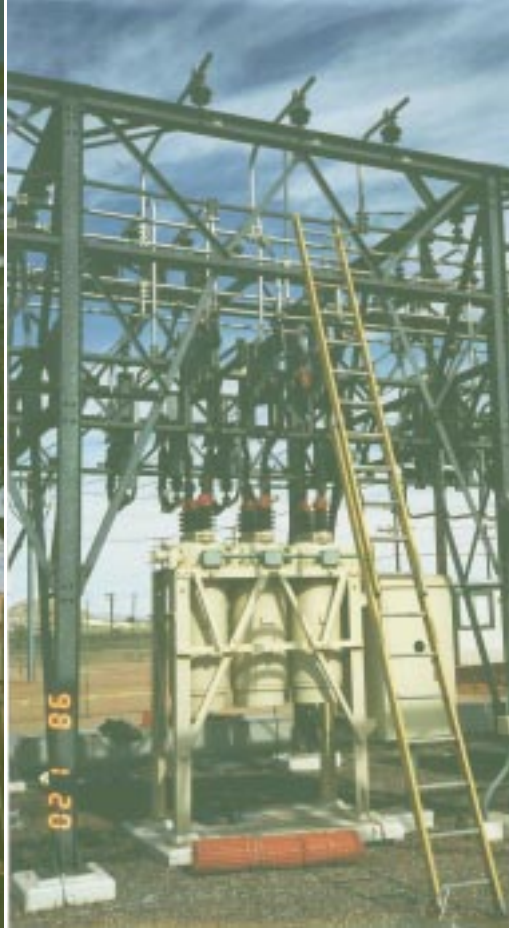
## **BAY Z1 NORTH VIEW**

Showing the location where work was to be performed, which included removal of three pieces of stub bus

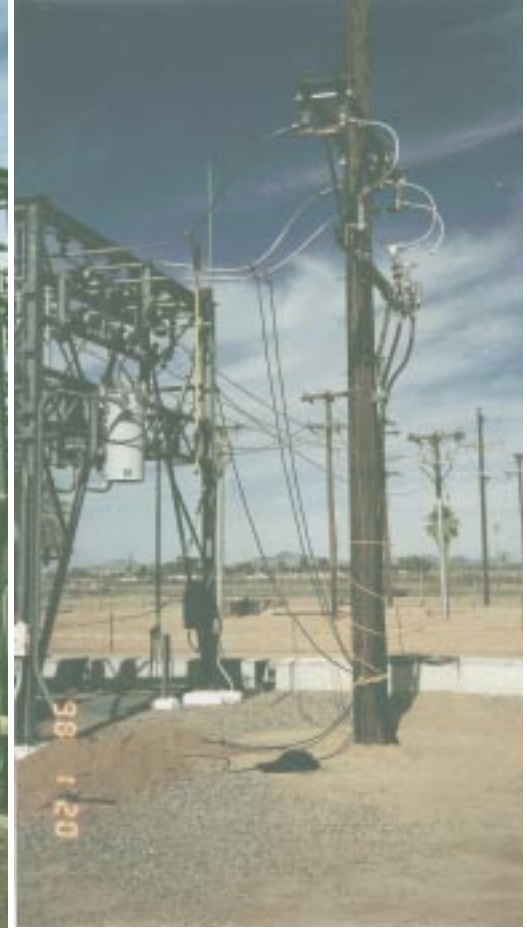
## **NORTH VIEW**

Temporary feed located east of the 12.47-kV bus structure. The picture also shows the location of personal protective grounds on the east side of the main bus.

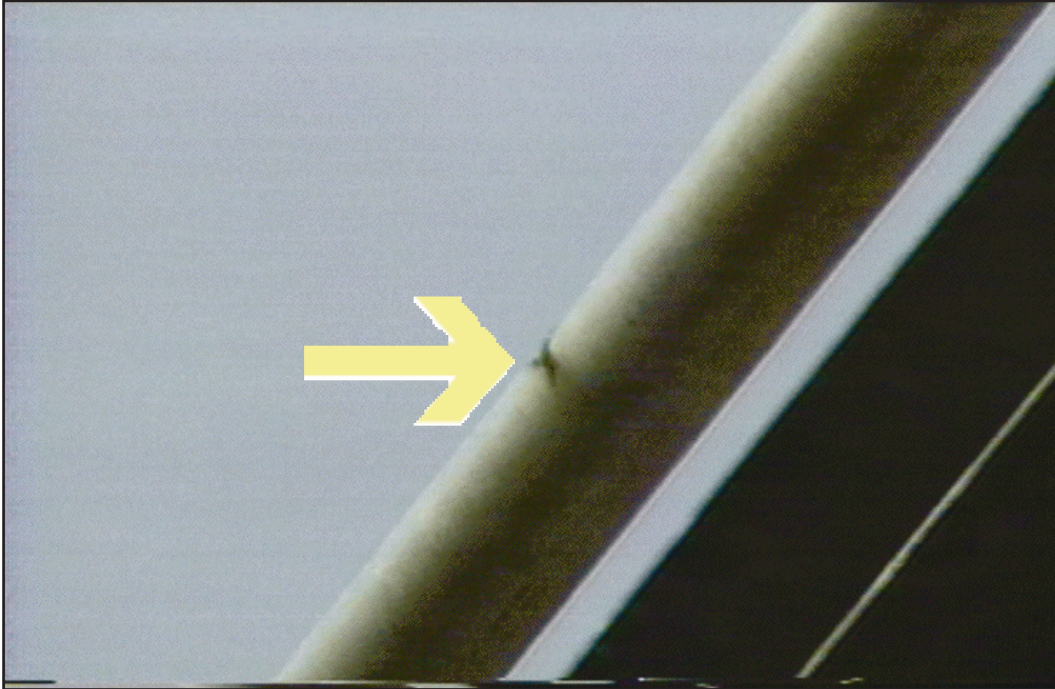
## **EXHIBIT B**

Electrical burn mark on south phase of 12.47-kV transfer bus

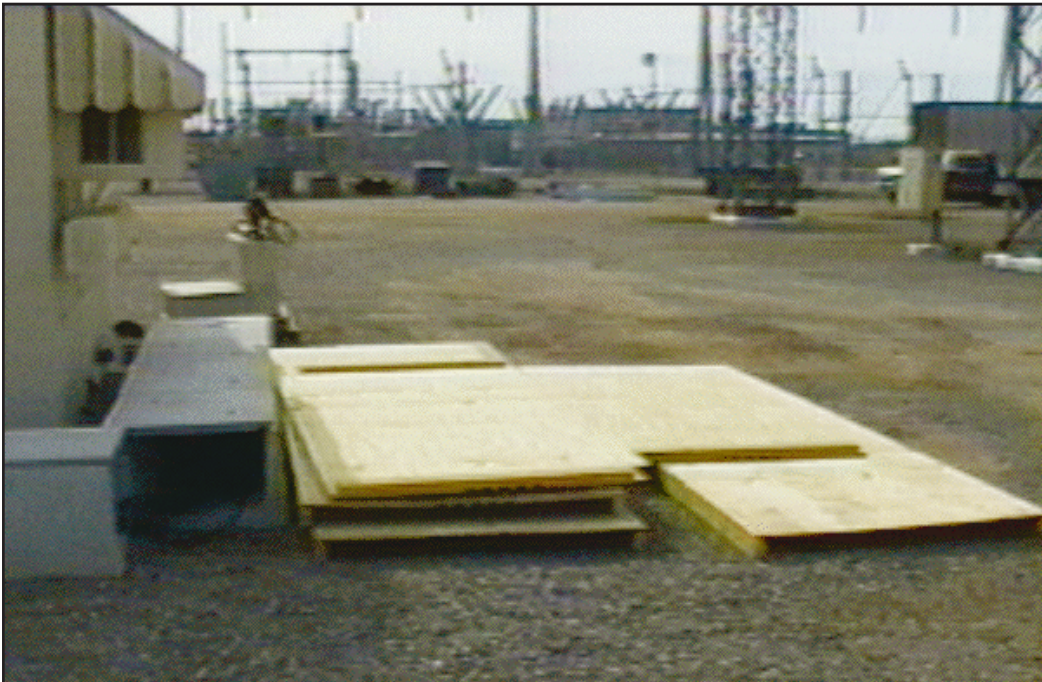
## **EXHIBIT C**

View of the prefabricated isolating barriers to be placed along the south and west sides of the 12.47-kV bus structure

This meeting, according to the minutes, was comprehensive and included some issues pertinent to the specific job. Placement of plywood barricades (Exhibit C) on portions of the south and west sides of the bus structure was discussed. Discussion items included working in close proximity to energized facilities, the need for a JHA, maintaining safe working distances, hot line orders (HLOs), and proper grounding procedures, including documentation of locations of grounds on the Special Work Permit (Appendix C).

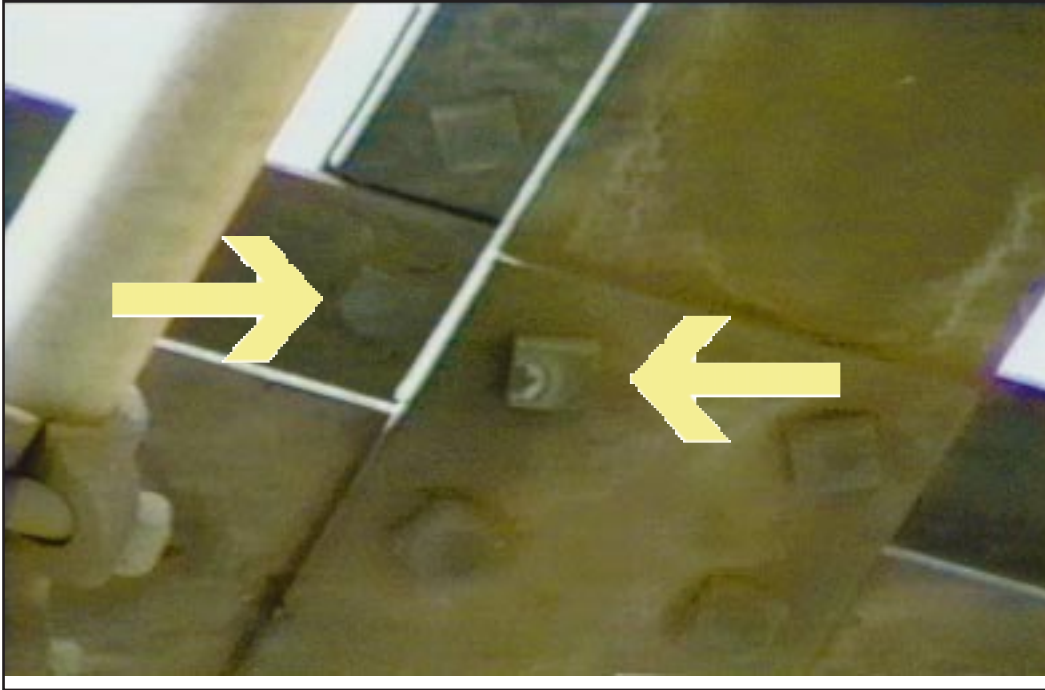
**EXHIBIT D**

View showing a burn mark on the bottom of the bolt head located on the 12.47-kV steel structure

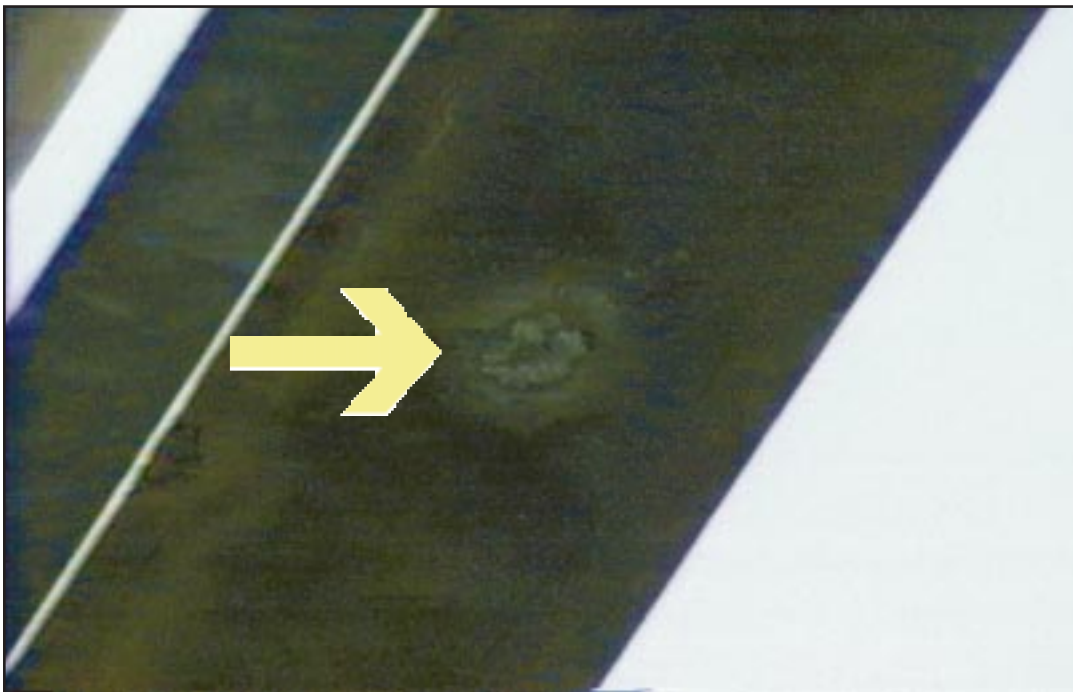
**EXHIBIT E**

View of a burn mark located on the bottom section of the steel beam

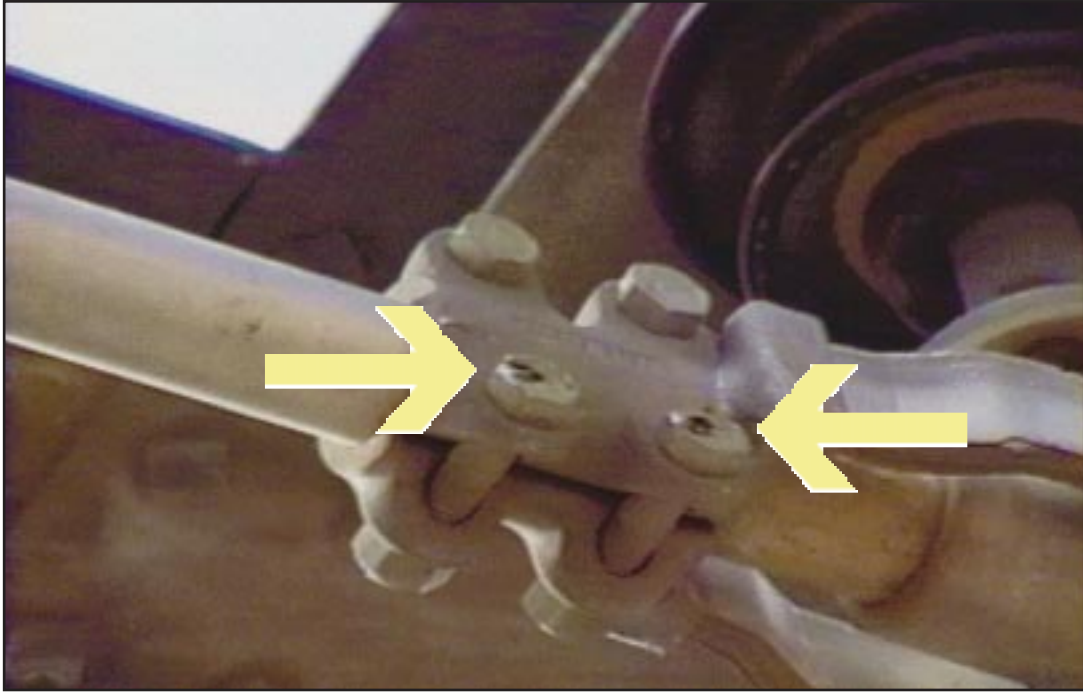
## **EXHIBIT F**

View of burn marks on the bolts located on the center phase transfer bus

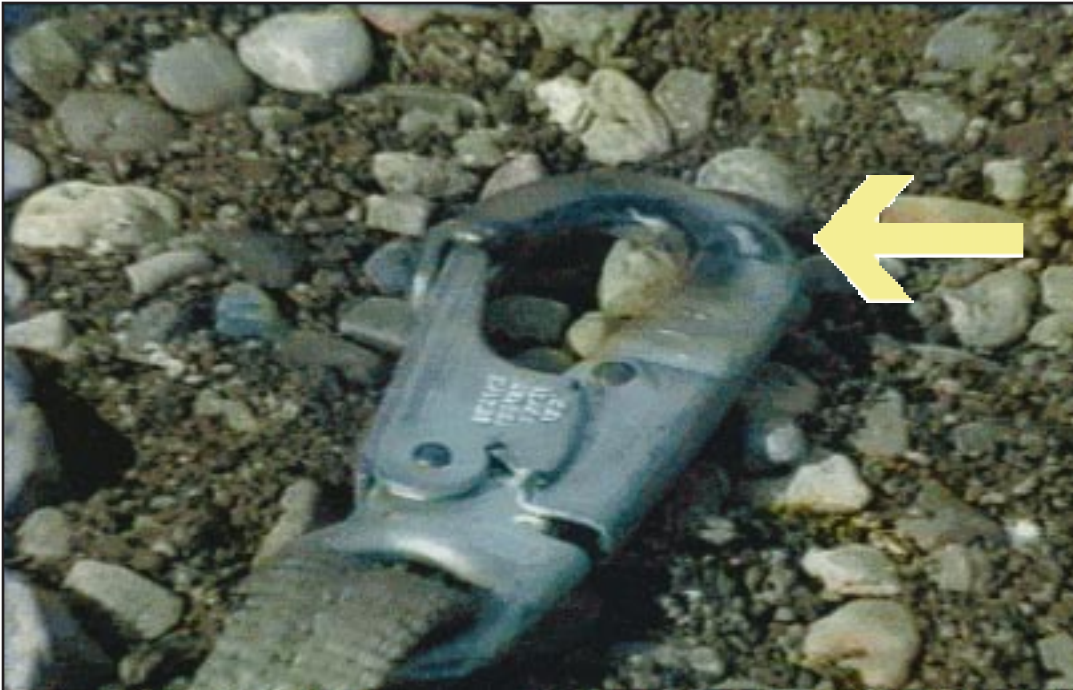
## **EXHIBIT G**

View of electrical burn mark located on the victim's lanyard

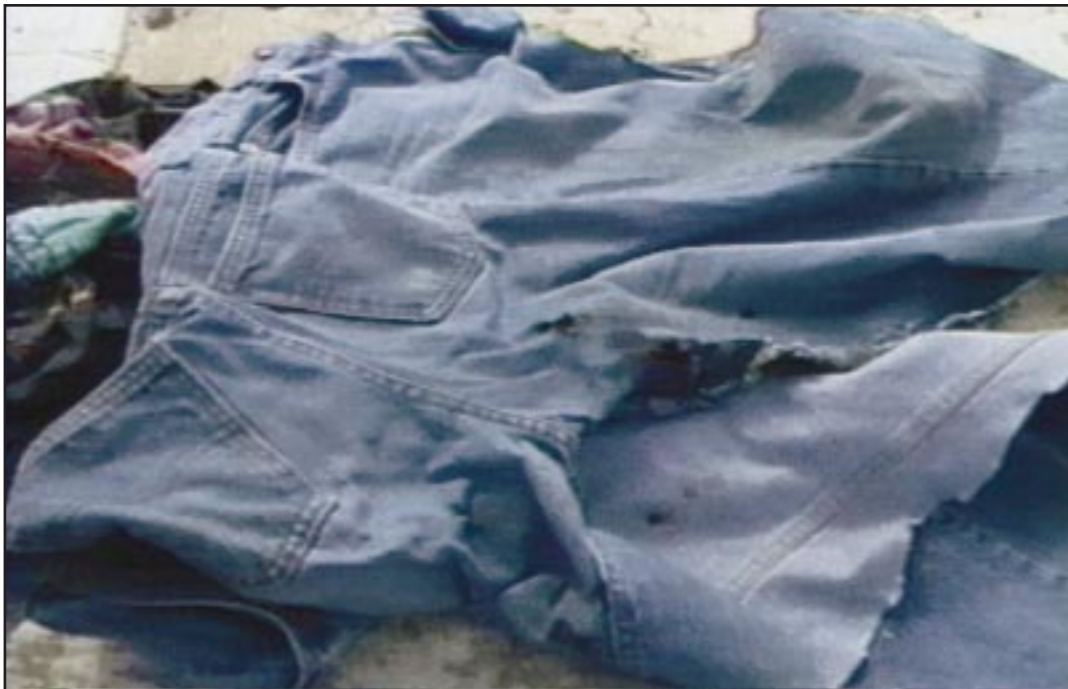
**EXHIBIT I**

View showing burn marks on the victim's pants
