**Type B Accident
Investigation Board Report
on the March 27, 1998
Rotating Shaft Accident
at
Ames Laboratory
Ames, Iowa**

April 1998

**Chicago Operations Office
U.S. Department of Energy**

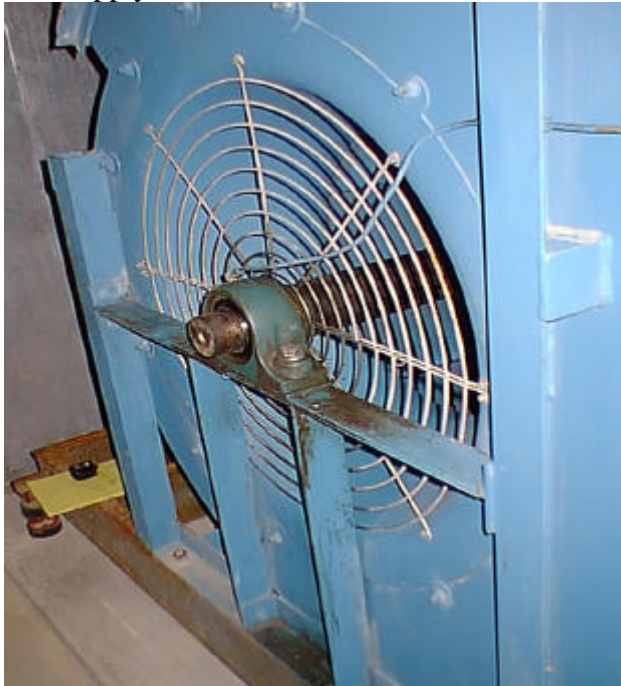
Exhibit 2-1. Supply Fan

A duct smoke detector alarm automatically shut off the air handling fans in TASF.

Exposed fan shaft
(not energized)

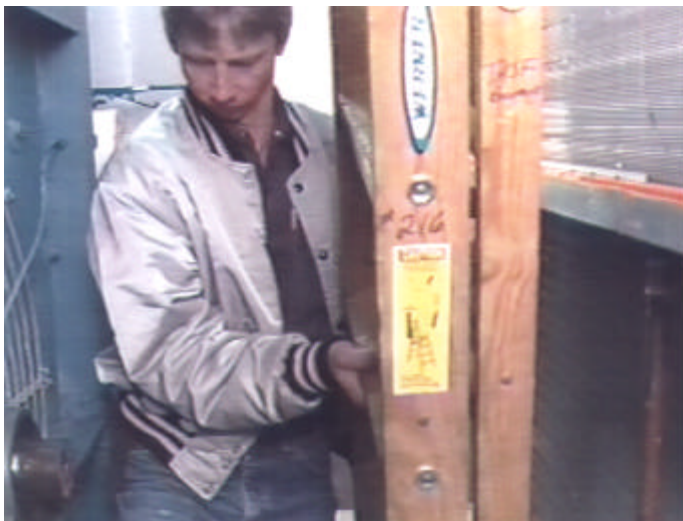
Exhibit 2-2. Re-enactment of Electrician Carrying Ladder in Supply Fan Room

Space in the supply fan room is cramped.

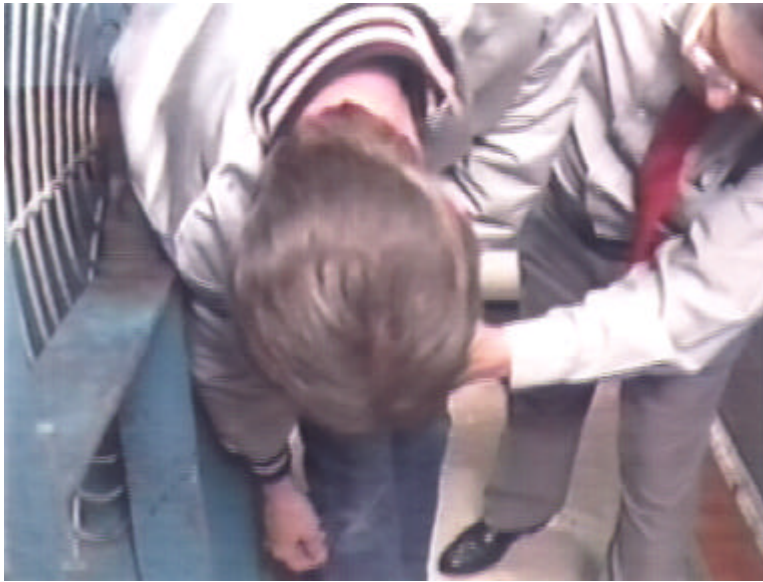
Exhibit 2-3. Re-enactment of Mechanic Assisting Injured Electrician

The Mechanic saw the Electrician slumped, lifted him off the shaft, then gently laid him on the floor. He then called for assistance.

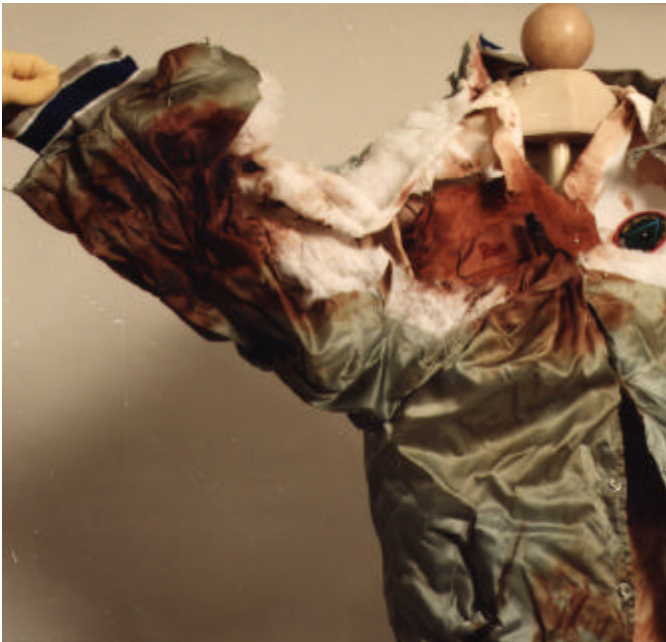
Exhibit 2-4. Electrician's Jacket

- No hazard analysis of the work that the Electrician and the Mechanic were performing at the time of the accident was conducted before commencing the work.
- The Electrician’s jacket was unbuttoned at the time of the accident.

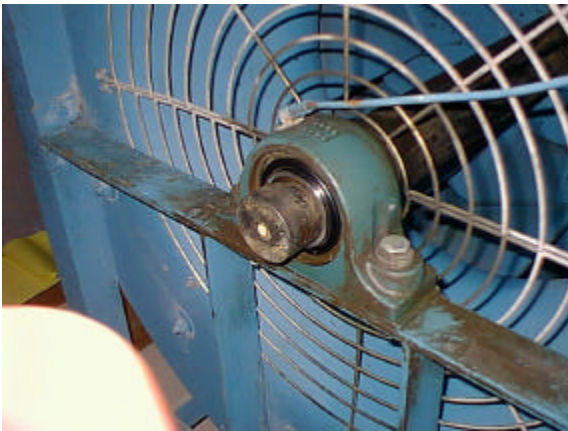
Exposed Shaft

- The exposed rotating shaft was not guarded to prevent possible contact.
- There was no motion hazard safeguarding device that would prevent or stop normal motion of the shaft if someone were to enter the hazardous area.
- Maintaining a safe distance from possible contact did not guard the exposed shaft. The top of the shaft was located only 45 inches from the floor.
